report no. CDOT-DTP-R-86-3

CRUMB RUBBER CHIP SEAL East of Punkin Center

Final Report
March 1986

Project RS 0094(7)
East of Punkin Center

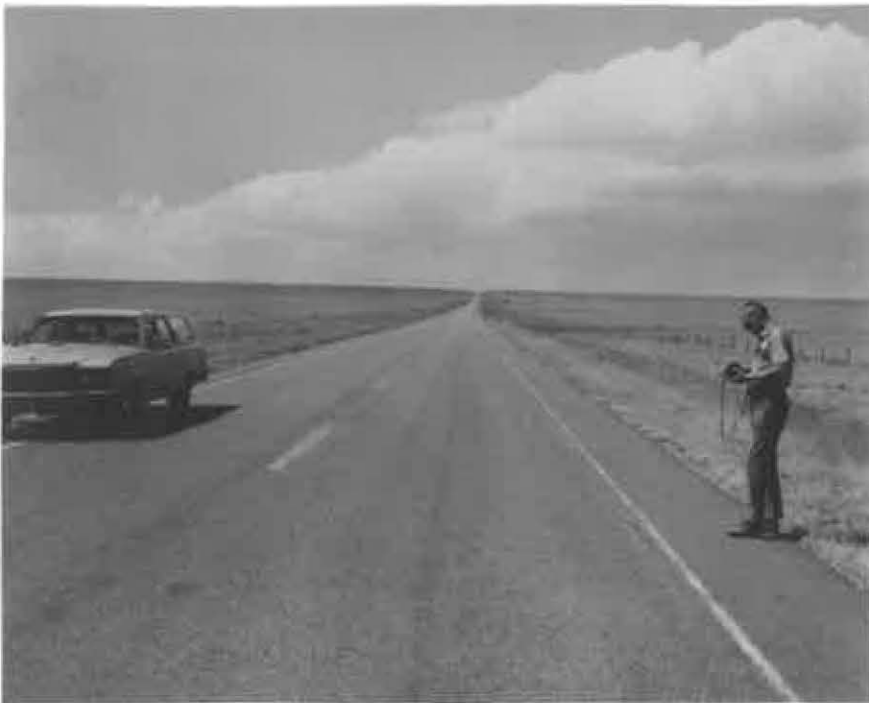
Photograph No. 1

Typical pavement condition prior to crumb rubber chip seal. Pavement is in good condition except for minor cracking and surface raveling.

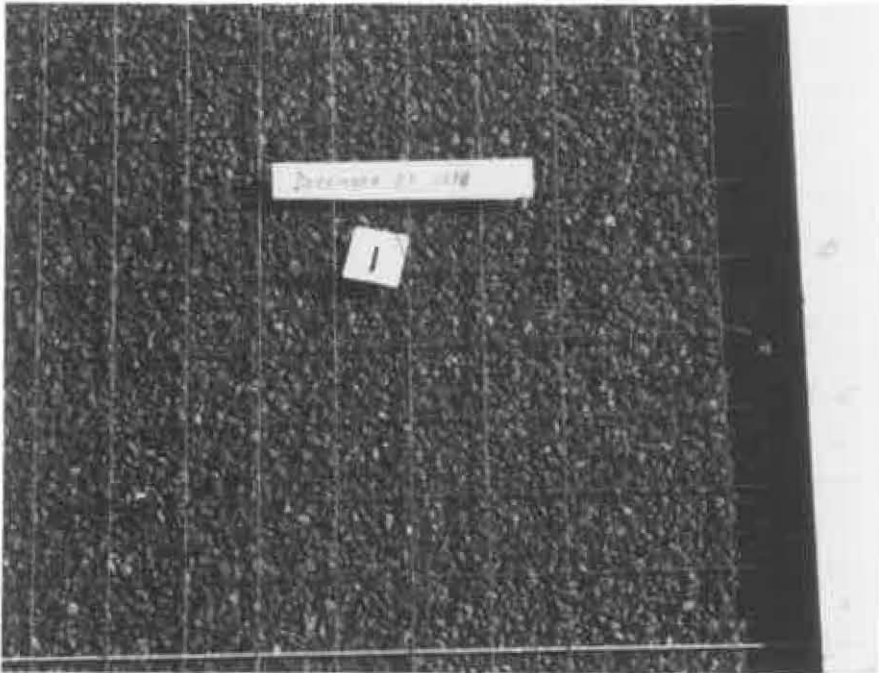
Photograph No. 5
12/27/78
Sections 1 & 5 — Sahuaro
Crumb Rubber binder.
Typical surface appearance 5
months after construction.
Sections 1 & 5 contained the
same binder material (the
string grid was used to
measure chip loss).

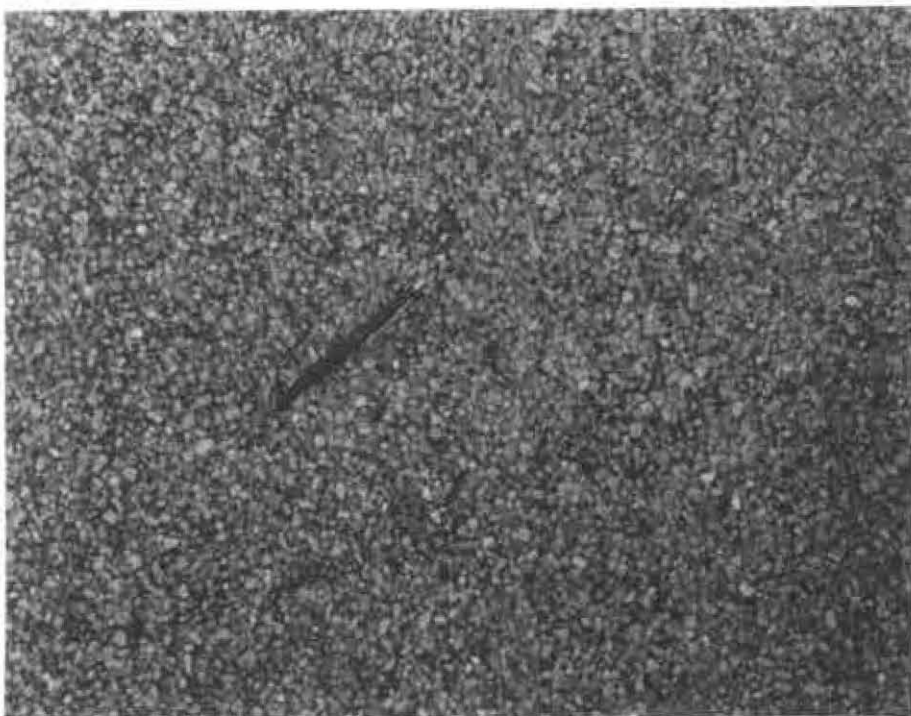
Photograph No. 6
4/28/82
Sections 1 & 5 — Sahuaro
Crumb Rubber binder.
Typical surface appearance 4
years after construction of
Sections 1 & 5. Note that
the 1% AC-10 coating has
weathered off the chips, but
they are firmly attached to
the pavement surface.

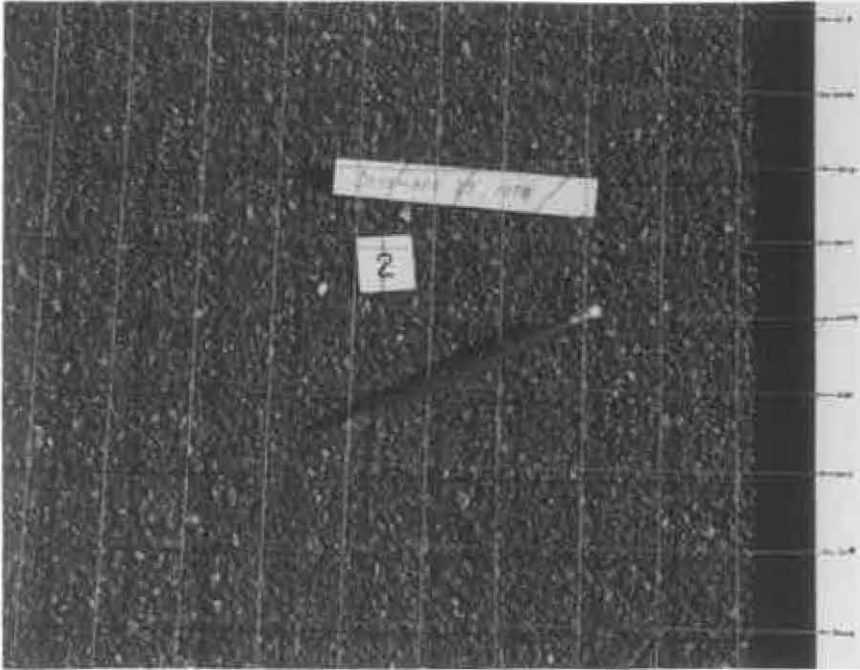
Photograph No. 7
12/27/78
Sections 2 & 6 -- RC-800
Rubberized binder.
Typical appearance after 5
months.

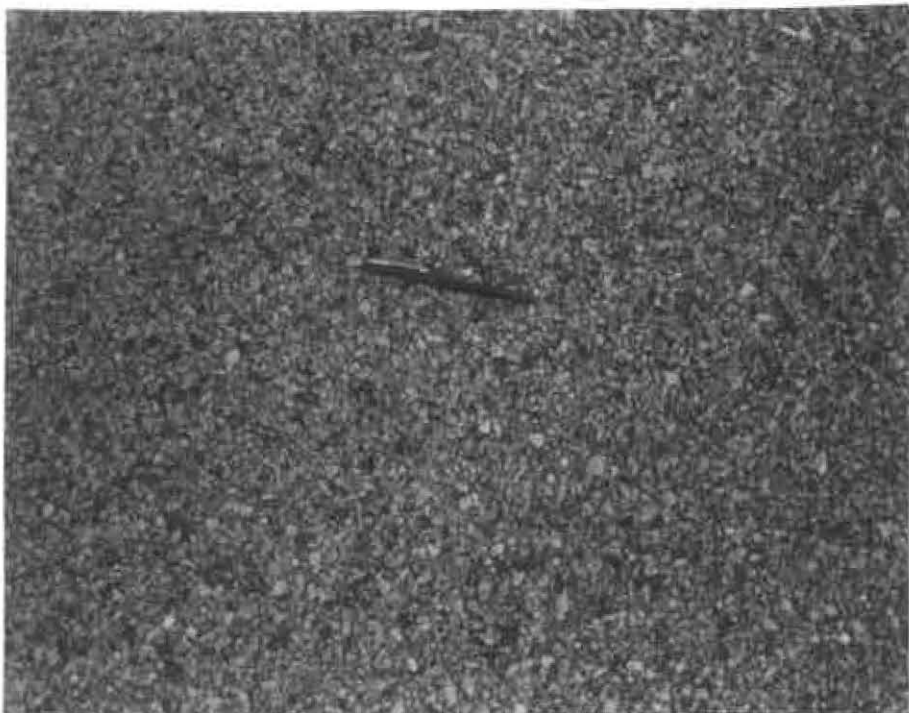
Photograph No. 8
4/28/82
Sections 2 & 6 -- RC-800
Rubberized binder.
Typical appearance after 4
years.

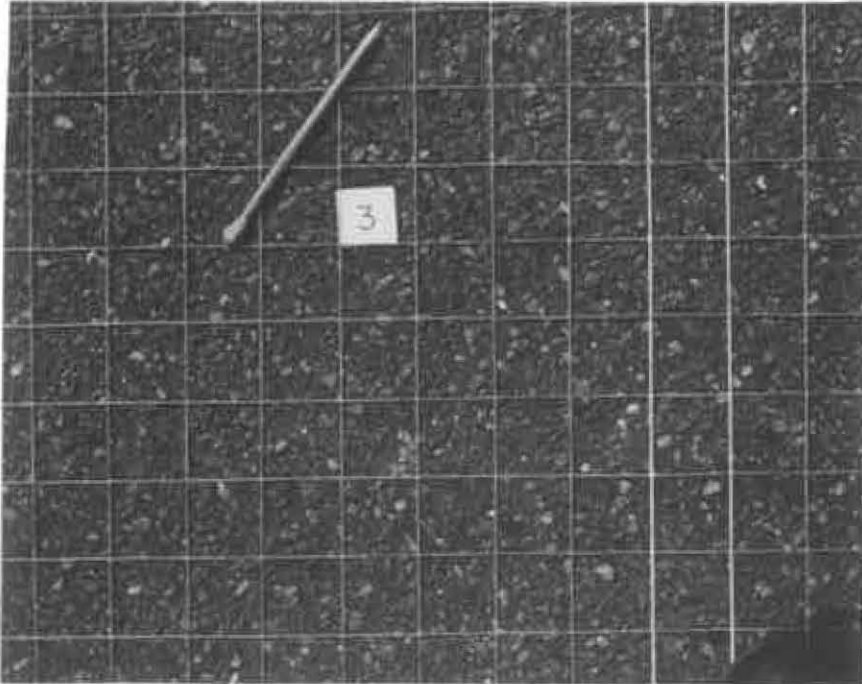
Photograph No. 9
7/21/78
Sections 3 & 7 — AC-10
binder.
Typical appearance two weeks
after construction.

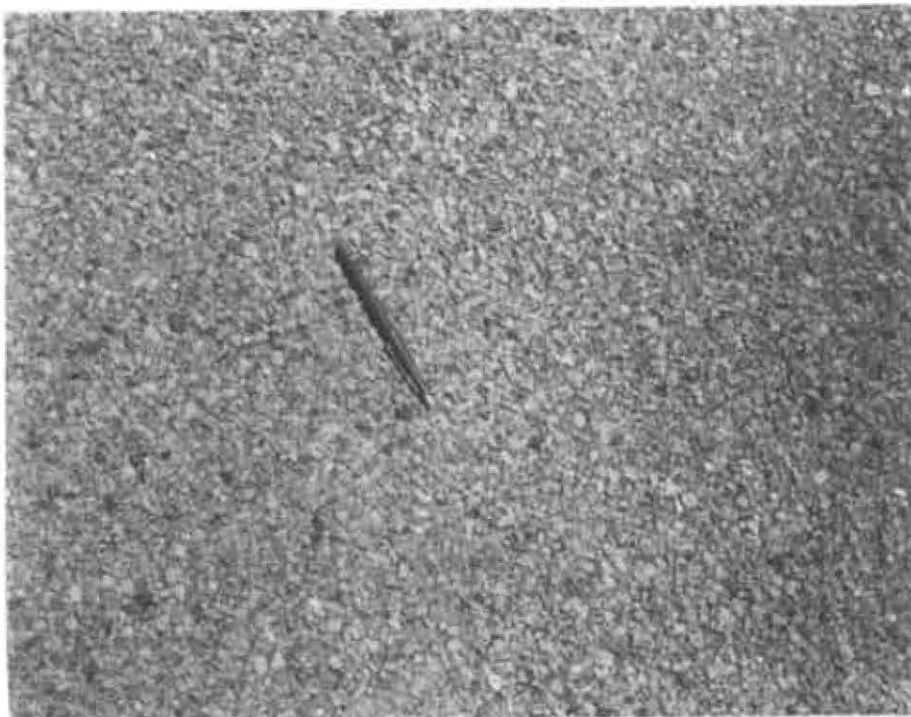
Photograph No. 10
4/28/82
Sections 3 & 7 — AC-10
binder.
Typical appearance after 4
years.

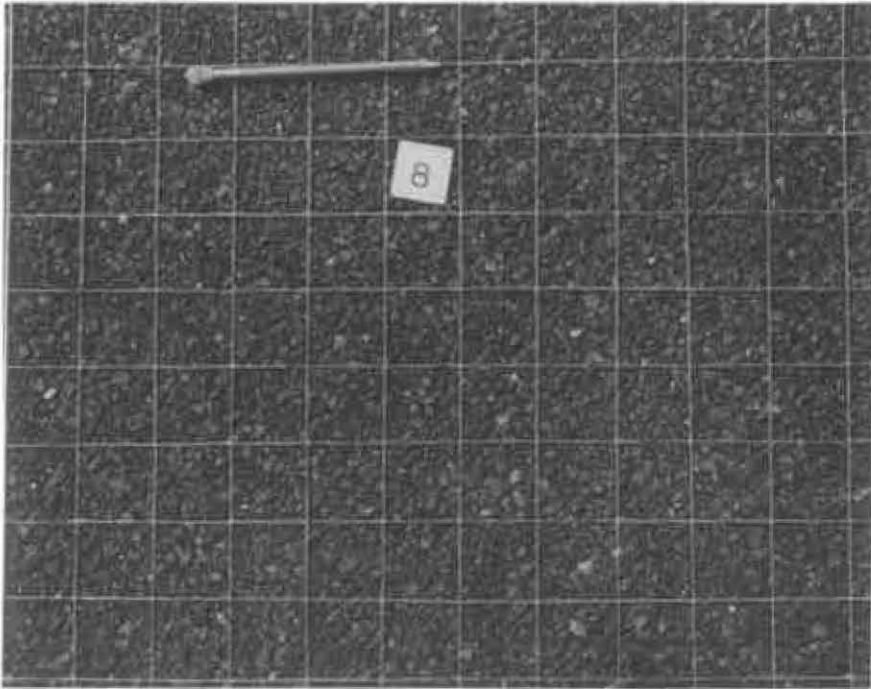
Photograph No. 11

Sections 4 & 8 -- Arizona
Refineries Crumb Rubber
binder.

Typical appearance two weeks
after construction.

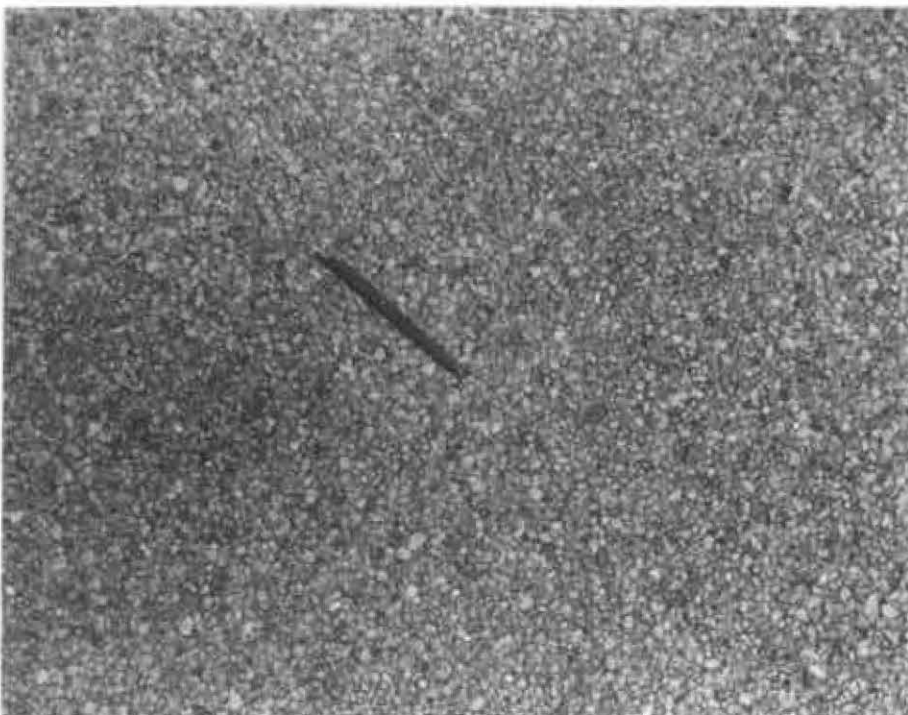
Photograph No. 12

Sections 4 & 8 -- Arizona
Refineries Crumb Rubber
binder.

Typical appearance after 4
years.

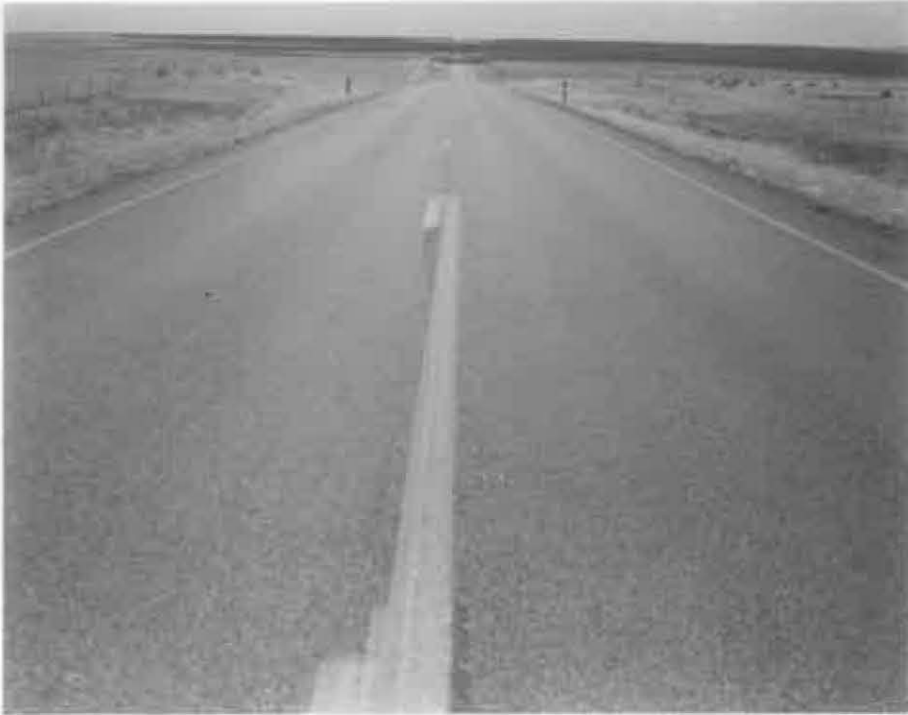
Photograph No. 13
4/28/82
Looking east at Test
Sections 1-4 after 4 years.
The performance of the
different binders is
difficult to distinguish
without close inspection.

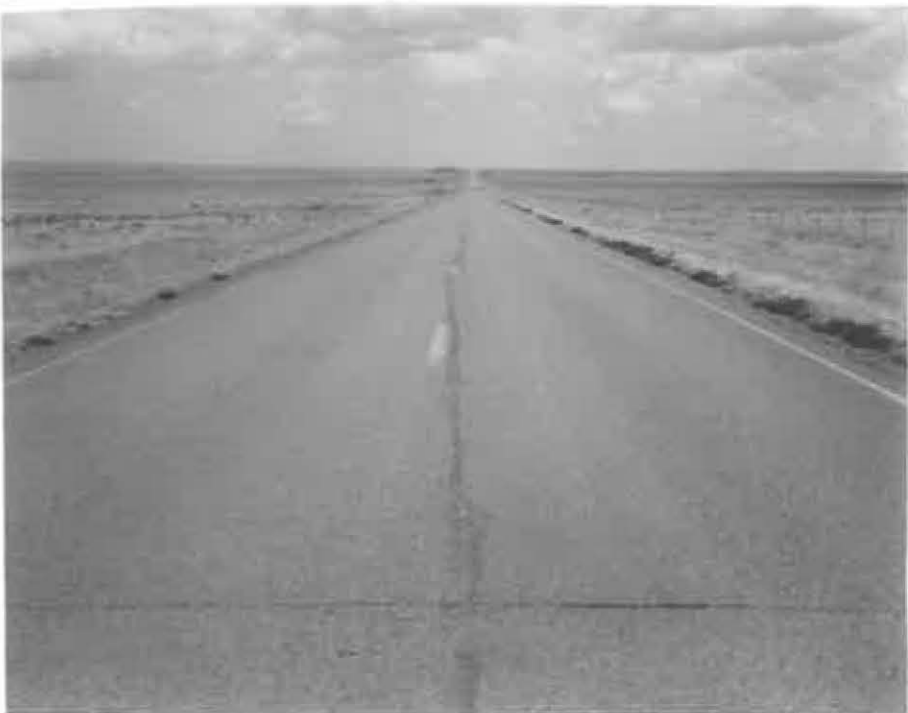
Photograph No. 14
4/28/82
Looking east at Test
Sections 5-8 after 4 years.
All of the binder materials
performed well on this
project.
