# REHABILITATION OF CONCRETE PAVEMENTS

**COLORADO DEPARTMENT OF HIGHWAYS**

Final Report  
January, 1983

1. Report No. CDOH-R-83-1		2. Government Accession No.		3. Recipient's Catalog No.	
4. Title and Subtitle Rehabilitation of Concrete Pavements				5. Report Date

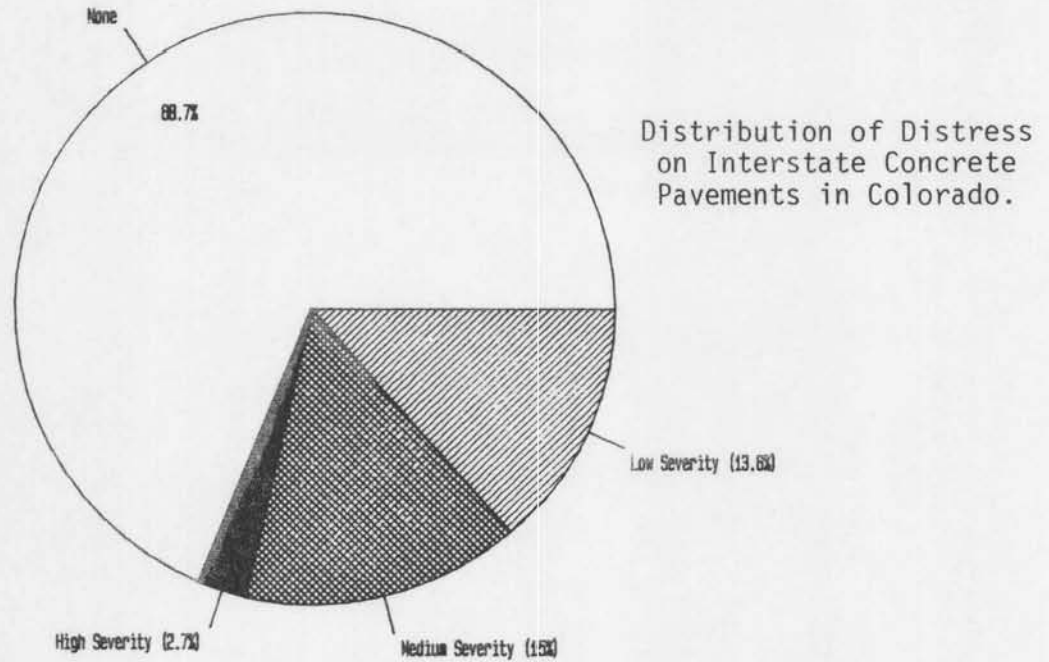
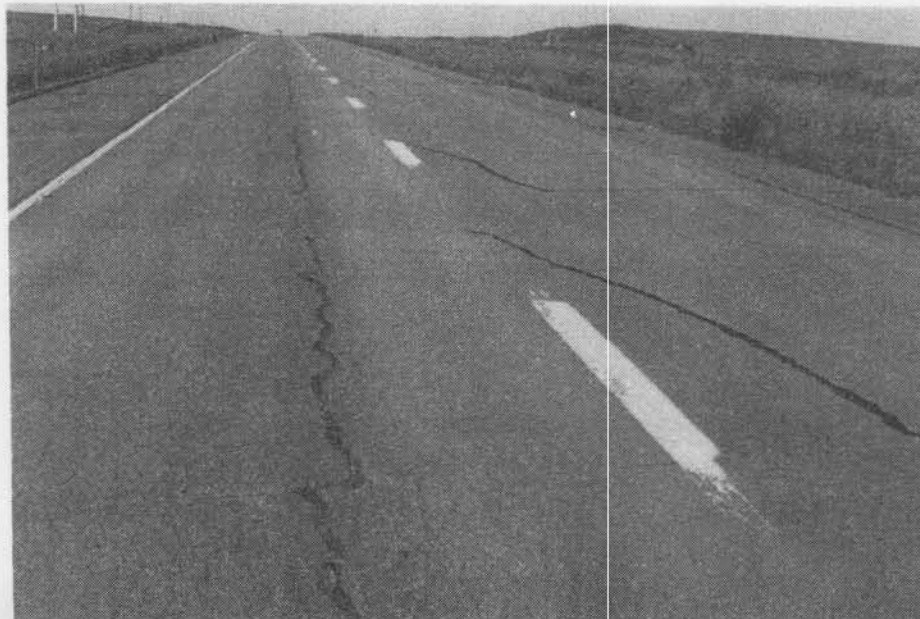
Figure 3

LONGITUDINAL CRACKING DISTRESS

Longitudinal cracks occur generally parallel to the centerline of the pavement. They are often caused by improper construction of longitudinal joints, or by a combination of heavy load repetition, loss of foundation support, internal vibrator failure, and thermal and moisture gradient stresses.

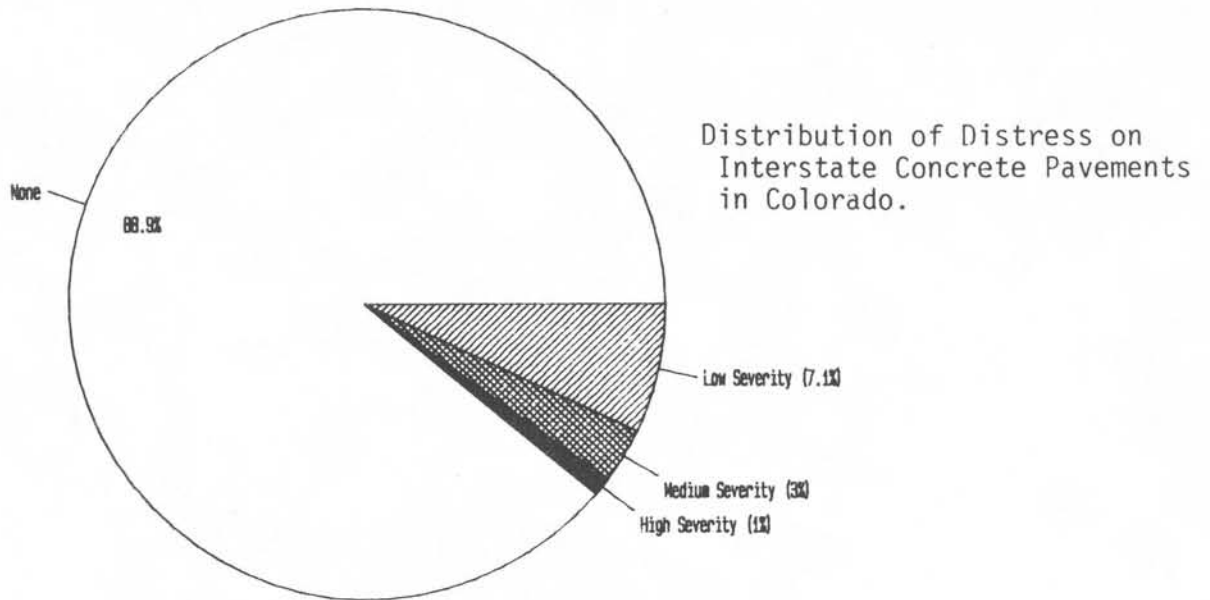
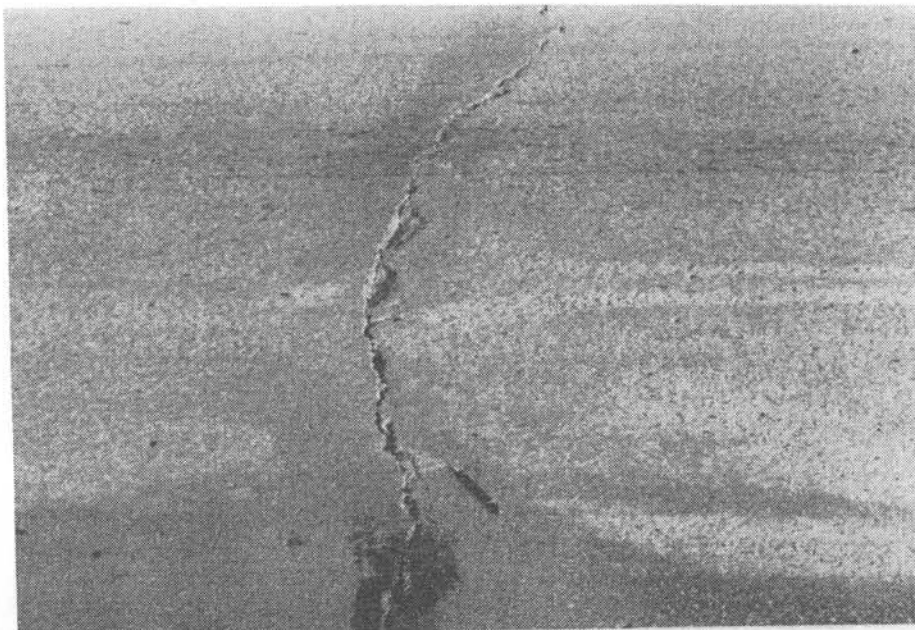
Figure 4

### TRANSVERSE CRACKING DISTRESS

These cracks are usually caused by a combination of heavy load repetition, thermal and moisture gradient stresses, and drying shrinkage stresses. Medium or high severity cracks are working cracks and are considered major structural distresses.

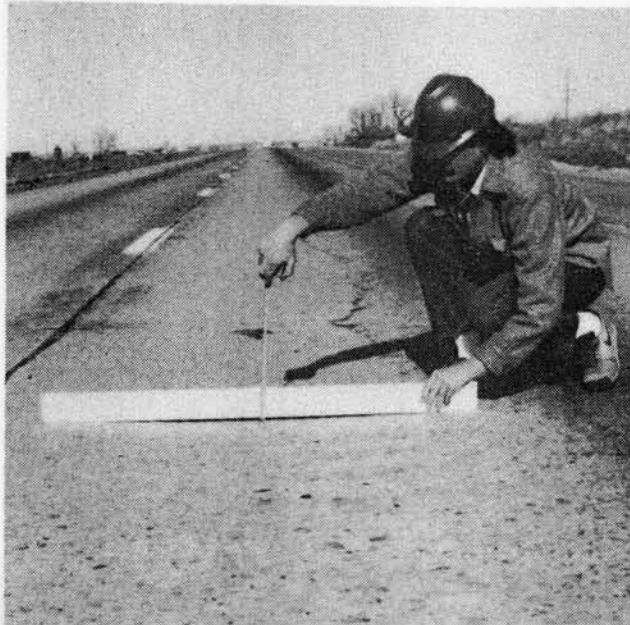
RUTTING DISTRESS

A rut is a surface depression in the wheel paths. In many instances ruts are noticeable only after a rain-fall, when the wheel paths are filled with water. Significant rutting can lead to major structural failure of the pavement and hydroplaning potential. Rutting stems from wearing of the surface in the wheel paths from studded tires.

Medium Severity

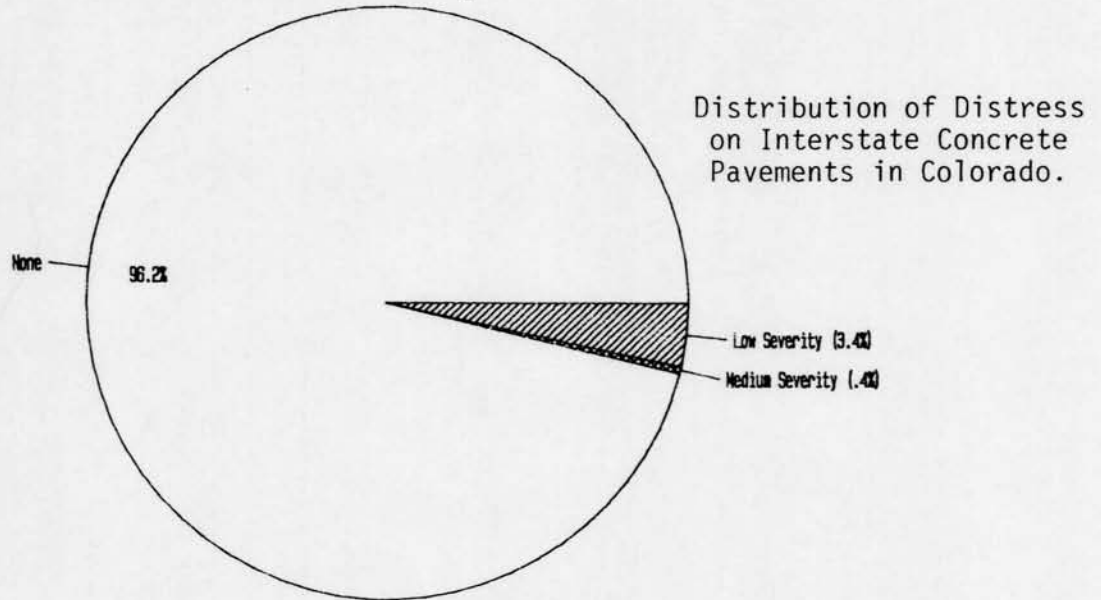
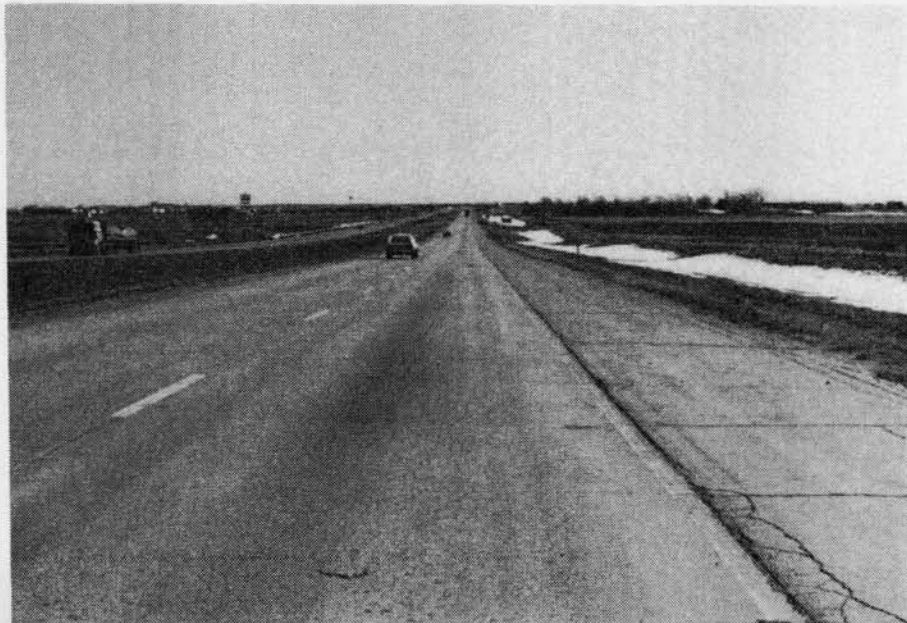
Figure 6

### DEPRESSION DISTRESS

Depressions in concrete pavements are surface areas having elevations lower than those of the surrounding pavement. There is generally significant slab cracking in these areas due to uneven settlement. In many instances, light depressions are not noticeable until after a rain when ponding water creates "bird-bath" areas. The depressions may also be located without rain by stains caused by oil droppings from vehicles. Depressions can be caused by settlement or consolidation of the foundation soil or can be "built in" during construction. They are frequently found above culverts. This is usually caused by poor compaction of soil around the culvert during construction. Depressions cause slab cracking, roughness, and hydroplaning when filled with water of sufficient depth.

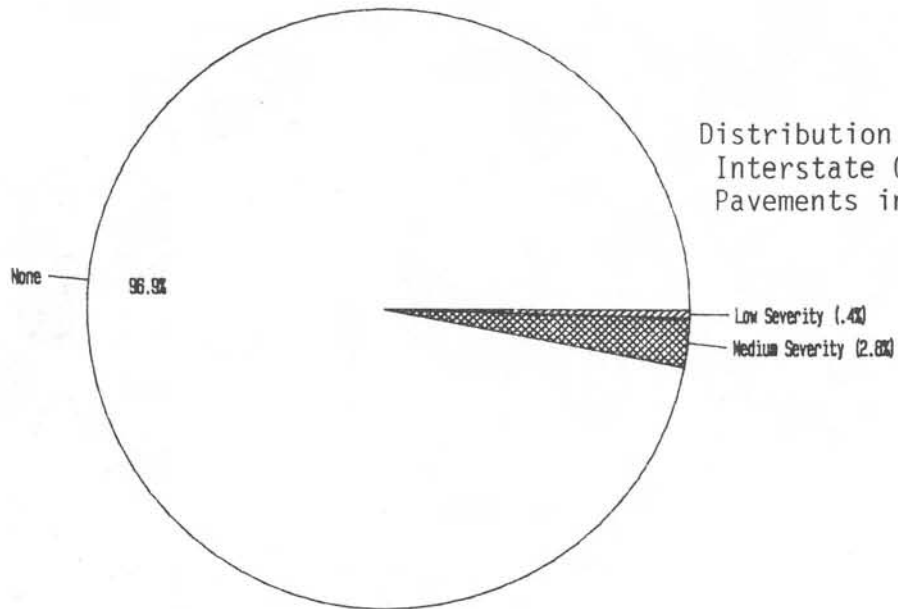
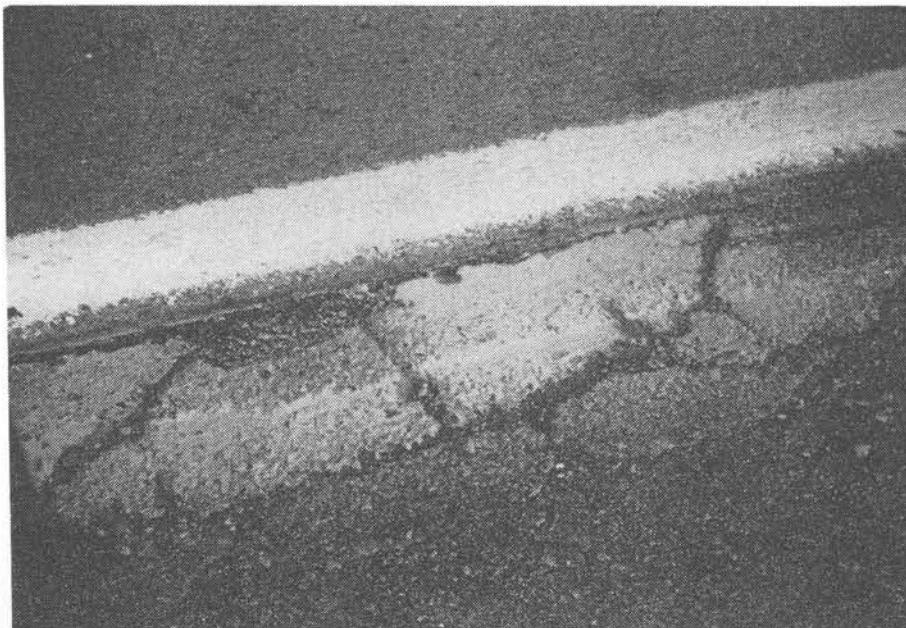
Figure 7

### PUMPING DISTRESS

Pumping is the ejection of material by water through joints or cracks, caused by deflection of the slab under moving loads. As the water is ejected, it carries particles of gravel, sand clay, or silt, resulting in a progressive loss of pavement support. Surface staining or accumulation of base or subgrade material on the pavement surface close to joints or cracks is evidence of pumping. Pumping can occur without such evidence, particularly when stabilized bases are used. The observation of water being ejected by heavy traffic loads after a rain storm can also be used to identify pumping. Water bleeding occurs when water seeps out of joints or cracks.

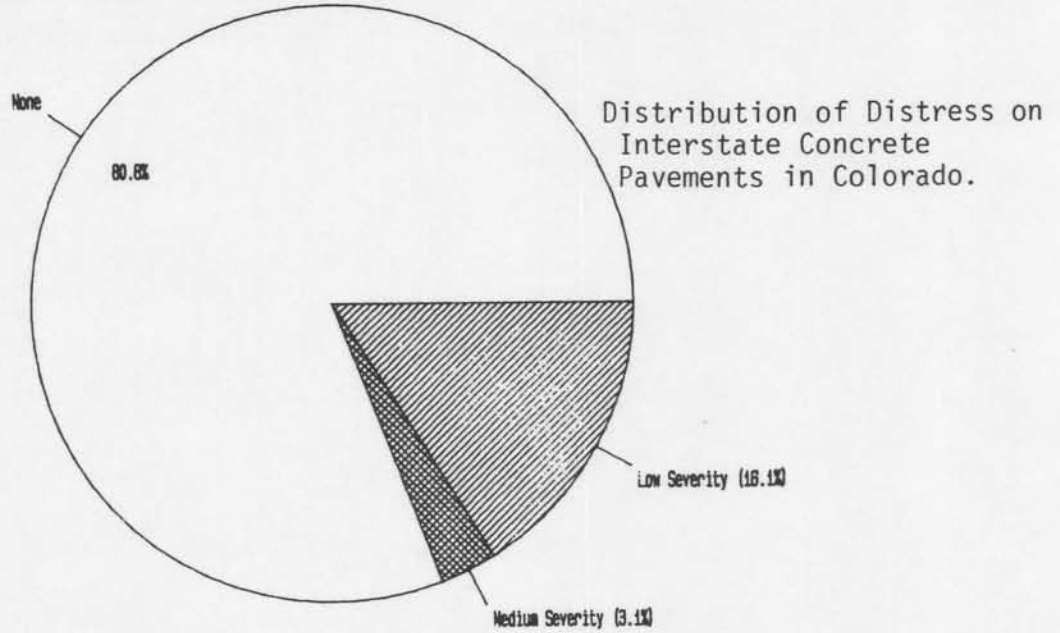
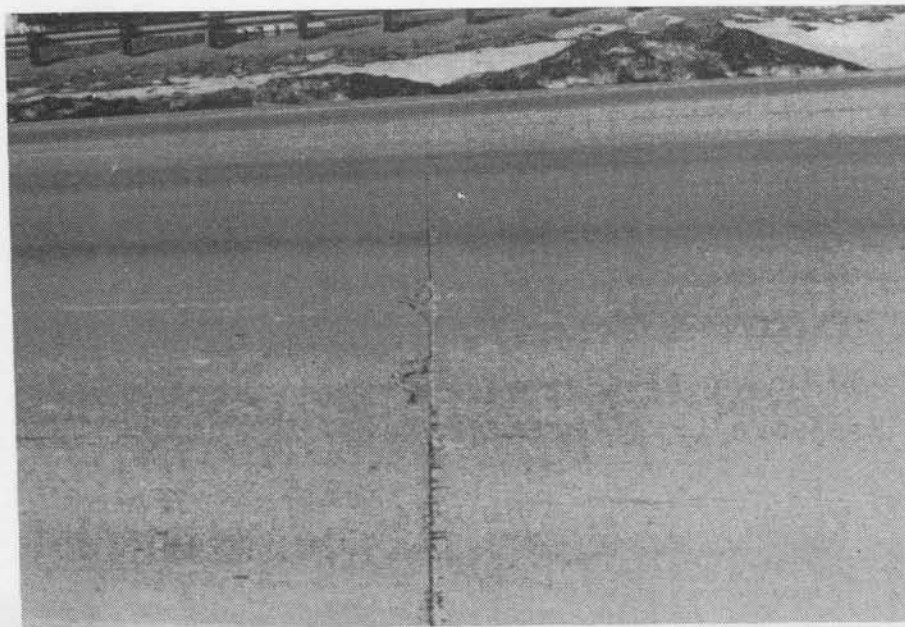
Figure 8

SPALLING DISTRESS

Spalling of cracks and joints is the cracking, breaking or chipping of the slab edges within 2 ft. of the joint. A joint spall usually does not extend vertically through the whole slab thickness, but extends to intersect the joint at an angle. Spalling usually results from (1) excessive stresses at the joint or crack caused by infiltration of incompressible materials and subsequent expansion or traffic loading, (2) disintegration of the concrete, (3) weak concrete at the joint (caused by over-working) combined with traffic loads, or (4) poorly designed or constructed load transfer device.

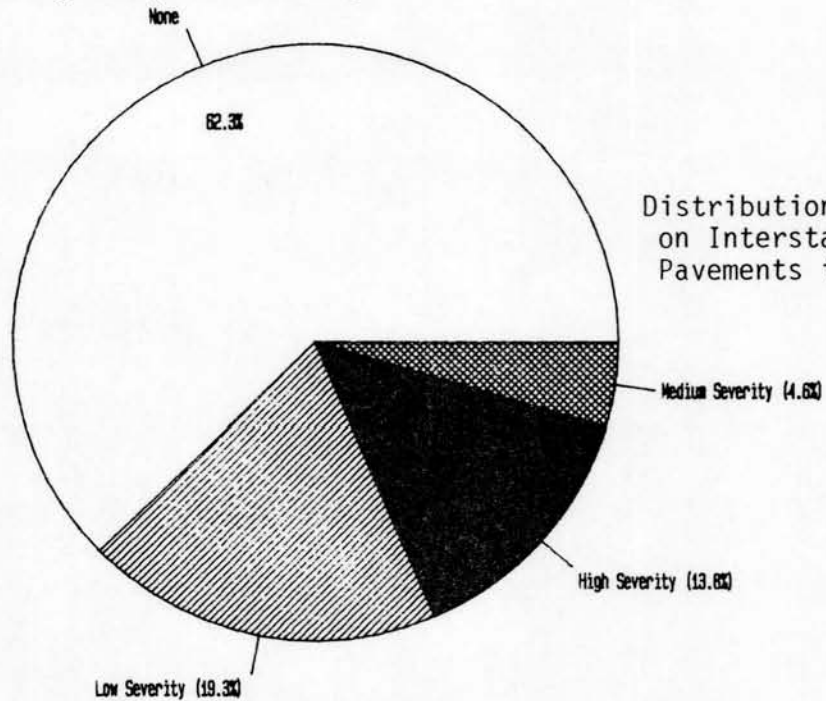
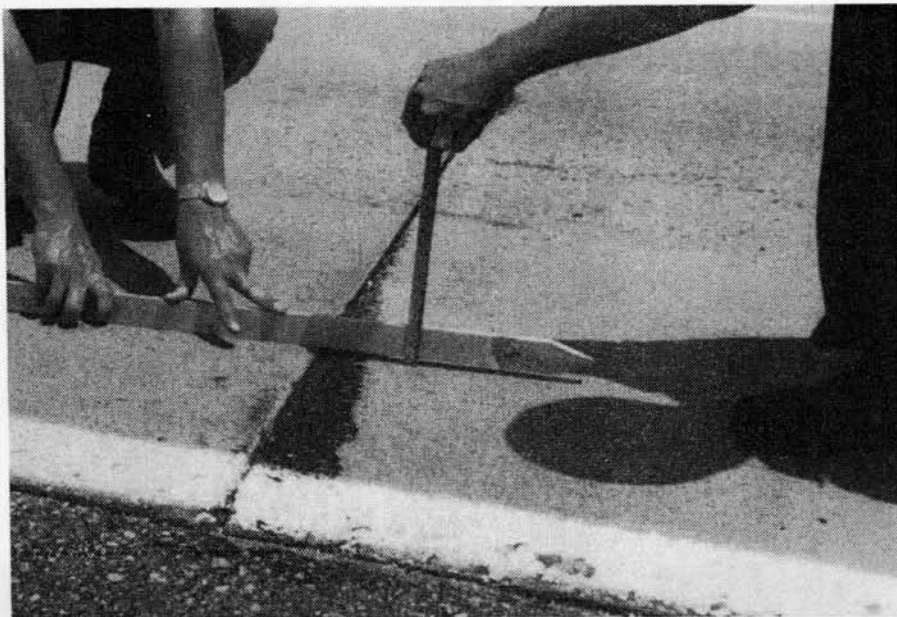
Figure 9

### FAULTING DISTRESS

Faulting is the difference of elevation across a joint or crack. Faulting is caused part by a buildup of loose materials under the approach slab near the joint or crack as well as depression of the leave slab. The buildup of eroded or infiltrated materials is caused by pumping (free moisture under pressure) due to heavy loadings. The warp and/or curl upward of the slab near the joint or crack due to moisture and/or temperature gradient contributes to the pumping condition. Lack of load transfer contributes greatly to faulting.

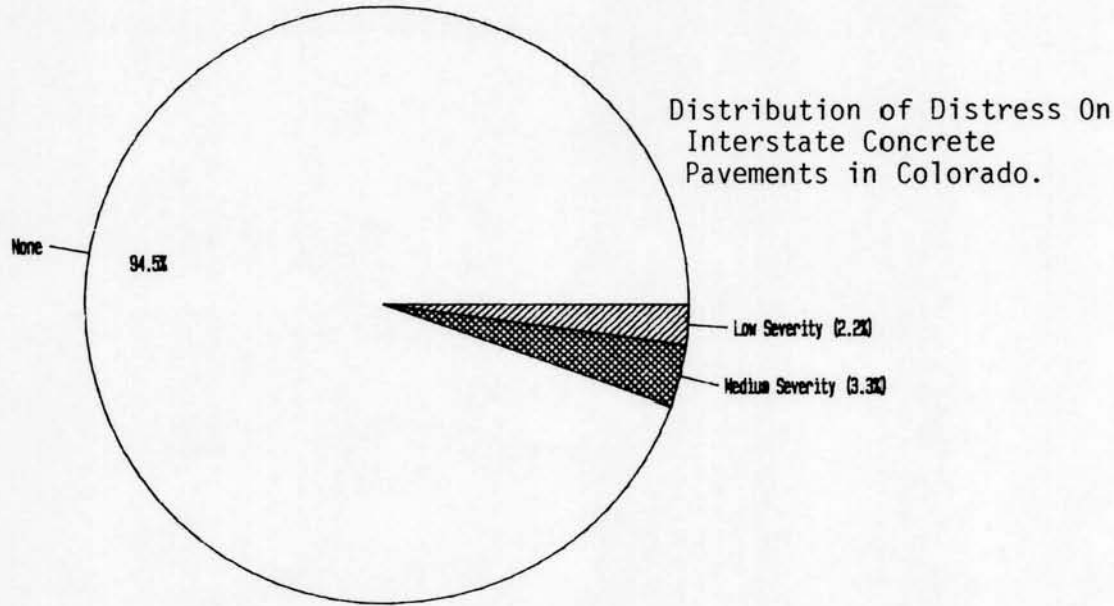
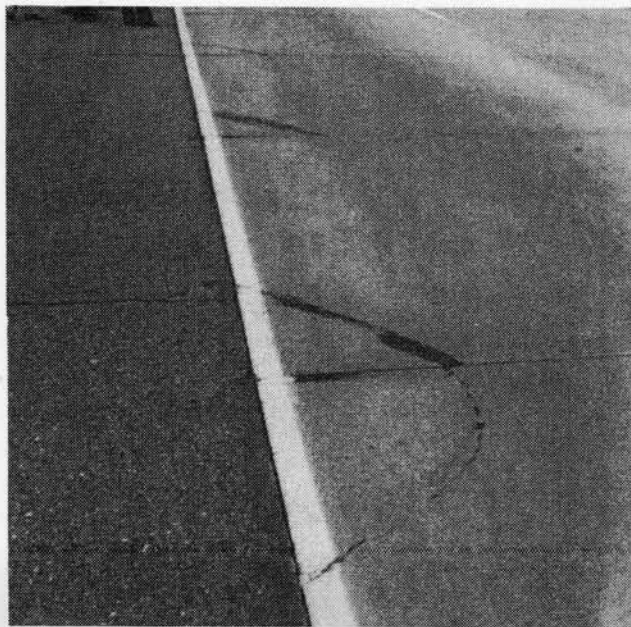
Figure 10

### CORNER BREAKS DISTRESS

A corner break is a crack that intersects the joints at a distance less than 6 ft on either side measured from the corner of the slab. A corner break differs from a corner spall in that the crack extends vertically through the entire slab thickness, while a corner spall intersects the joint at an angle. Load repetition combined with loss of support, poor load transfer across joint, and thermal curling and moisture warping stresses usually cause corner breaks.
