Report No. CDOH-DTD-R-89-4

# **VERGLIMIT EVALUATION (BOULDER)**

Final Report  
February, 1989

## VERGLIMIT EVALUATION (BOULDER)

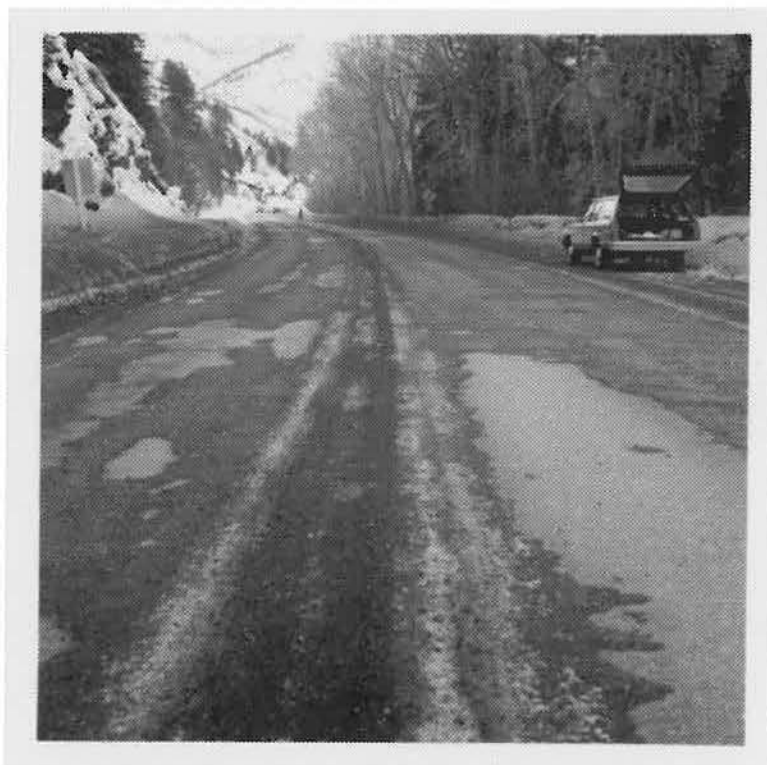
(B) Severe ravelling  
observed from  
the center of the  
section looking  
northwest on SH-82  
(February, 1984)

In 1981, the Colorado Department of Highways (CDOH) placed a 100 ton section of Verglimit-treated pavement on a hazardous section of State Highway 82 near Snowmass, Colorado (elevation 6900 ft) in Pitkin County. The site was in a shady location near the Roaring Fork River, and was prone to becoming snow-packed. The material was placed fairly late in the season, and had an average lift thickness of 1½ inches. It was placed with conventional paving equipment by state maintenance forces using a mix batched in a commercial plant in Grand Junction, Colorado 115 miles away. The pavement was the subject of a Research Branch study at that time. Although the pavement performed well in controlling snow and ice, it failed within six months due to extensive ravelling

as shown in Photo B.

The investigator speculated that the early failure of this overlay may have been due to one or more of the following construction problems:

1. over mixing of the Verglimit during batching;
2. too low an AC content in the design mix;
3. placement with too high a void content; or
4. the material may have reacted with the aggregate in pavement.

Further placement of this material was not recommended without strict adherence to the manufacturer's recommendations for mixing and that effective measures be used to control slickness.

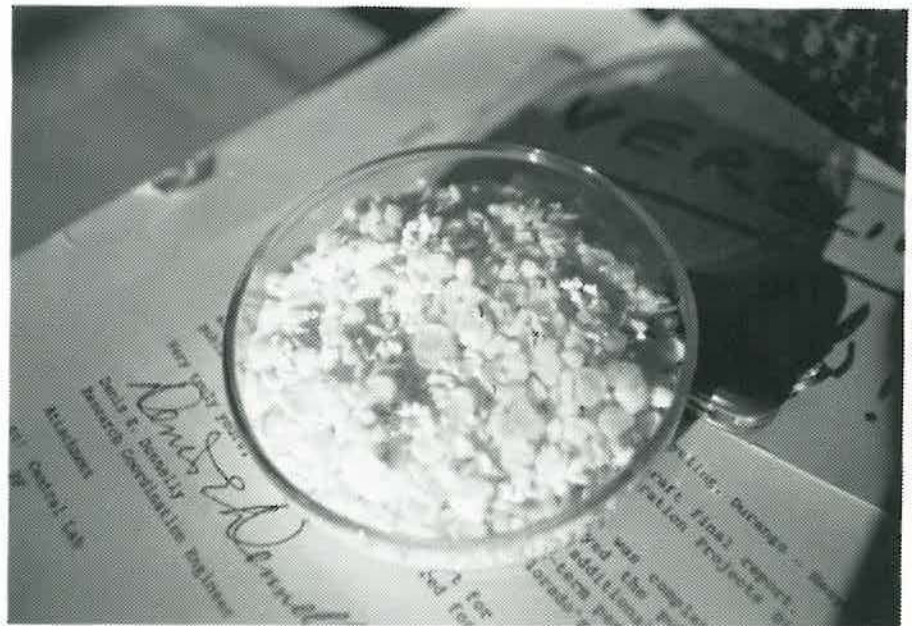
One of the bags that had been left open absorbed moisture from the air or possibly from a light rain. These flakes had begun to swell and look wet and partially dissolved as shown in the petri dish sample in Photos E and F. When handled (something that is not recommended), the flakes left the hands feeling slippery and caused a burning sensation after several minutes. The material was difficult to wash off and felt like fresh chicken fat on the skin.

(F) The same sample after exposure to air

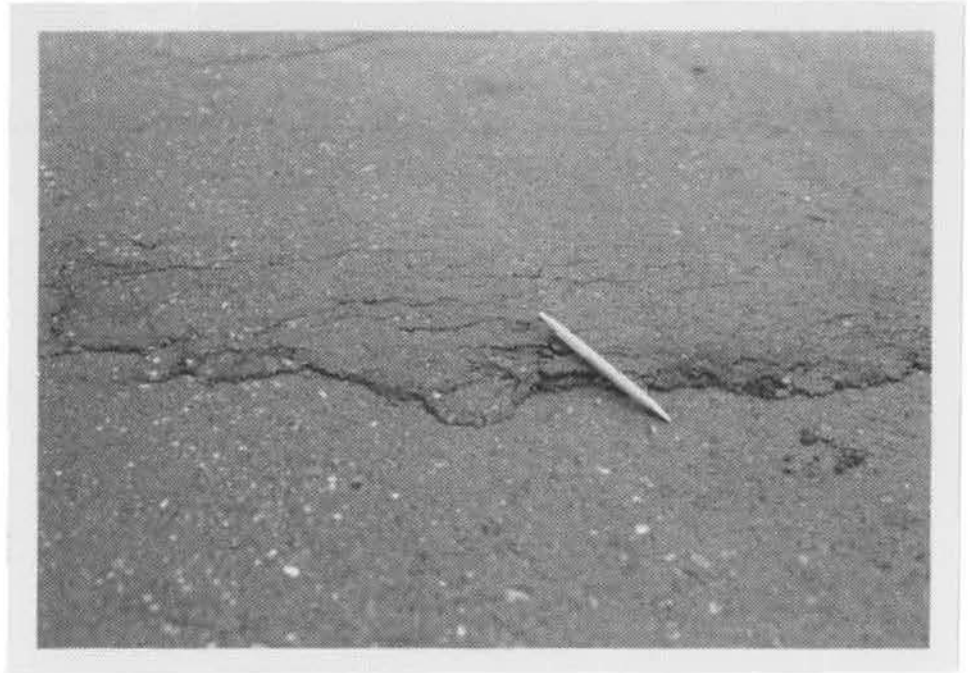
(I) An area of shoved pavement on the east side of the roadway

There is also no noticeable indications of ravelling or surface deterioration. This is also true in the few areas that shoved during paving or were sealed the following day because they appeared open. Visually, the pavement looks as if it will have a normal service life.

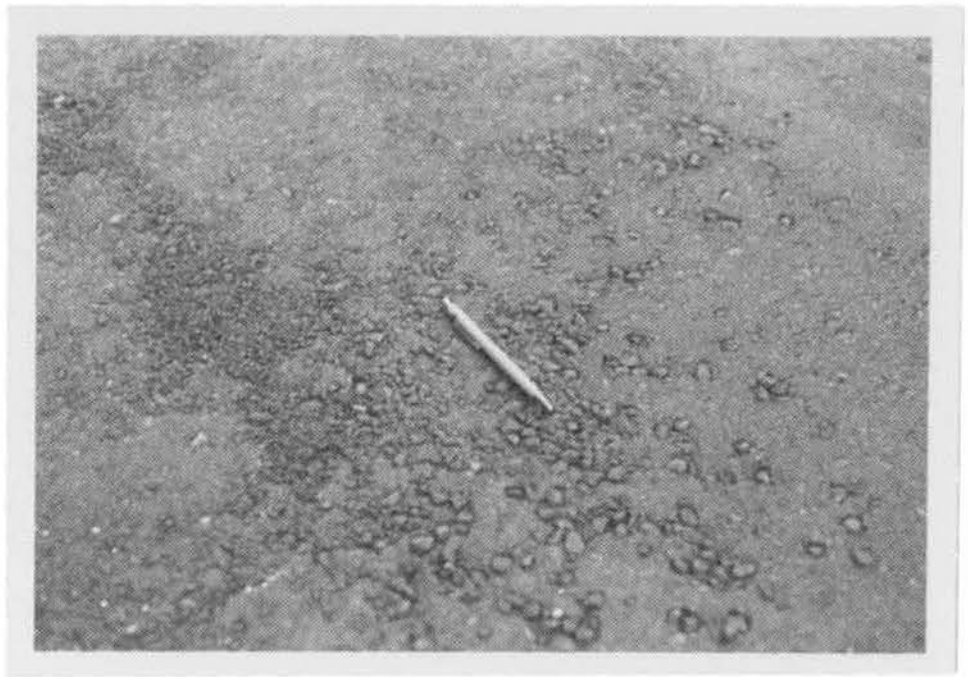
The surface appeared "open" in some small areas in the first pass (see Photo J), and these spots were resealed the following day with tack coat, an emulsified asphalt SS-1H diluted 50:50 with water. A special effort was made to achieve density around utility covers. Since there was no calibration available for the nuclear density gauge, density rings were placed in the mat during paving to check for proper compaction. These were pulled and tested the following day. They showed that the specified

(J) Open surface area that was subsequently sealed

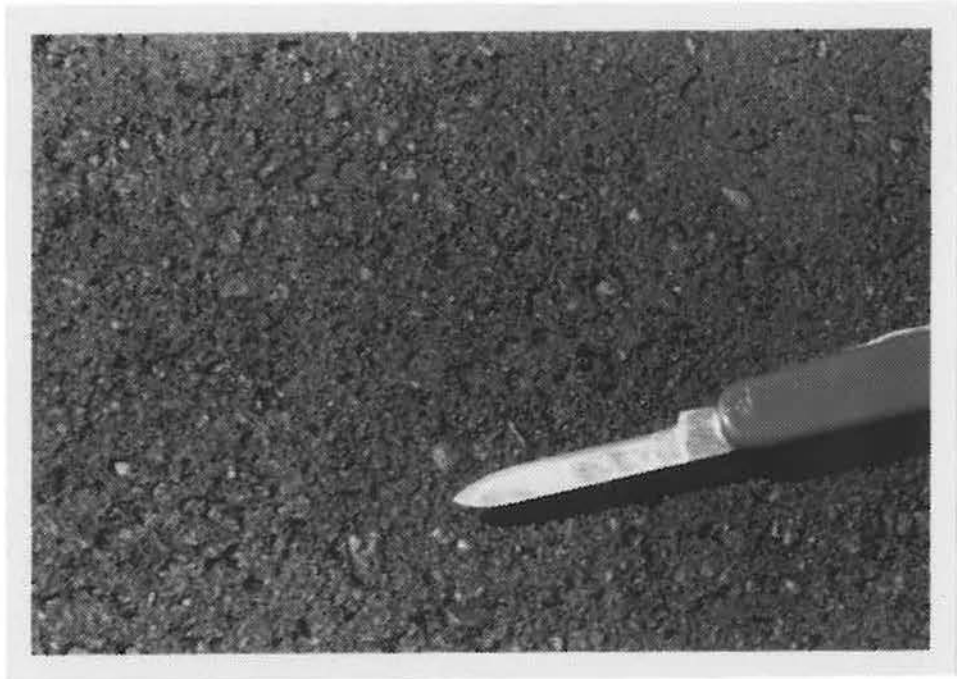
Other than having a somewhat brownish appearance, nothing unusual was noticed about the pavement until the sixth day following paving when, after light rain during the night, the surface began to "sweat". The surface then felt a little oily and very small pits could be seen in the surface where the Verglimit flakes had been embedded and now (presumably) had been washed away (see Photo K). At that time, city crews were attempting to stripe the roadway in preparation for its opening the following morning. The self-adhesive plastic marking tape being used would not bond to the part of the roadway that had the Verglimit-treated mat (see Photo L). The tape had to be pulled up and that section of the roadway was painted with conventional striping paint some months later.

(K) Detail of pavement surface after the first rain

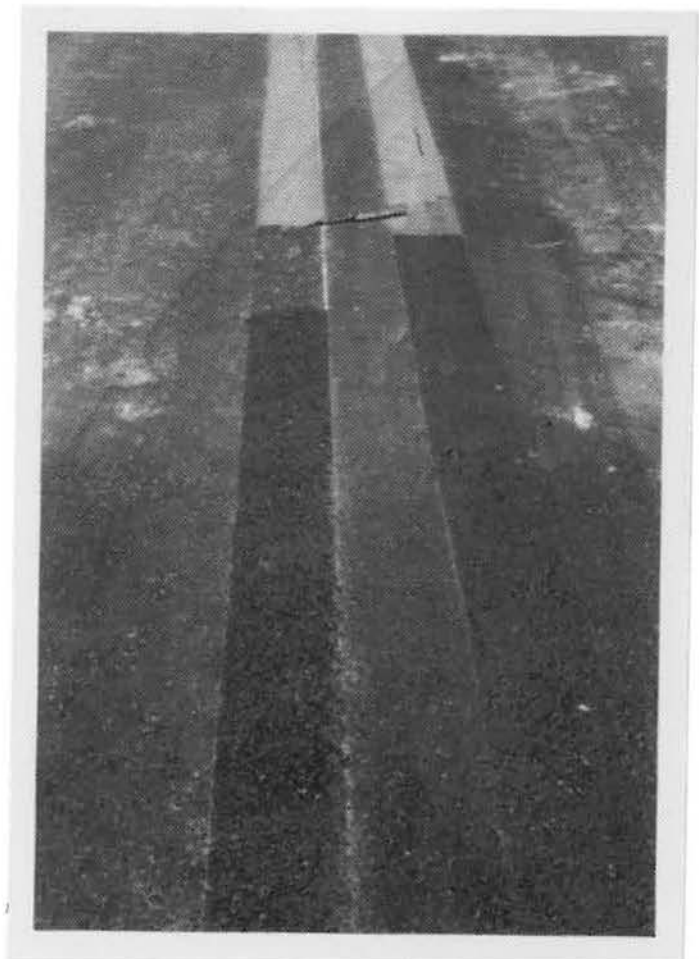
(L) Section where the pavement marking tape did not adhere

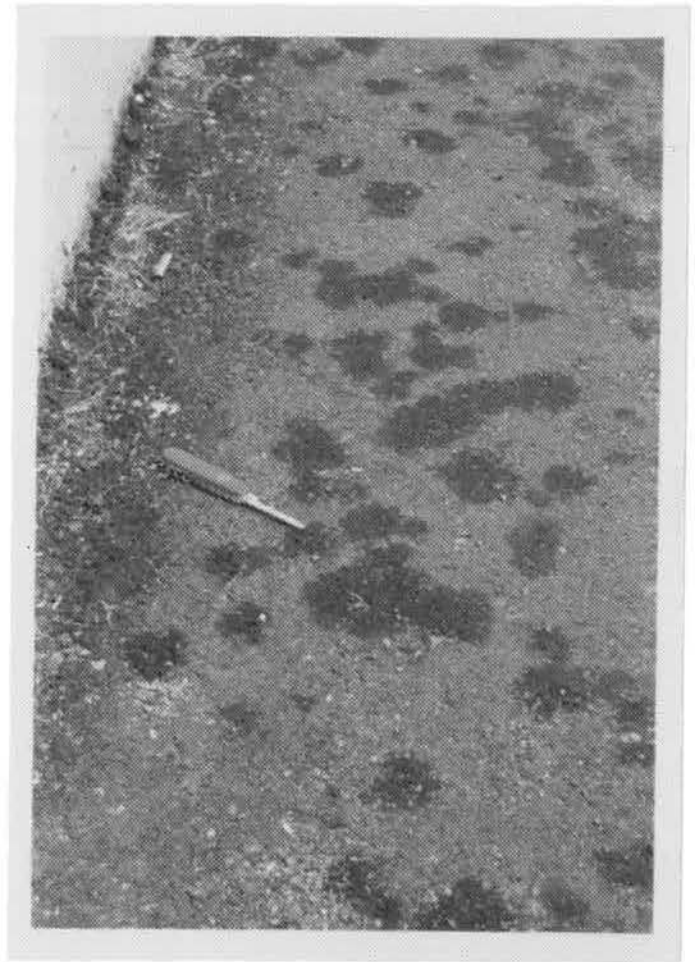
(S) Detail near shoulder  
of East Lion's Head  
Lane

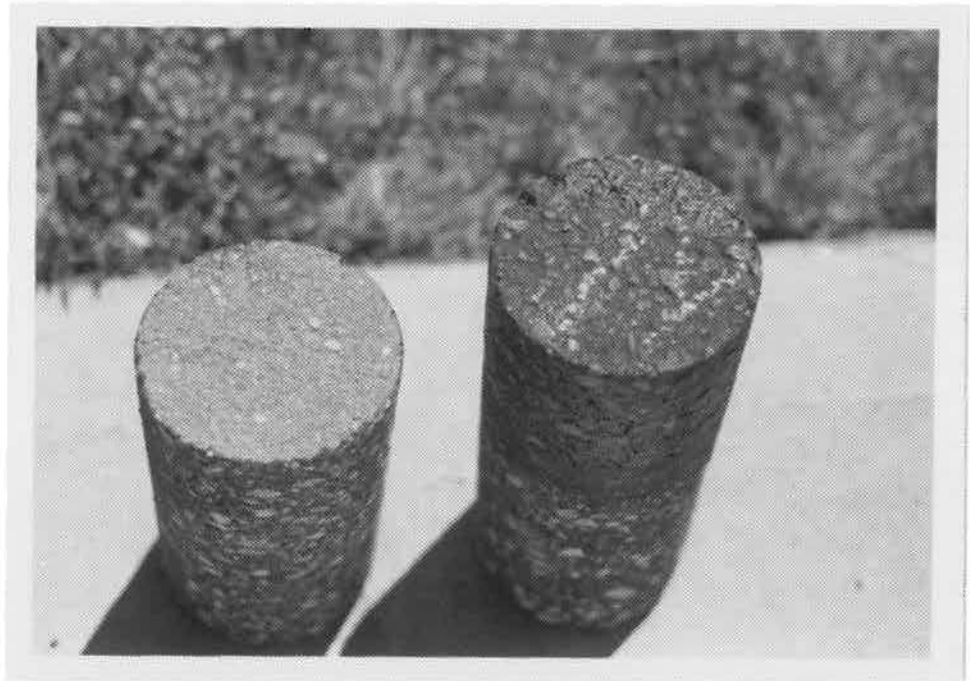
(W) core with pits from dissolved Verglimit

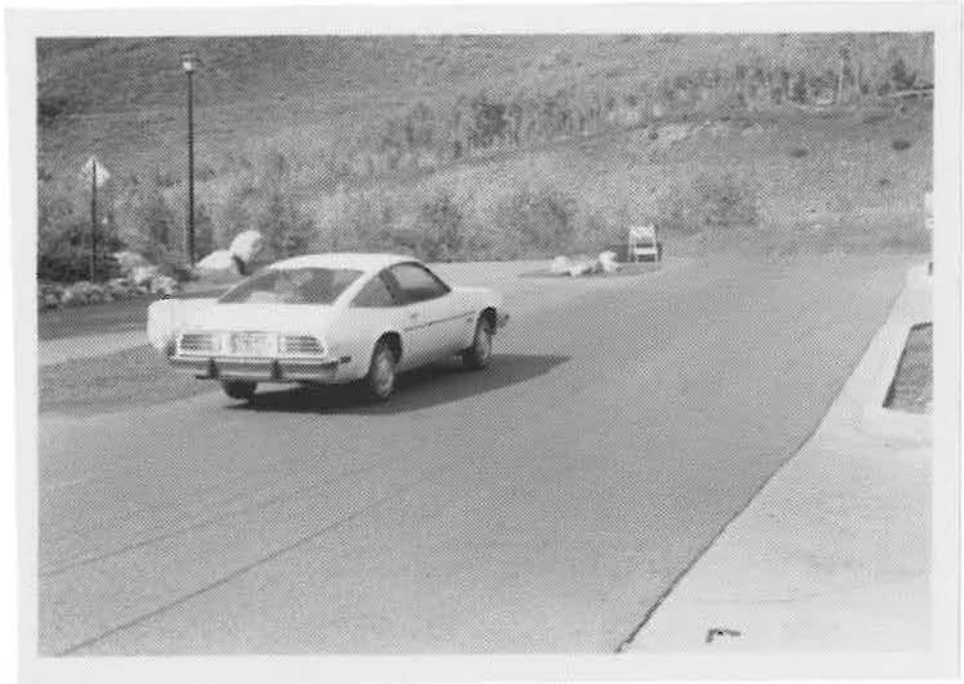
Evaluations at the Vail sites consisted of visual examinations only. The appearance of the sections was much the same as the Boulder site. Blotches on the road turned white when tested with silver nitrate (an indicator of chloride) as did the road surface in the wheelpaths which did not have a blotchy appearance (see Photo X). There were no signs of significant cracking, ravelling, or rutting. There was also no damage from skidding tires at the car park exit on Village Center Road (see Photo Y). Overall, the three pavements appear to be holding up very well.

(Y) Car park exit after three years
