**PRE-DEMOLITION/RENOVATION
ASBESTOS AND LEAD-BASED PAINT
INSPECTION REPORT FOR
COLORADO DEPARTMENT OF
TRANSPORTATION BRIDGE STRUCTURE
H-17-BC**

**I-25 Southbound and Air Force Academy
Road 70
Mile Marker 155.931**

WALSH Project Number: WA-000944-0186

July 13, 2012

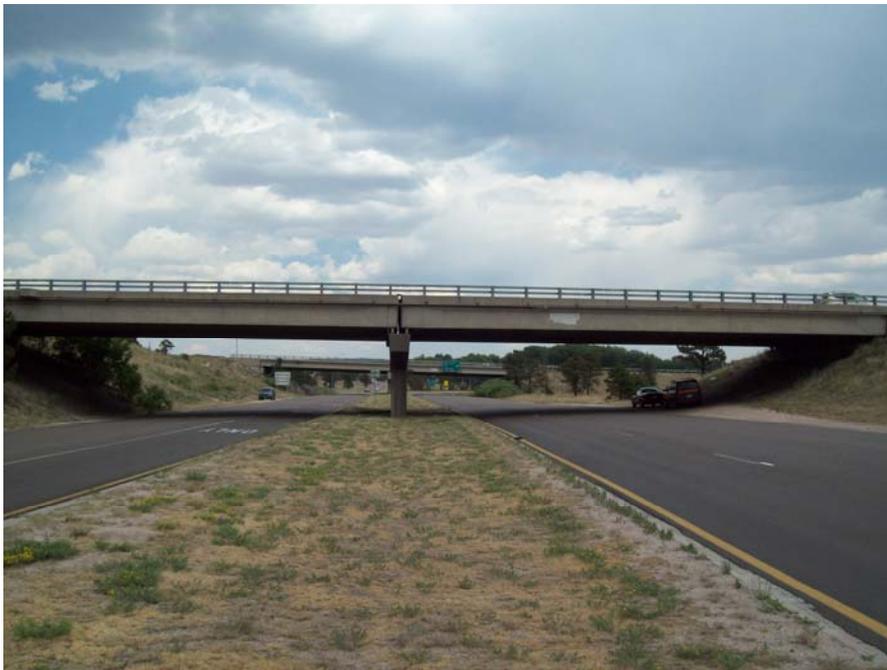
Photo 1 – View of Bridge Structure ID: H-17-BC.

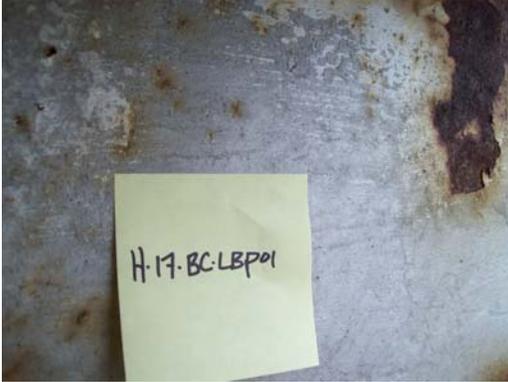
LBP01

SAMPLE ID	LOCATION	SUBSTRATE	COLOR	CONDITION	RESULT (% BY WEIGHT)
H-17-BC-LBP01	On Steel Structural Support Beams	Steel	Silver over Red	Poor	1.2
H-17-BC-LBP02	On Shoulders and Main Road Lanes	Asphalt	White	Intact	BRL
H-17-BC-LBP03	Median of Road	Asphalt	Yellow	Intact	BRL

- Steel Substrate-Silver Paint over Red Paint-Located on Steel Structural Beams.

Additionally, lead-containing materials require a hazardous waste determination pursuant to 40 CFR 262.11, and 40 CFR 261.24. It is a standard industry approach that demolition waste characterization should be performed on structures containing lead-based paint. This procedure is the Toxicity Characteristic Leaching Process (TCLP), where sample composite representative of all building components to be demolished (i.e. all lead-based paint coated and non-lead-based paint coated materials from the structure) is submitted to the laboratory for analysis. The Toxicity Characteristic (TC) limit for lead is 5ppm in the leachate. Materials that exceed this limit must be disposed of as hazardous waste. Materials that do not exceed this limit may be disposed of as solid waste.
