**PRE-DEMOLITION/RENOVATION
ASBESTOS AND LEAD-BASED PAINT
INSPECTION REPORT FOR
COLORADO DEPARTMENT OF
TRANSPORTATION BRIDGE STRUCTURE
H-17-BD**

**I-25 Northbound and Air Force Academy
Road 70
Mile Marker 155.931**

STRUCTURE ID: H-17-BD

July 13, 2012

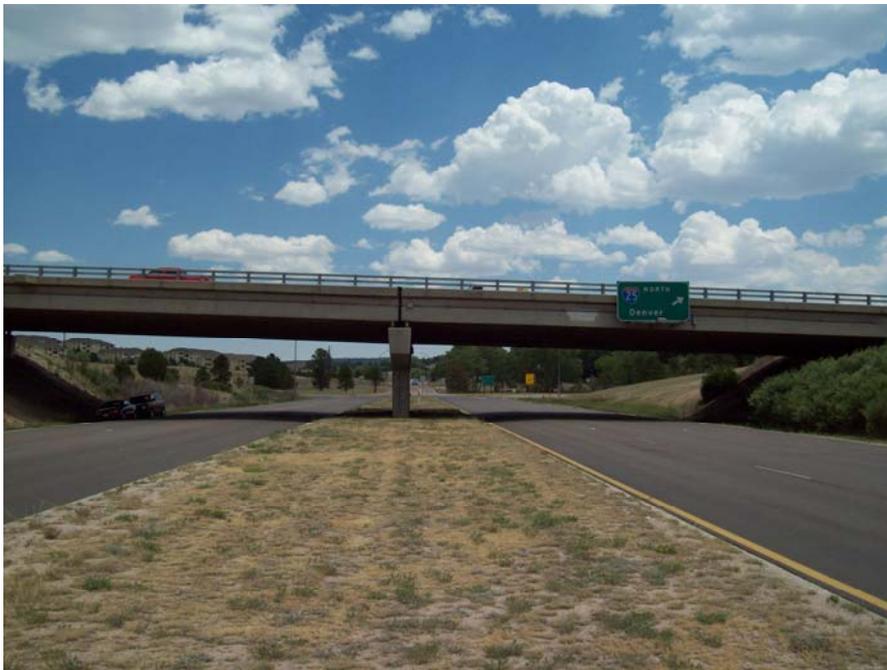
Photo 1 – View of Bridge Structure ID: H-17-BD.

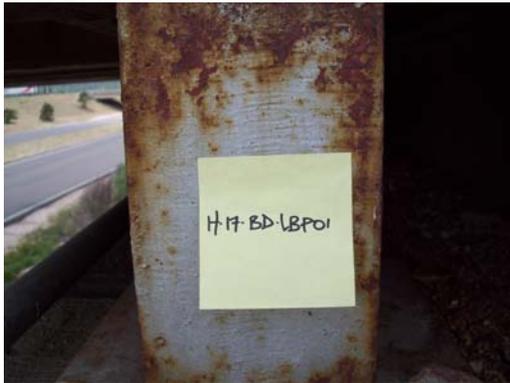
LBP01

Lead-Containing Paint (LCP) (<0.5% by weight) was identified during the inspection. The following component was confirmed to be LCP and should be disclosed to the demolition contractor, and is subject to waste determination procedures.

- Steel-Silver Paint over Red Paint – Located on Steel Support Beams.

Additionally, lead-containing materials require a hazardous waste determination pursuant to 40 CFR 262.11, and 40 CFR 261.24. It is a standard industry approach that demolition waste characterization should be performed on structures containing lead-based paint. This procedure is the Toxicity Characteristic Leaching Process (TCLP), where sample composite representative of all building components to be demolished (i.e. all lead-based paint coated and non-lead-based paint coated materials from the structure) is submitted to the laboratory for analysis. The Toxicity Characteristic (TC) limit for lead is 5ppm in the leachate. Materials that exceed this limit must be disposed of as hazardous waste. Materials that do not exceed this limit may be disposed of as solid waste.
