STATE HIGHWAY 9 AND U.S. HIGHWAY 6 IMPROVEMENT PROJECT  
AT THE  
INTERSTATE 70 SILVERTHORNE/DILLON INTERCHANGE

LAUNCH PHASE TECHNICAL SUMMARY

February 2011

Colorado Department of Transportation  
Region 1

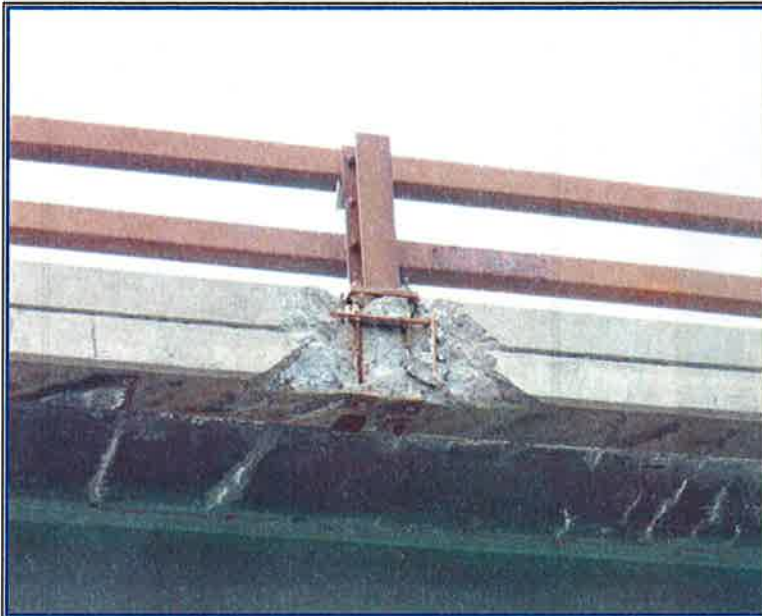
F12R (Exterior side of right curb spalled above Span 2).JPG taken: 2009/06/16 2:33

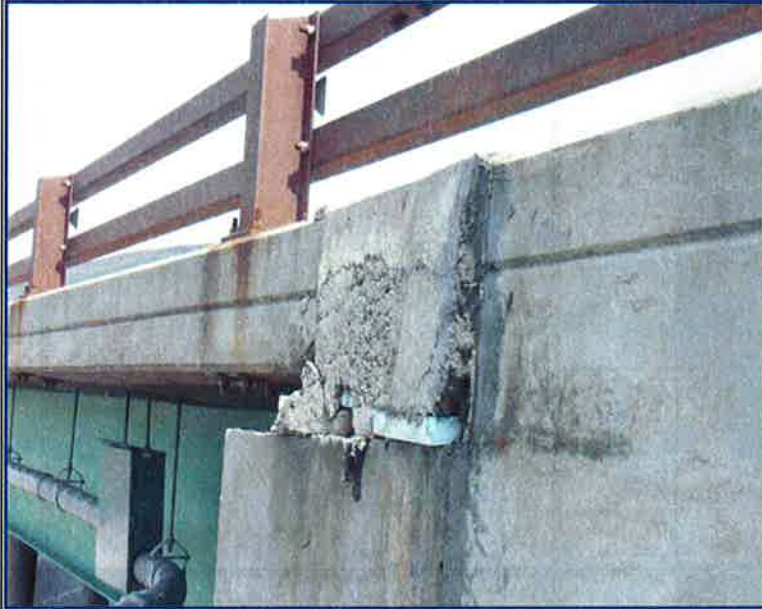
F12R (Curb on left has been repaired at Abutment 1).JPG taken: 2009/06/16 2:46

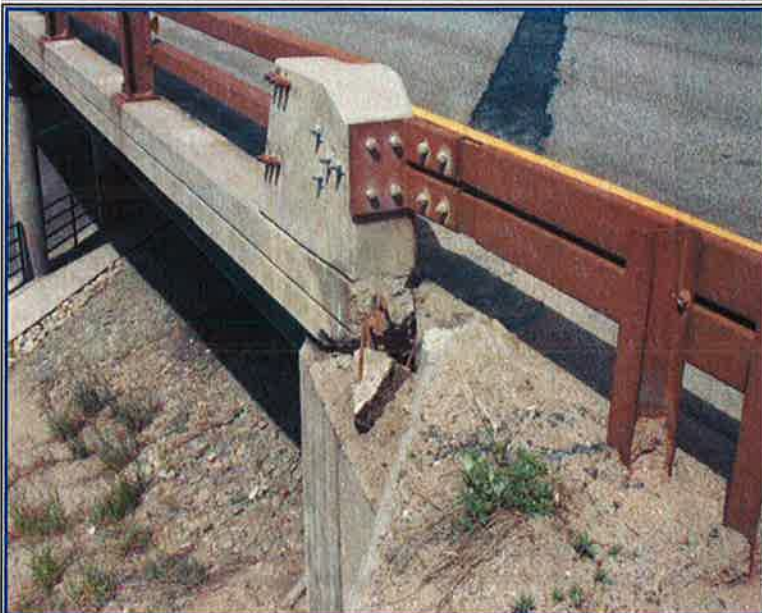
F-12-R Curb broken at right corner of Abut. 5..JPG taken: 2003/06/308:45

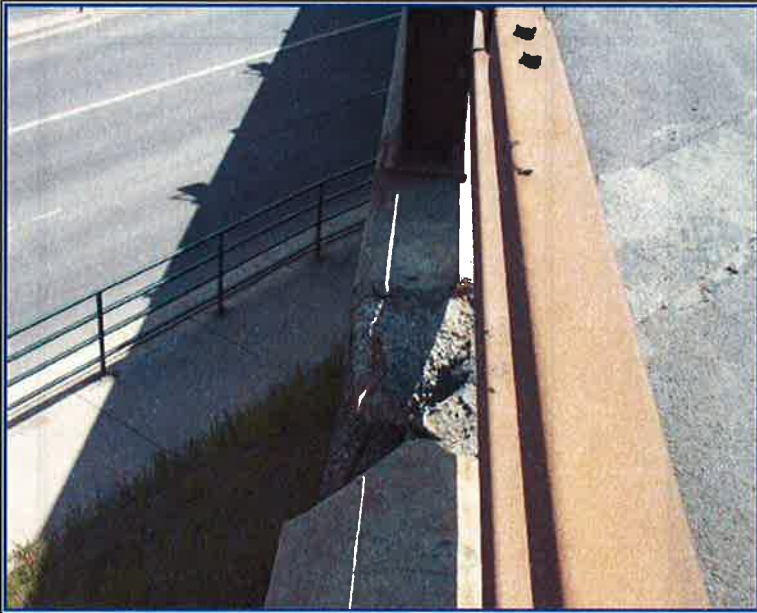
F-12-R Curb broken at left corner of Abut. 1..JPG taken: 2003/06/308:46

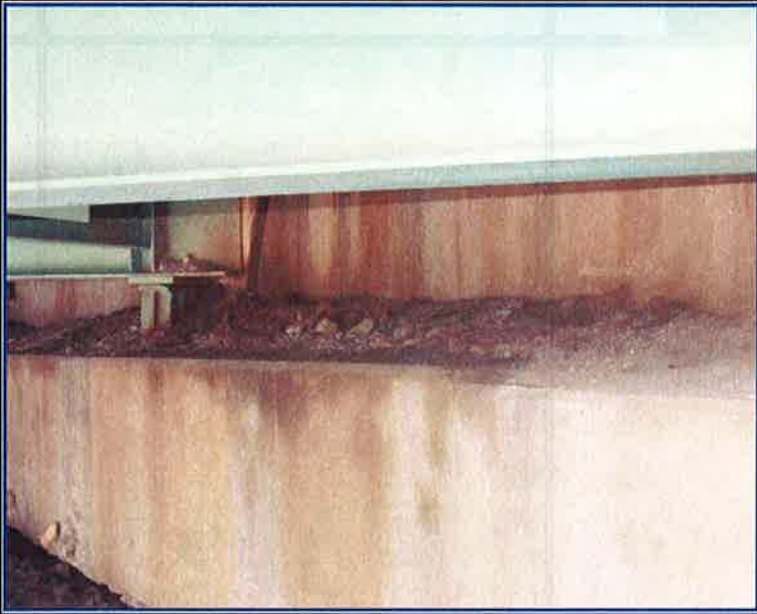
F-12-R Sand & concrete built up on abut. seats (Abut. 1 shown)..JPG taken: 2003/06/308:47

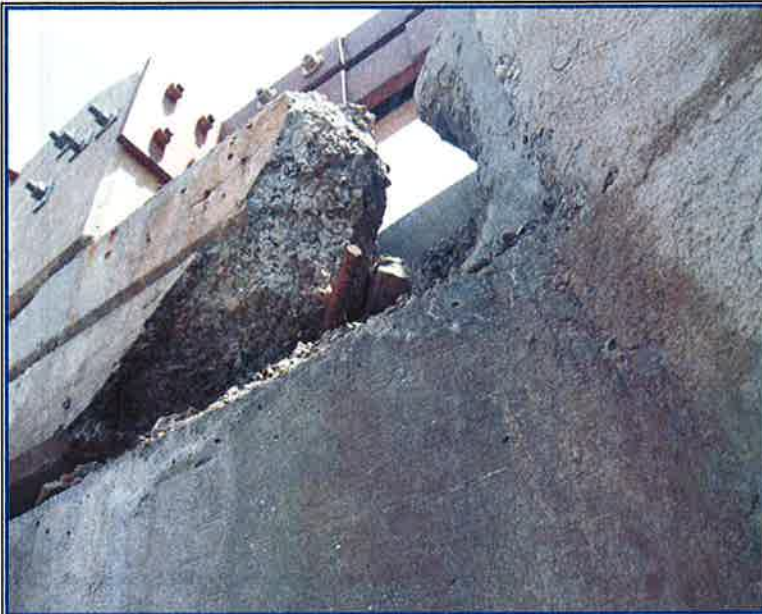
F12S Broken curb Abut. 1 left..jpg  
taken: 2009/06/18 8:53

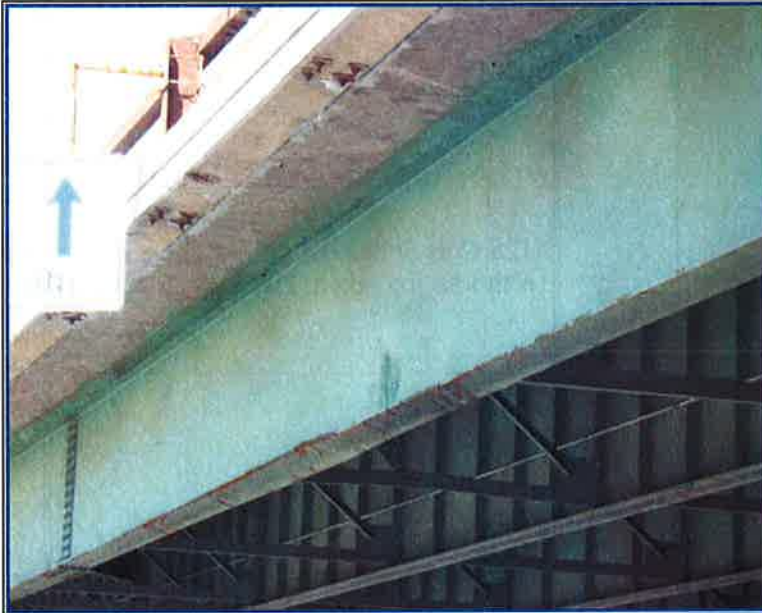
F12S scrapes and slight twist to lower  
flange of gir 3E.jpg taken:  
2007/06/2610:54

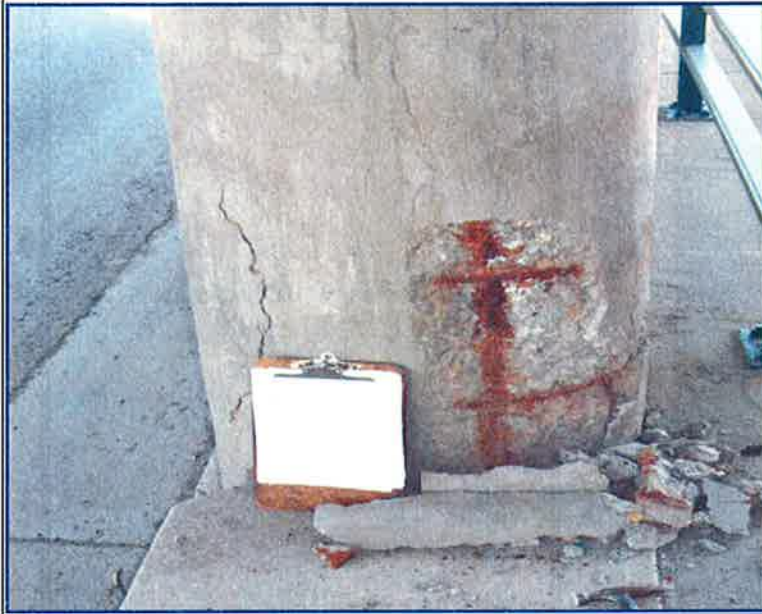
F12S Spalling with exposed corr rebar in splash zone of col; this is 2C ~8 sf total.jpg taken: 2007/06/26 10:31

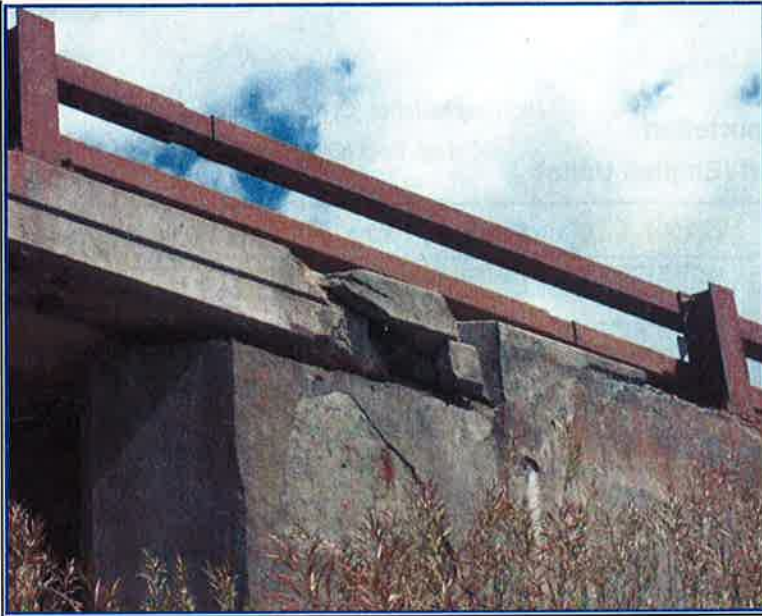
F-12-S Curb broken at Abut. 5, right corner..JPG taken: 2003/06/308:48

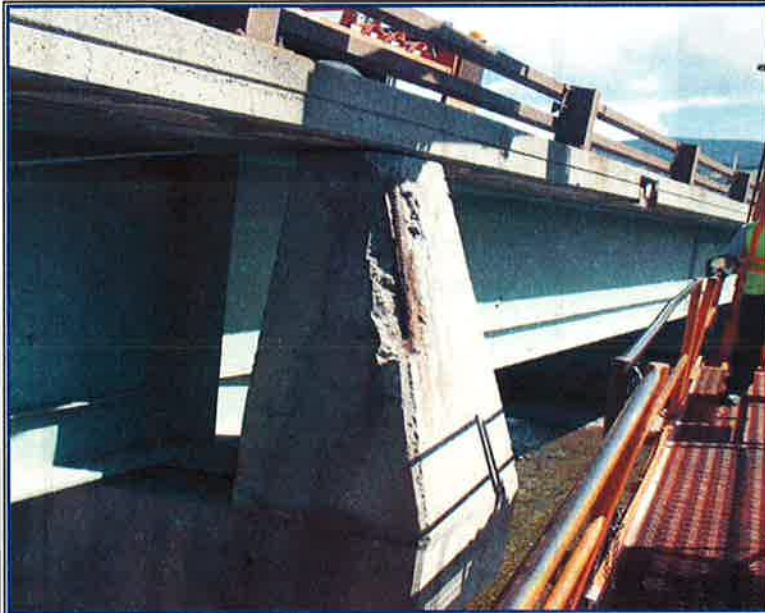
F12X 072307 Risers have spalling with exposed rebar on the right side. This is P-3 with two #8 bars exposed.jpg taken: 2007/07/2612:20

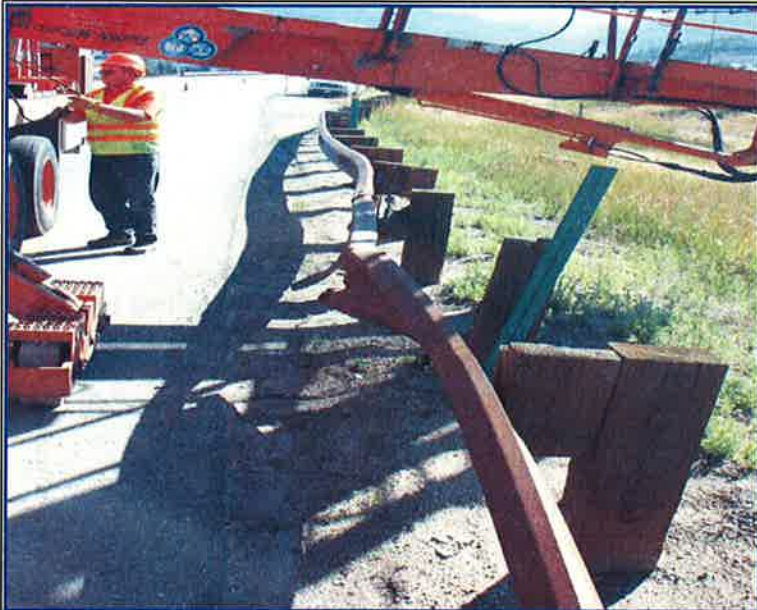
F12X 072307 A5 Approach Bridge Rail is damage.jpg taken: 2007/07/2611:32 pos 200

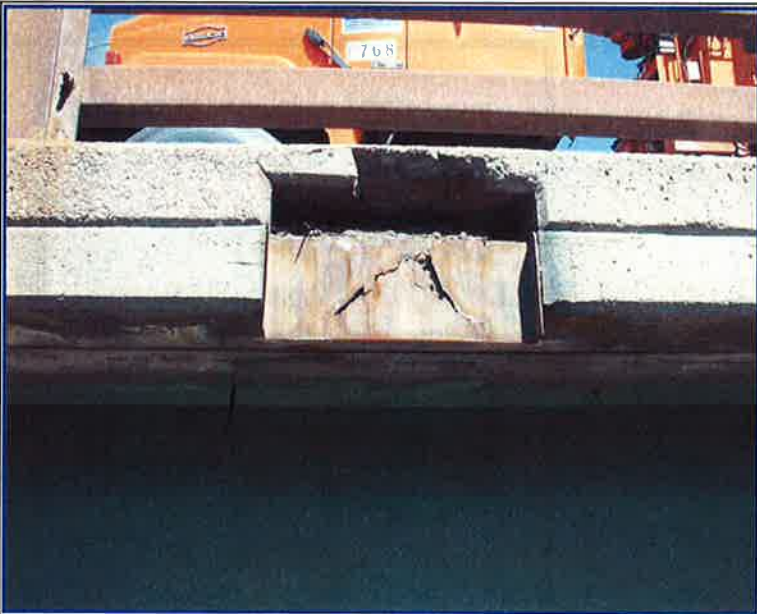
F12X 072307 Gutter steel plate has R4 corrosion.JPG taken: 2007/07/2310:22 pos 200

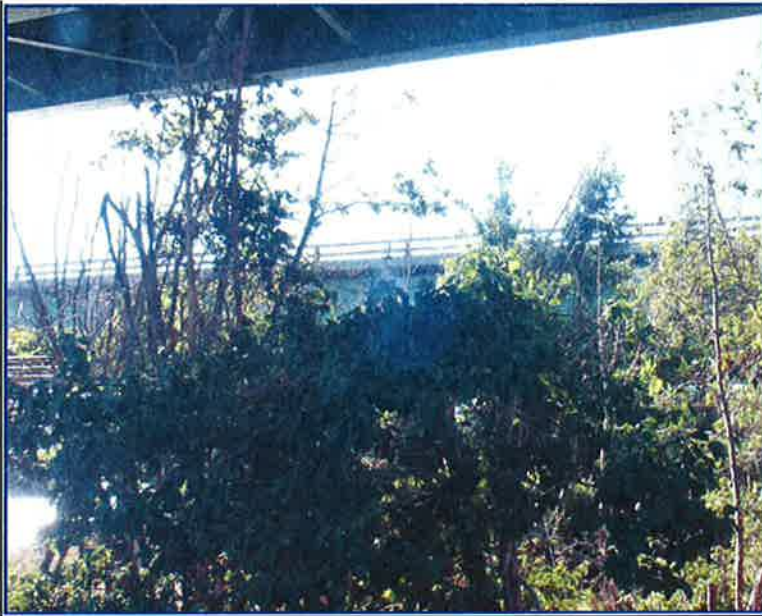
F12X 072307 Trees are growing under span 2..JPG taken: 2007/07/23 8:13

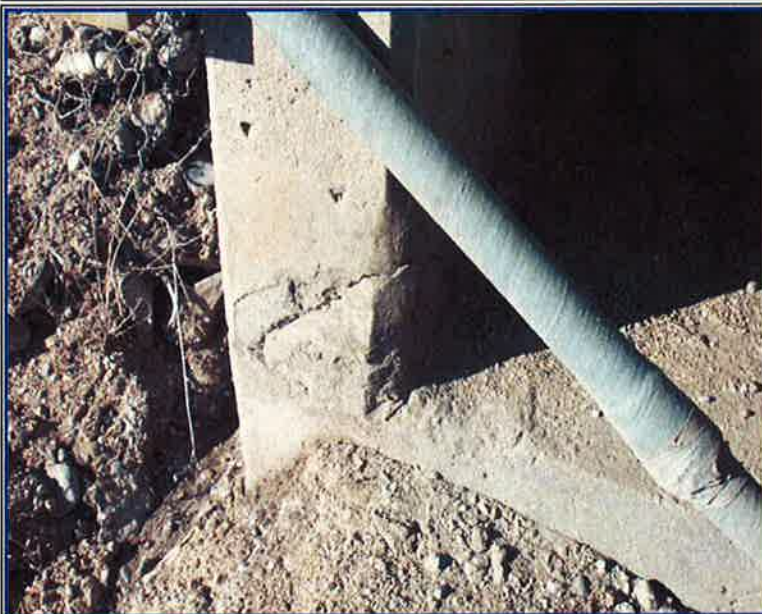
F12X 072307 Bottom of right corner at A1 with spall, delam, and crack..JPG taken: 2007/07/23 8:00

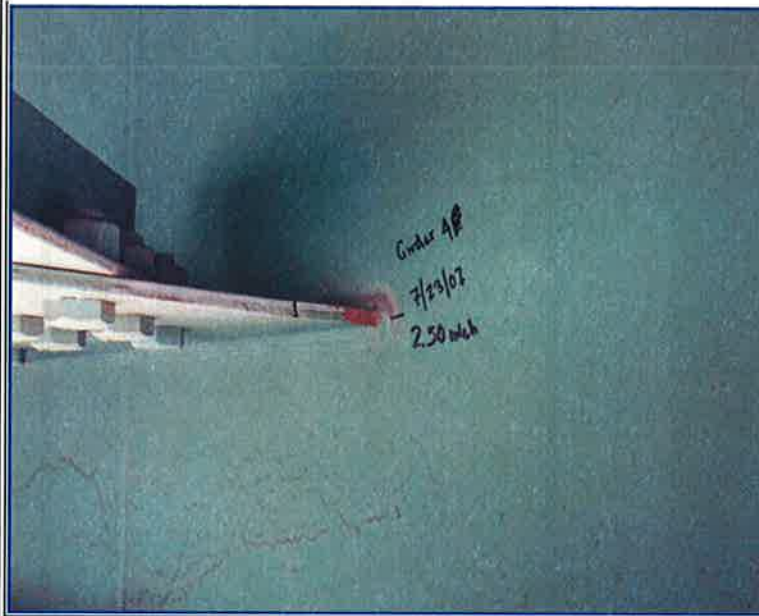
F12X 072307 This is typical of Girders gusset plates, longitude and vertical stiffeners. Sheared edges were never dressed.JPG taken: 2007/07/23 9:10

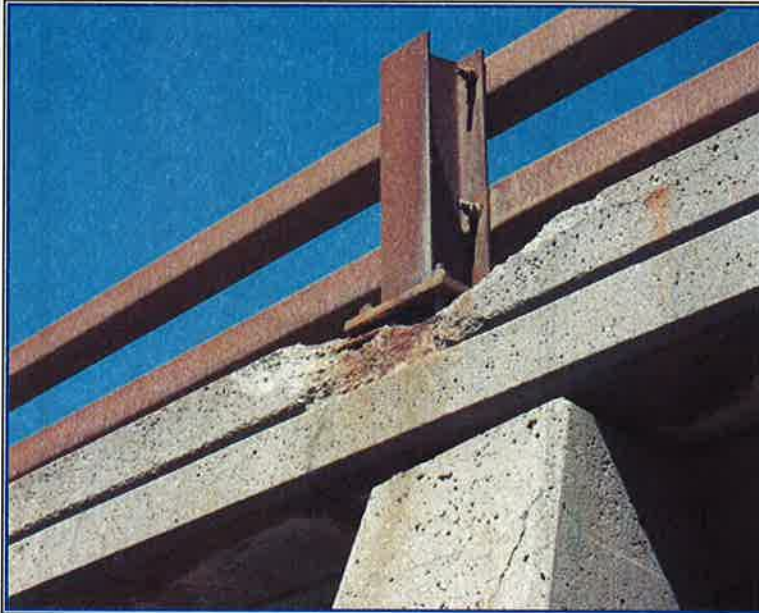
F12X 072307 Spalling of concrete under Bridge rail post. This is the right side span 1 with exposed rebar.JPG taken: 2007/07/23 10:42

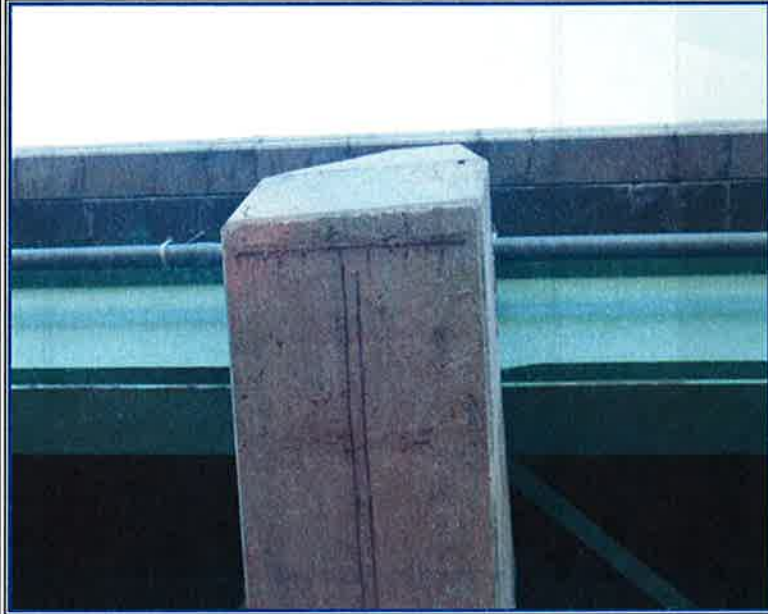
<p>F12X 072307 P-2 Left end with longitude wires exposed. Exposed rebars and rust stains.JPG taken: 2007/07/23 8:09</p>	<p>pos 200</p>

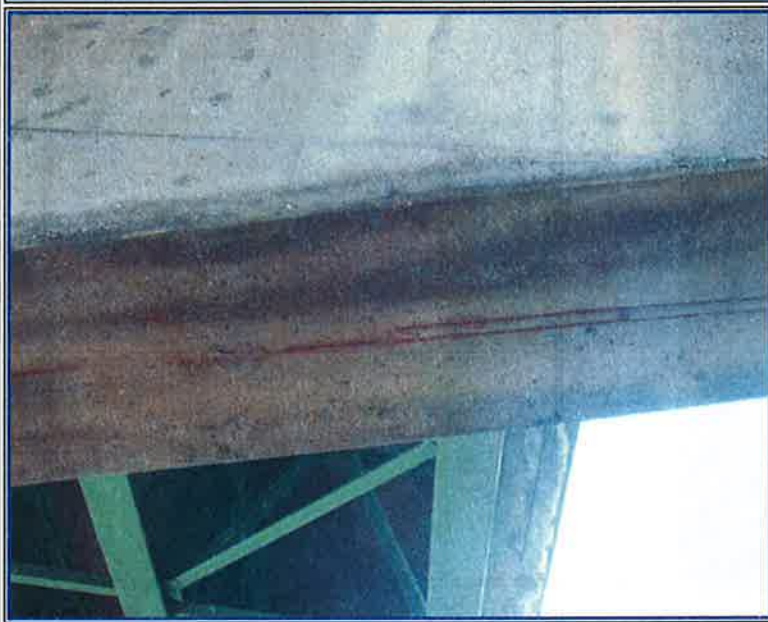
<p>F12X 072307 P-2 Cap right side with longitude wires exposed. Rust and moderate scale.JPG taken: 2007/07/23 8:07</p>	<p>pos 200</p>

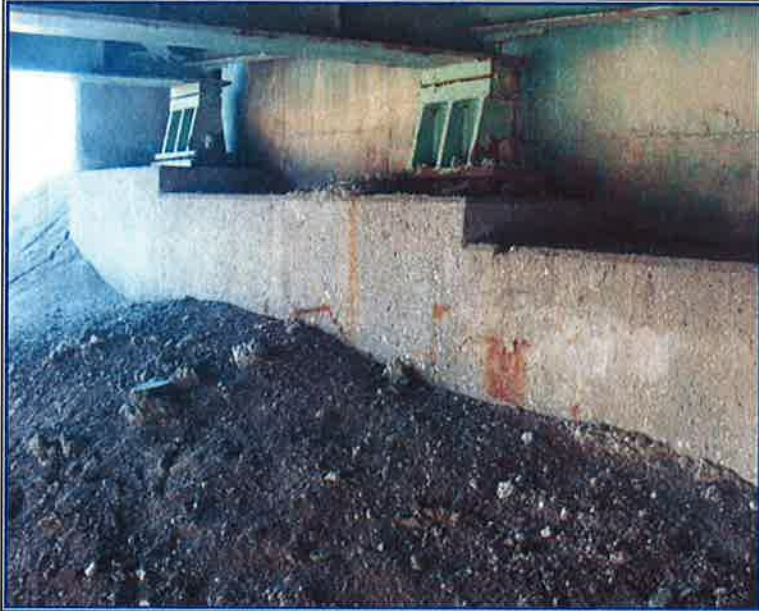
F12X 072307 A-5 Abutment seat has horizontal and vertical cracks. Delam and rust stains.JPG taken: 2007/07/23 8:23

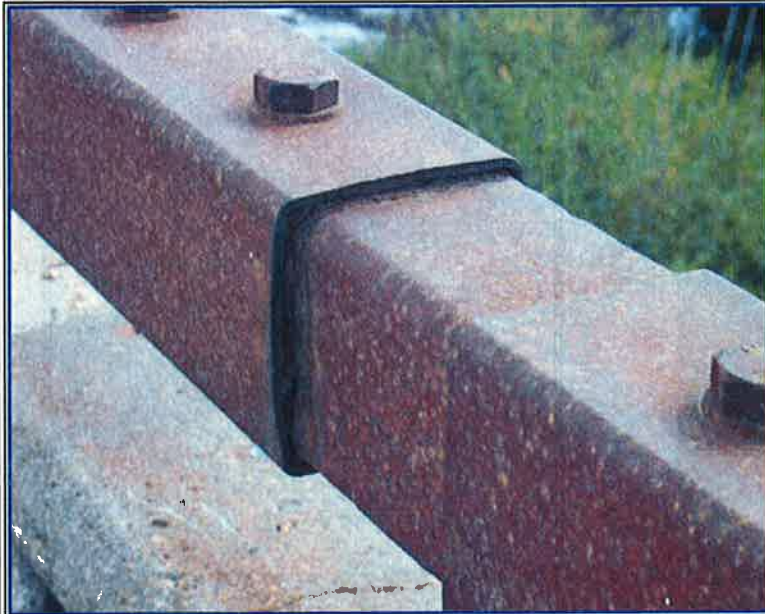
F12Y uncoated tube rails get rusting at expansion sleeve portions, will inhibit expansion-contraction.JPG taken: 2005/09/21 9:33

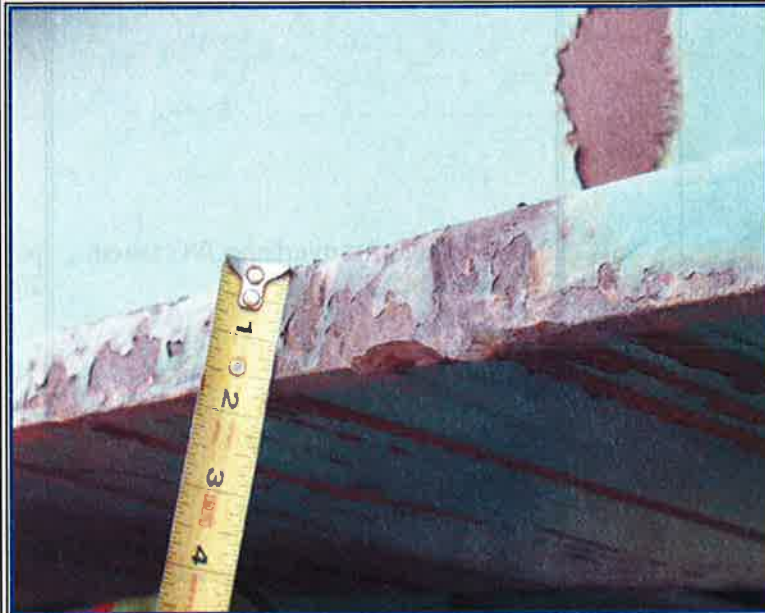
F12Y Worst impact damage to girder - Gir 1F, deformation of flange edge, closeup.JPG taken: 2005/09/21 12:10

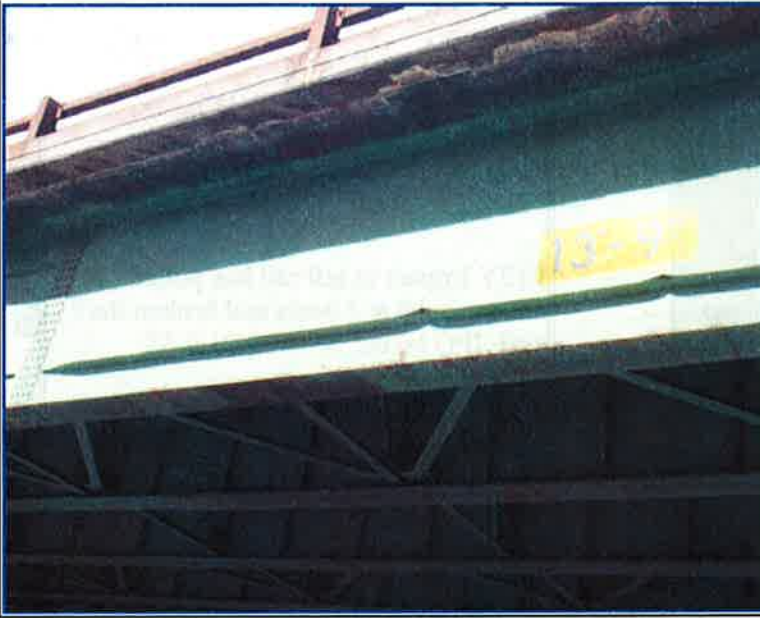
F12Y impact damage to girder 1F.JPG  
taken: 2005/09/21 10:38

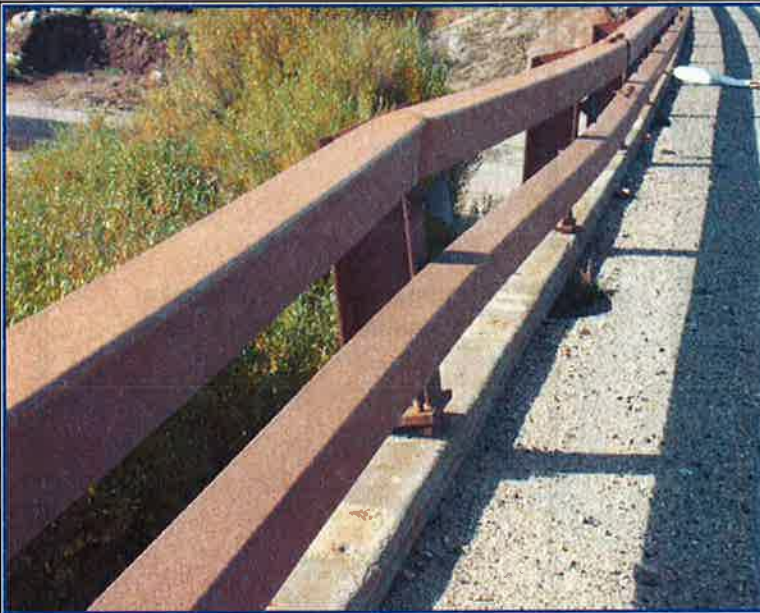
F12Y Impact damage to rt rail, 8" from  
alignment, post anchor bolts failed.JPG  
taken: 2005/09/21 9:26

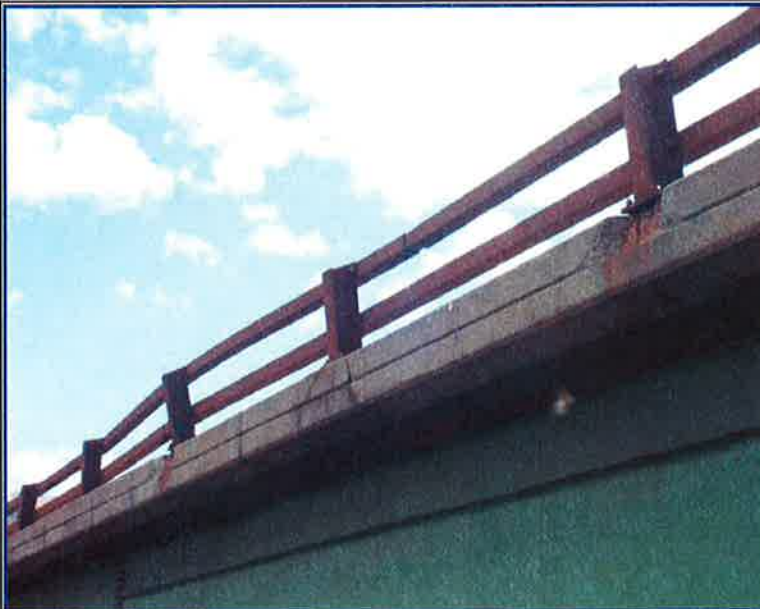
F12Y Impact to left rail has broken the  
curb at base of posts, plus the anchor  
bolts were pulled out.JPG taken:  
2005/09/21 9:50

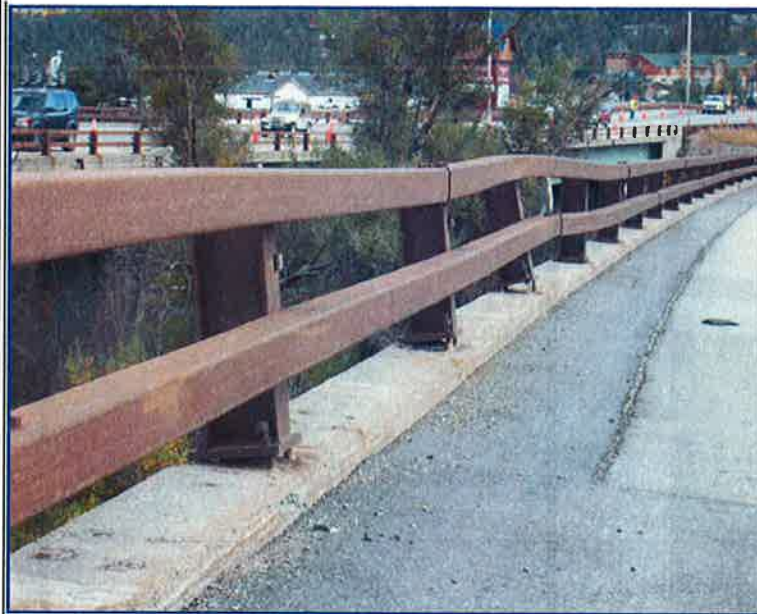
F12Y Impact to left rail has pulled out anchor bolts at 3 posts and broken the curb.JPG taken: 2005/09/21 9:53

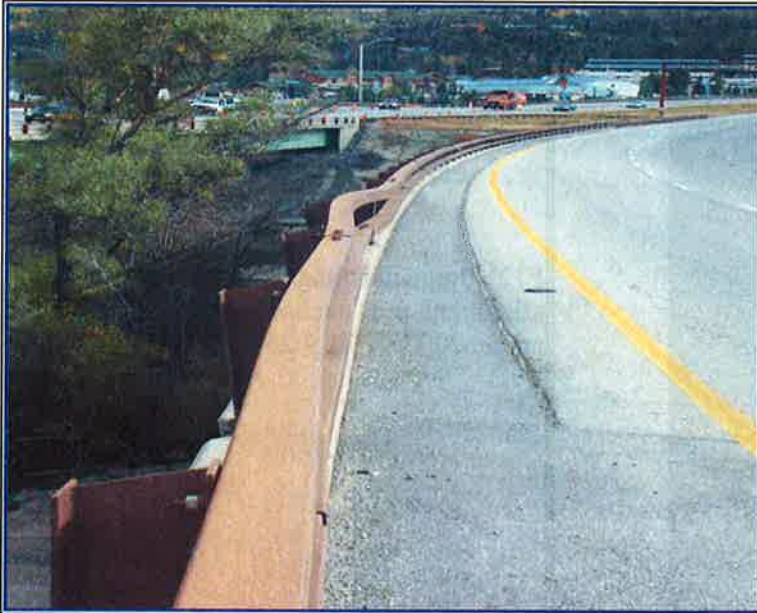
F12Y Impacted left rail alignment now.JPG taken: 2005/09/21 9:54

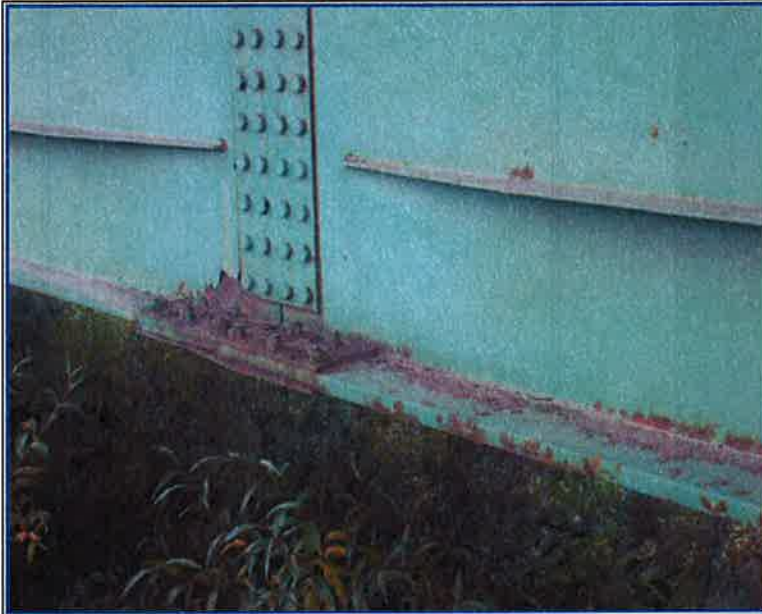
F12Y increased rusting at splice bottom flange plate, this is gir 2F.JPG taken: 2005/09/2112:33

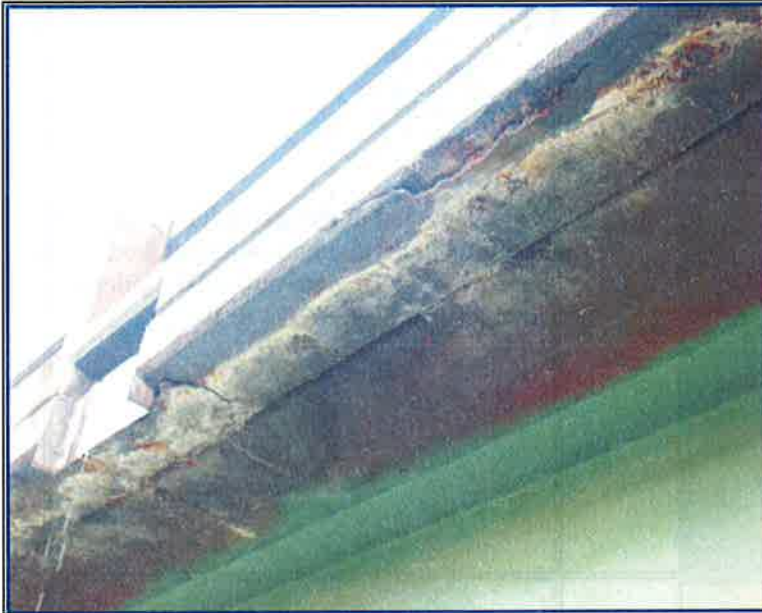
F12Y spalling and delam of rt overhang.JPG taken: 2005/09/2112:42

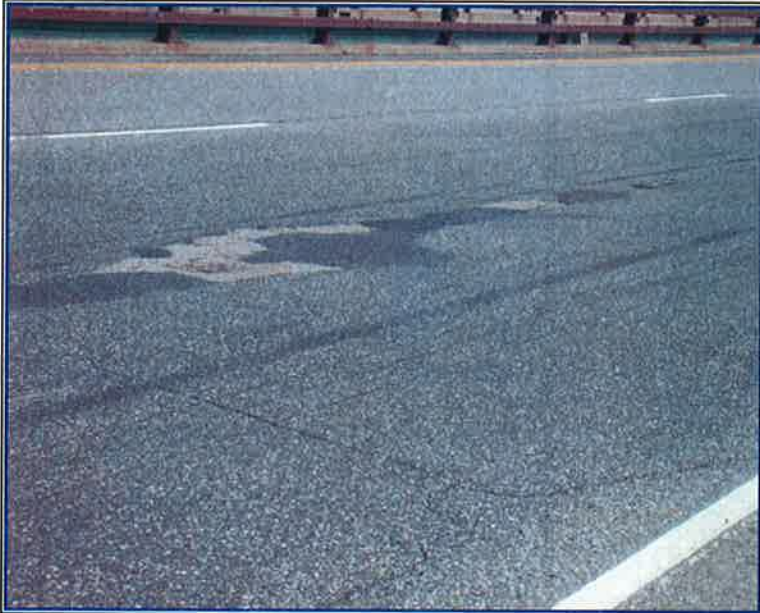
F12Y Raveled or rutted asphalt exposing previous layer and had to be patched, a little rough now, note unsealed moderate crack taken: 2005/09/21 9:36

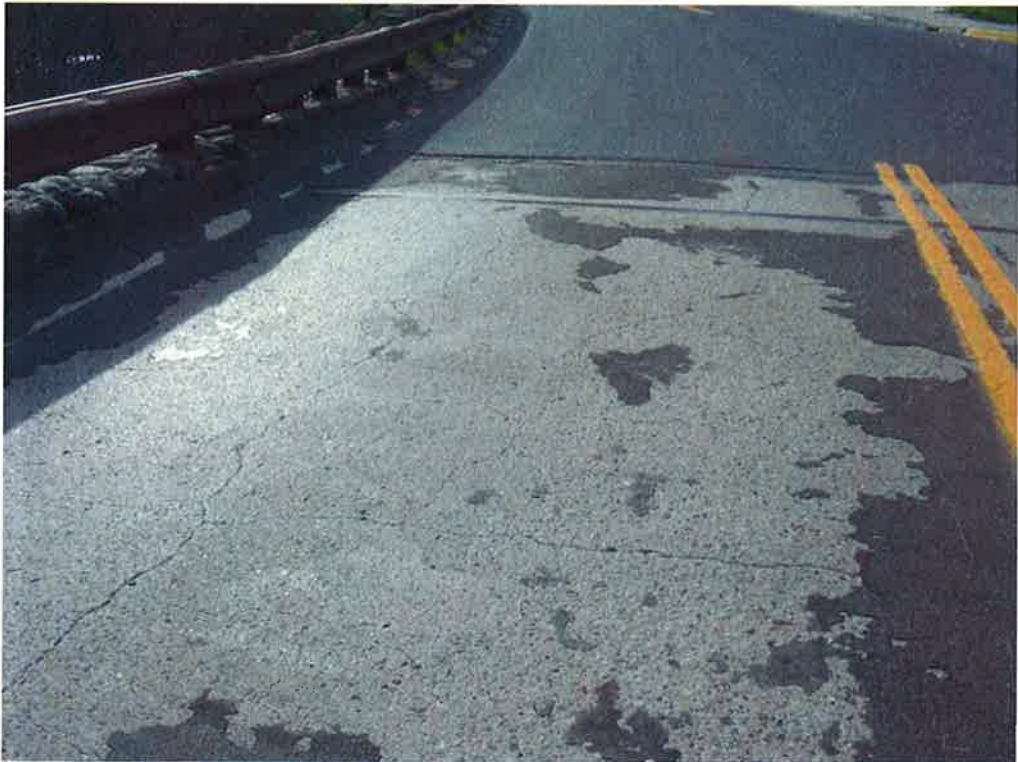
View Showing Polymer Coating Peeling Off of Deck Surface

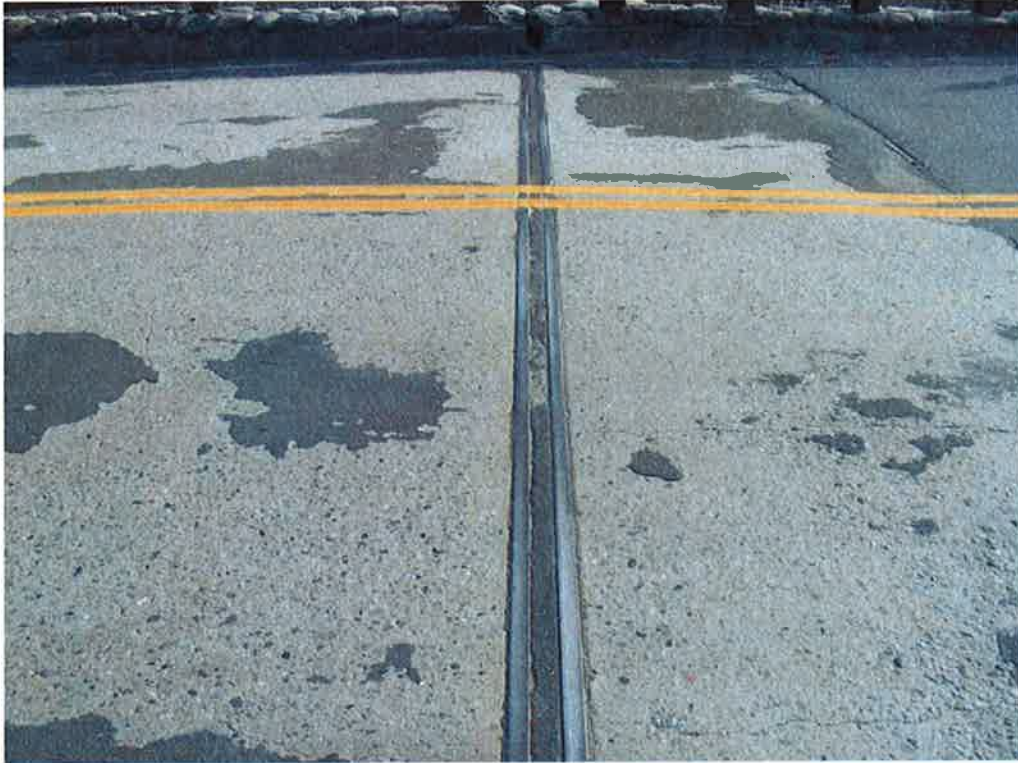
View Showing Cracks on Surface of Deck
