**US 6/Wadsworth**

**Environmental  
Assessment**

# Existing Conditions Report of Engineering Design Elements

CDOT Project STU #0062-019 (15215)  
CH2M HILL Project No. 358660

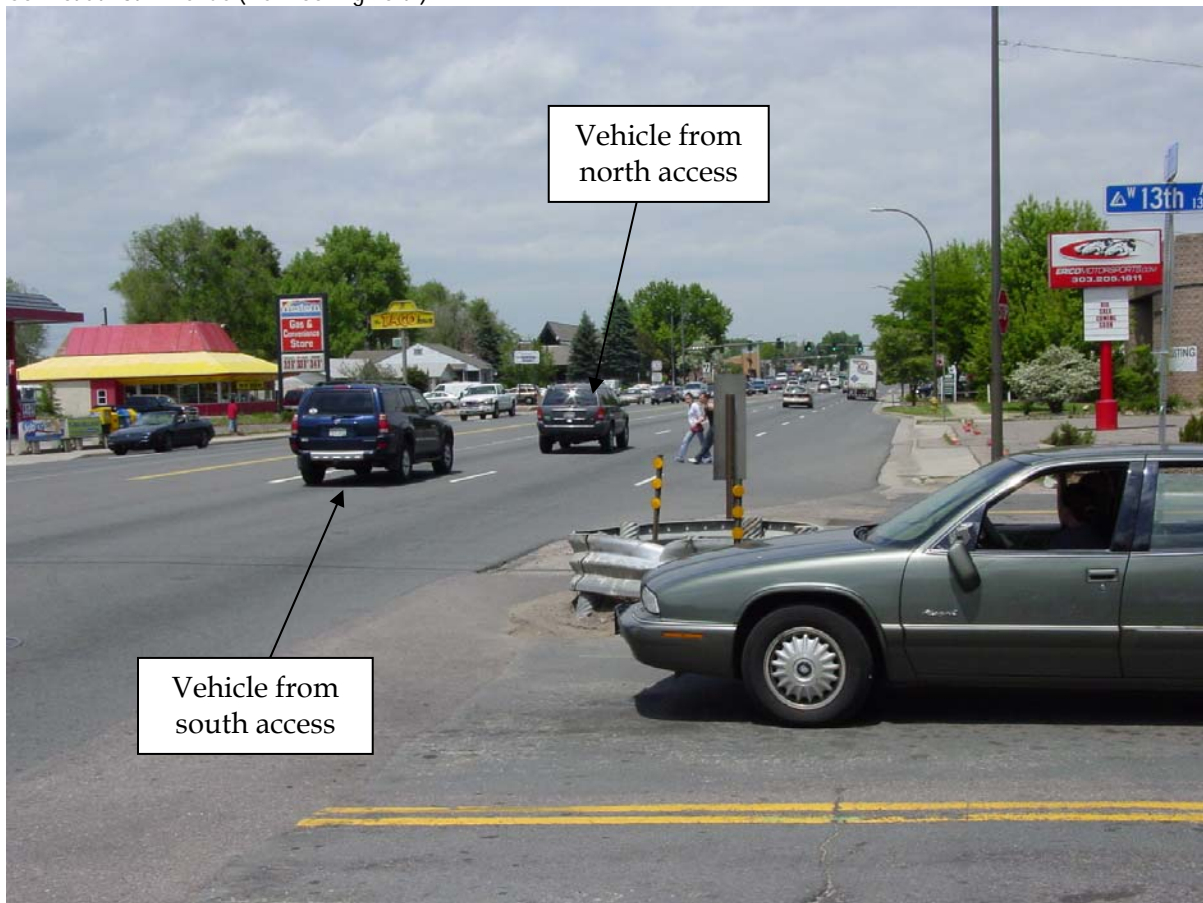
FIGURE 1  
Conflict at 13th Avenue (view looking north)

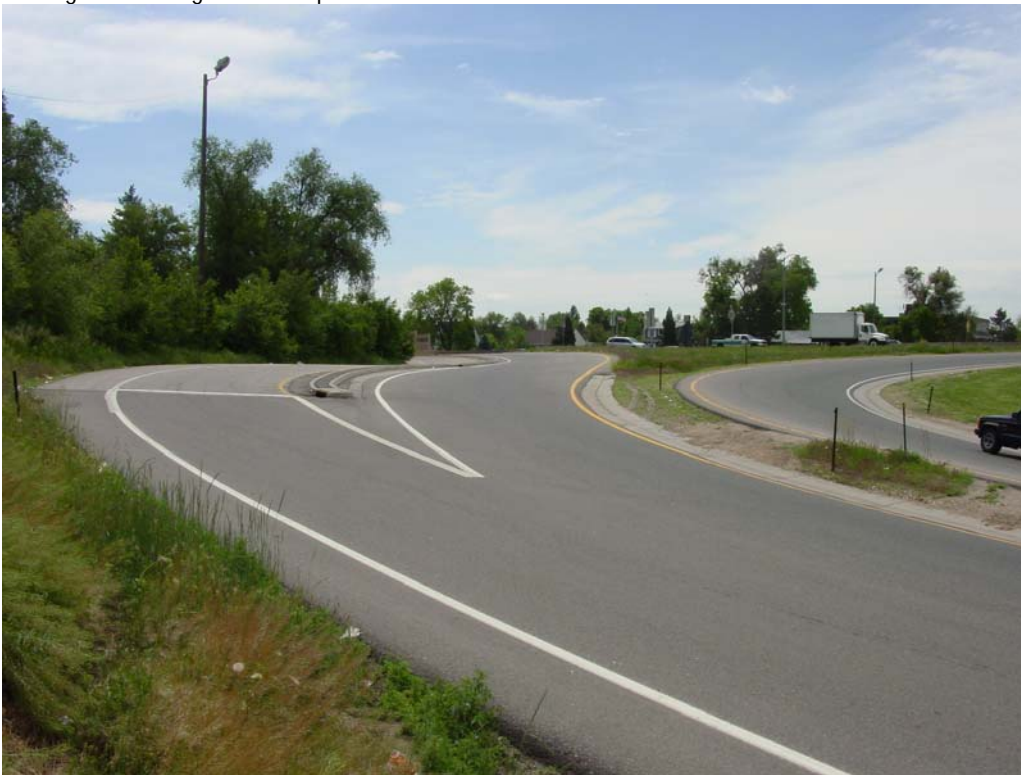
FIGURE 2  
Frontage Road Merge onto Ramp

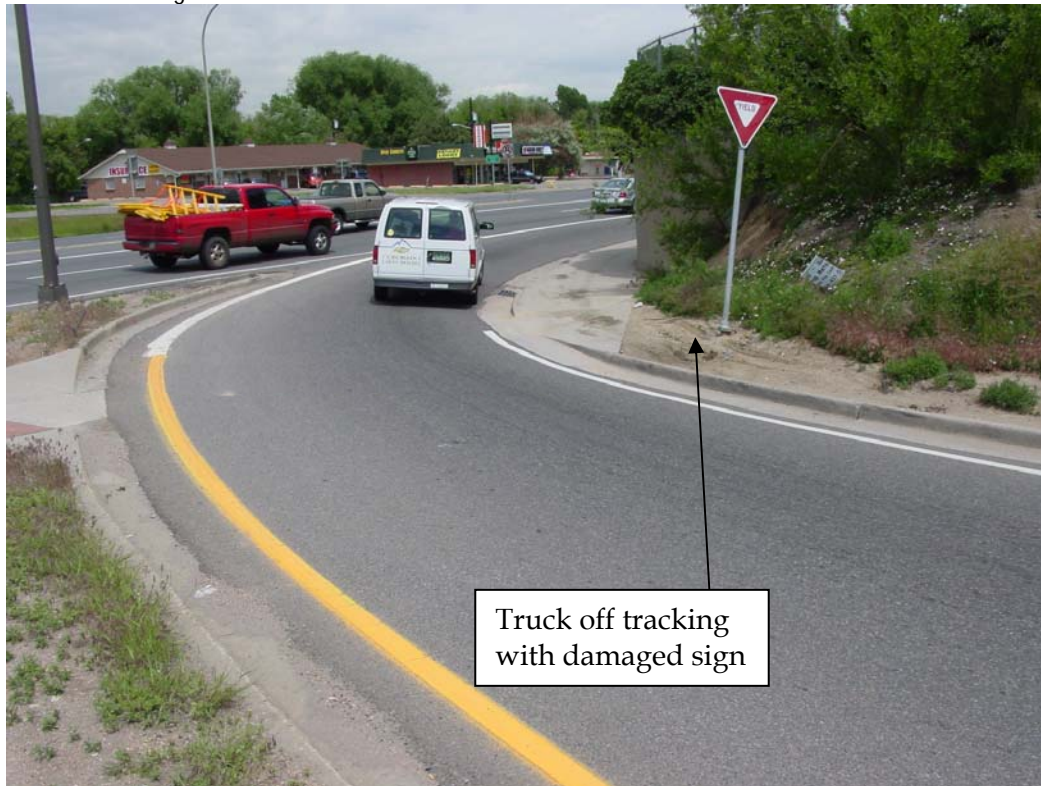
FIGURE 3  
Truck Off Tracking at NE-1 Intersection

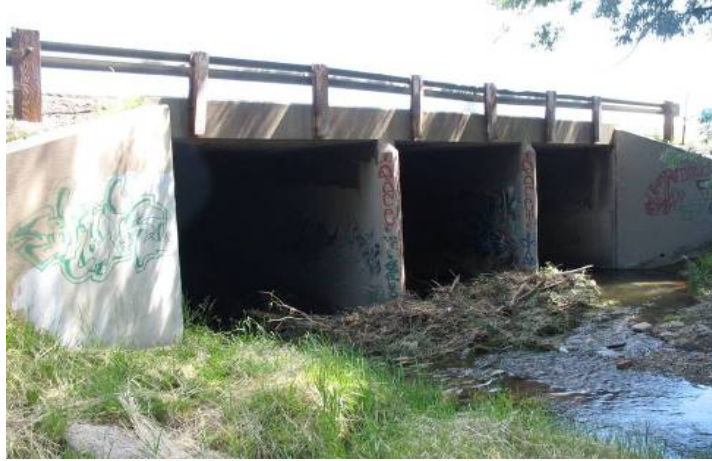
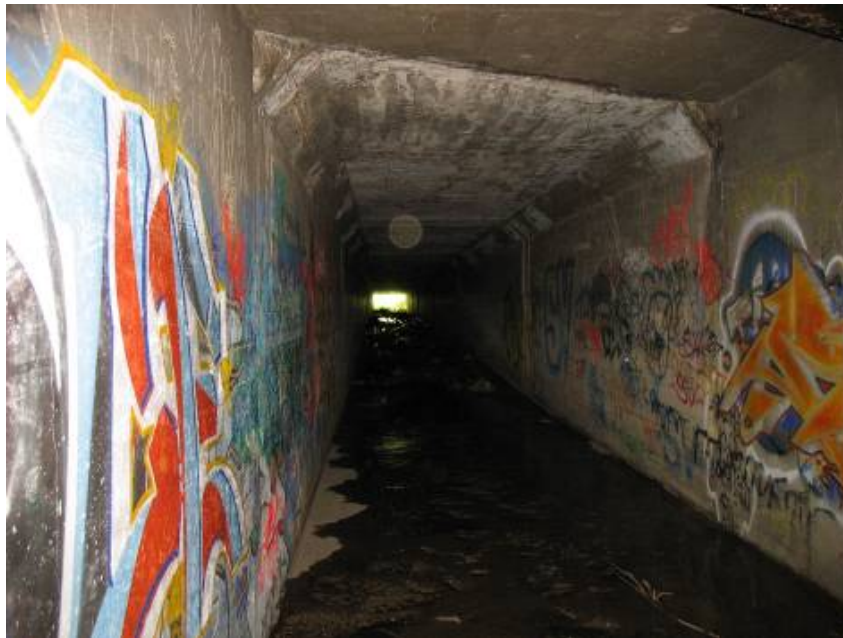
The first structure assessed was a three-cell, cast-in-place concrete box culvert located under Sixth Avenue, west of the Wadsworth Boulevard interchange. This multi-cell box is approximately 30 feet wide, with each cell measuring roughly 10 feet wide by 10 feet tall and nearly 275 feet in length (measured from an aerial photograph). The top slab of the original structure contains some minor cracking and shows efflorescence from magnesium chloride and road salts, especially at the joint where the culvert appears to have been widened. Otherwise, the structure appears to be in fair condition. During the time of the assessment, the box was carrying a decent flow and, therefore, a thorough assessment could not be made. The guardrail along the frontage road is in poor condition and should be updated and replaced. The *Colorado Department of Transportation (CDOT) Structure Inspection and Inventory Report* shows the condition rating of this structure as a 5, on a scale of 1 to 10. A rating of 5 is defined as "Fair Condition - all primary structural elements are sound but may have minor section loss, cracking, spalling, or scour." According to the same report, this structure has a sufficiency rating of 63.8. The CDOT report can be found in Attachment 1 of this technical memorandum (TM), while photographs of the structure are presented in Pictures 1 and 2 below.

PICTURE 1: SOUTH SIDE OF SIXTH AVENUE, LOOKING NORTH

PICTURE 2: CENTER CELL, LOOKING NORTH

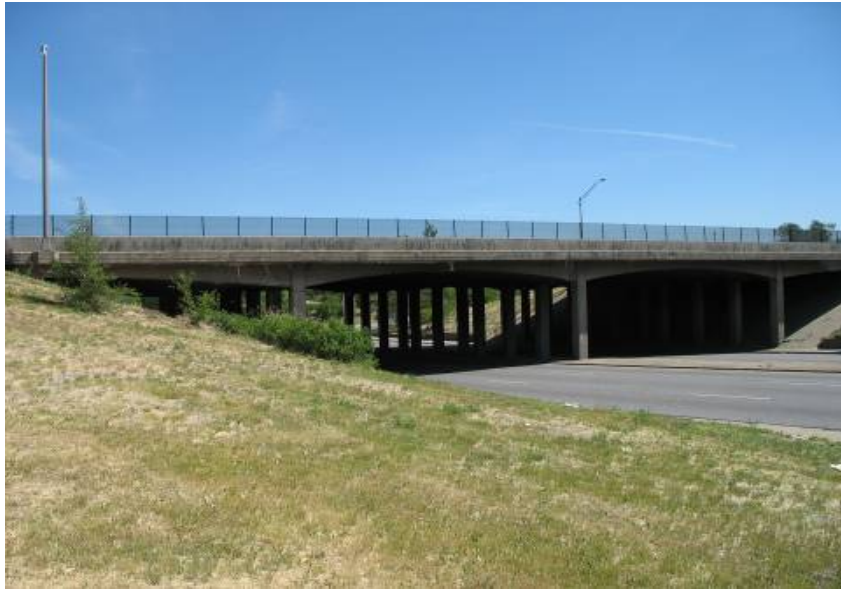
The second structure observed was the Sixth Avenue bridge over Wadsworth Boulevard (see Picture 3). The bridge shows significant deterioration of the bridge deck, while the overhangs show cracks and spalling of the concrete. The underside of the deck contains longitudinal cracking as seen by the penetration of the efflorescence. An example of these conditions can be seen in Pictures 4 and 5. The girders and substructure appear to be in fair condition with little sign of deterioration. The horizontal clearance between the existing roadway and the bridge piers is narrow and may present problems in widening Wadsworth Boulevard.

PICTURE 3: SIXTH AVENUE BRIDGE OVER WADSWORTH BOULEVARD, LOOKING NORTHEAST

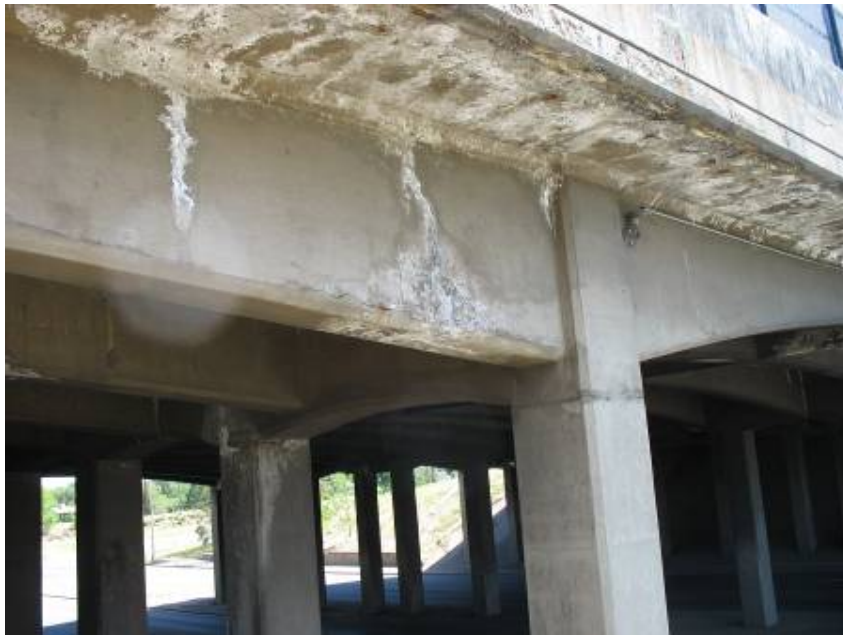
PICTURE 4: OVERHANG OF EASTBOUND BRIDGE

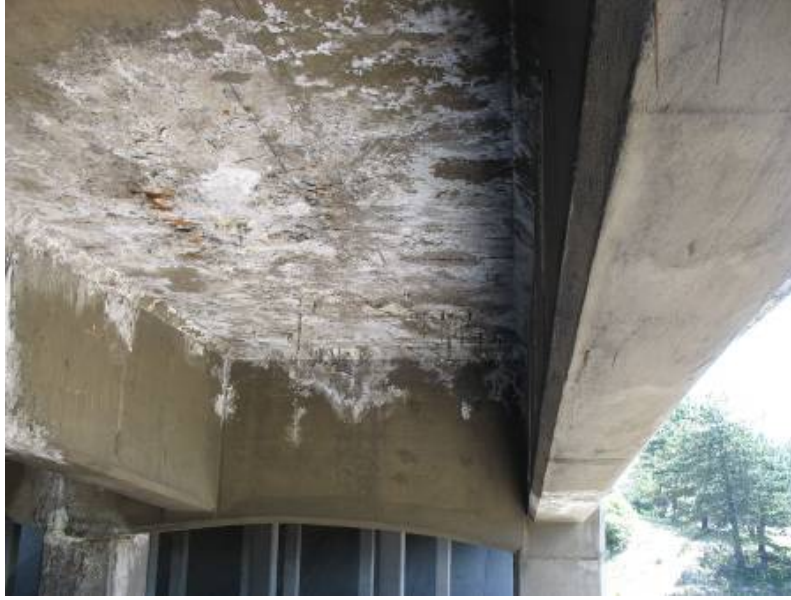
PICTURE 5: EFFLORESCENCE AND RUST ON UNDERSIDE OF DECK

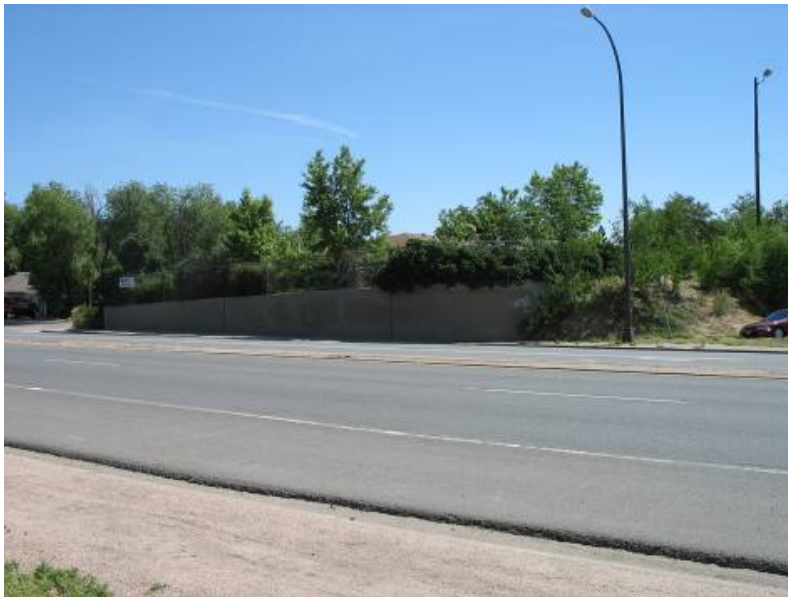
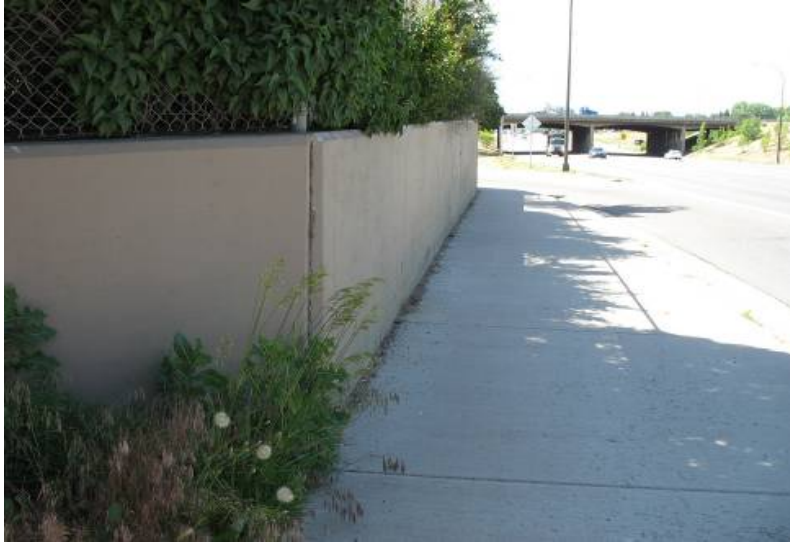
The third structure assessed was a cast-in-place concrete retaining wall on the ramp from eastbound Sixth Avenue to northbound Wadsworth Boulevard. This wall, located on the corner of Broadview Drive and Wadsworth Boulevard, is approximately 10 feet tall at its peak and nearly 120 feet in length. The wall shows minor cracks where typical crack control joints should have been placed. The wall as apparently built with expansion joints but no crack control joints. This wall appears to be stable and cracking is minimal. Overall, this wall is in good condition. However, poor sight distance from the northbound ramp onto Wadsworth Boulevard creates a hazard to pedestrians and oncoming traffic. This wall is shown in Pictures 6 and 7.

PICTURE 6: WALL AT NORTHEAST CORNER OF SIXTH AVENUE AND WADSWORTH BOULEVARD, LOOKING NORTHEAST

PICTURE 7: WALL AT NORTHEAST CORNER OF SIXTH AVENUE AND WADSWORTH BOULEVARD, LOOKING SOUTH

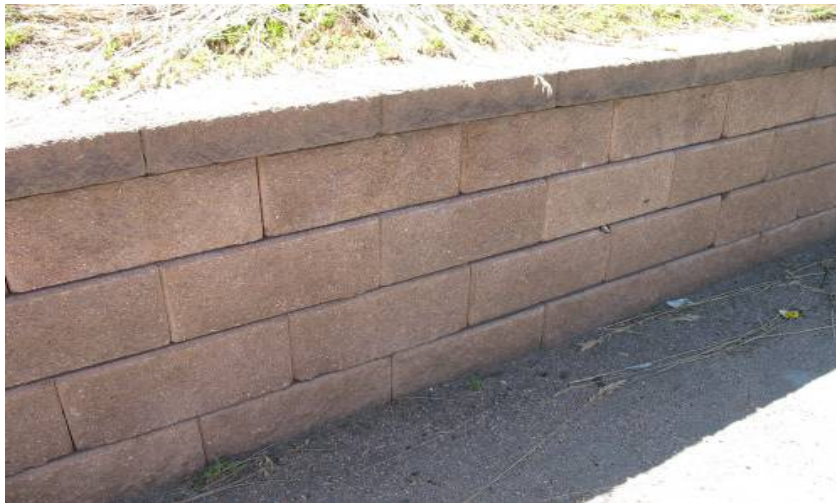
Several block landscaping walls are present along northbound Wadsworth Boulevard, north and south of the slope paving of the bridge. These walls are not considered major structures and should be of little significance to the Environmental Assessment (EA). They are in good condition and appear to be structurally sound. An example of one of these walls is shown in Picture 8.

PICTURE 8: LANDSCAPE WALL AT NORTHEAST CORNER OF SIXTH AVENUE AND WADSWORTH BOULEVARD

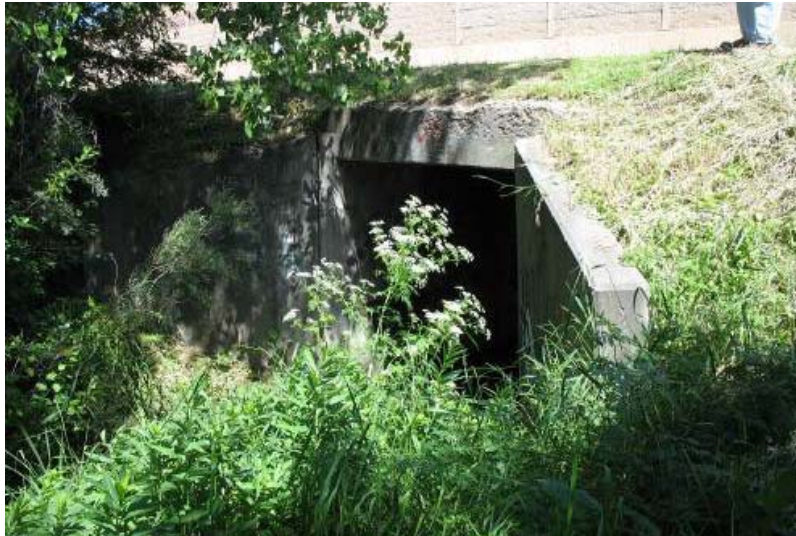
A minor structure within the project boundaries is a cast-in-place concrete box culvert located under Sixth Avenue, east of the Sixth Avenue and Wadsworth Boulevard interchange. This box culvert is approximately 10 feet wide by 8 feet tall and about 175 feet in length (measured from an aerial photograph). This culvert is not considered to be a major structure but appears to be in fair condition. However, water was running through the culvert at the time of the site visit, and a walk-through assessment was not performed. This culvert is shown in Picture 9.

PICTURE 9: MINOR STRUCTURE UNDER SIXTH AVENUE;  
PICTURE IS FROM THE SOUTH SIDE OF SIXTH AVENUE, LOOKING NORTHWEST

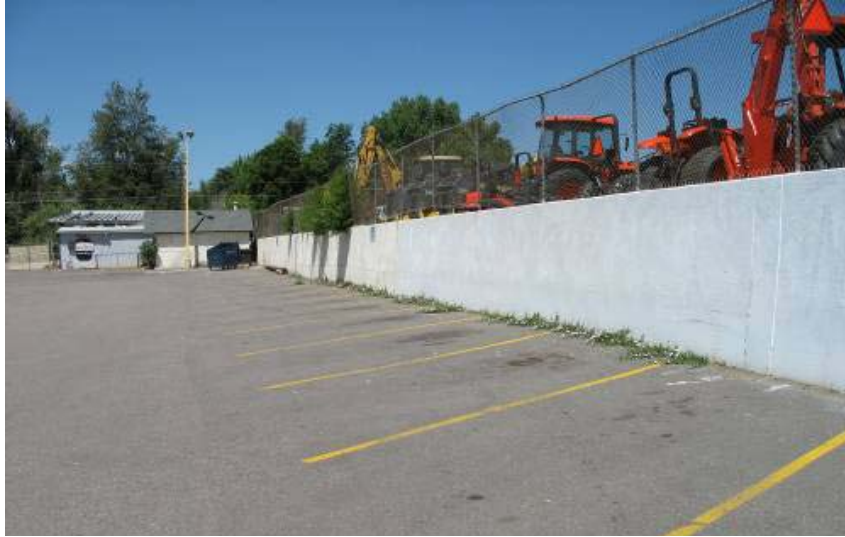
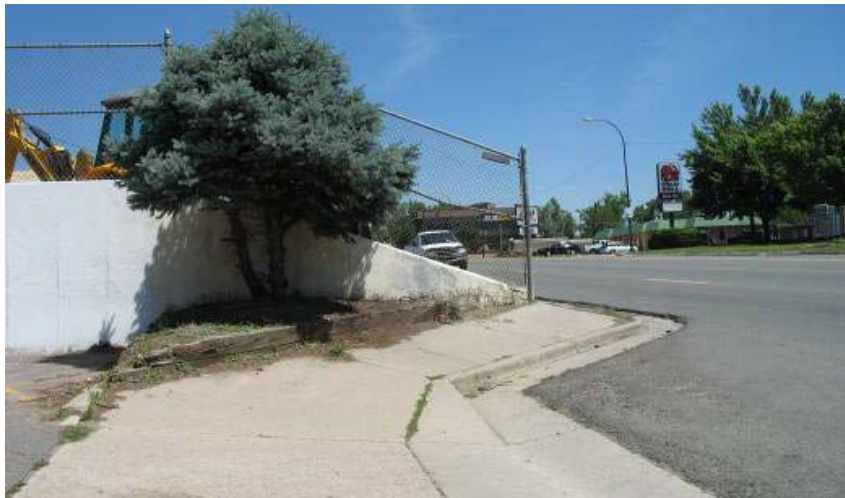
The fourth structure assessed was a cast-in-place concrete retaining wall between the New Holland tractor dealership and Three Margaritas restaurant (See Pictures 10 and 11). This wall is approximately 8 feet tall and measures nearly 300 feet in length. The wall appears to be stable with few cracks and new paint. At the edge of Wadsworth Boulevard, the wall extends to the sidewalk, which creates an unsafe walking condition and also obstructs sight distance at the entryway to the Three Margaritas restaurant.

PICTURE 10: CAST-IN-PLACE WALL ON WEST SIDE OF WADSWORTH BOULEVARD, LOOKING WEST

PICTURE 11: CAST-IN-PLACE WALL ON WEST SIDE OF WADSWORTH BOULEVARD, LOOKING NORTH

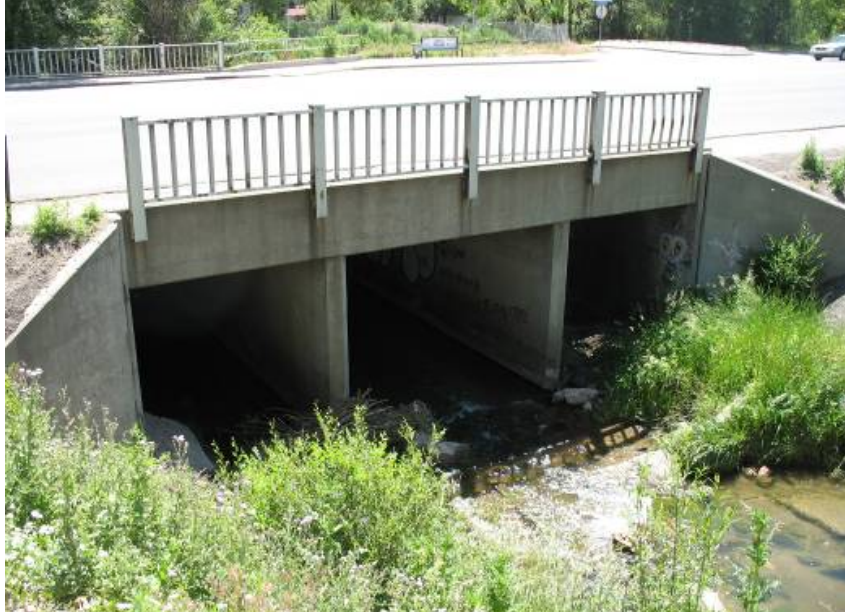
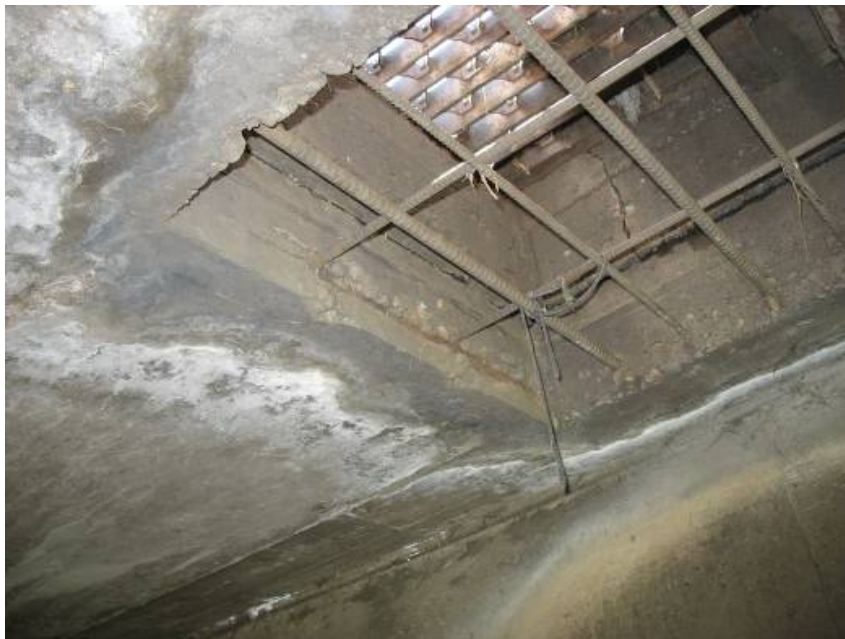
The last structure observed was a three-cell cast-in-place concrete box culvert located under Wadsworth Boulevard at Lakewood Gulch (see Pictures 12 and 13). This multi-cell box shows little sign of deterioration except near the bridge drains, which are cut into the top slab of the box, as shown in Picture 13. The interior of the box is in fair condition. There are longitudinal pipe penetrations through all four walls near the top slab, and the wing walls appear to be stable. However, the railing mounted to the headwalls is substandard. The overall condition of this structure is fair to good.

The CDOT Structure Inspection and Inventory Report shows the condition rating of this structure as a 6, on a scale of 1 to 10. A rating of 6 is defined as "Satisfactory Condition – structural elements show some minor deterioration." According to the same report, this structure has a sufficiency rating of 93.6. The CDOT report can be found in the Attachment 1 of this TM.

PICTURE 12: BOX CULVERT CARRYING SIXTH AVENUE OVER LAKEWOOD GULCH; WEST SIDE, LOOKING EAST

PICTURE 13: BOX CULVERT CARRYING SIXTH AVENUE OVER LAKEWOOD GULCH, TOP SLAB DRAIN

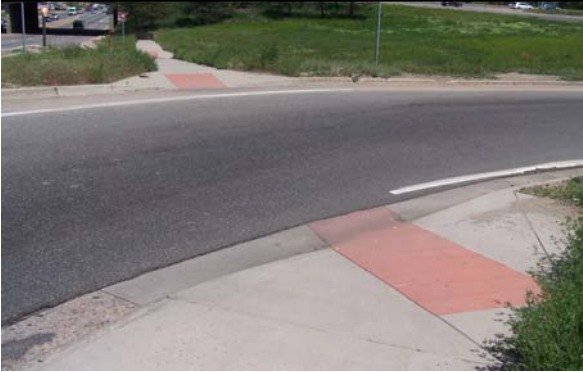
Sidewalk crossing at high-volume on-ramp  
(NB Wadsworth to EB US 6)

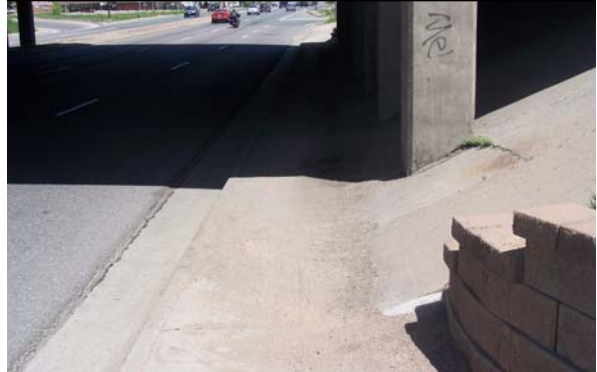
Narrow attached sidewalk under US 6 bridge  
(east side of Wadsworth)

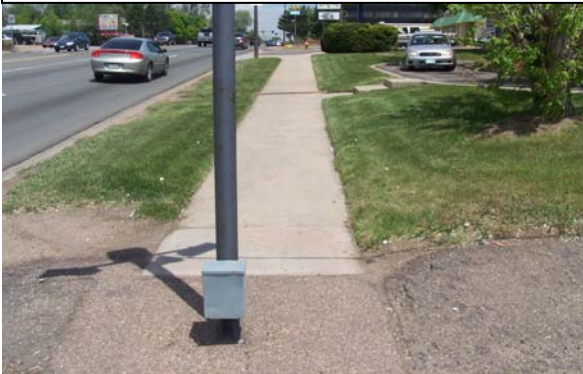
Light Pole obstructing pedestrian traveled way  
(East side Wadsworth from 6<sup>th</sup> to 8<sup>th</sup> Avenue)

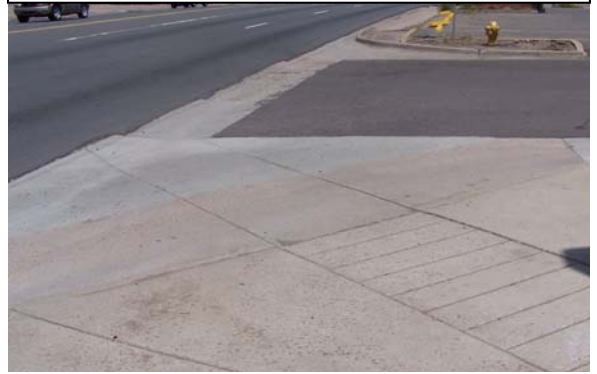
Missing curb ramp on northeast corner of 8<sup>th</sup>  
Place and Wadsworth

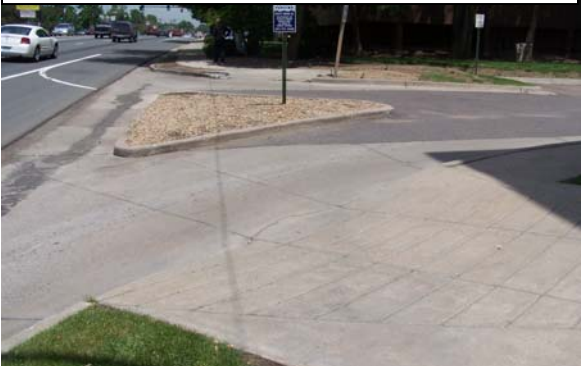
Turn island without curb ramps in pedestrian  
path (940 Wadsworth Parking Lot Access)

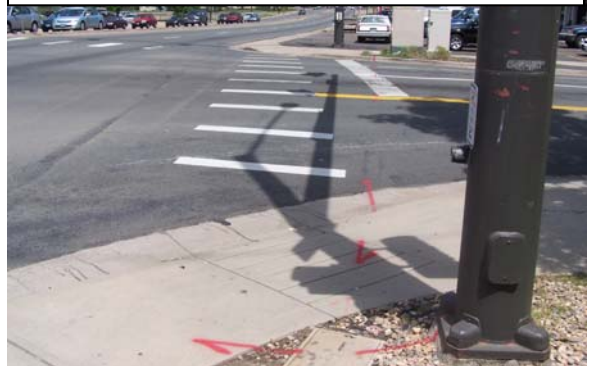
Non-ADA curb ramp at southeast corner of  
10<sup>th</sup> Avenue/Wadsworth Boulevard
