2. Existing Conditions

The existing 4th St. Bridge, structure number K-18-Z, was constructed in 1958 and is approximately 1068 feet long and 68 feet wide. The bridge superstructure is constructed of built-up riveted steel plate girders with a cast-in-place mildly reinforced concrete deck (non-composite). Lead based paint was used for corrosion protection. The substructure bents are multiple column and bent cap construction. There are seven spans ranging in length from 117 feet to 202 feet. The structure is divided into three continuous units: a two-span unit over the Arkansas River and floodwall, a three-span unit across the Union Pacific Railroad yard (UPRR), and a two-span unit over the Burlington Northern Santa Fe Railroad yard (BNSF). The maximum span length over the Arkansas River is 202 feet, over the UPRR, 182 feet, and over the BNSF, 117'-5". The existing configuration results in five piers in the Pueblo Yard, and one pier on the western bank of the Arkansas River.

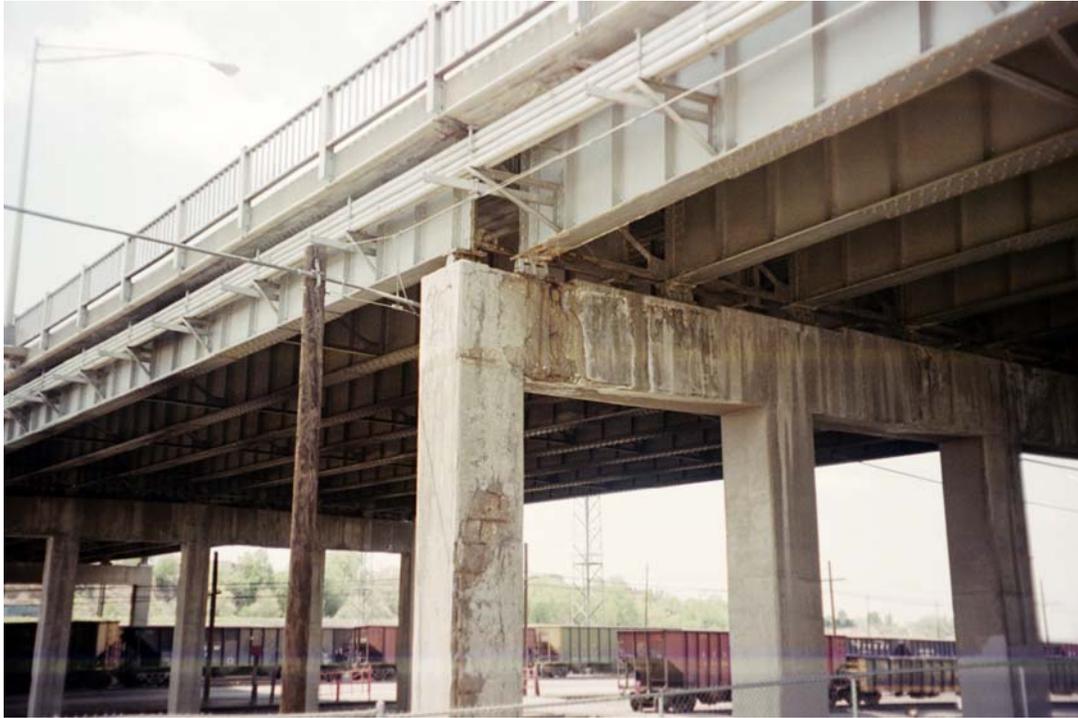
The SD classification is based on substantial substructure pier deterioration, which is described as "poor with advanced section loss, deterioration, spalling, and/or scour." Joint failure and leakage have caused significant concrete and reinforcing deterioration of the substructure piers. Loss of concrete cover has led to corrosion of column and bent cap reinforcing steel, including the full section loss of some primary and secondary bars.

The substructure condition is rated as "poor with advanced section loss, deterioration, spalling, and/or scour." The substructure is deteriorating rapidly as loss of concrete has led to the corrosion of major and minor reinforcing steel in the piers. The substructure is stable for scour, indicating that there are no scour issues with Pier 6 located in the Arkansas River channel.

Figure 2.3 Bent 1 Concrete and Reinforcing Deterioration

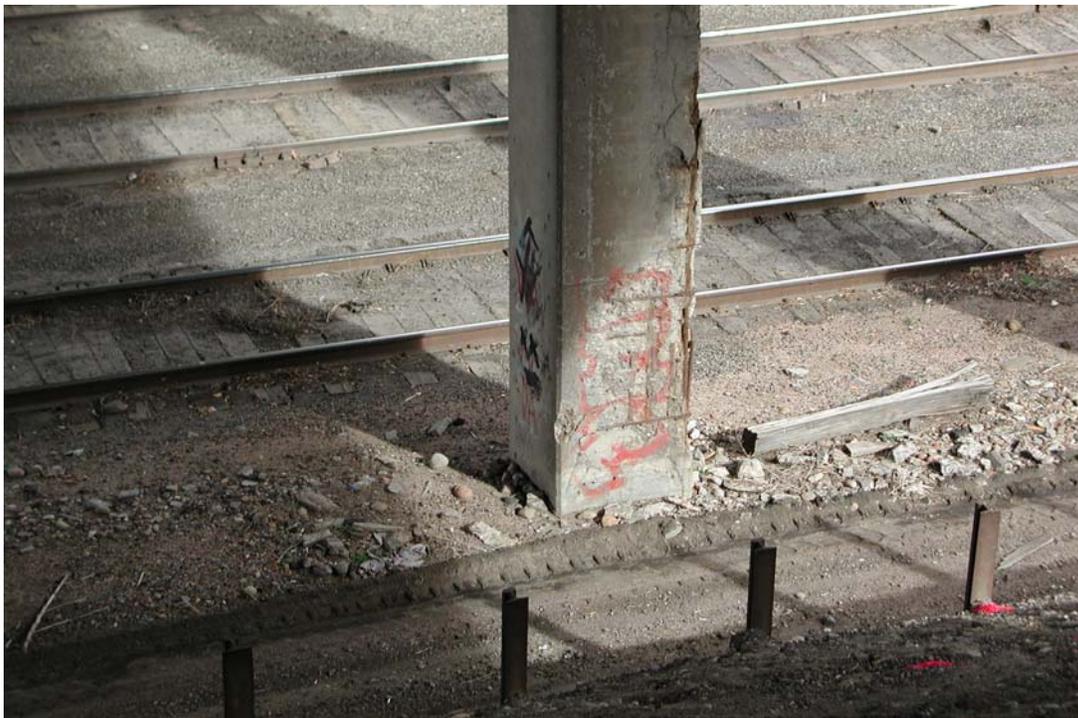
Figure 2.4 Bent 5 Concrete and Reinforcing Deterioration

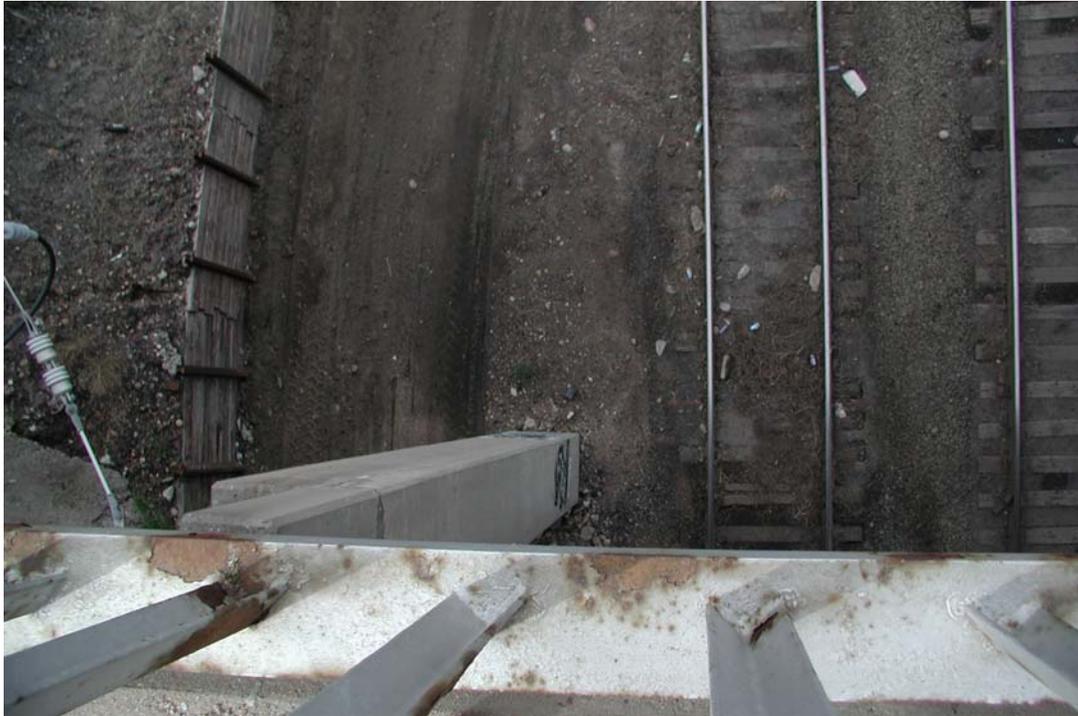
to the close proximity of railroad tracks to existing bridge piers. Recently, an empty railroad flatcar traveling at slow speed derailed and struck a pier causing damage, illustrating the importance of adequate clearance between the centerline of track and the face of an adjacent pier. The minimum existing horizontal clearance is 8'-3" from the centerline of UPRR Yard Track 21 to the face of Pier 5. This pier is located adjacent to the Arkansas River Floodwall. Table 2.1 shows existing horizontal clearances for each pier, the majority of which are less than 25'-0", the current railroad, AREMA, and AASHTO requirement when crash walls are not provided (18'-0" with crash walls). Inadequate horizontal clearance to the railroad tracks is a major concern as it relates to the safety of the traveling public and railroad personnel.

Figure 2.5 Proximity of Pier 5 to UPRR Yard Track 21 and Floodwall

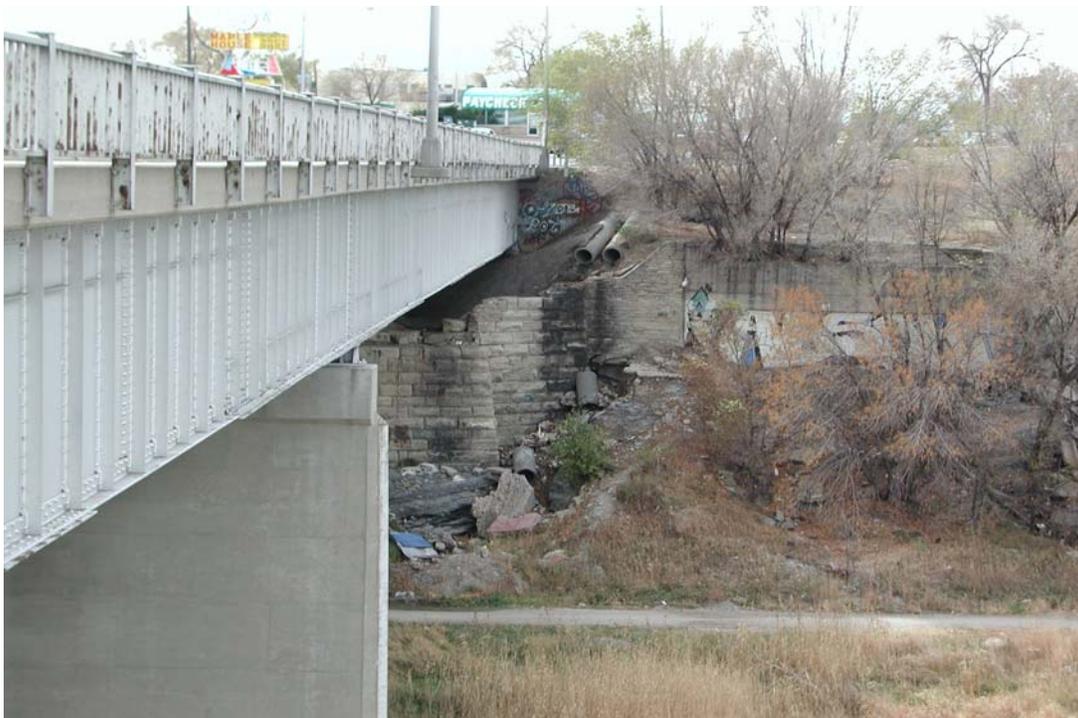
Overhead electric lines cross the bridge at both the east and west ends. Underground gas lines exist in the railroad yard and east approach fill. Gas, electric and communications lines run on the bridge outside of the edge girders. Storm water runoff from the west approach is collected in a sewer system which daylights at the west abutment on the north side of the bridge. Outfall from the pipes has caused significant slope erosion.

Figure 2.6 Storm Sewer Outfall at West Abutment

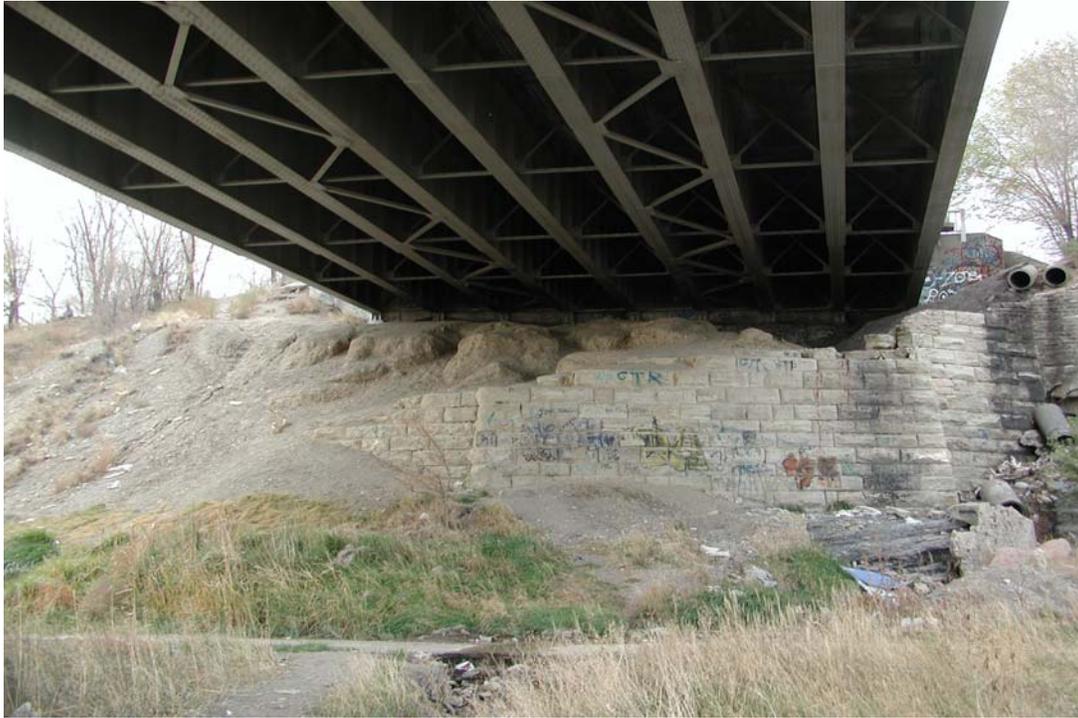
flaking lead paint on the girders raises environmental concerns as well as corrosion issues. There is a significant build-up of sand on the abutment seats, and the slopes in front of both abutments are eroding due to poor drainage and slope protection. Signs of corrosion on the steel elements shows the beginnings of what can be a rapid deterioration of the superstructure.

Figure 2.7 Erosion at West Abutment

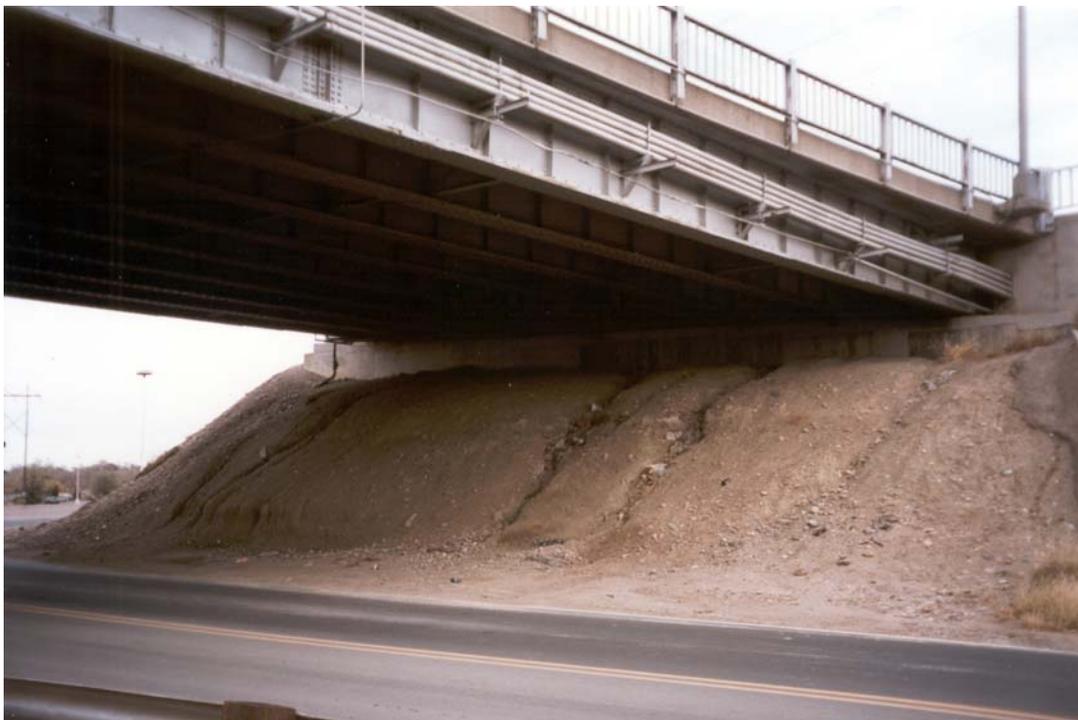
Figure 2.8 Erosion at East Abutment
