## 2. Existing Conditions

### 2.1 Existing Bridge Configuration

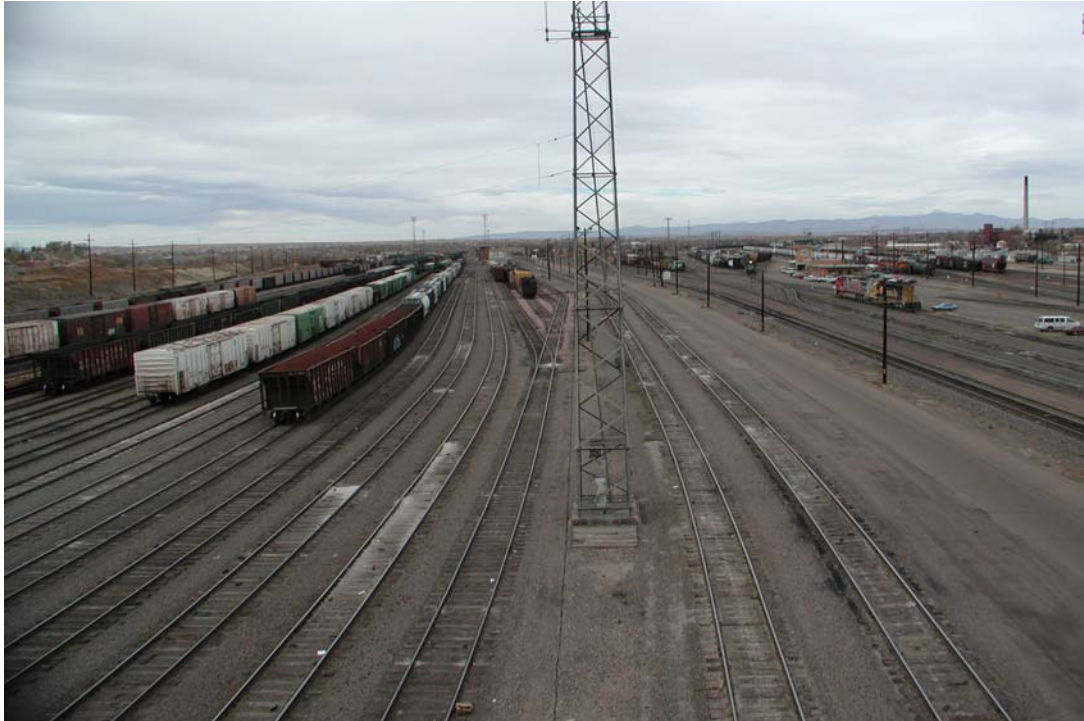
**Figure 2.1 Pueblo Yard Looking North**

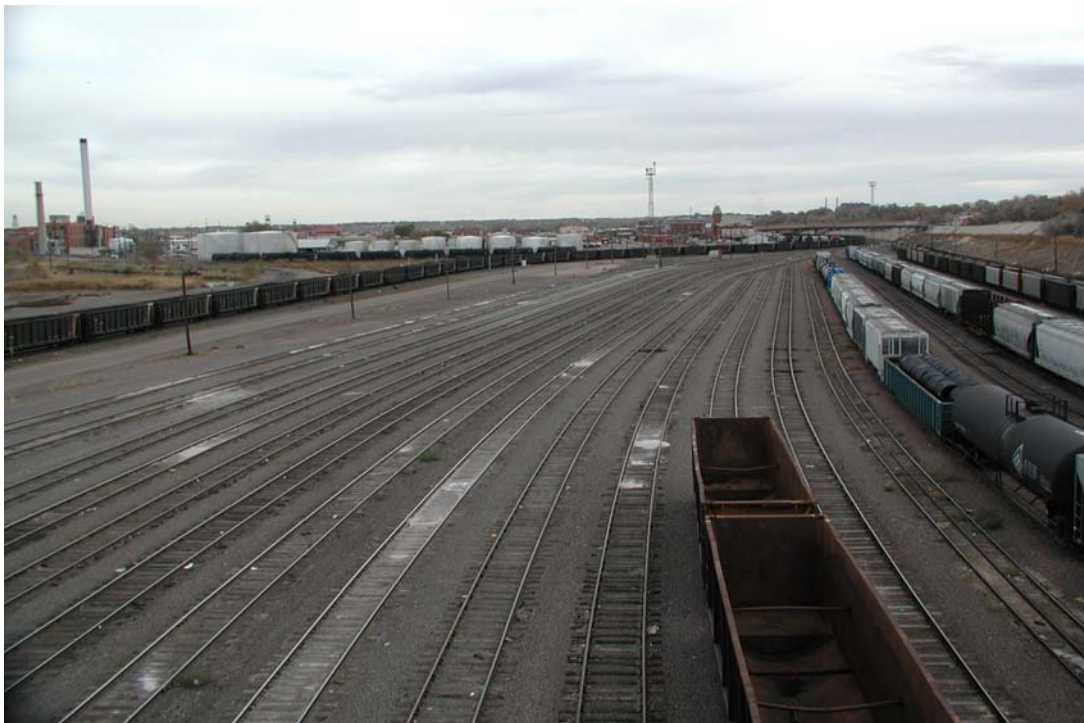
**Figure 2.2 Pueblo Yard Looking South**

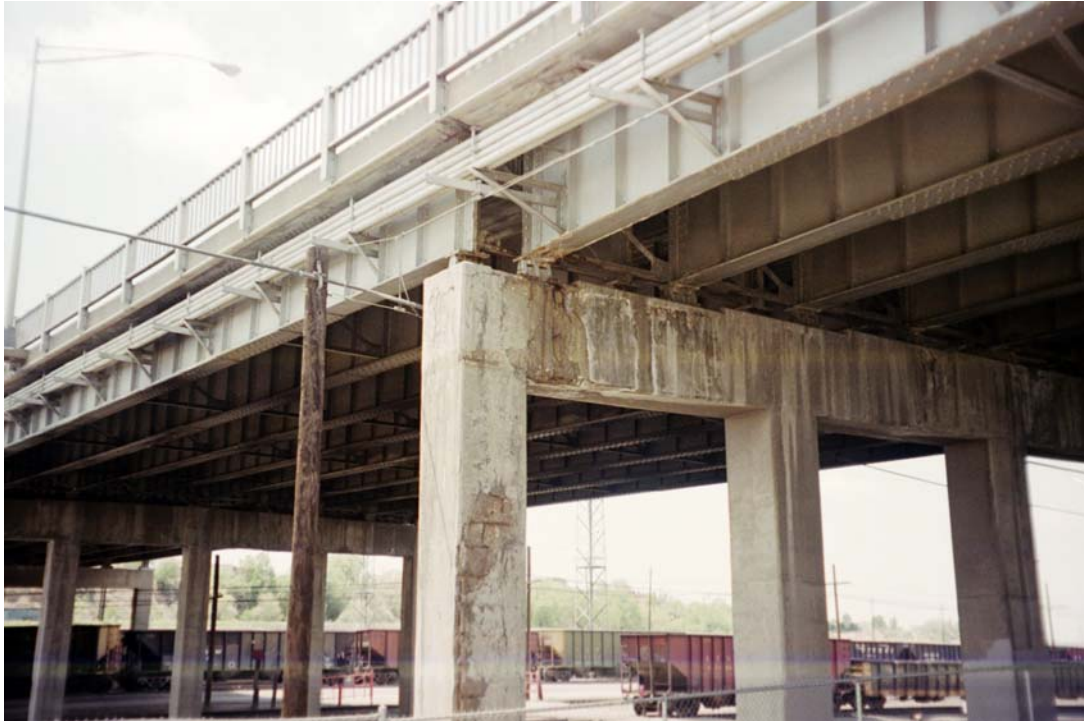
The SD classification is based on substantial substructure pier deterioration, which is described as "poor with advanced section loss, deterioration, spalling, and/or scour." Joint failure and leakage have caused significant concrete and reinforcing deterioration of the substructure piers. Loss of concrete cover has led to corrosion of column and bent cap reinforcing steel, including the full section loss of some primary and secondary bars.

The substructure condition is rated as "poor with advanced section loss, deterioration, spalling, and/or scour." The substructure is deteriorating rapidly as loss of concrete has led to the corrosion of major and minor reinforcing steel in the piers. The substructure is stable for scour, indicating that there are no scour issues with Pier 6 located in the Arkansas River channel.

**Figure 2.3 Bent 1 Concrete and Reinforcing Deterioration**

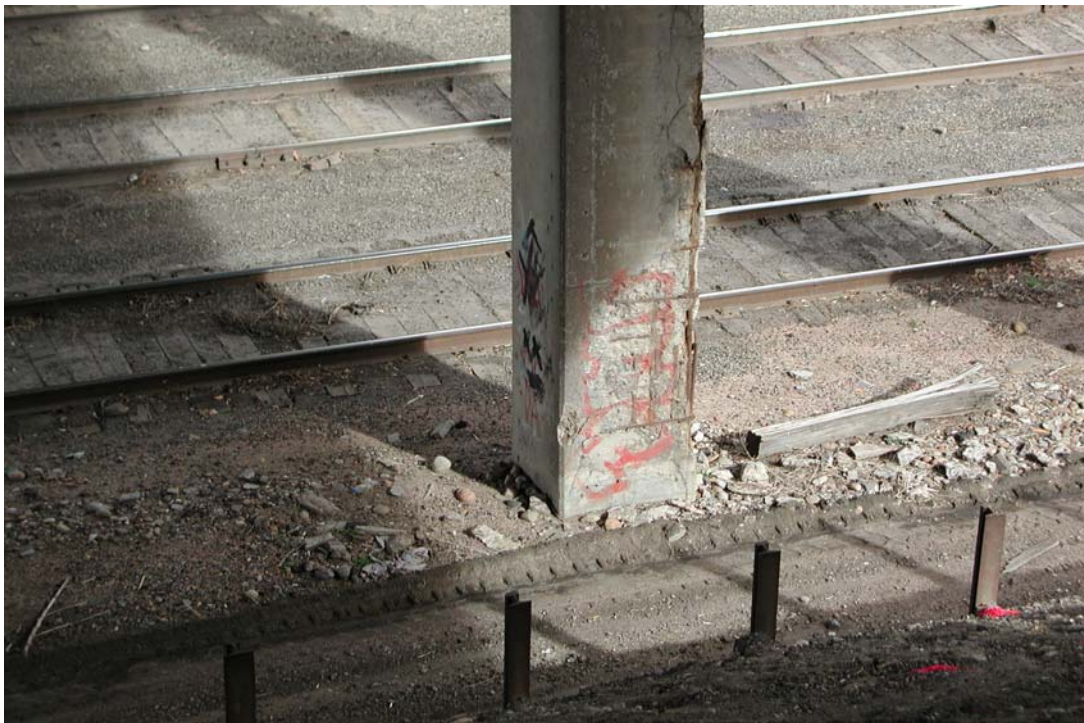
**Figure 2.4 Bent 5 Concrete and Reinforcing Deterioration**

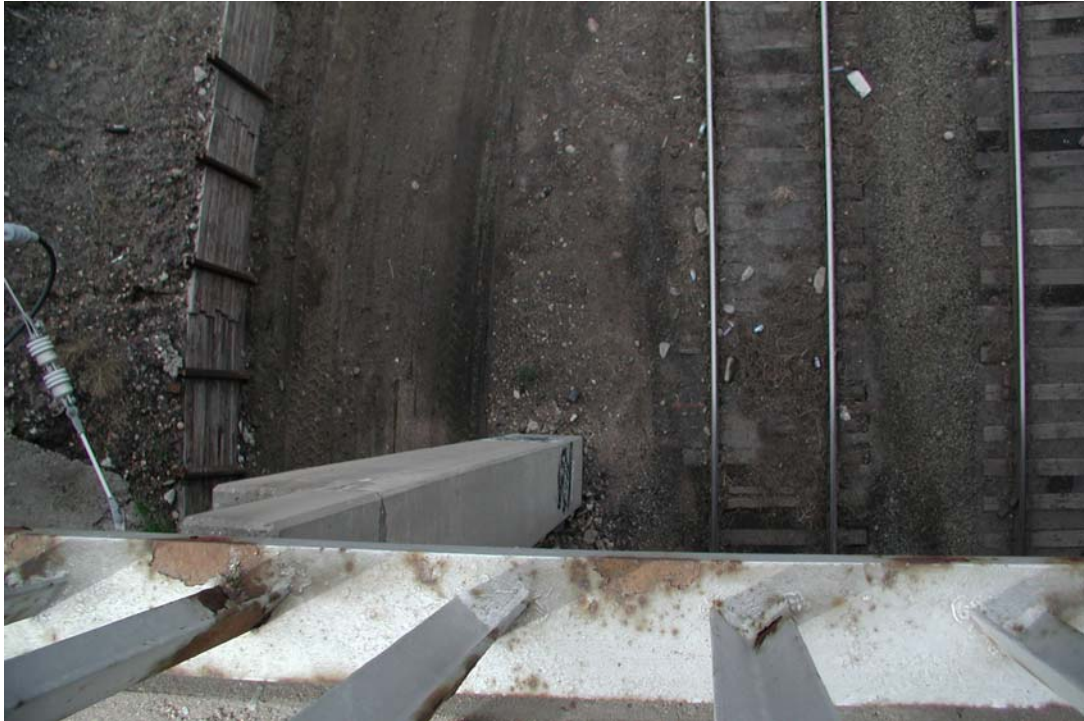
to the close proximity of railroad tracks to existing bridge piers. Recently, an empty railroad flatcar traveling at slow speed derailed and struck a pier causing damage, illustrating the importance of adequate clearance between the centerline of track and the face of an adjacent pier. The minimum existing horizontal clearance is 8'-3" from the centerline of UPRR Yard Track 21 to the face of Pier 5. This pier is located adjacent to the Arkansas River Floodwall. Table 2.1 shows existing horizontal clearances for each pier, the majority of which are less than 25'-0", the current railroad, AREMA, and AASHTO requirement when crash walls are not provided (18'-0" with crash walls). Inadequate horizontal clearance to the railroad tracks is a major concern as it relates to the safety of the traveling public and railroad personnel.

Pier	Horizontal Clearance Face of Pier to Centerline Track *
1	27'-6"
2	11'-0"
3	10'-6"
4	11'-9"
5	8'-3"
6	N/A (River Pier)

**Figure 2.5 Proximity of Pier 5 to UPRR Yard Track 21 and Floodwall**

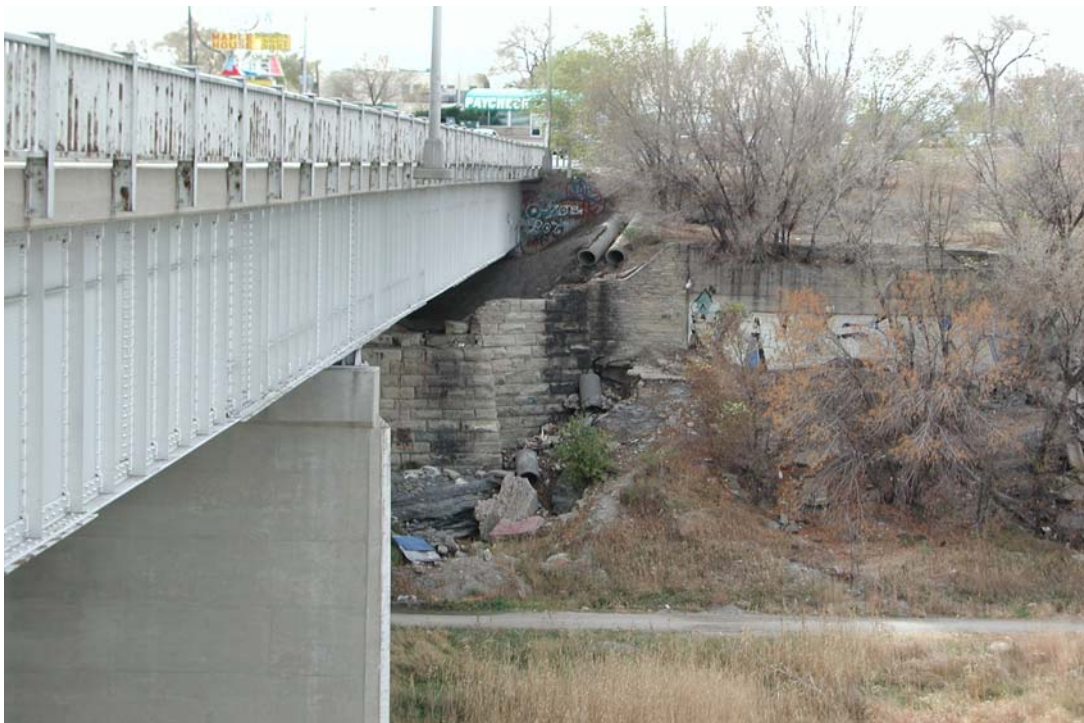
Overhead electric lines cross the bridge at both the east and west ends. Underground gas lines exist in the railroad yard and east approach fill. Gas, electric and communications lines run on the bridge outside of the edge girders. Storm water runoff from the west approach is collected in a sewer system which daylight at the west abutment on the north side of the bridge. Outfall from the pipes has caused significant slope erosion.

**Figure 2.6 Storm Sewer Outfall at West Abutment**

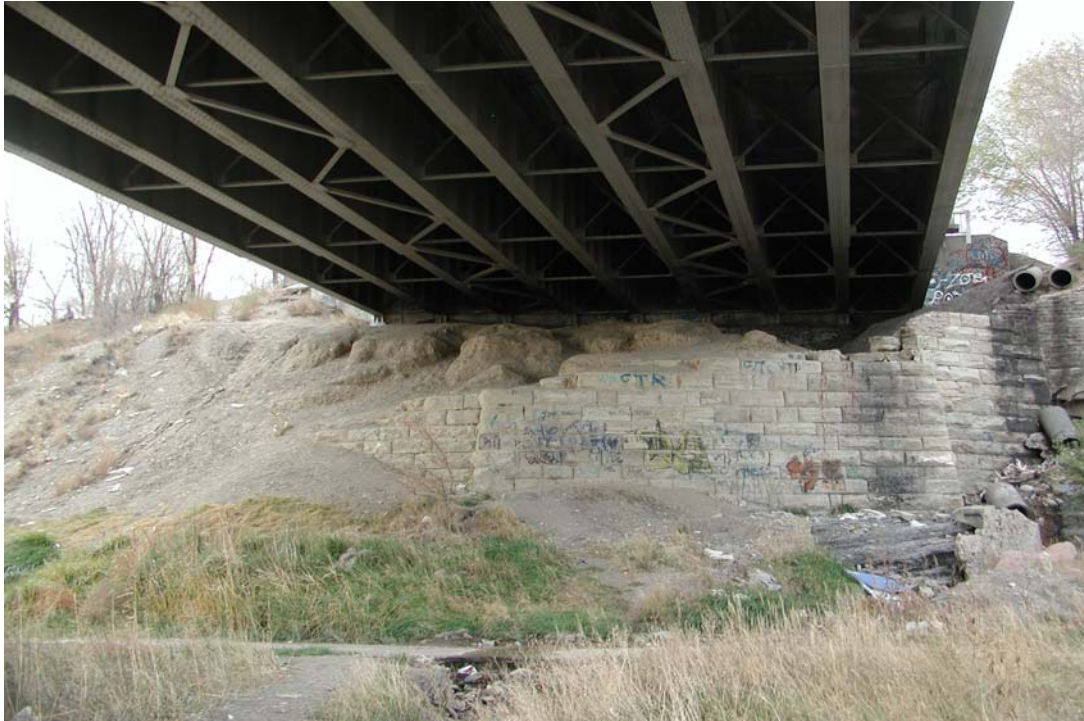
flaking lead paint on the girders raises environmental concerns as well as corrosion issues. There is a significant build-up of sand on the abutment seats, and the slopes in front of both abutments are eroding due to poor drainage and slope protection. Signs of corrosion on the steel elements shows the beginnings of what can be a rapid deterioration of the superstructure.

**Figure 2.7 Erosion at West Abutment**

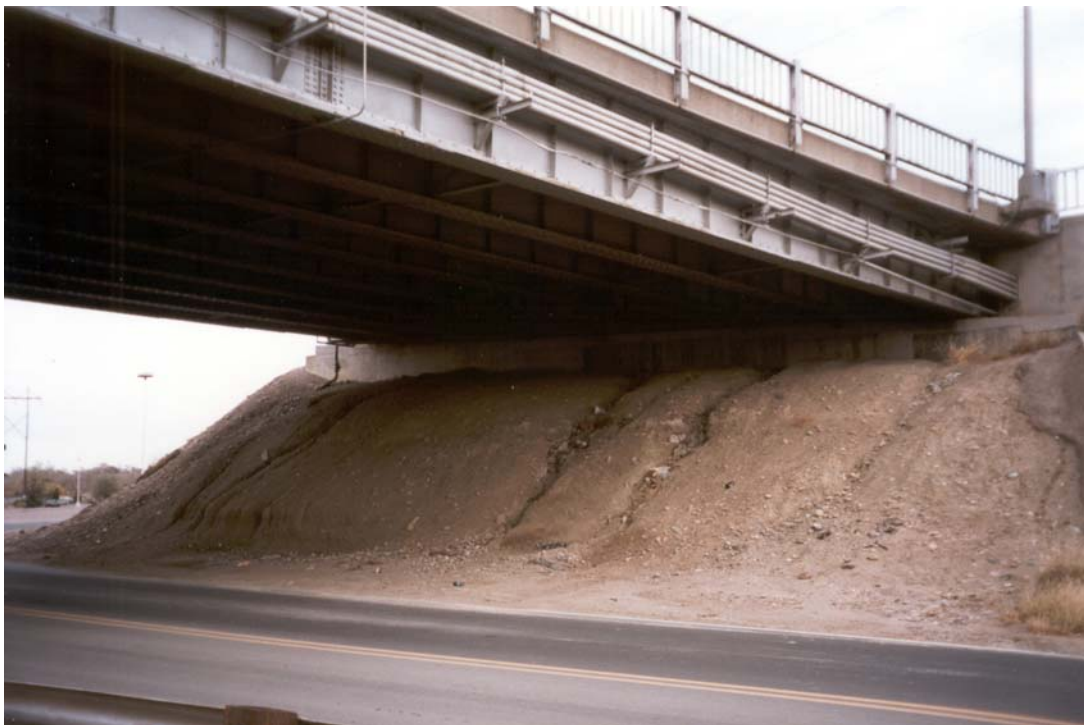
**Figure 2.8 Erosion at East Abutment**
