## 2. Existing Conditions

The existing 4<sup>th</sup> St. Bridge, structure number K-18-Z, was constructed in 1958 and is approximately 1068 feet long and 68 feet wide. The bridge is comprised of seven spans ranging in length from 117 feet on the east-end to 202 feet on the west-end, and is separated into three units. There is a two-span unit over the Arkansas River and floodwall, a three-span unit across the Union Pacific Railroad yard (UPRR), and a two-span unit over the Burlington Northern Santa Fe Railroad yard (BNSF). The maximum span length over the Arkansas River is 202 feet. The maximum span length over the UPRR is 182 feet and the maximum span over the BNSF is 117'-5". The existing configuration results in five piers in the Pueblo Yard, and one pier on the western bank of the Arkansas River.

### 2.2 Summary of Latest CDOT Inspection and Rating Report

The existing 4<sup>th</sup> St. Bridge was most recently rated by CDOT in February 2001. Rating information and the Structure Inspection Inventory (SIA) Report are included in Appendix C for reference. This section summarizes the information and findings of the rating.

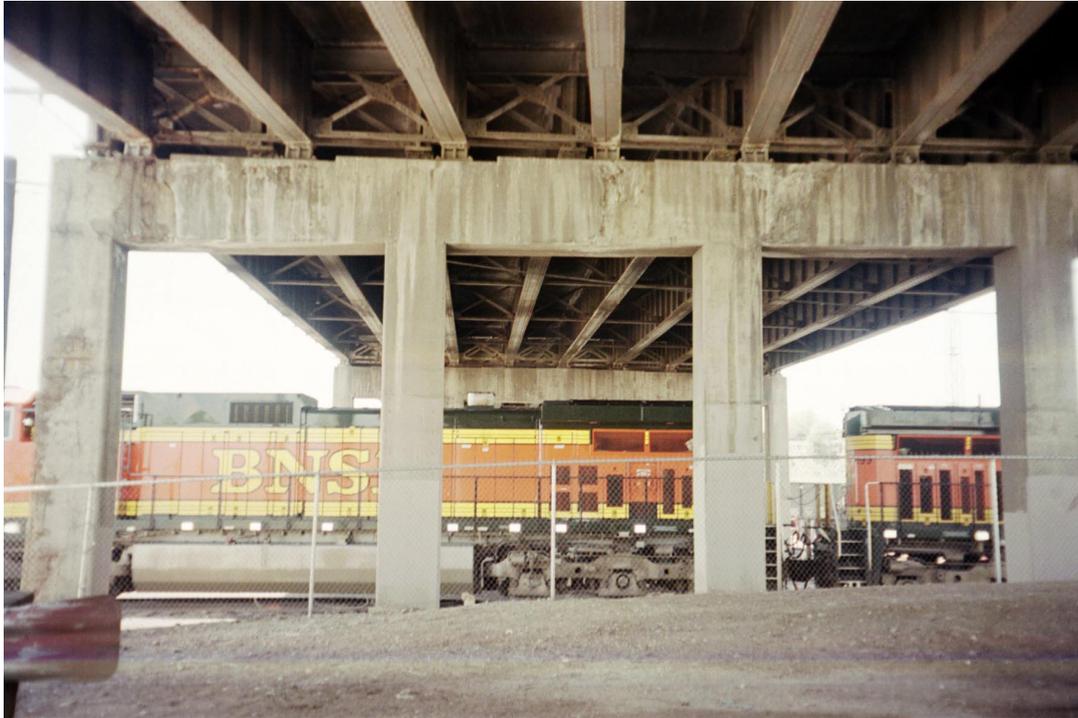
The concrete substructure has cracking, spalling, and delamination at bents 1, 2, and 5, or 50% of the substructure bents. These problems are associated with poorly functioning and leaking expansion joint devices. This is true at Bent 1 as well where there is no joint device, but the original plans called for a deck joint at this location. It is clear that there is reflective cracking allowing moisture migration through the deck and onto the supporting bent. In many locations, loss of concrete cover has resulted in exposed corroding reinforcing steel.

**Figure 2.1 Bent 1 Substructure Condition**

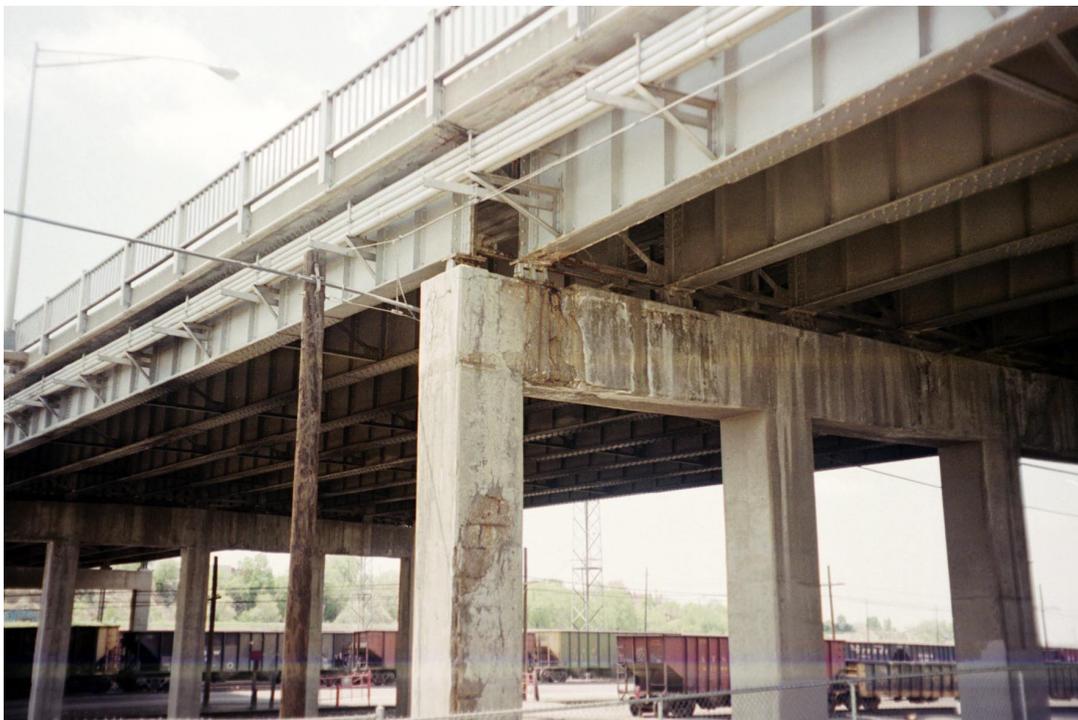
**Figure 2.2 Bent 1 Concrete Deterioration and Exposed Reinforcing**

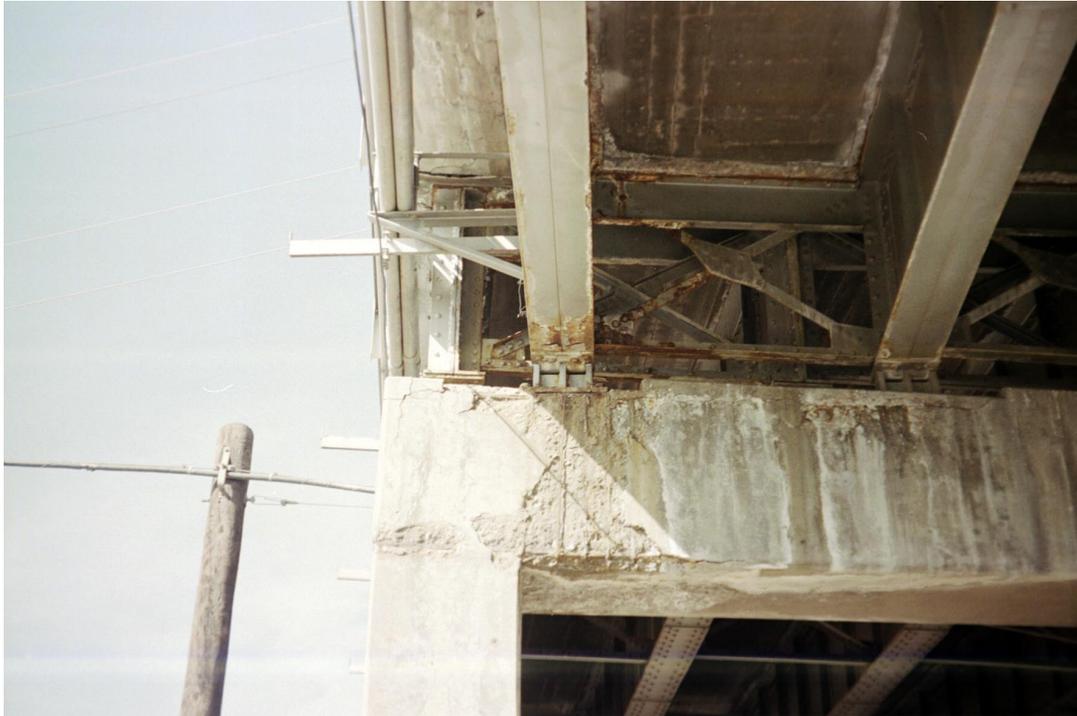
**Figure 2.3 Bent 1 Concrete Beam Deterioration and Steel Corrosion**

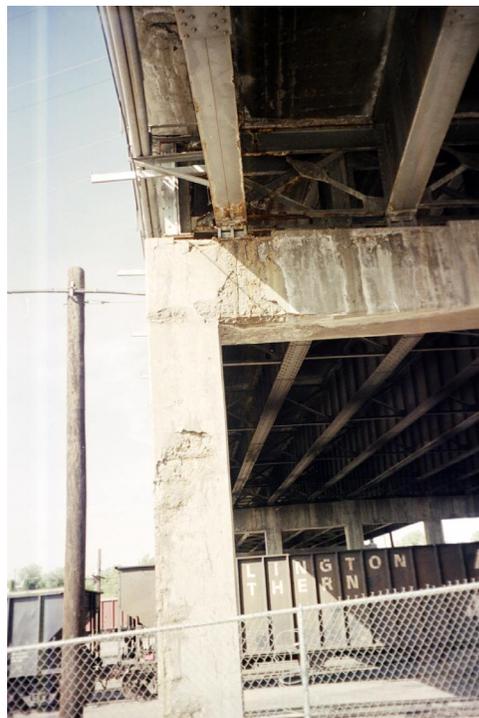
**Figure 2.4 Bent 1 Concrete Deterioration and Steel Corrosion**

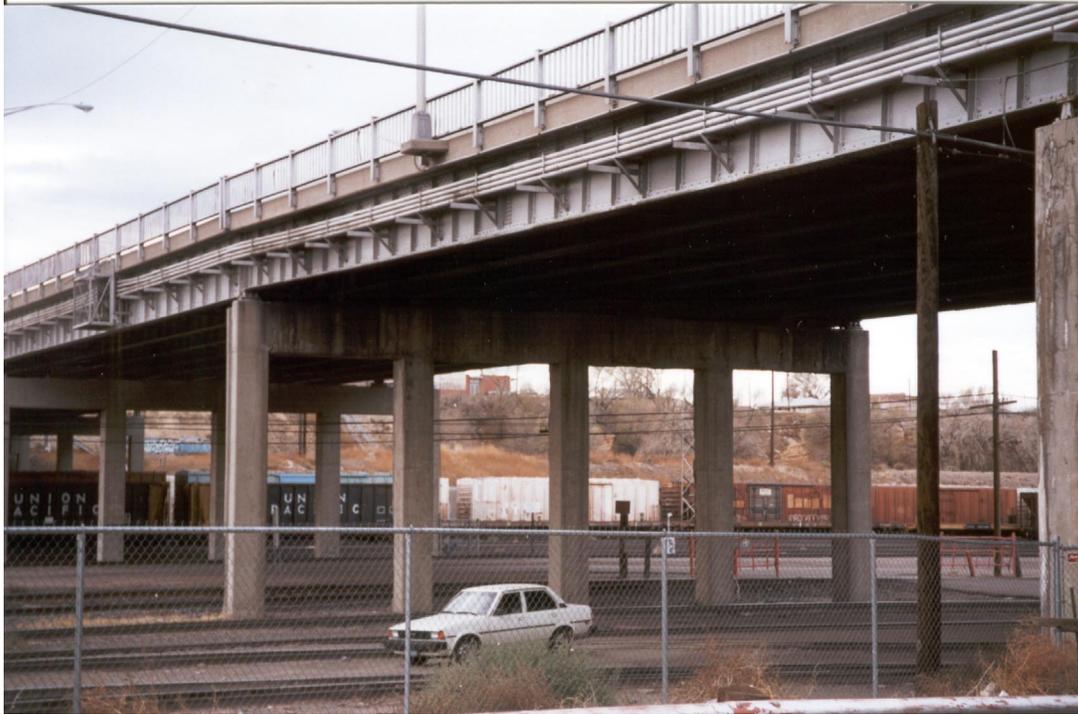
- Column 1-E and all columns at bents 2 and 5 have concrete spalling and exposed corroding reinforcing steel. Columns for remaining bents appear satisfactory.
- The concrete pier wall at Bent 6 on the western bank of the Arkansas River is acceptable and shows little deterioration.
- The concrete bent caps at bents 1, 2, and 5 show heavy spalling with exposed corroding reinforcing steel. There is sand build up on these caps but no loss in bearing.

**Figure 2.5 Bent 2 Substructure Condition**

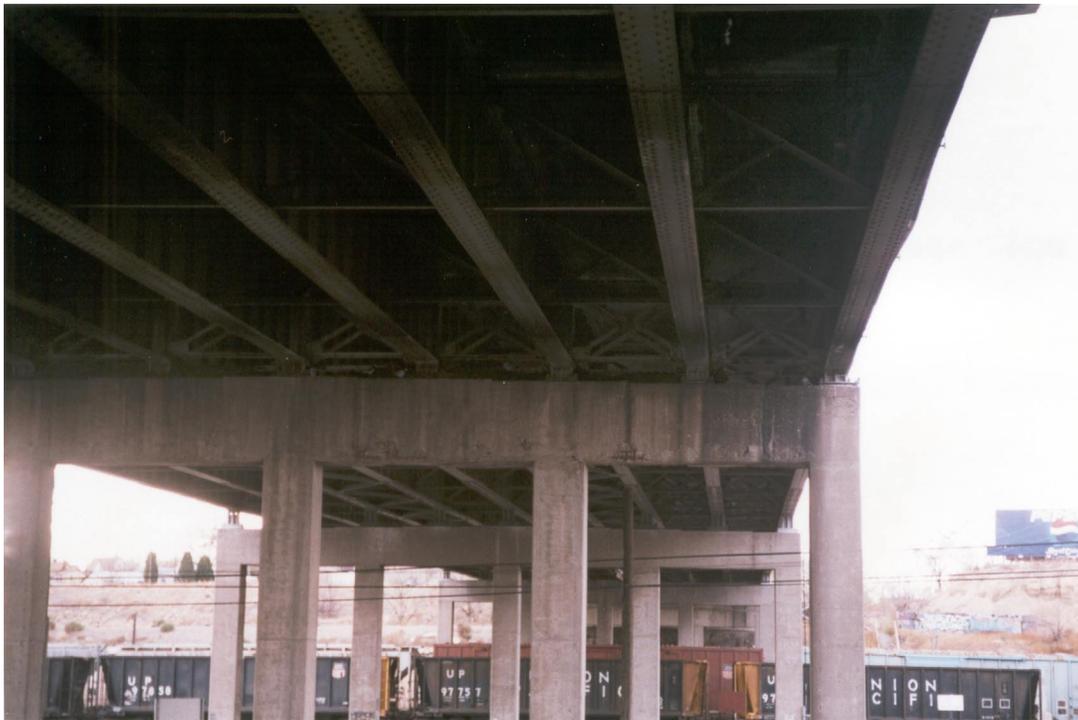
**Figure 2.6 Bent 2 Concrete Beam Deterioration**

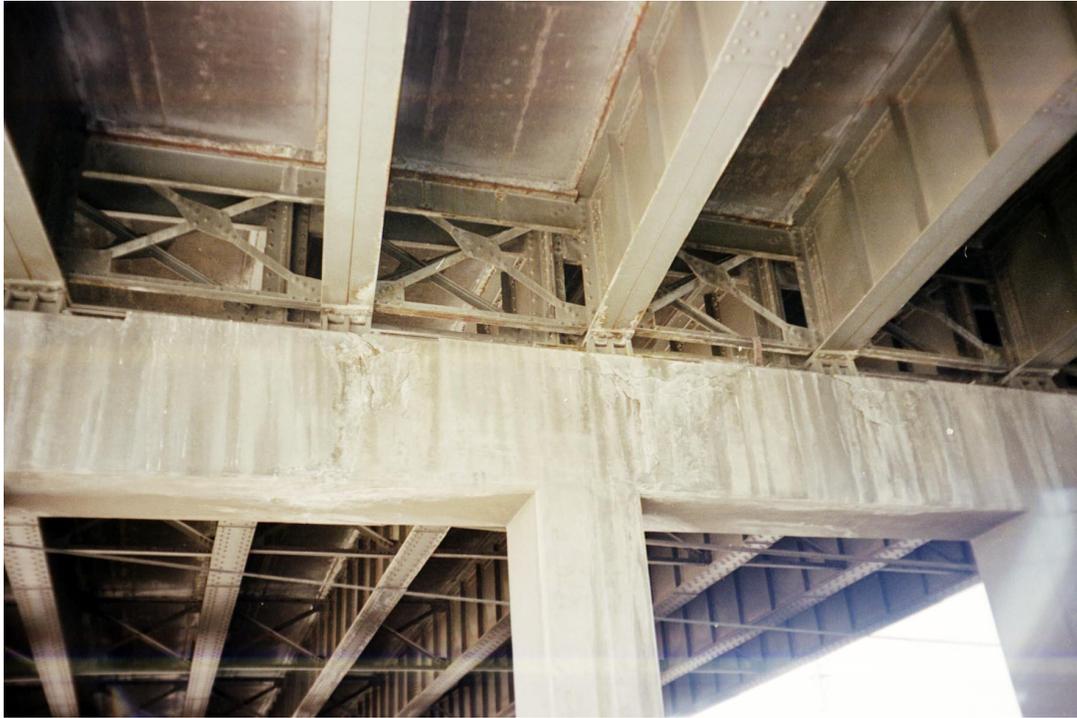
**Figure 2.7 Bent 2 Concrete Beam Deterioration and Corroded Steel**

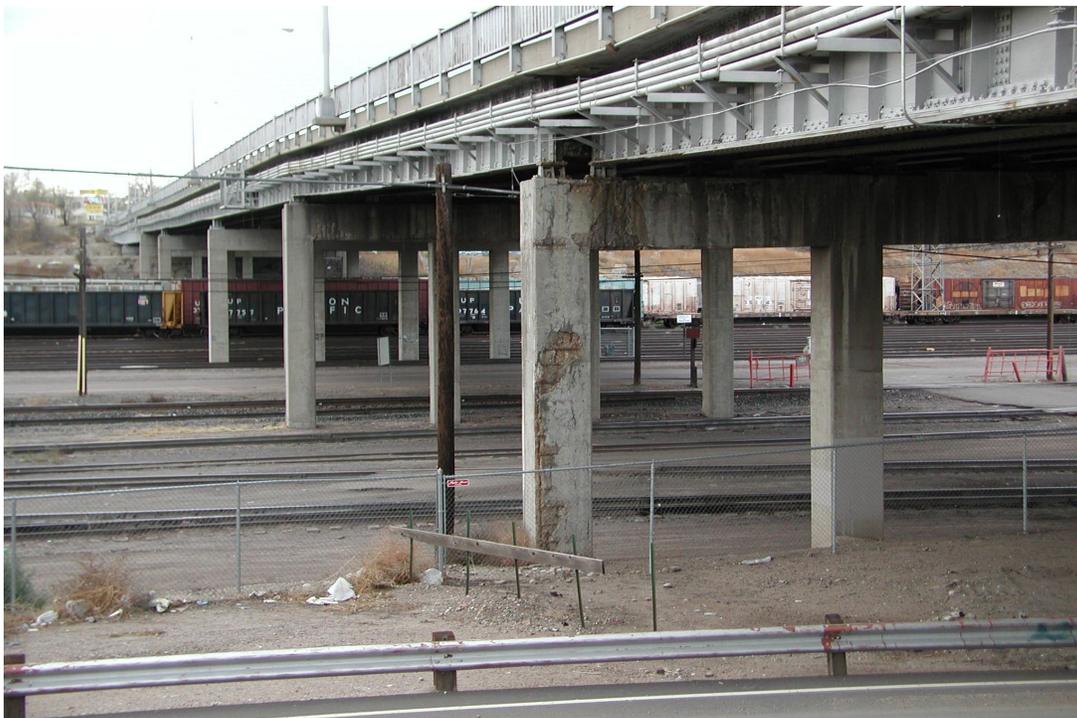
**Figure 2.8 Bents 1 and 2 Relative Condition**

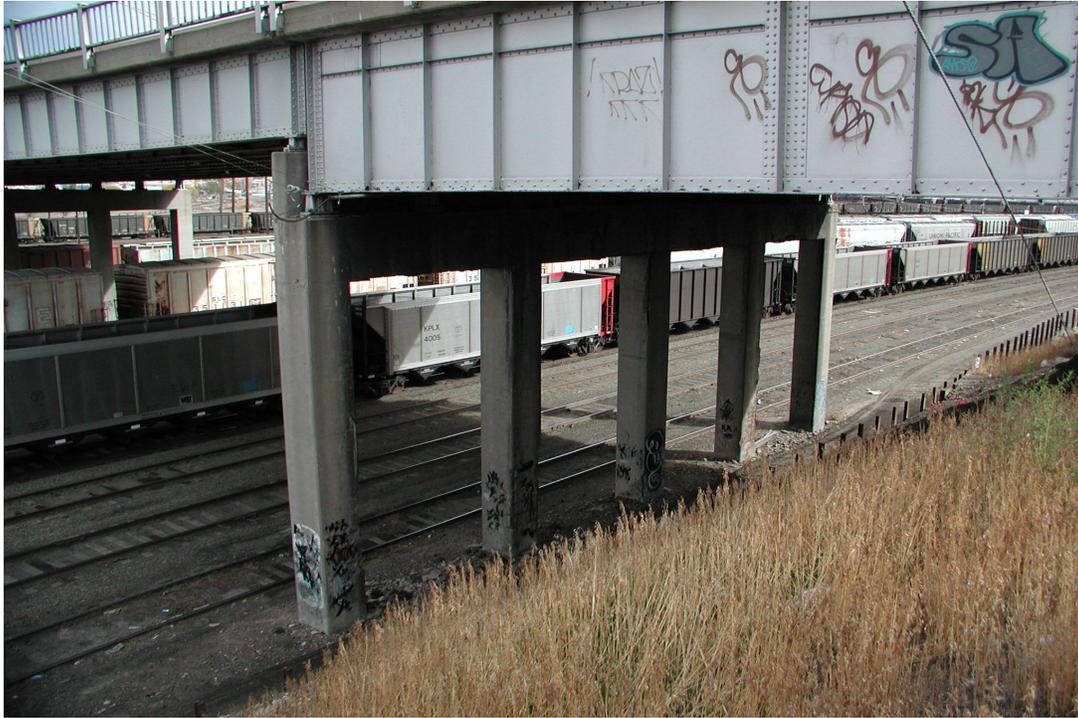
**Figure 2.9 Bent 5 Substructure Condition**

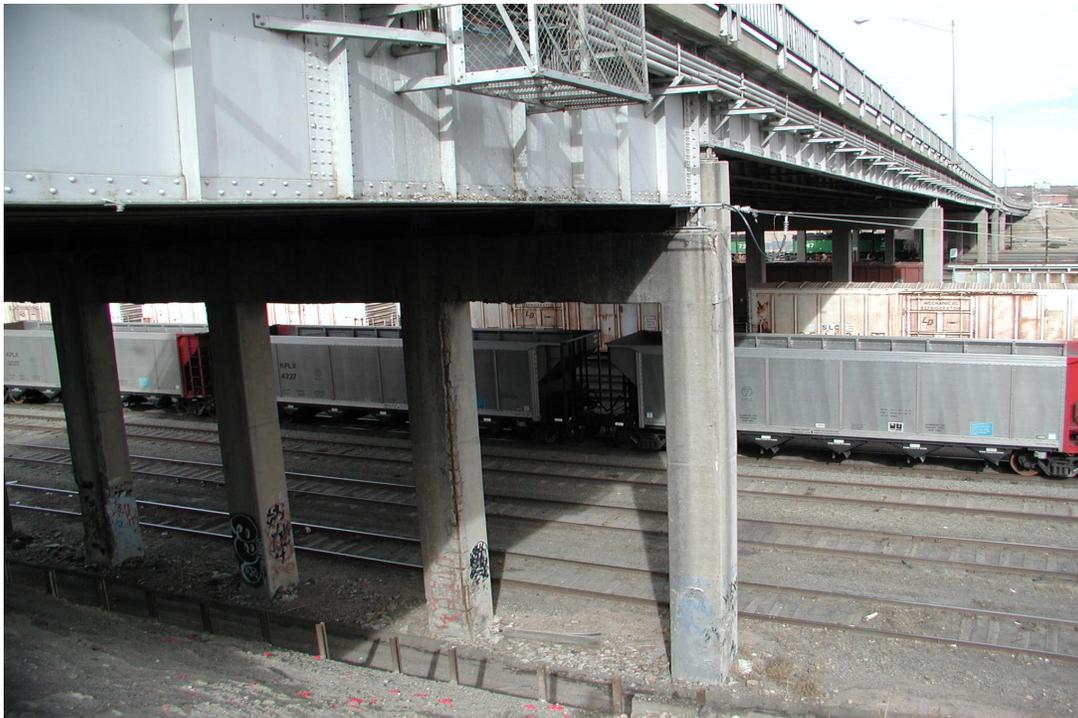
**Figure 2.10 Bent 5 Concrete Column Deterioration and Corroded Rebar**

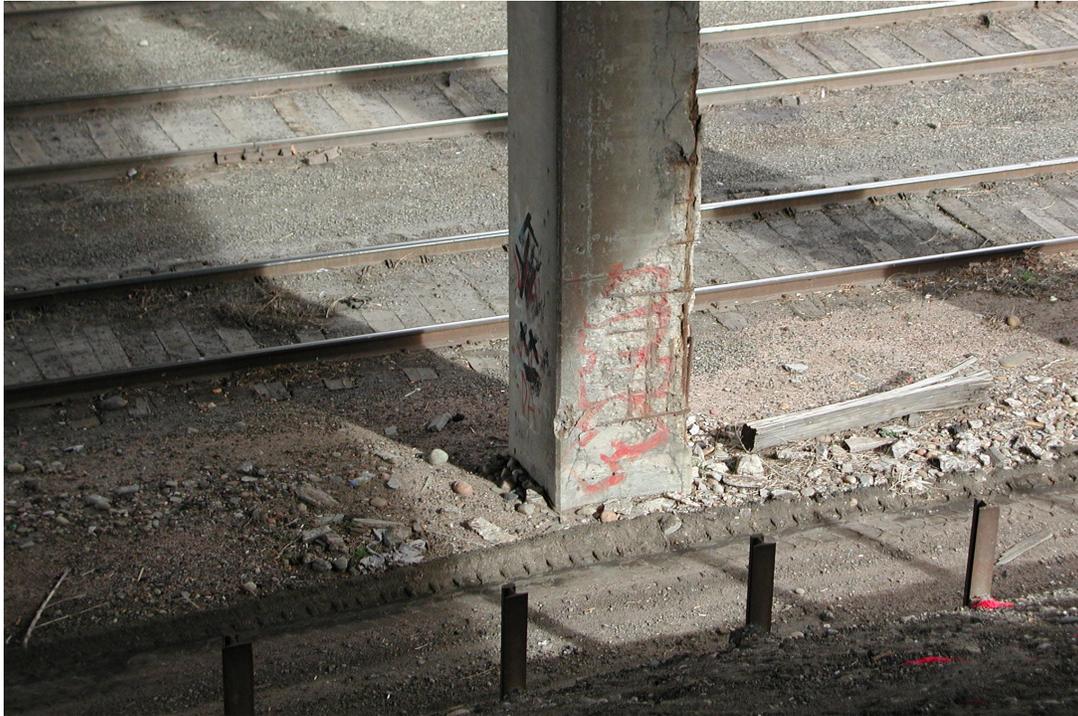
**Figure 2.11 Bent 5 Column Deterioration and Corroded Broken Rebar**

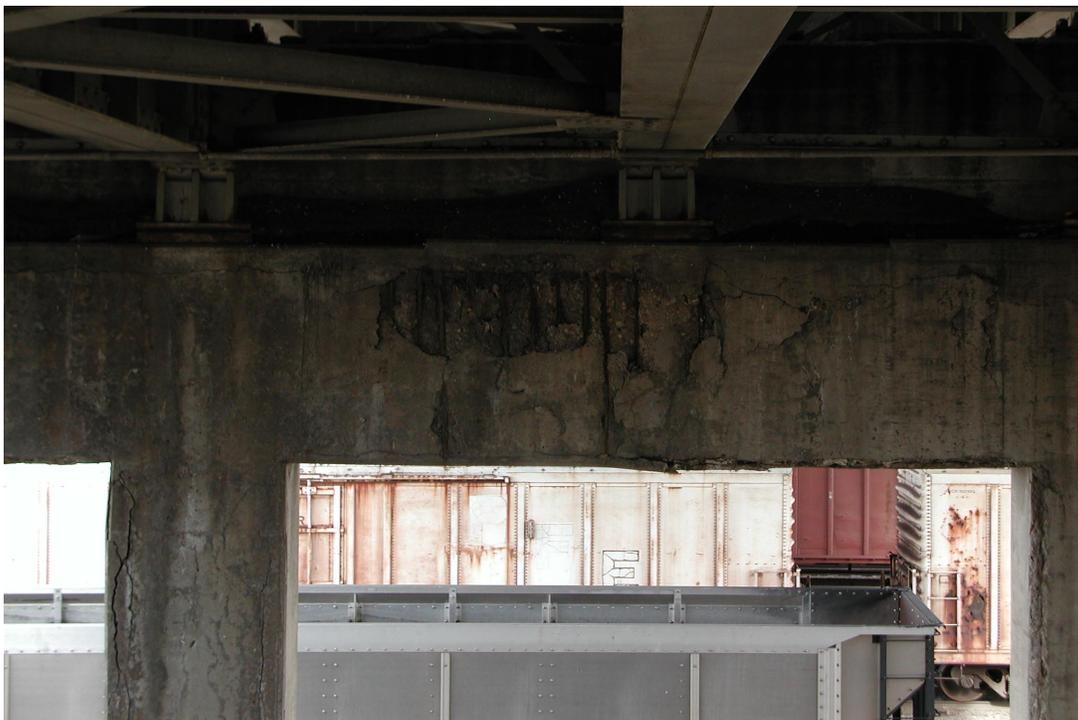
**Figure 2.12 Bent 5 Concrete Beam Deterioration and Corroded Rebar**

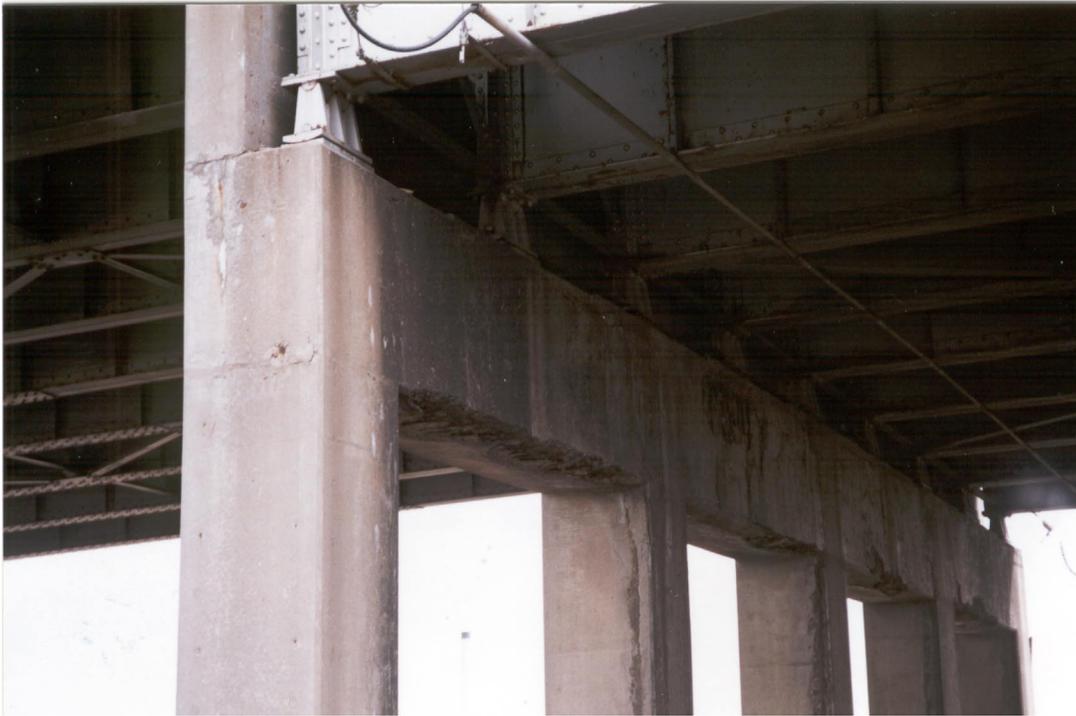
**Figure 2.13 Bent 5 Bent Cap Deterioration and Corroded Rebar**

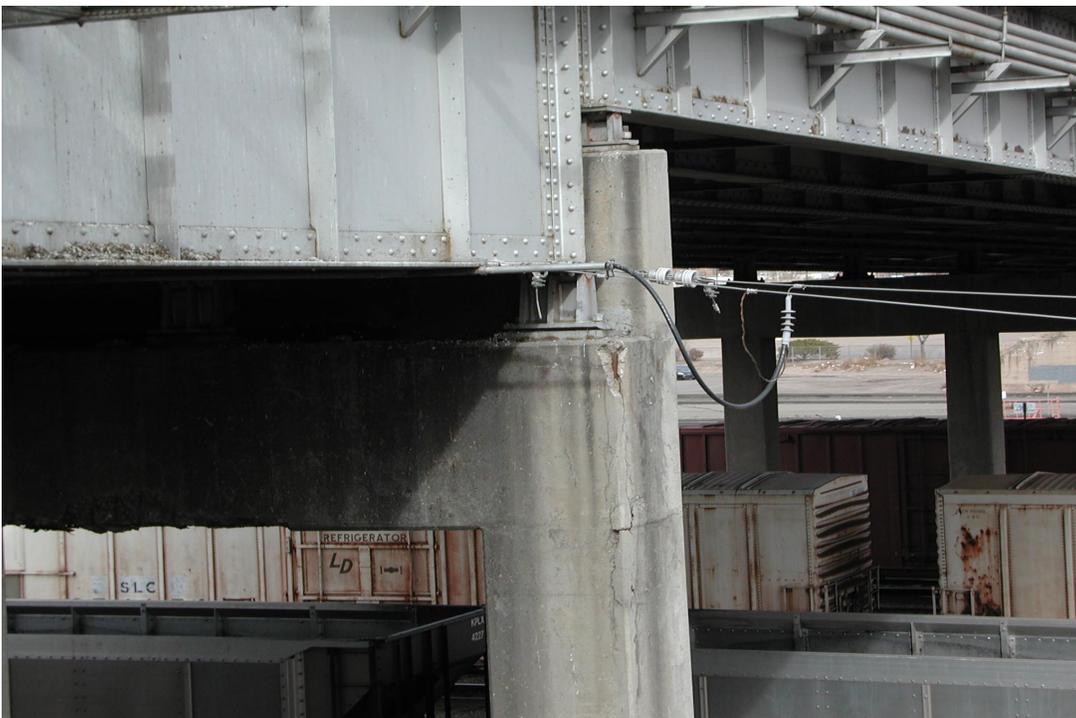
**Figure 2.14 Bent 5 Bent Cap Deterioration and Corroded Rebar**

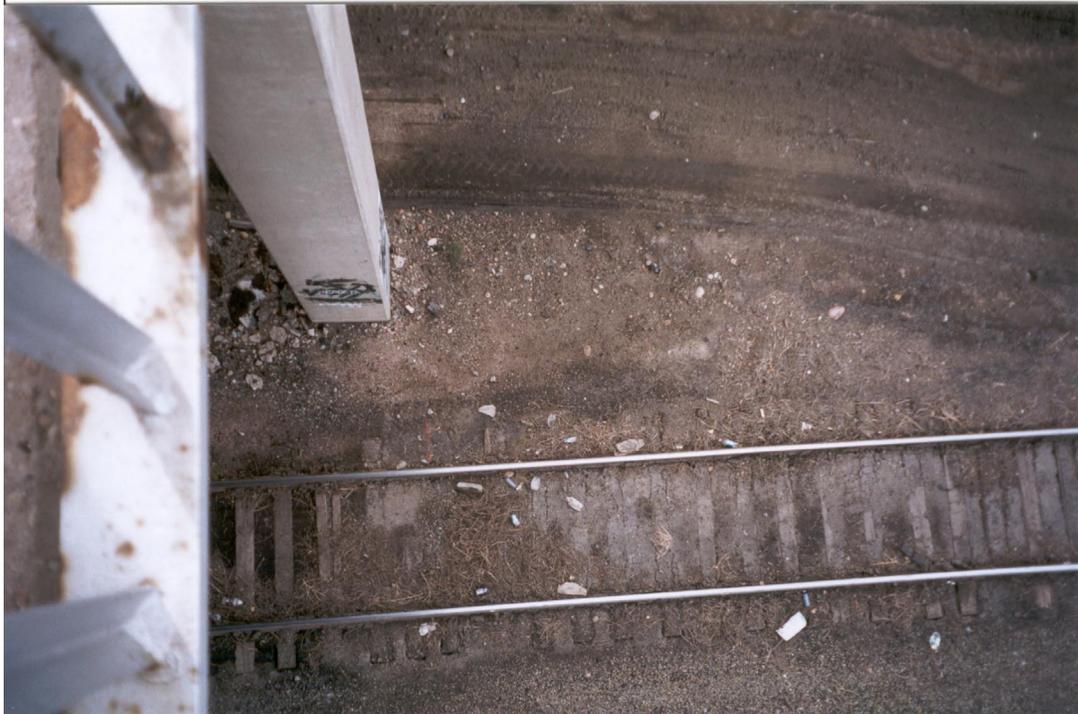
**Figure 2.15 Proximity of Pier 2 to BNSF Mainline Track (11'-0")**

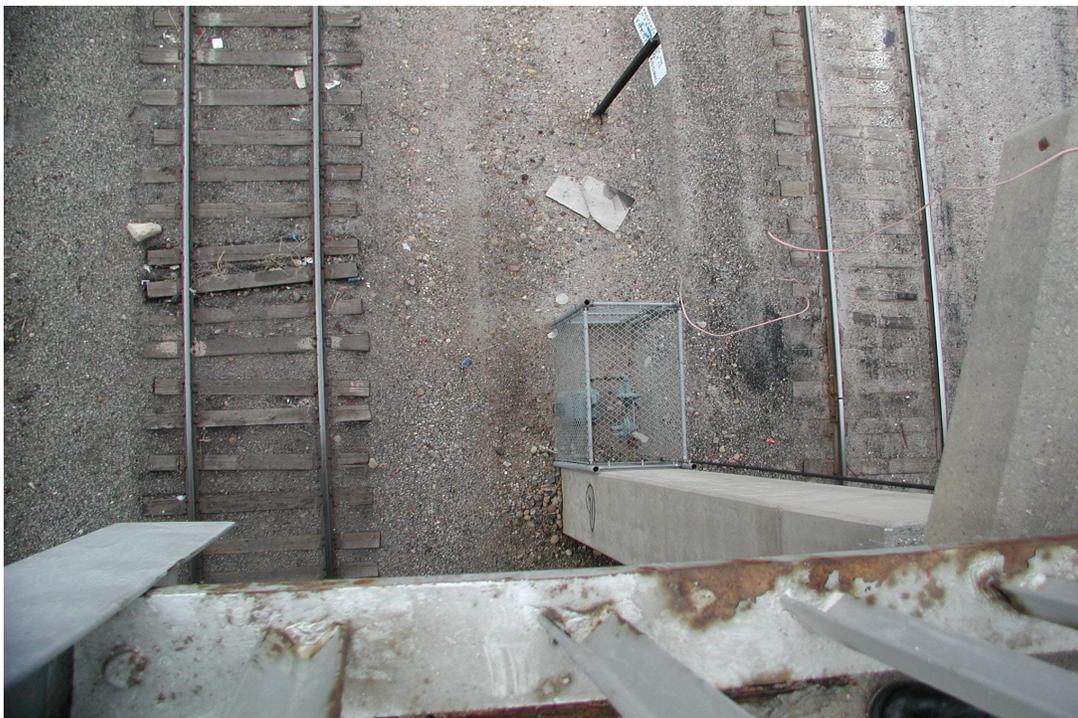
**Figure 2.16 Proximity of Pier 3 to UPRR E. Mainline Track and Yard Track 1 (10'-6")**

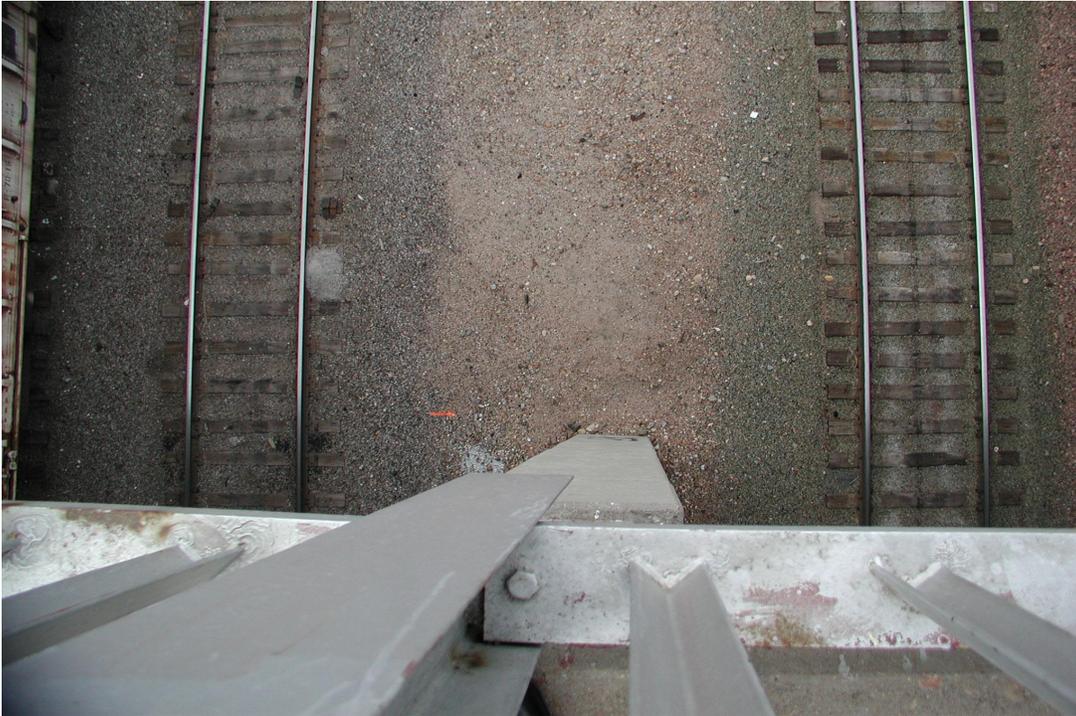
**Figure 2.17 Proximity of Pier 4 to UPRR Yard Tracks 13 and 14 (11'-9")**

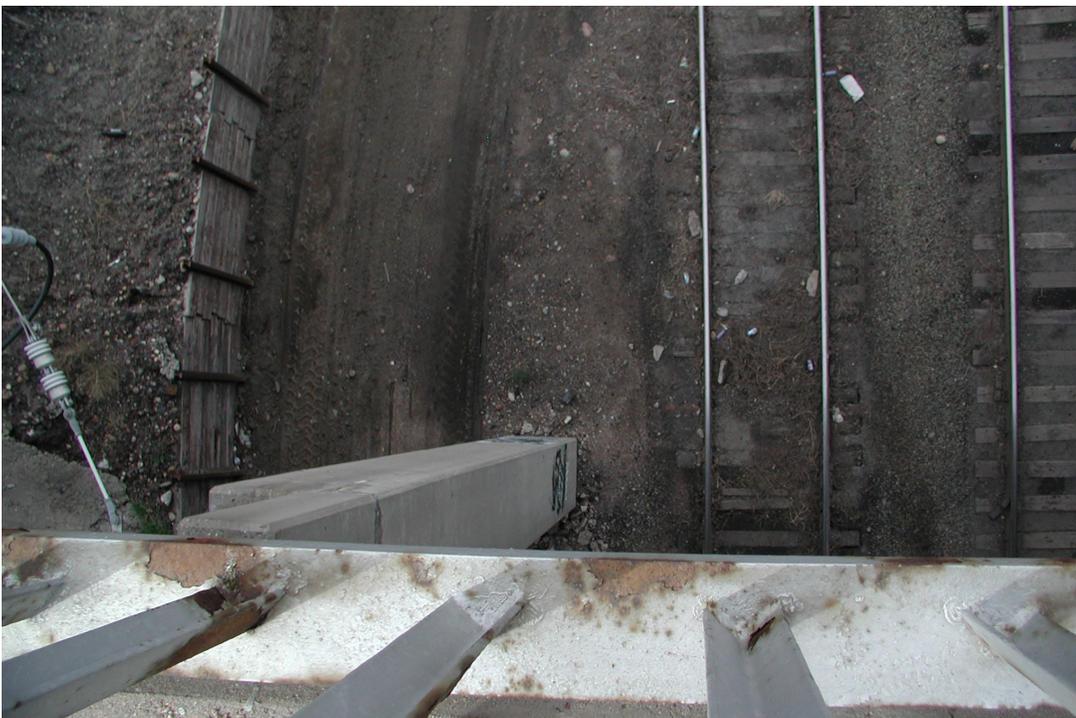
The existing 4<sup>th</sup> St. Bridge piers do not have crash walls and do not meet the minimum railroad clearance requirements. According to the project survey, the minimum horizontal clearance from centerline of track to face of pier is 8'-3" at Pier 5, located next to the Arkansas River floodwall. This is much less than current railroad requirements. Existing horizontal clearance for all of the existing piers in the railroad yard are shown in Table 2.1. These clearances are based on the project survey and show some differences when compared to the original bridge plans. The differences are attributed to track removals and relocations and the as-built state of the existing bridge.

**Figure 2.18 Proximity of Pier 5 to UPRR Yard Track 21 and Floodwall (8'-3")**

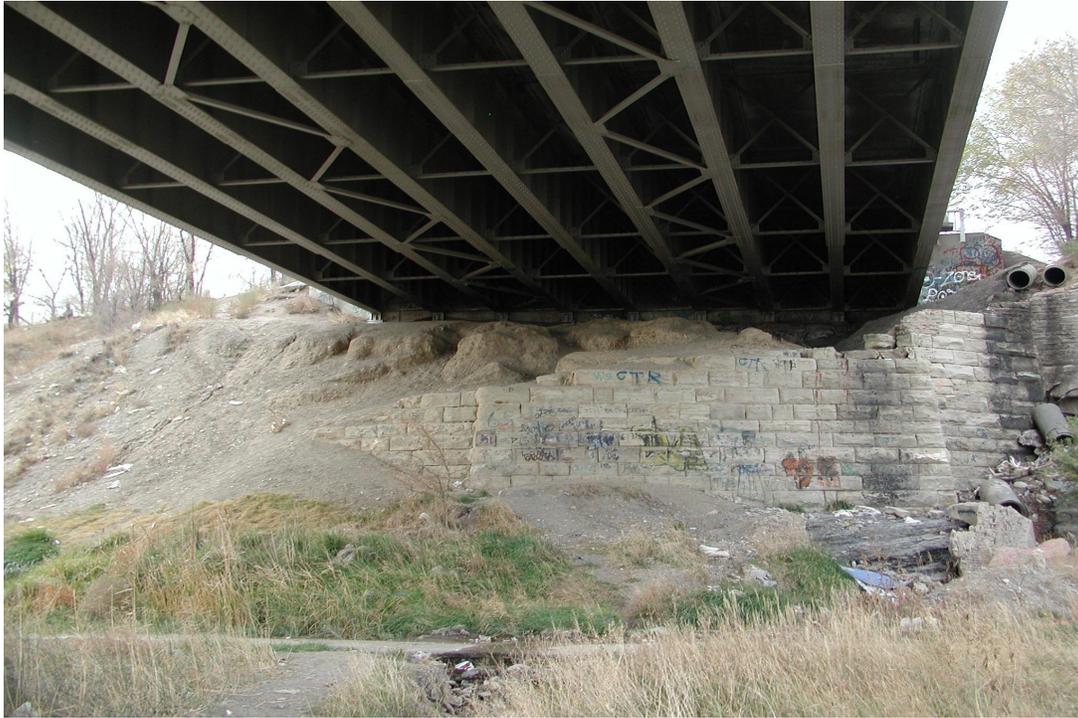
Overhead electric lines cross the bridge at both the east and west ends. Underground gas lines exist in the railroad yard and east approach fill. Gas, electric and communications lines run on the bridge outside of the edge girders. Storm water runoff from the west approach is collected in a sewer system which daylights at the west abutment on the north side of the bridge. Outfall from the pipes has caused significant slope erosion.

**Figure 2.19 Storm Sewer Outfall and Erosion at West Abutment**

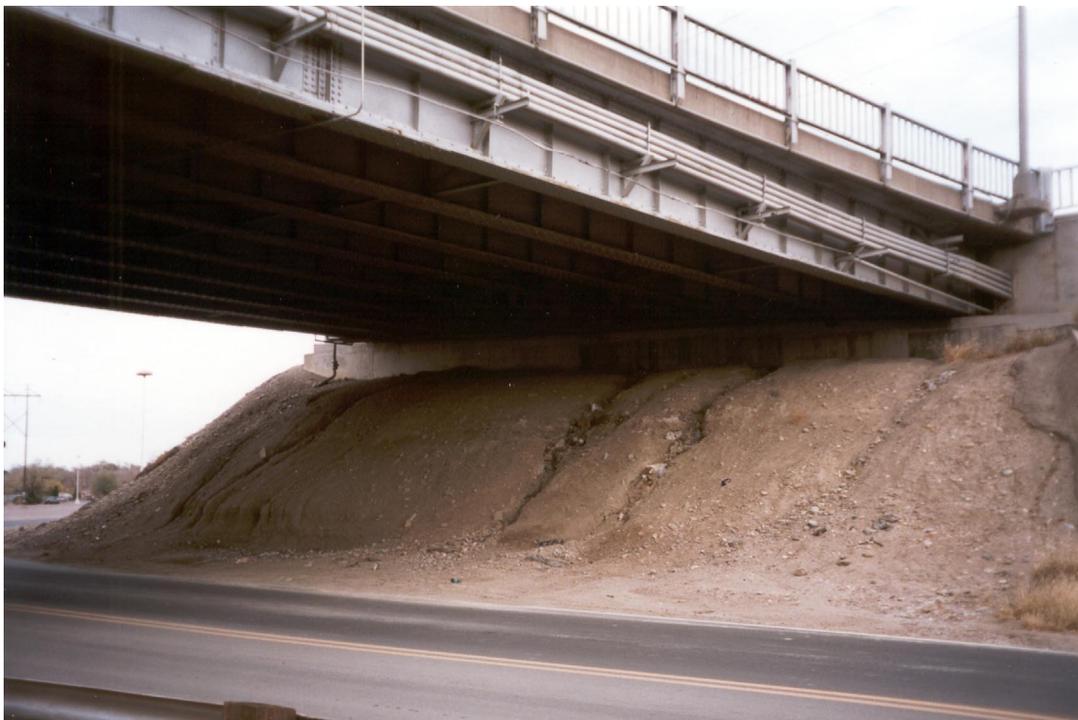
**Figure 2.20 Erosion at East Abutment**

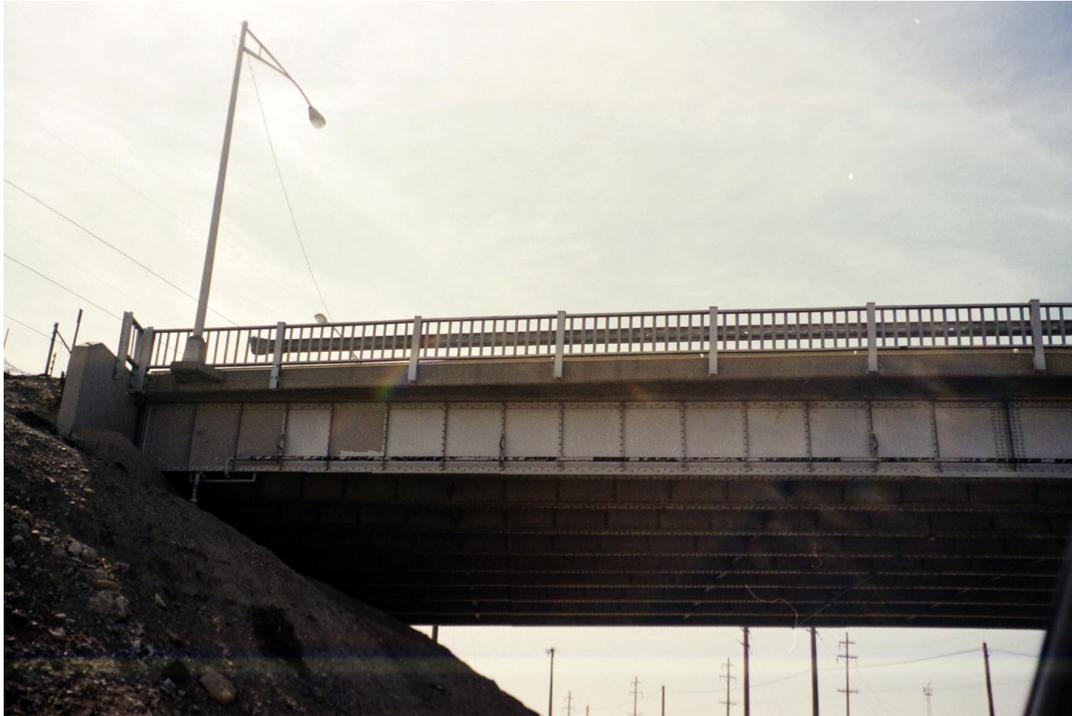
**Figure 2.21 Flaking Lead Based Paint Span 1 Girders**

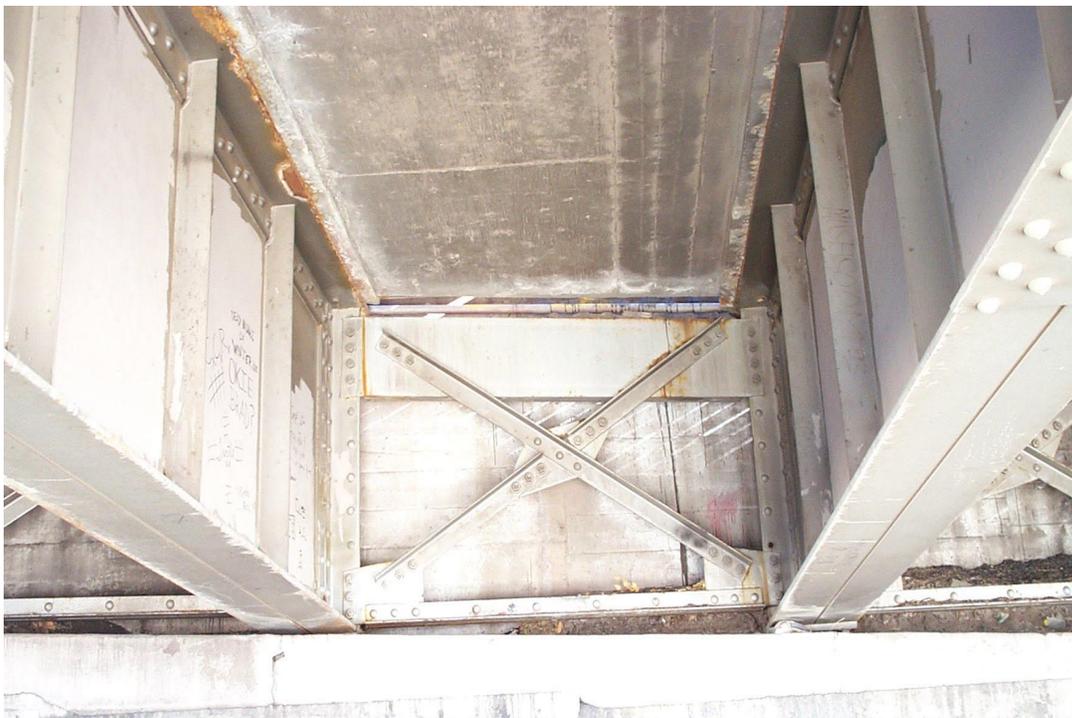
**Figure 2.22 Corrosion of Steel Members, Flaking Paint, Debris on Abutment Seat**

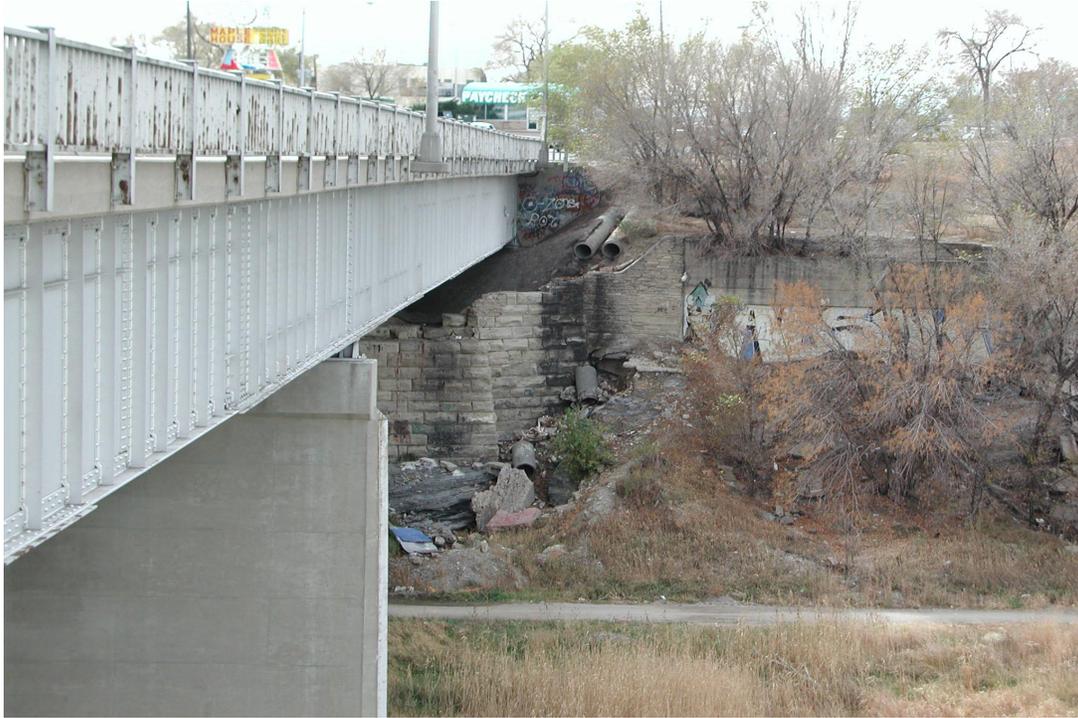
**Figure 2.23 Corroded Bridge Rail, Storm Sewer Outfall at West Abutment**

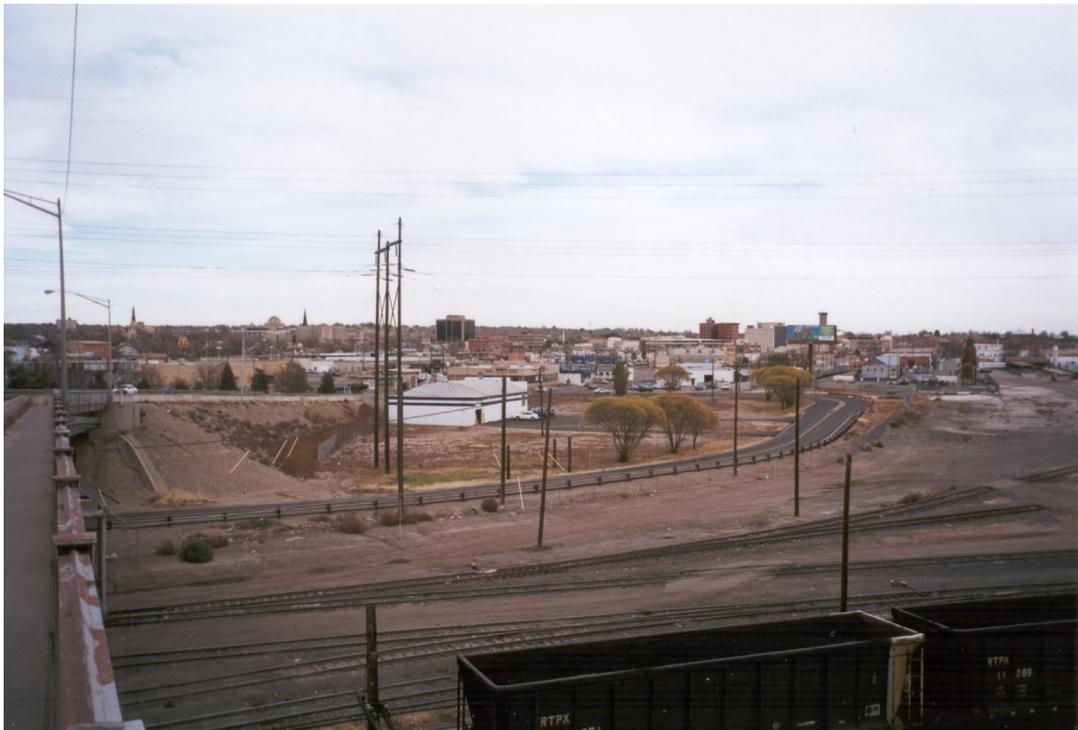
**Figure 2.24 Corrosion of Bridge Rail, Loop Ramp Under Span 1**

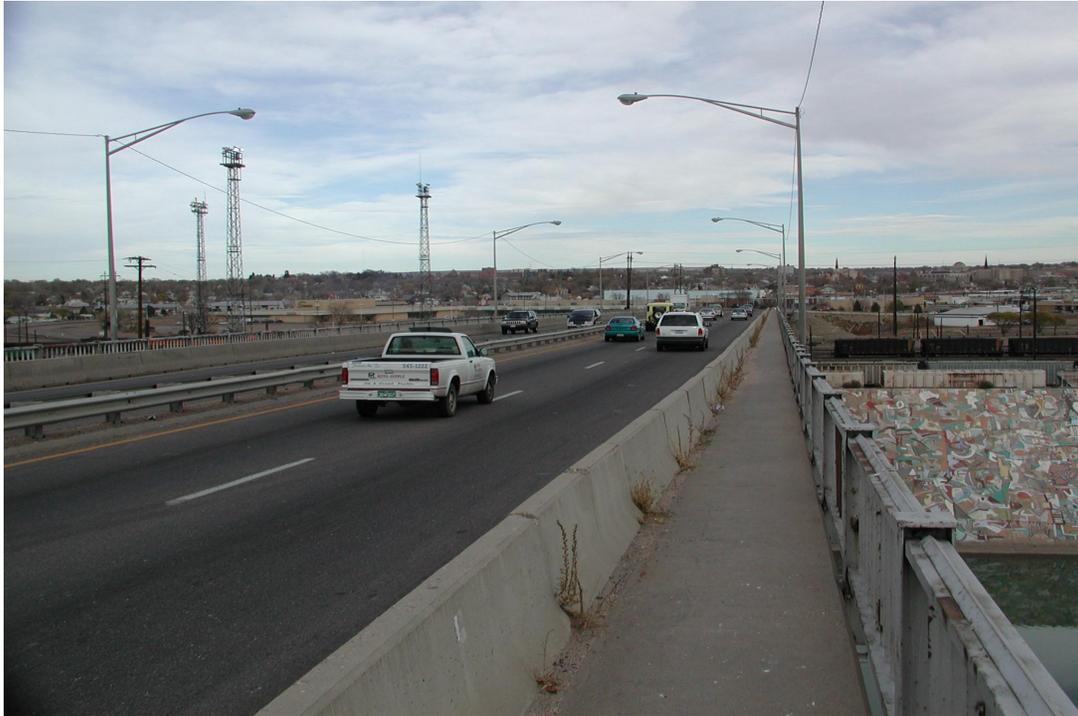
**Figure 2.25 Corroded Bridge Rail, Narrow Pedestrian/Bicycle Facilities**

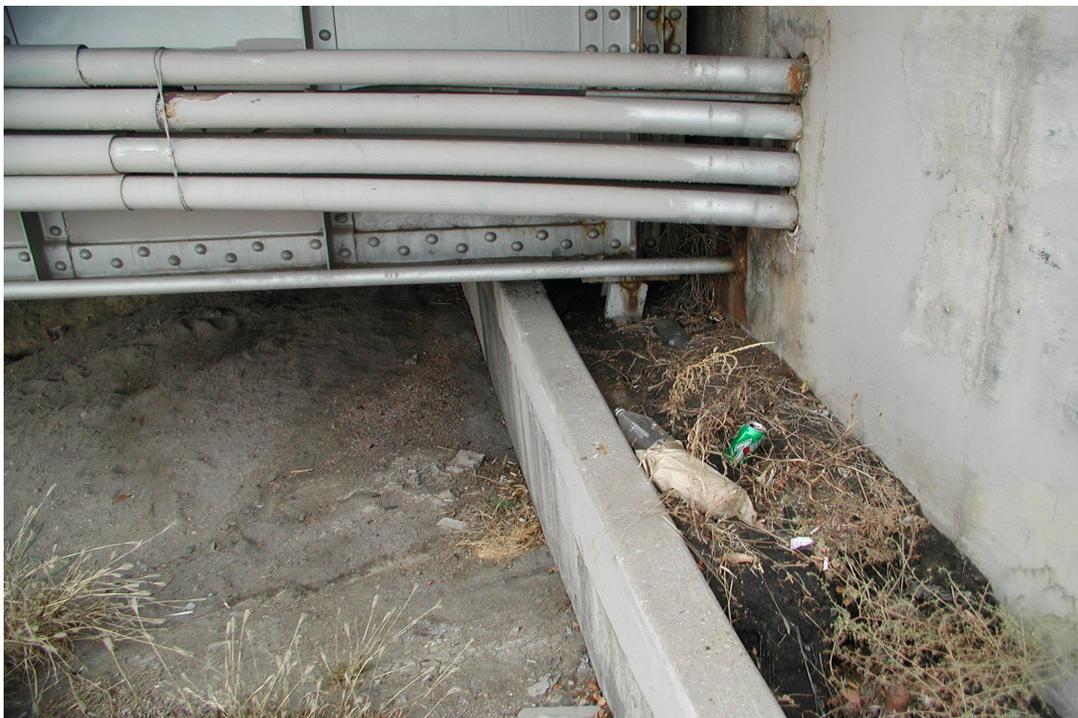
**Figure 2.26 East Abutment Debris in Bearing Seat**

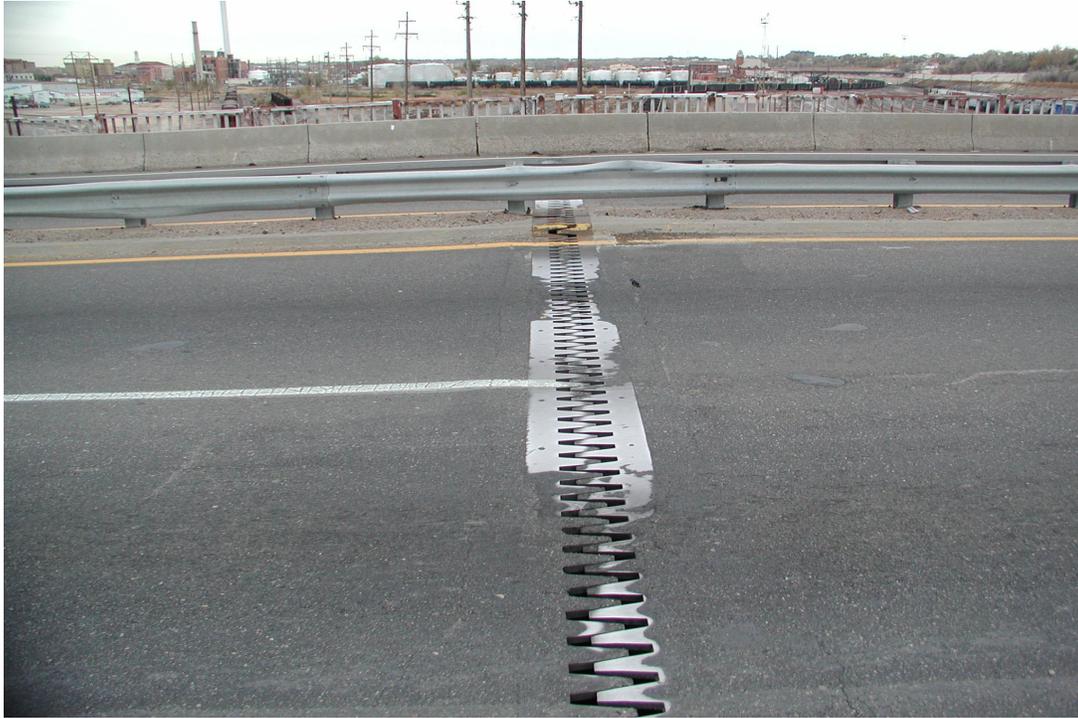
**Figure 2.27 Open Expansion Joint Device, Damaged Median Rail**

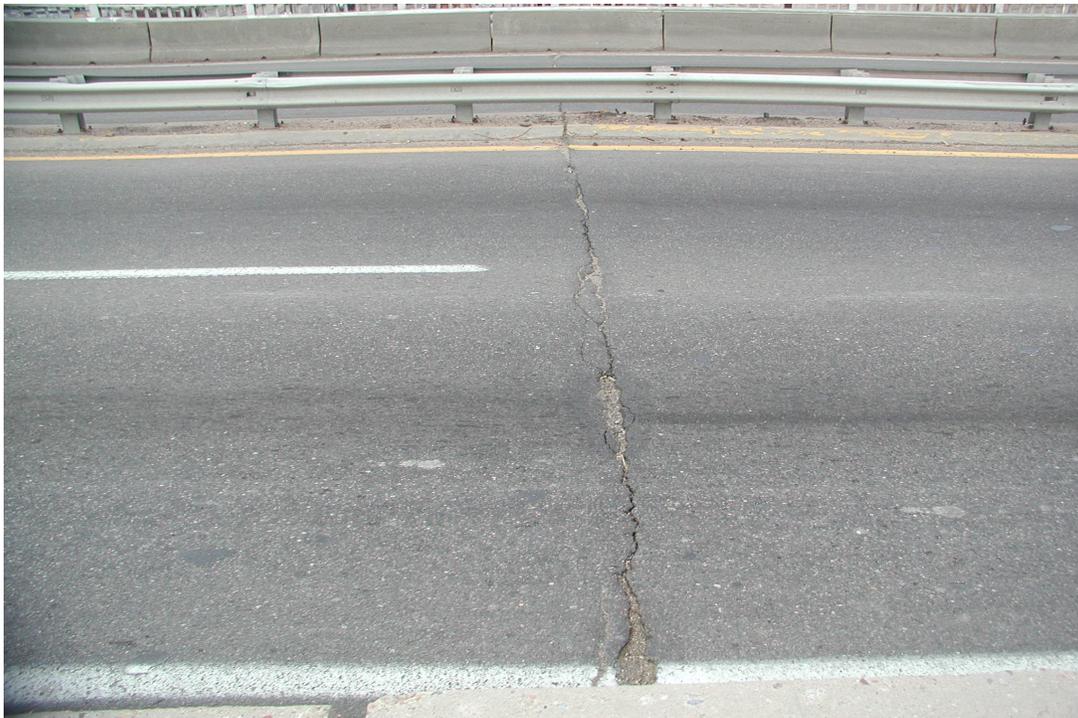
**Figure 2.28 Deck Joint at Pier 1 Causes Substructure Deterioration**
