**PRE-DEMOLITION/RENOVATION
ASBESTOS AND LEAD-BASED PAINT
INSPECTION REPORT FOR
COLORADO DEPARTMENT OF
TRANSPORTATION BRIDGE STRUCTURE
H-17-AI**

**I-25 and Jackson Creek Intersection
Mile Marker 157.703**

STRUCTURE ID: H-17-AI

July 13, 2012

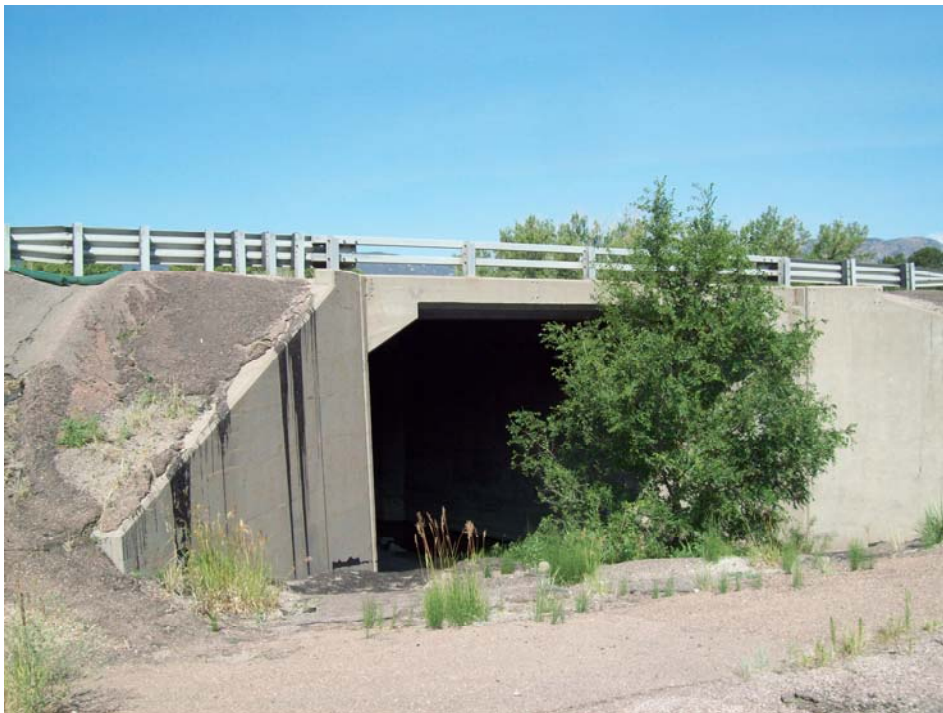
Photo 1 – View of Bridge Structure ID: H-17-AI.

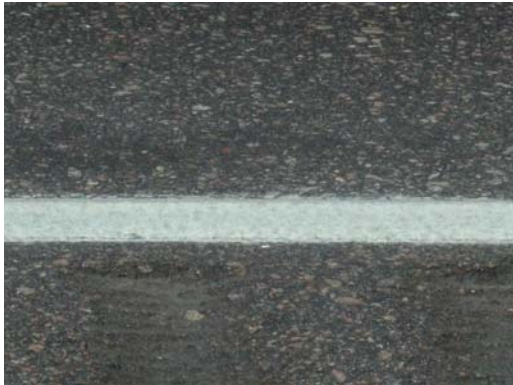
LBP01

SAMPLE ID	LOCATION	SUBSTRATE	COLOR	CONDITION	RESULT (% BY WEIGHT)
H-17-AI-LBP01	Shoulder and Center Lane	Asphalt	White	Intact	BRL
H-17-AI-LBP02	Median Lane	Asphalt	Yellow	Intact	BRL
