**PRE-DEMOLITION/RENOVATION
ASBESTOS AND LEAD-BASED PAINT
INSPECTION REPORT FOR
COLORADO DEPARTMENT OF
TRANSPORTATION BRIDGE STRUCTURE
H-17-J**

**I-25 Northbound and Black Squirrel Creek
Mile Marker 153.947**

STRUCTURE ID: H-17-J

July 13, 2012

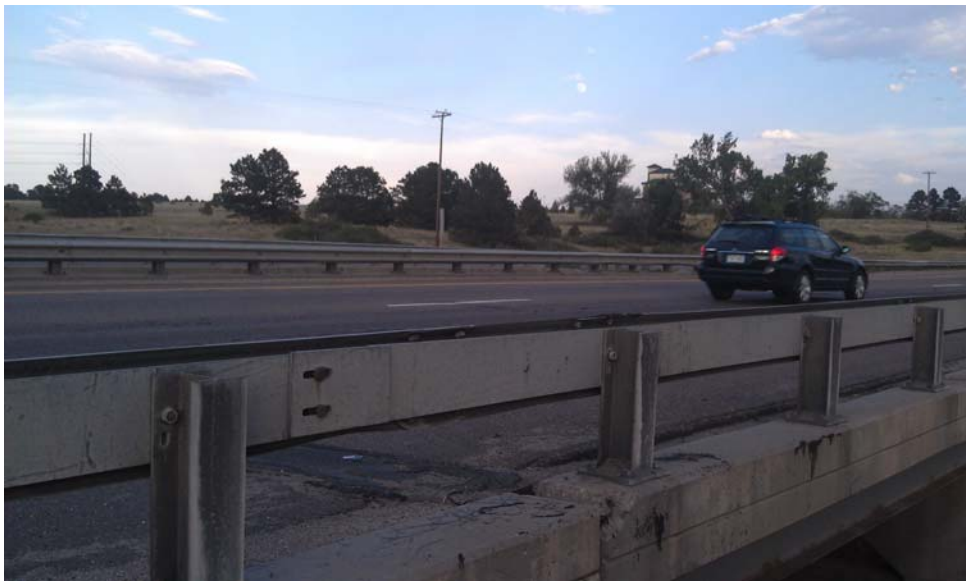
Photo 1 – View of Bridge Structure ID: H-17-J.

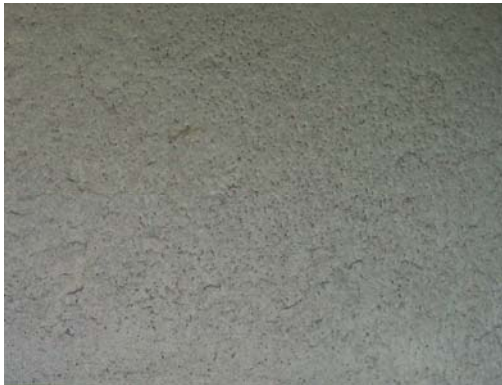
LBP01

- Steel Substrate-Silver-On Steel I-Beams.

The types and locations of lead-containing paint (LCP), and regulatory requirements should be disclosed to the demolition contractor and/or salvage contractor to avoid accidental disturbance, and for contractor compliance with applicable regulations (to ensure proper worker protection).
