DATE: January 20, 2011
To: Gerald Hoefler – Region 2 Maintenance Super.
Jeff Anderson
FROM: Jeff Anderson – Staff Bridge
SUBJECT: H-17-M – Spalled CBC Wall (2nd Notice)

Structure No. H-17-M: I 25 over a Draw at Milepoint 156.936.

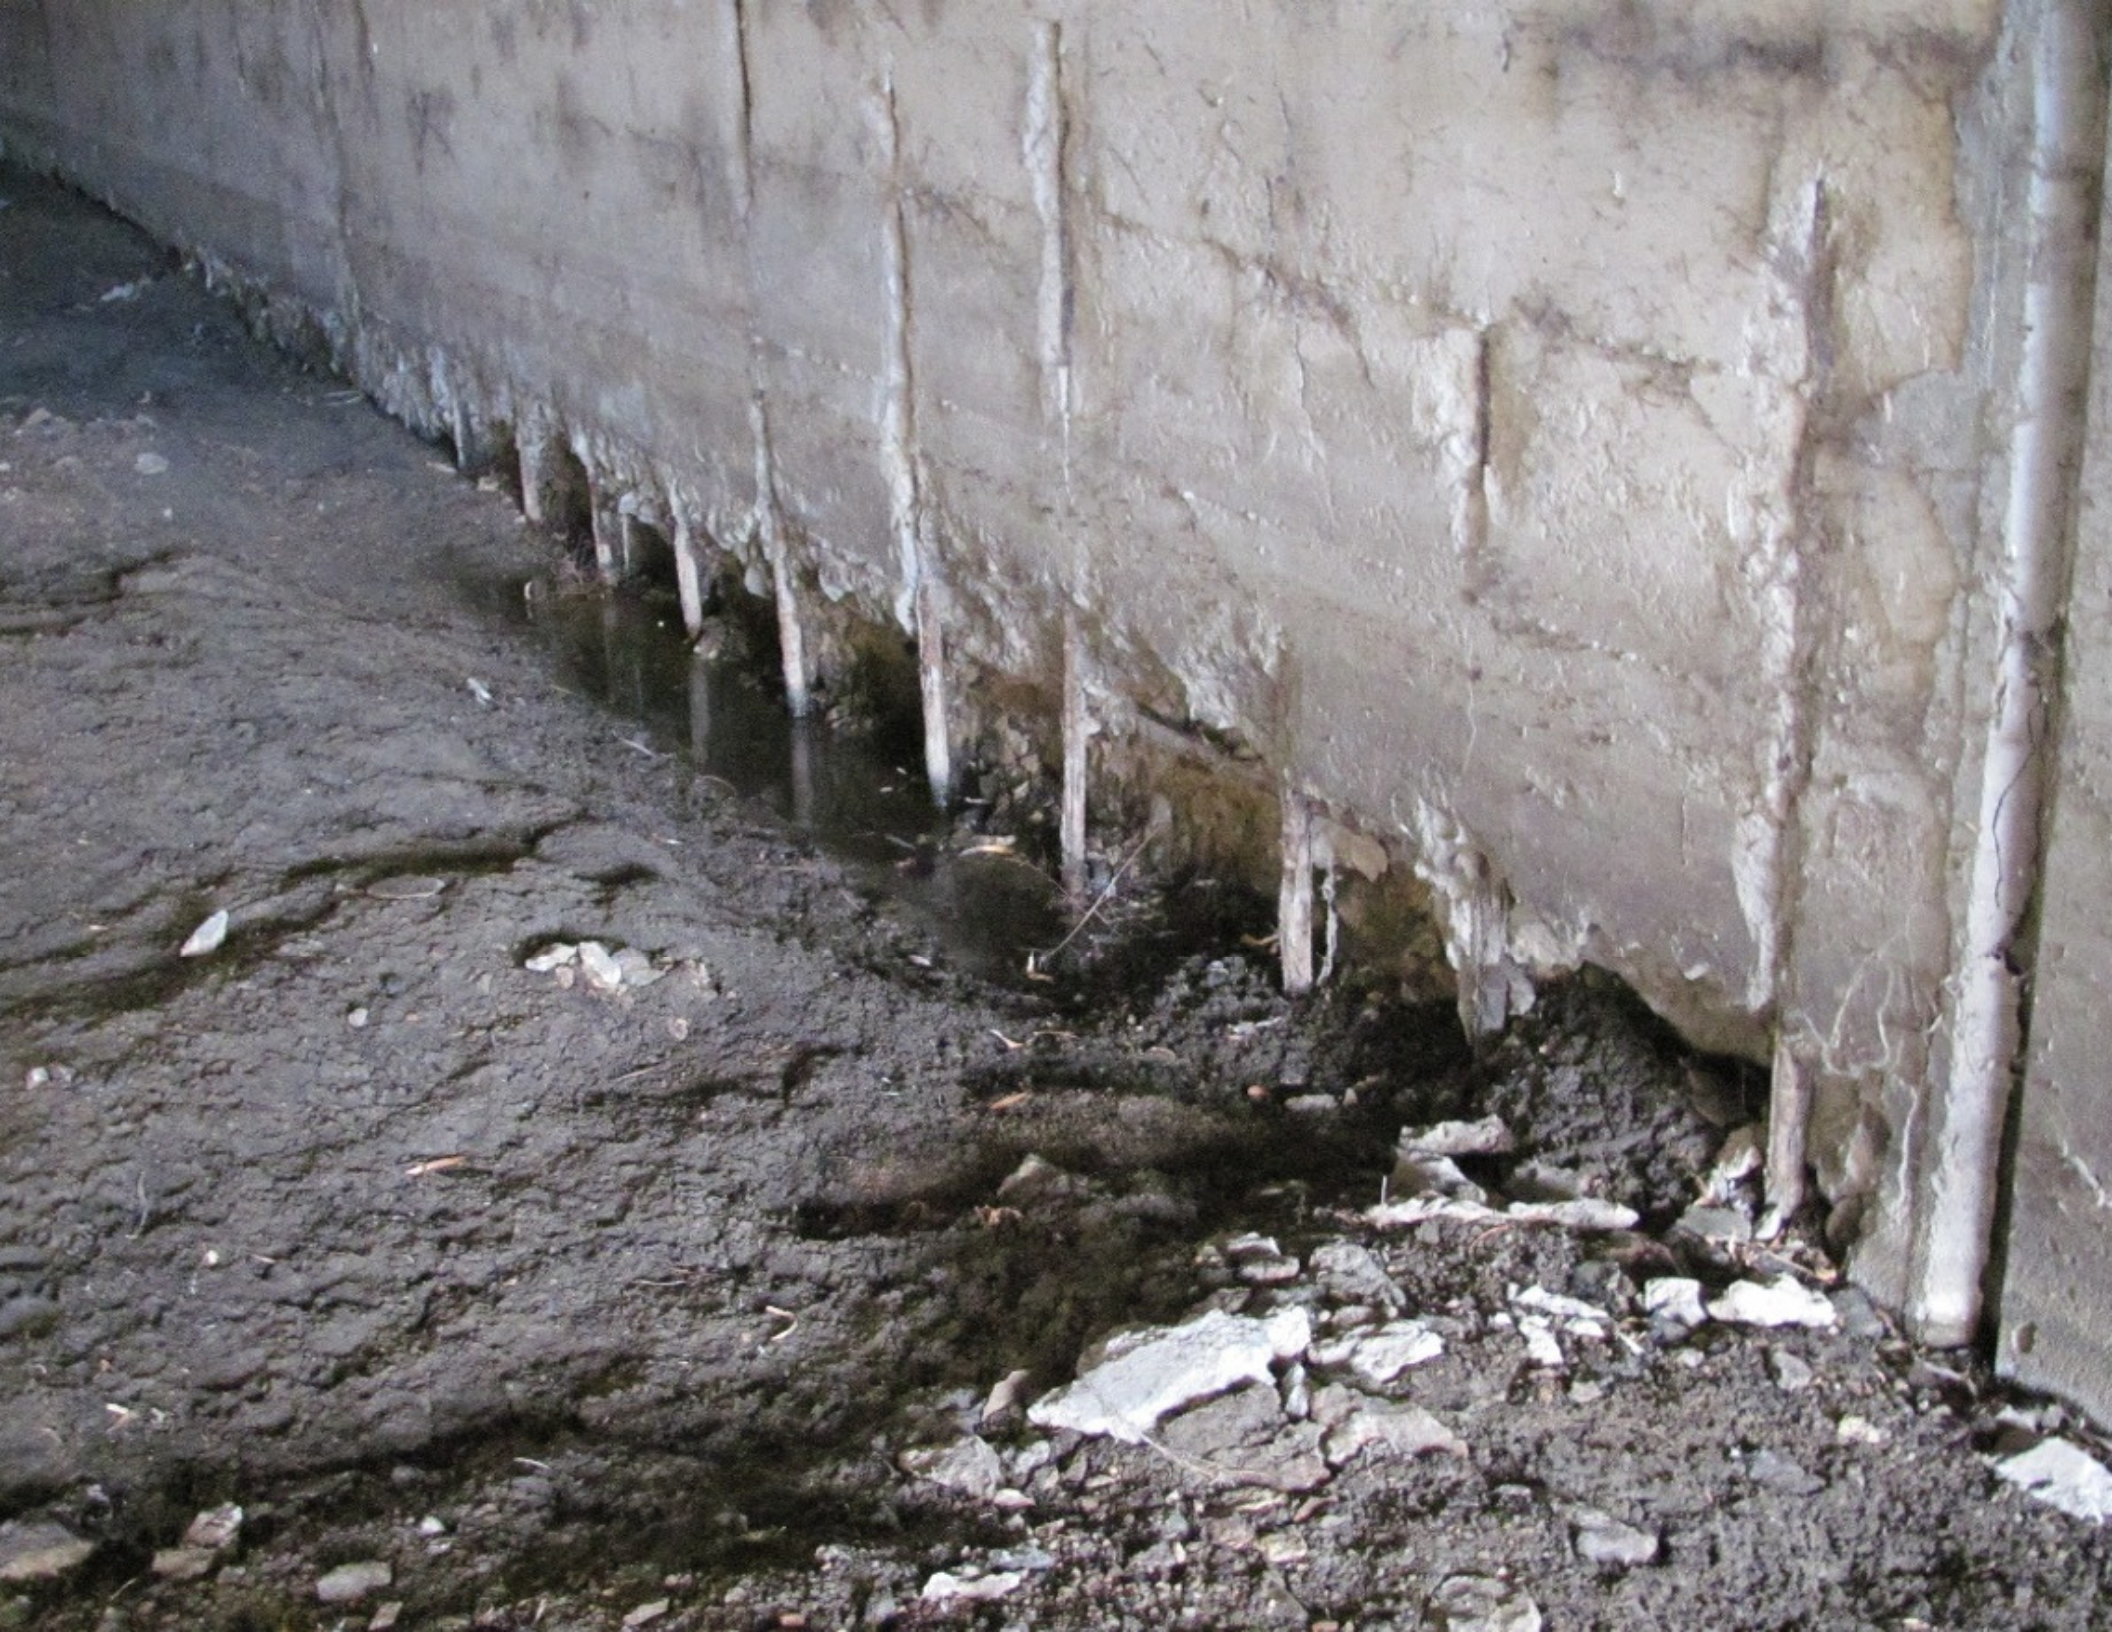
The divider wall is badly spalled, as deep as four inches for a length of fifty feet. The spalling continues below the groundline.

It is our office's recommendation that these items be repaired. Should you have any questions regarding the work, please contact John Deland at (303) 512-4076. Thank you!
