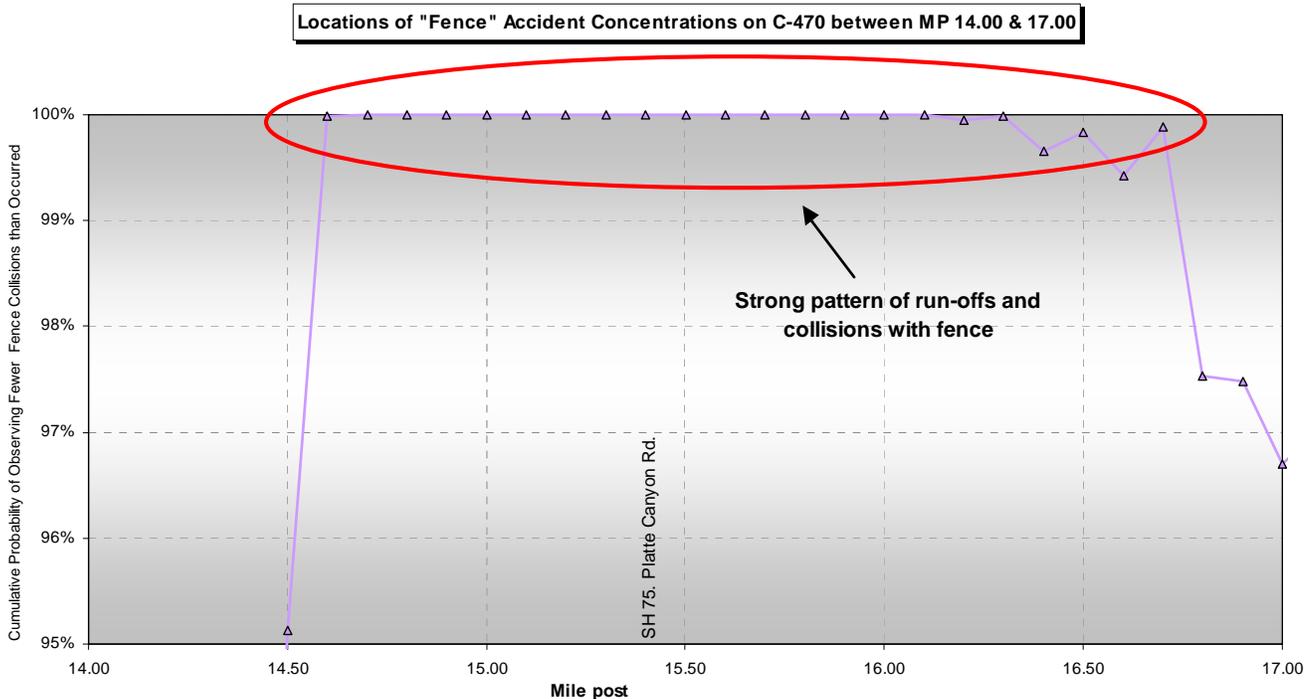
Figure 11 shows locations with high frequencies of collisions with roadside fencing. This well-defined pattern of collisions with off-highway features reflects run-off-road accidents in the vicinity of a curve near MP 15.0. Two of the three fatal accidents in this area involved eastbound vehicles crossing the median. The curve is somewhat isolated by nearly mile-long tangents, a condition sometimes associated with the potential for loss of control at a curve. Consideration may be given to installation of a median barrier such as the cable rail safety fencing, recently installed east of this location, together with outside and median shoulder rumble strips at this curve if not already implemented. The reverse curve between MPs 16 and 17 also records occasional run-off incidents. This curve appears to have a shorter radius than other nearby curves on C-470. Some drivers were not able to negotiate the turns and subsequently lost control resulting in a run off. Crashes at each curve location occurred with good road conditions and lighting. Together with the existing median guardrail, outer and median shoulder rumble strips may further help reduce the occurrence of run-off-road accidents. Geometric and cross sectional changes such as curve flattening or sideslope flattening can also moderate accident frequency and severity here and may be considered during major reconstruction.

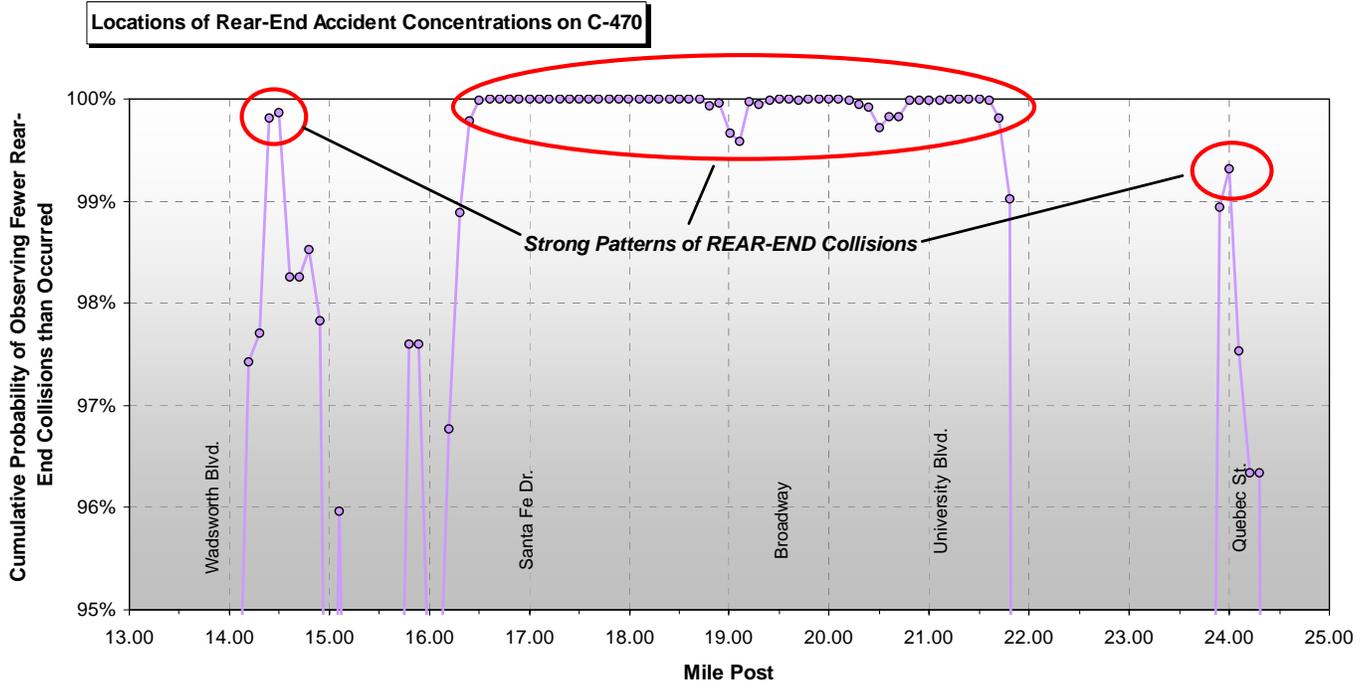
Figure 12

Locations with statistically high incidence of rear-end crashes along the C-470 corridor are revealed in the pattern graph of Figure 12. Clearly, crashes of this type can be seen as the major problem on C-470 with extended areas exhibiting rear-end accident patterns. In particular, a strong, continuous pattern of collisions occurs between MP 16.5 and MP 21.5 with lesser concentrations developing near MPs 14.4 and 24.0. Further examination of the wide pattern shows a time of day and directional bias in accident occurrence at various locations. Figure 8 shows the general time variation along the entire study corridor with conspicuous clusters during the morning and afternoon commuting periods. Figures 13 & 14 further break this down directionally, indicating pronounced rear-end accident occurrence during typical morning rush hours (approximately between 5:30 am and 8:30 am) in the eastbound lanes. Similar accident concentration is displayed during the afternoon volume peak (3 pm - 6 pm) in the westbound lanes of this pattern area.

An increase in rear-end accident frequency is typical during high ADT periods. Added traffic capacity will be the most effective improvement in reducing these congestion-related accidents. Additionally, providing on-ramp acceleration lanes as long as practical at interchanges may help minimize speed reduction and disruption to through traffic lanes. In some instances, the parallel type acceleration lane may create less disturbance in the mainline traffic flow as well. At several of the above locations (westbound in the Santa Fe interchange area, westbound from 22.95-23.1 and near the University Blvd. Interchange) downhill grades make slowing or stopping for unexpected traffic congestion even more difficult. Again, providing extended ramp lanes in these areas to segregate slowing traffic may marginally help reduce the incidence of rear-end collisions.

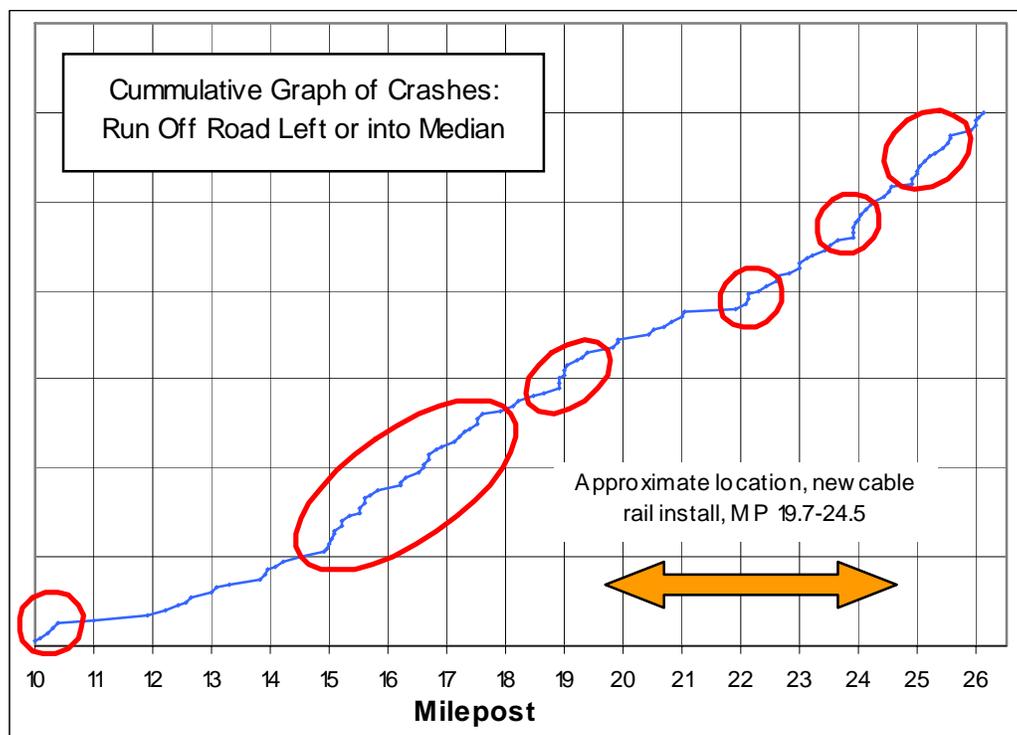
Figure 15

Over the corridor as a whole, it appears that C-470 records a lower percentage of vehicle collisions with median barrier compared to other similar highways while the percentage of median crossovers and crashes in the opposing lanes is slightly high. Additionally, the percentage of head-on and opposing direction sideswipe collisions is at or slightly above statewide averages for this highway type. These conditions suggest that installation of additional median barrier may be an effective safety improvement. Figures 15 & 16 (a & b) graphically depicts the locations where vehicles have run off the road to the left side and/or into the median.

In Figure 15, the circled areas identify isolated locations with slightly increased frequencies of median incursion or crossovers. The Region has recently installed median cable rail from MP 19.7 - 24.5. This type of median barrier is expected to improve safety significantly along this segment.

In conjunction with major widening or other large-scale improvements undertaken in the future, planners may consider additional median barrier installation following review of the accident reduction performance of this latest cable rail project.

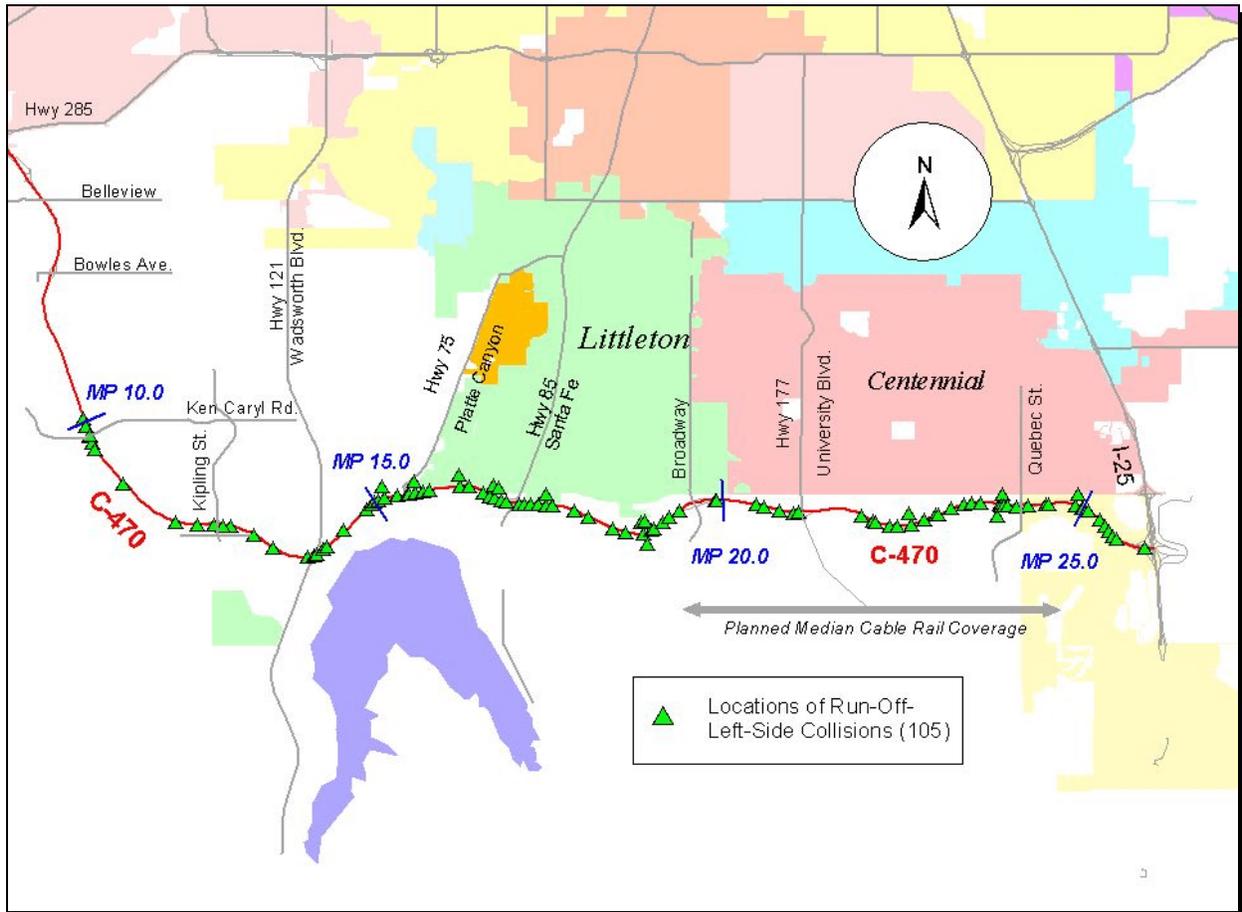
Figure 16a specifically indicates locations of those crashes involving run-off the left roadside
