C-470 & Kipling St. Interchange

**Accident Types at Kipling Interchange
Ramps & Crossroad Only**

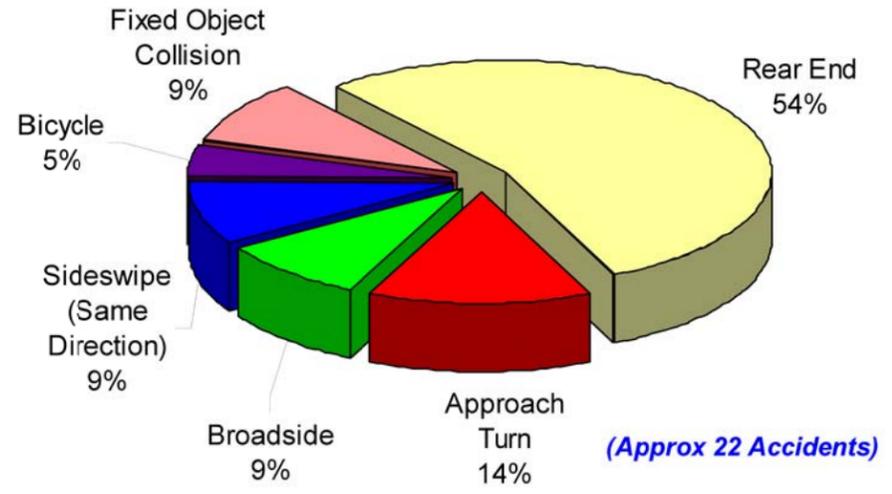
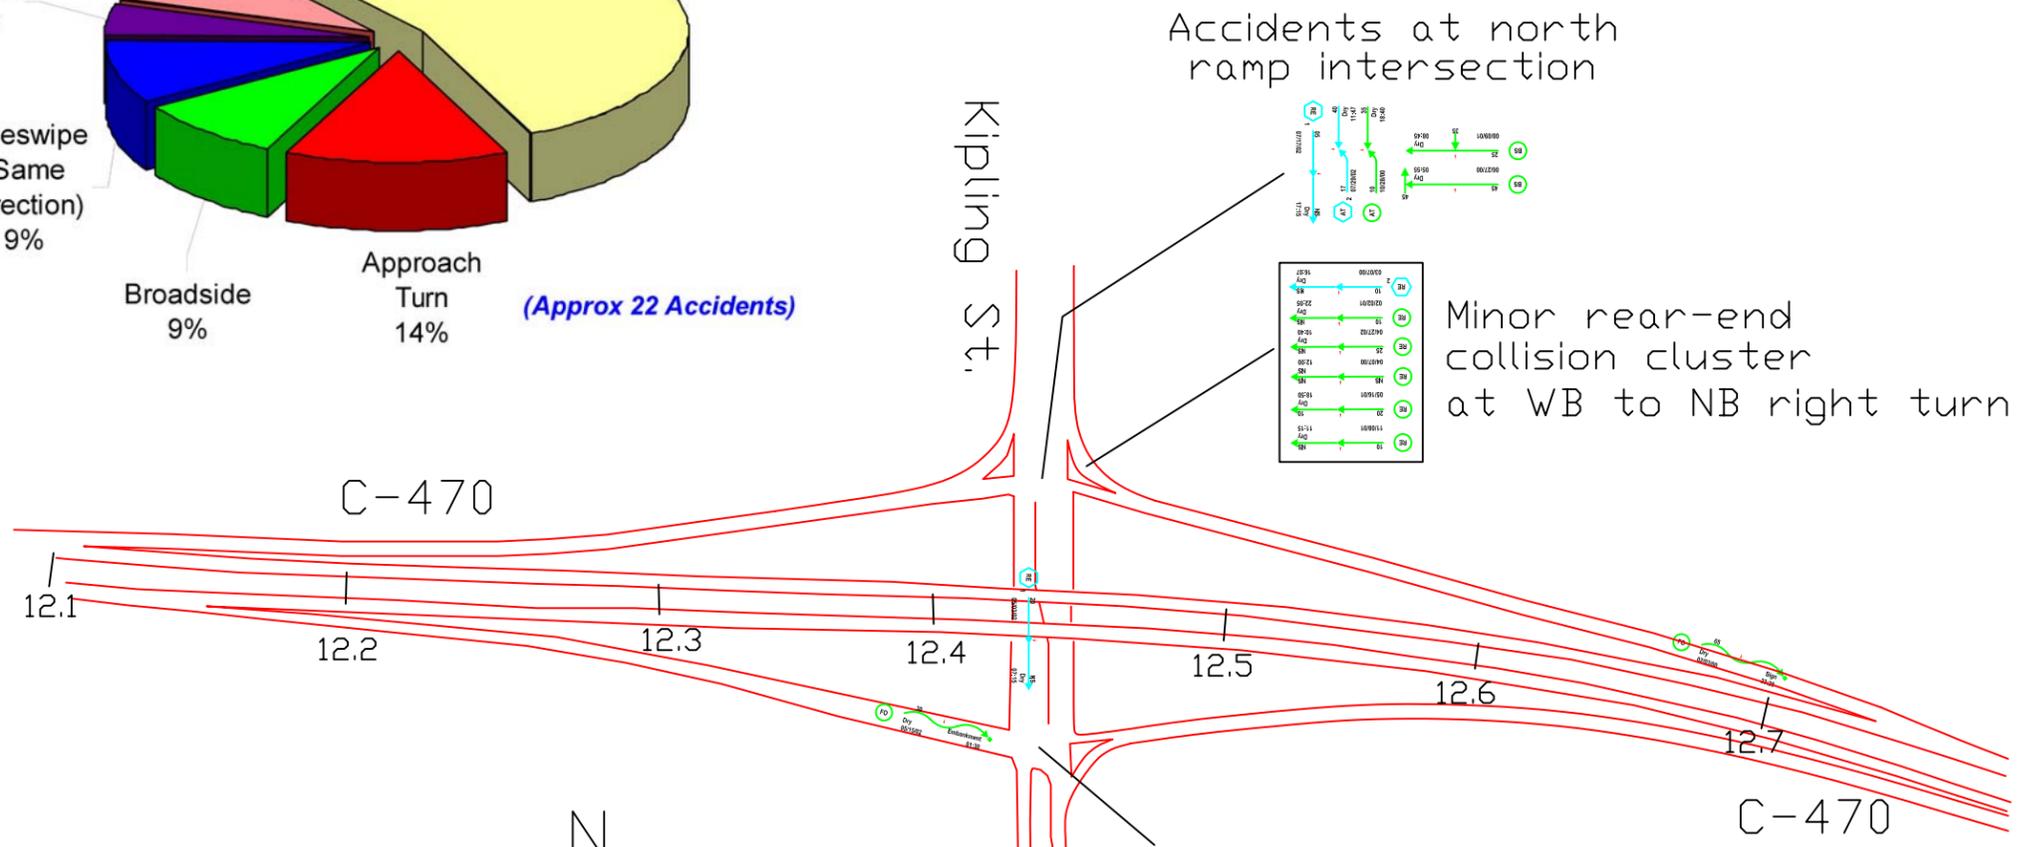
Accidents at north ramp intersection

Minor rear-end collision cluster at WB to NB right turn

Accidents at south ramp intersection

Minor Collision Cluster at SB to EB left turn
