# C-470 & Platte Canyon Rd. Interchange

### *C-470 and Santa Fe Drive Interchange*

# C-470 & Santa Fe Interchange

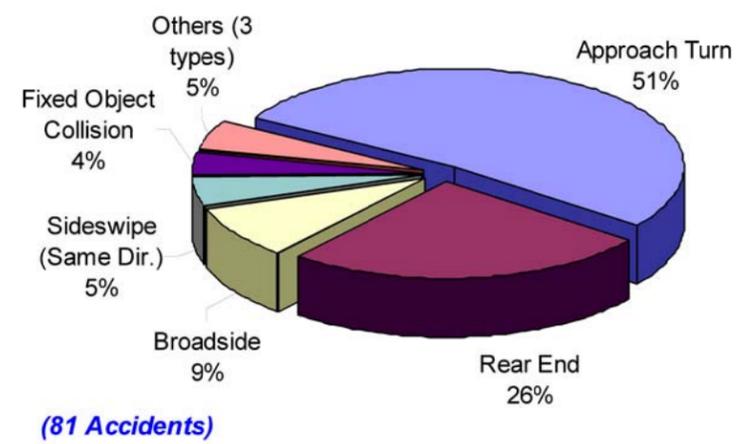
**Accident Types at the North Ramp Intersection of the Santa Fe Interchange**

Approximately 158 accidents were detected in the immediate interchange vicinity on Santa Fe Dr. and on the entrance/exit ramps to C-470. Rear-end and approach turn collisions together made up nearly 75% of these crashes. At the signalized ramp intersection on the north side of the bridge structure, over half of the accidents were approach turns. These crashes involved northbound vehicles on Santa Fe turning left onto the westbound C-470 entrance ramp colliding with southbound Santa Fe traffic. The frequency of these accidents is increased by periodic volume congestion and the limited storage capacity of the current northbound to westbound left turn lane configuration. The Region has recently changed from protected-permitted signal phasing to protected-only phasing. This improvement is expected to reduce the incidence of approach-turn crashes significantly, accompanied by a delay and capacity cost however.

Collisions occurring at north ramp intersection

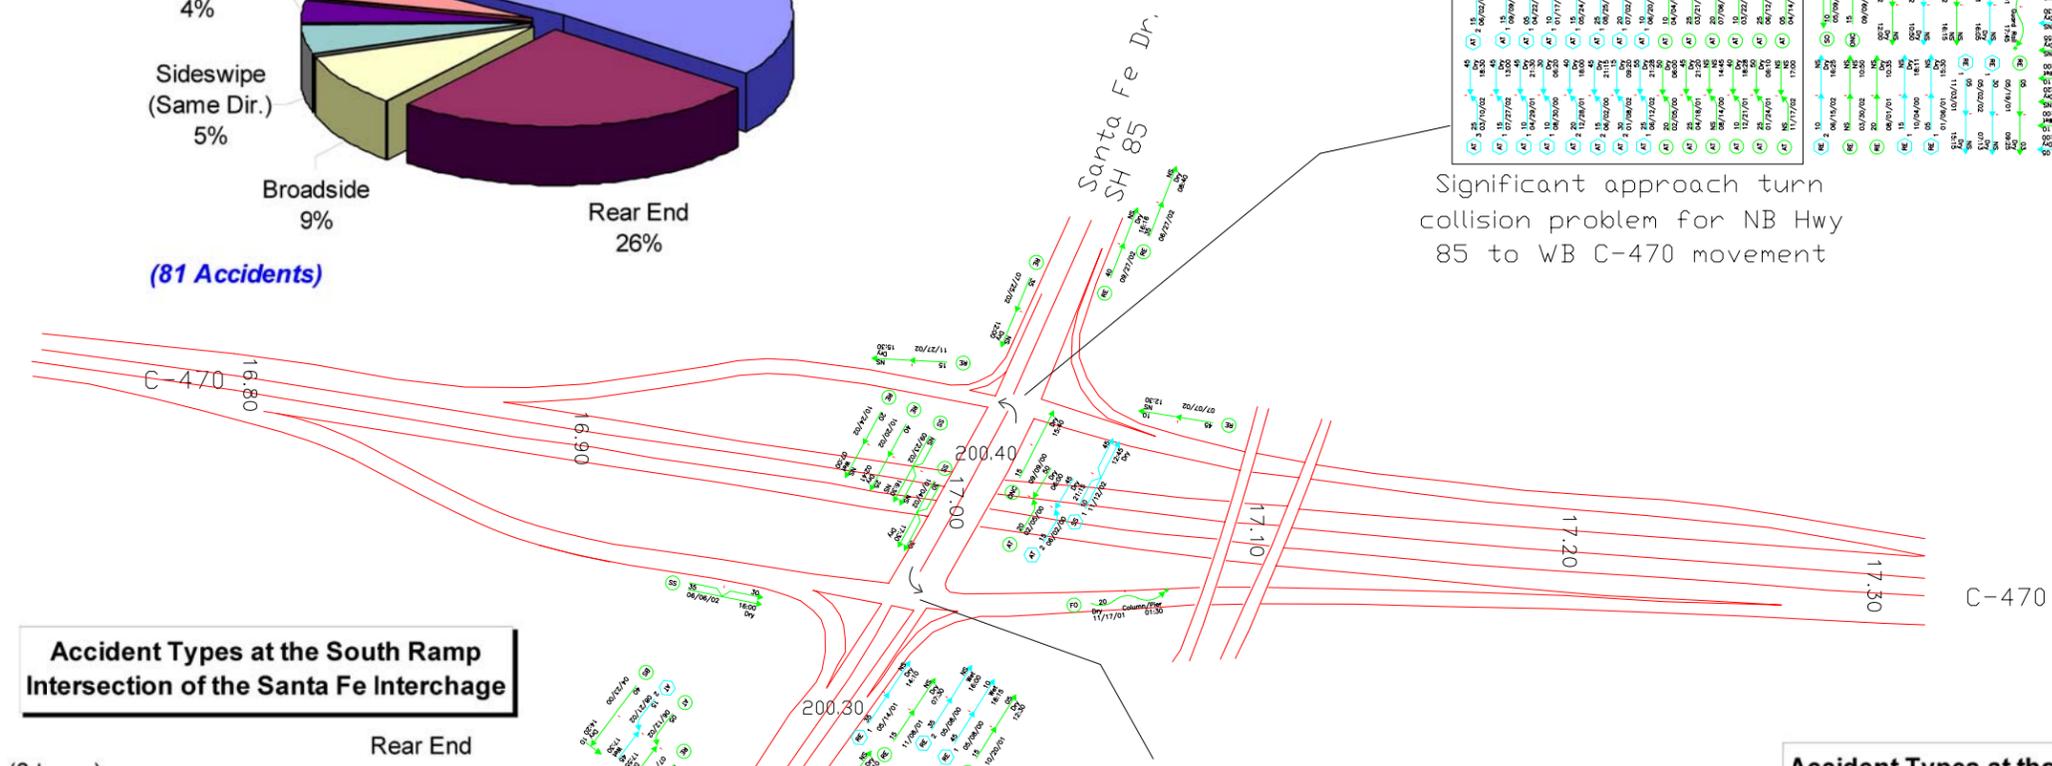
Significant approach turn collision problem for NB Hwy 85 to WB C-470 movement

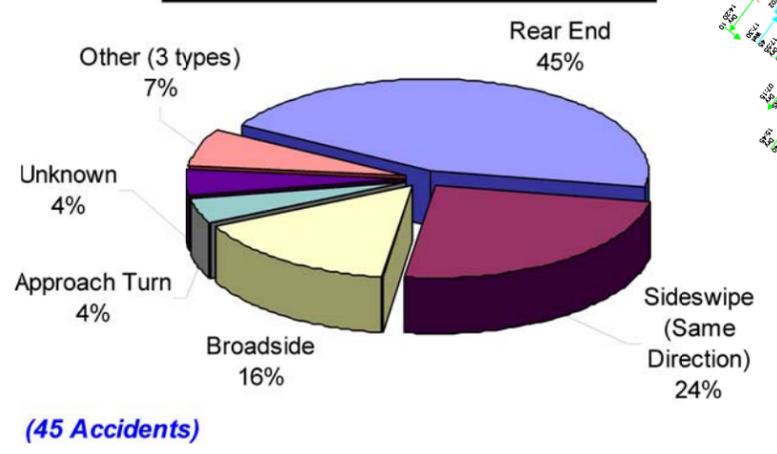
**Accident Types at the South Ramp Intersection of the Santa Fe Interchange**

Collisions occurring at the south ramp intersection

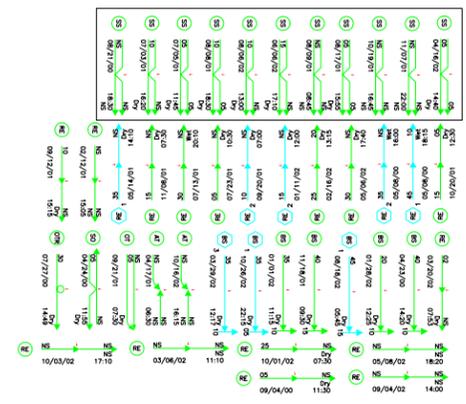
The south ramp intersection includes a double left turn lane for vehicles making the southbound to eastbound turn movement. This movement requires drivers to execute a turn through more than 90 degrees due to interchange skew. Approximately eleven same direction sideswipe accidents are noted in these lanes. Ensuring that durable pavement markings are used and maintained for the turn lane stripe extensions into the intersection can help mitigate this type of accident.

Moderate frequency same direction sideswipe accidents in double left turn lanes, SB Santa Fe Drive to EB C-470
