C-470 & Lucent Blvd. Interchange

C-470 and Broadway Interchange

C-470 and University Blvd. Interchange

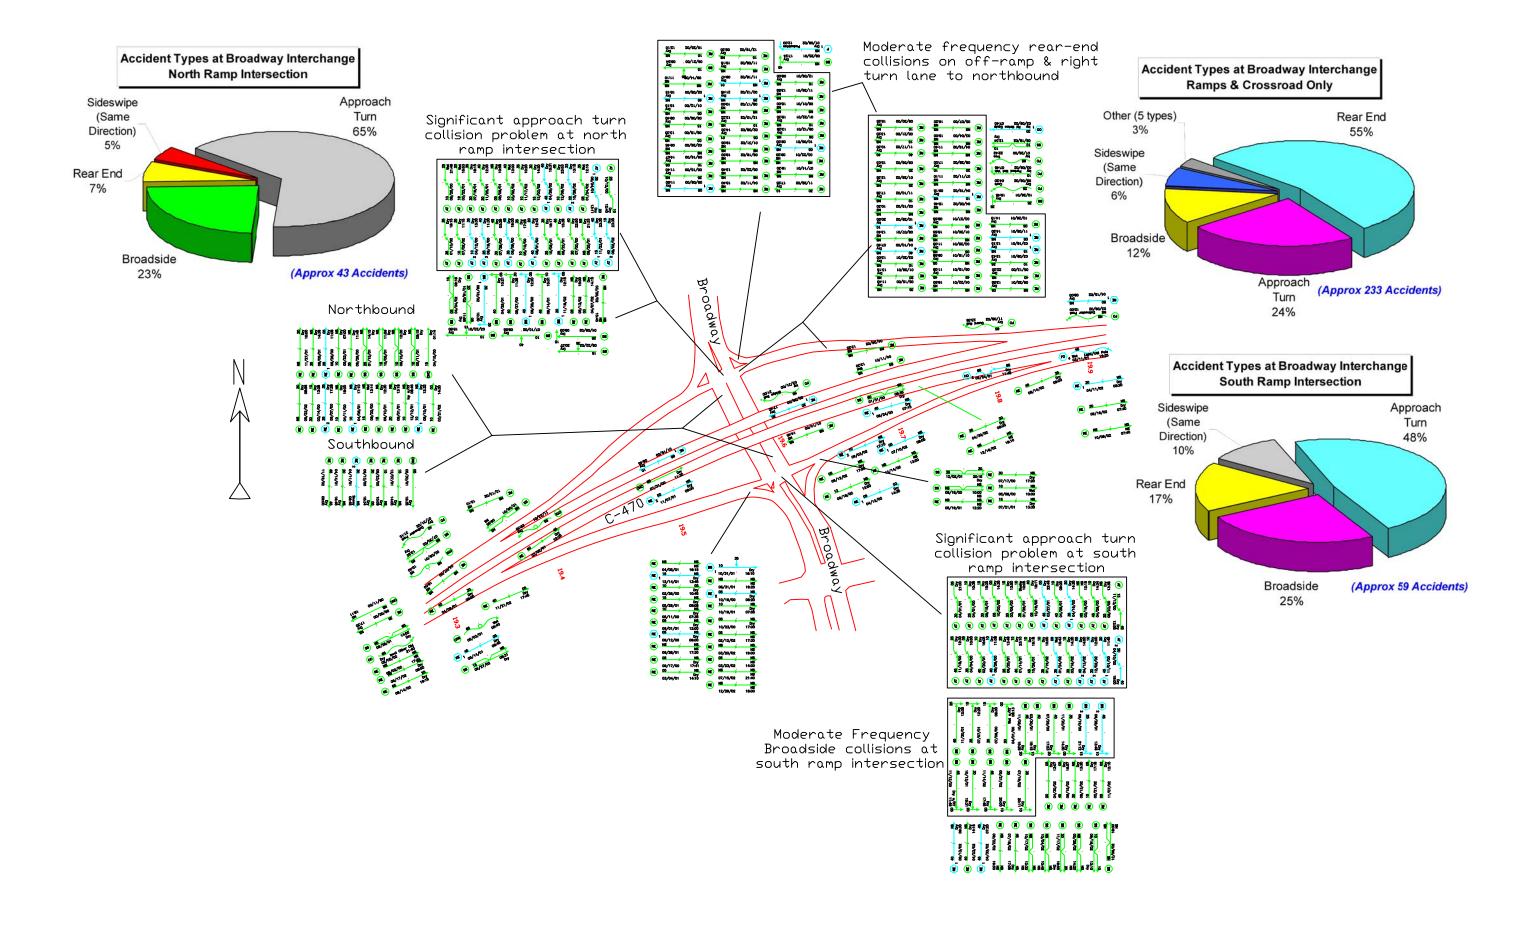
C-470 & Broadway Interchange

Approach turn type collisions were prevalent at the Broadway interchange. Both north and south ramp intersections exhibited these collisions during the study period. If not already implemented, fully protected left turn intervals for the north and southbound Broadway to C-470 left turn movements should be considered at both ramp intersection signals. Additionally, we note rear-end collisions occurring with moderate frequency in the channelized right turn lanes from the freeway off ramps to north & southbound Broadway. Again, these are generally congestion related typically occurring during peak volume hours. Provision of extended right turn acceleration lanes on Broadway, if practical, may be considered to eliminate some of these rear-end collisions. An occasional north or southbound vehicle on Broadway does not observe or disregards a red signal indication at the ramp intersection which generates a broadside collision potential. Improving the conspicuity of the traffic signal indications or minor extension of the signal change interval may be considered as an accident countermeasure for this accident type. This interchange currently carries relatively high traffic volume. This is acknowledged in the present double left turn lane configuration. Increasing the traffic capacity throughout this interchange may be considered in conjunction with improvement planning for mainline C-470.
