I17DG (Spalling below Girder 1Q at Abutment 1).JPG

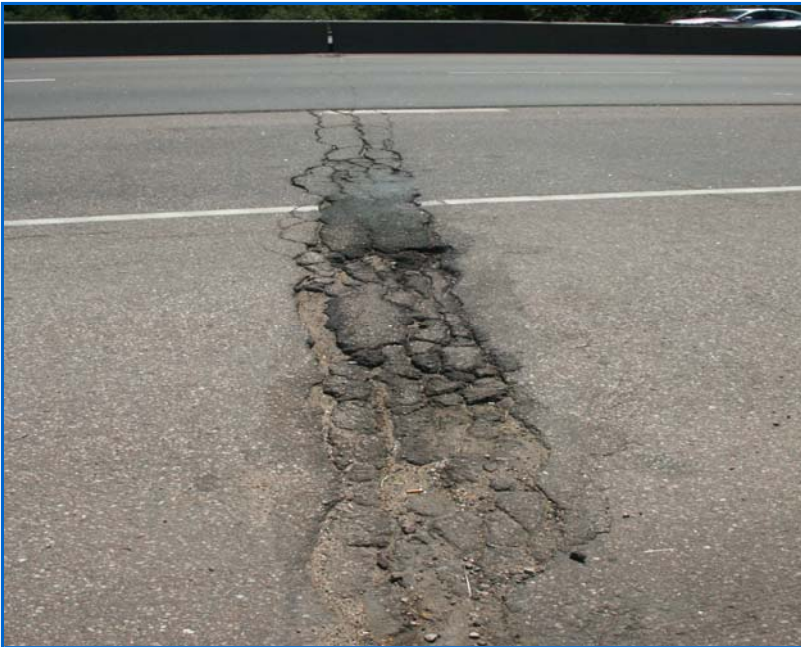
I17DG Asph. above Abut 5 outside lane and shldr is cracked moderately and has potholes.JPG

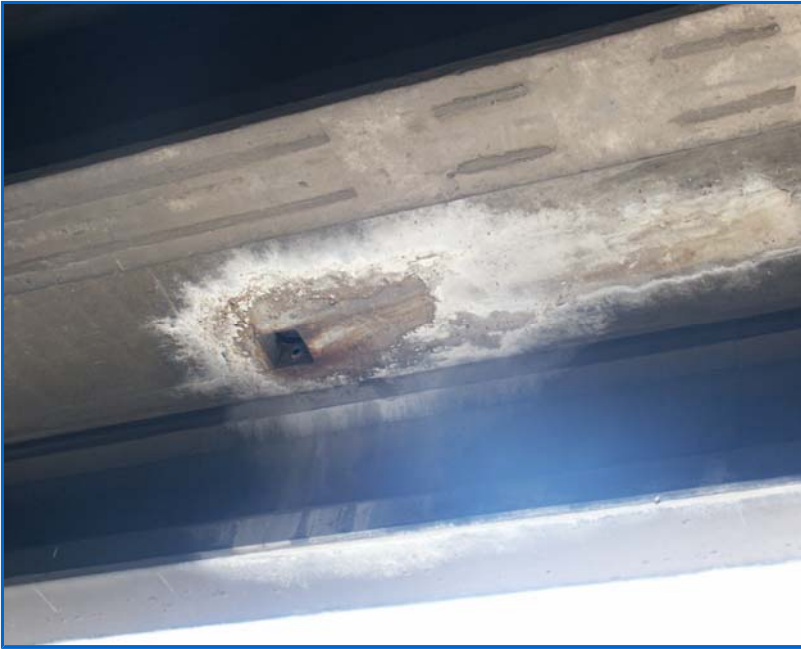
I17DG Old Utility box in deck bottom bay 3P has hole thru deck and is causing deter of deck bottom.JPG
