**GEO-RECOVERY SYSTEMS, INC.**

May 22, 1996

Re: Project Report: Ground Penetrating Radar Survey:  
Mine Drift Location, Interstate 70, East of Hidden  
Valley Exit

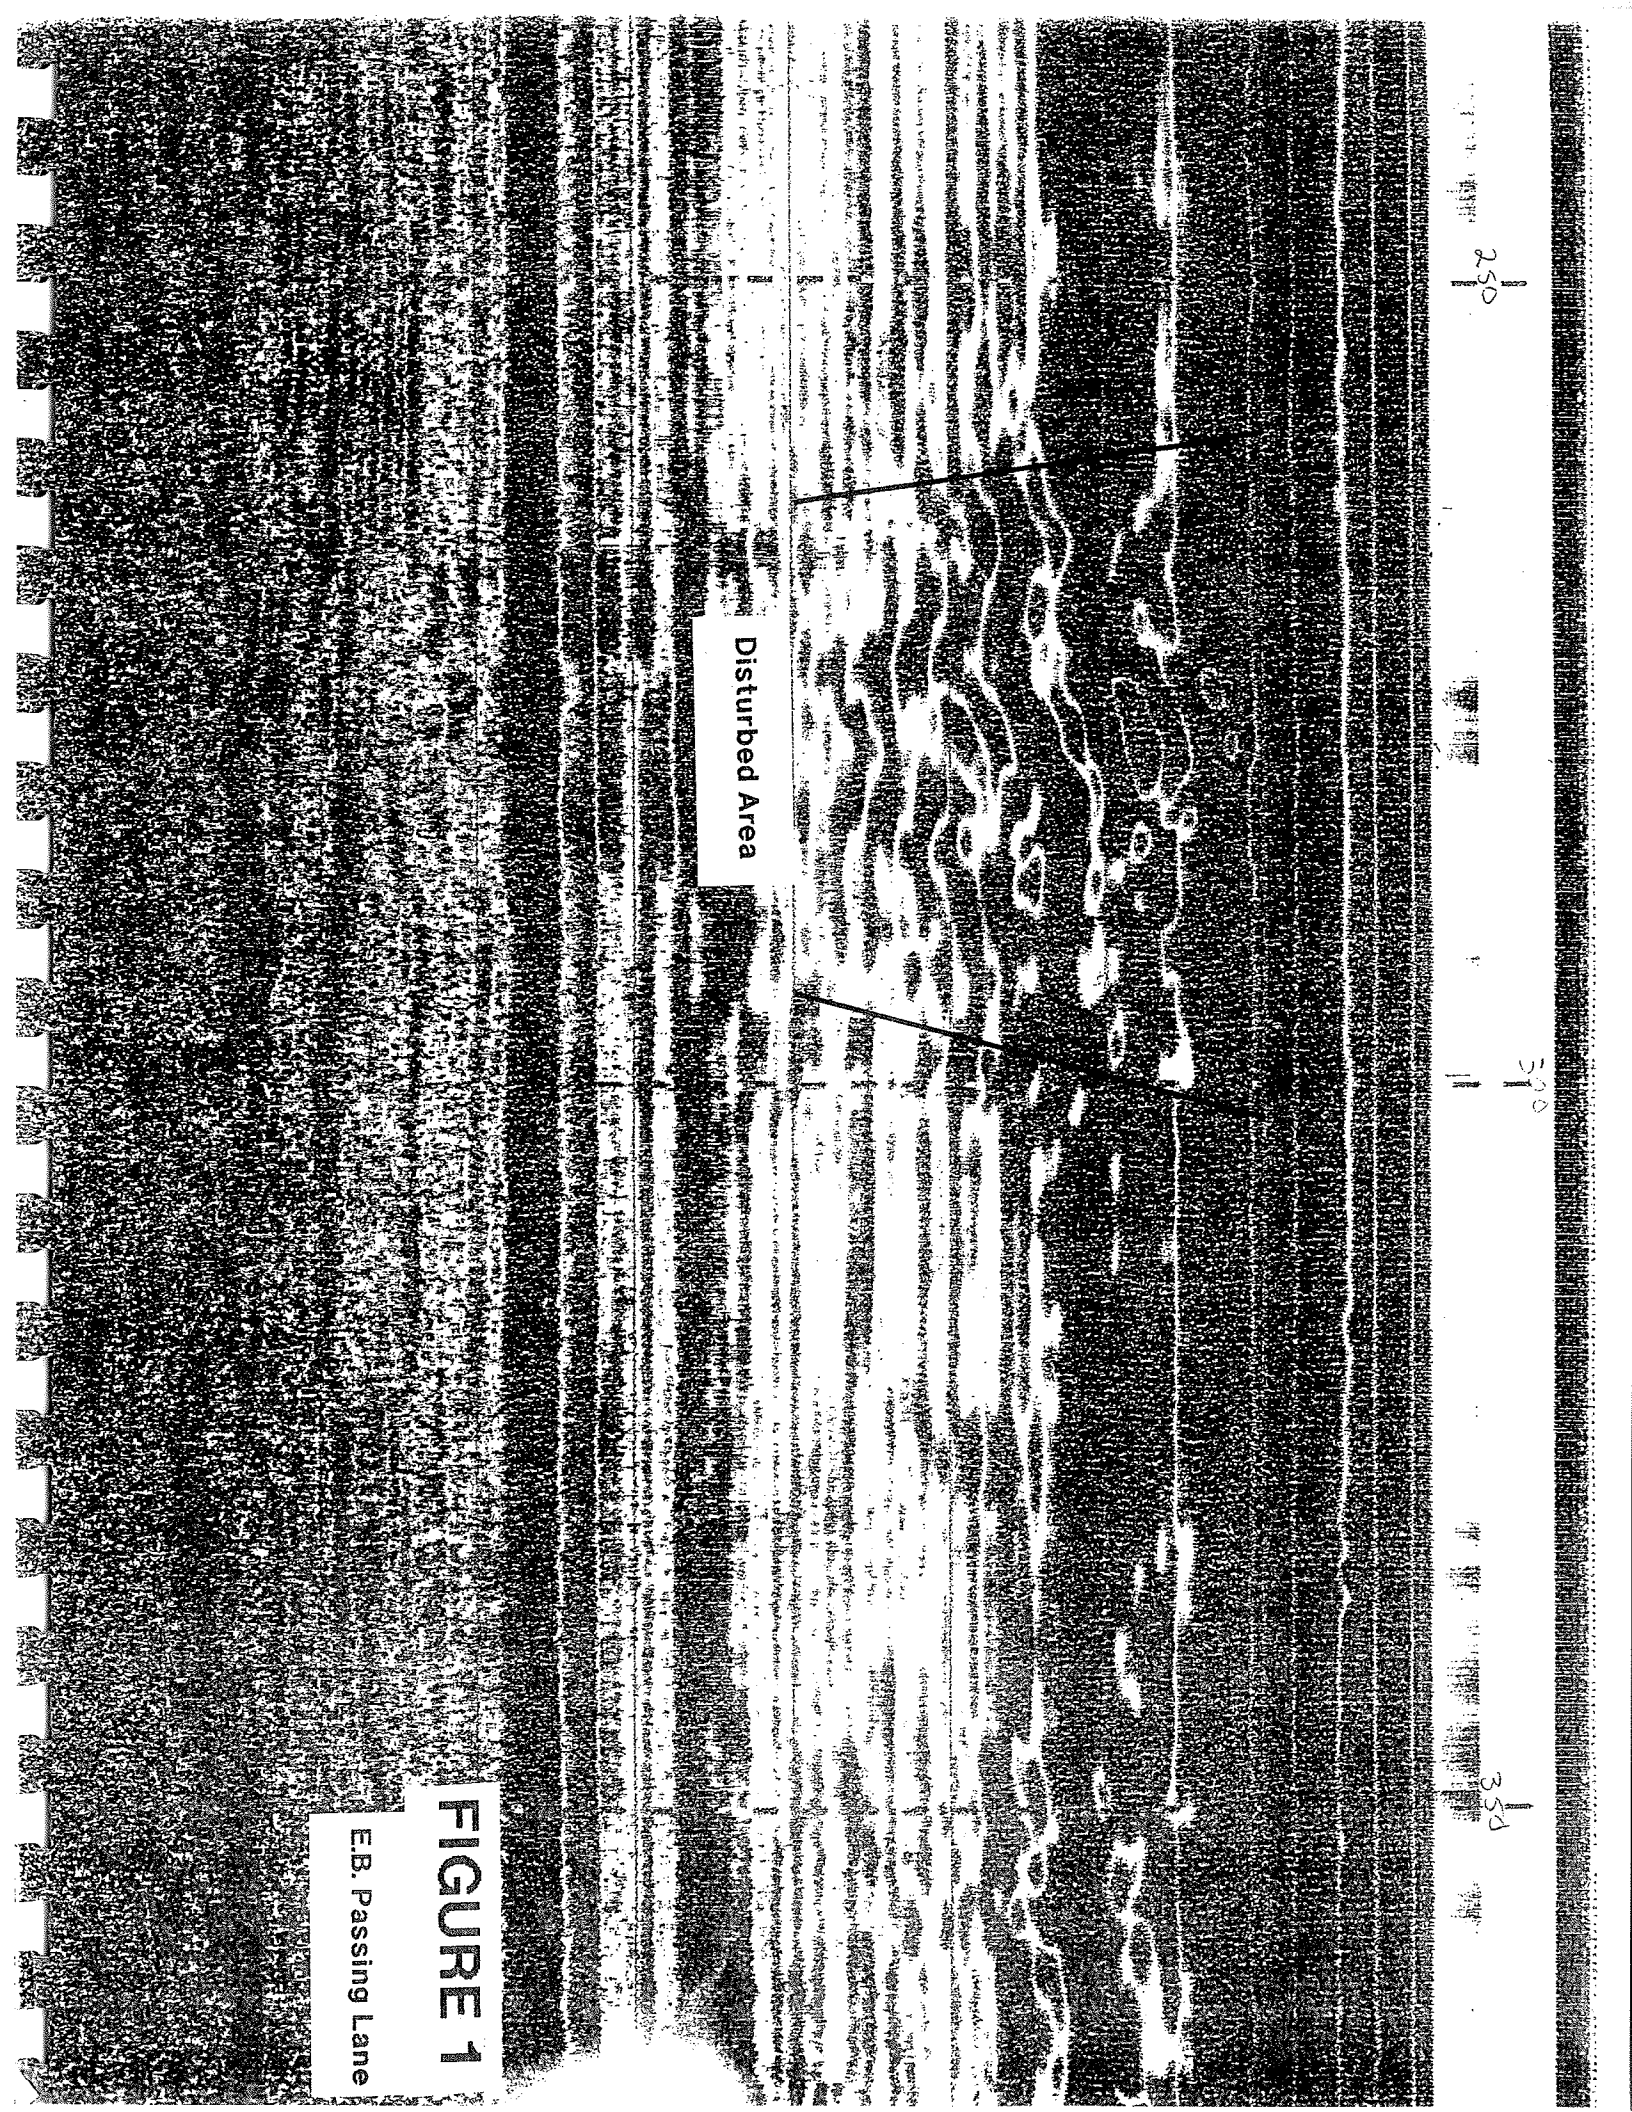
FIGURE 1

Disturbed Area

EB, Passing Lane

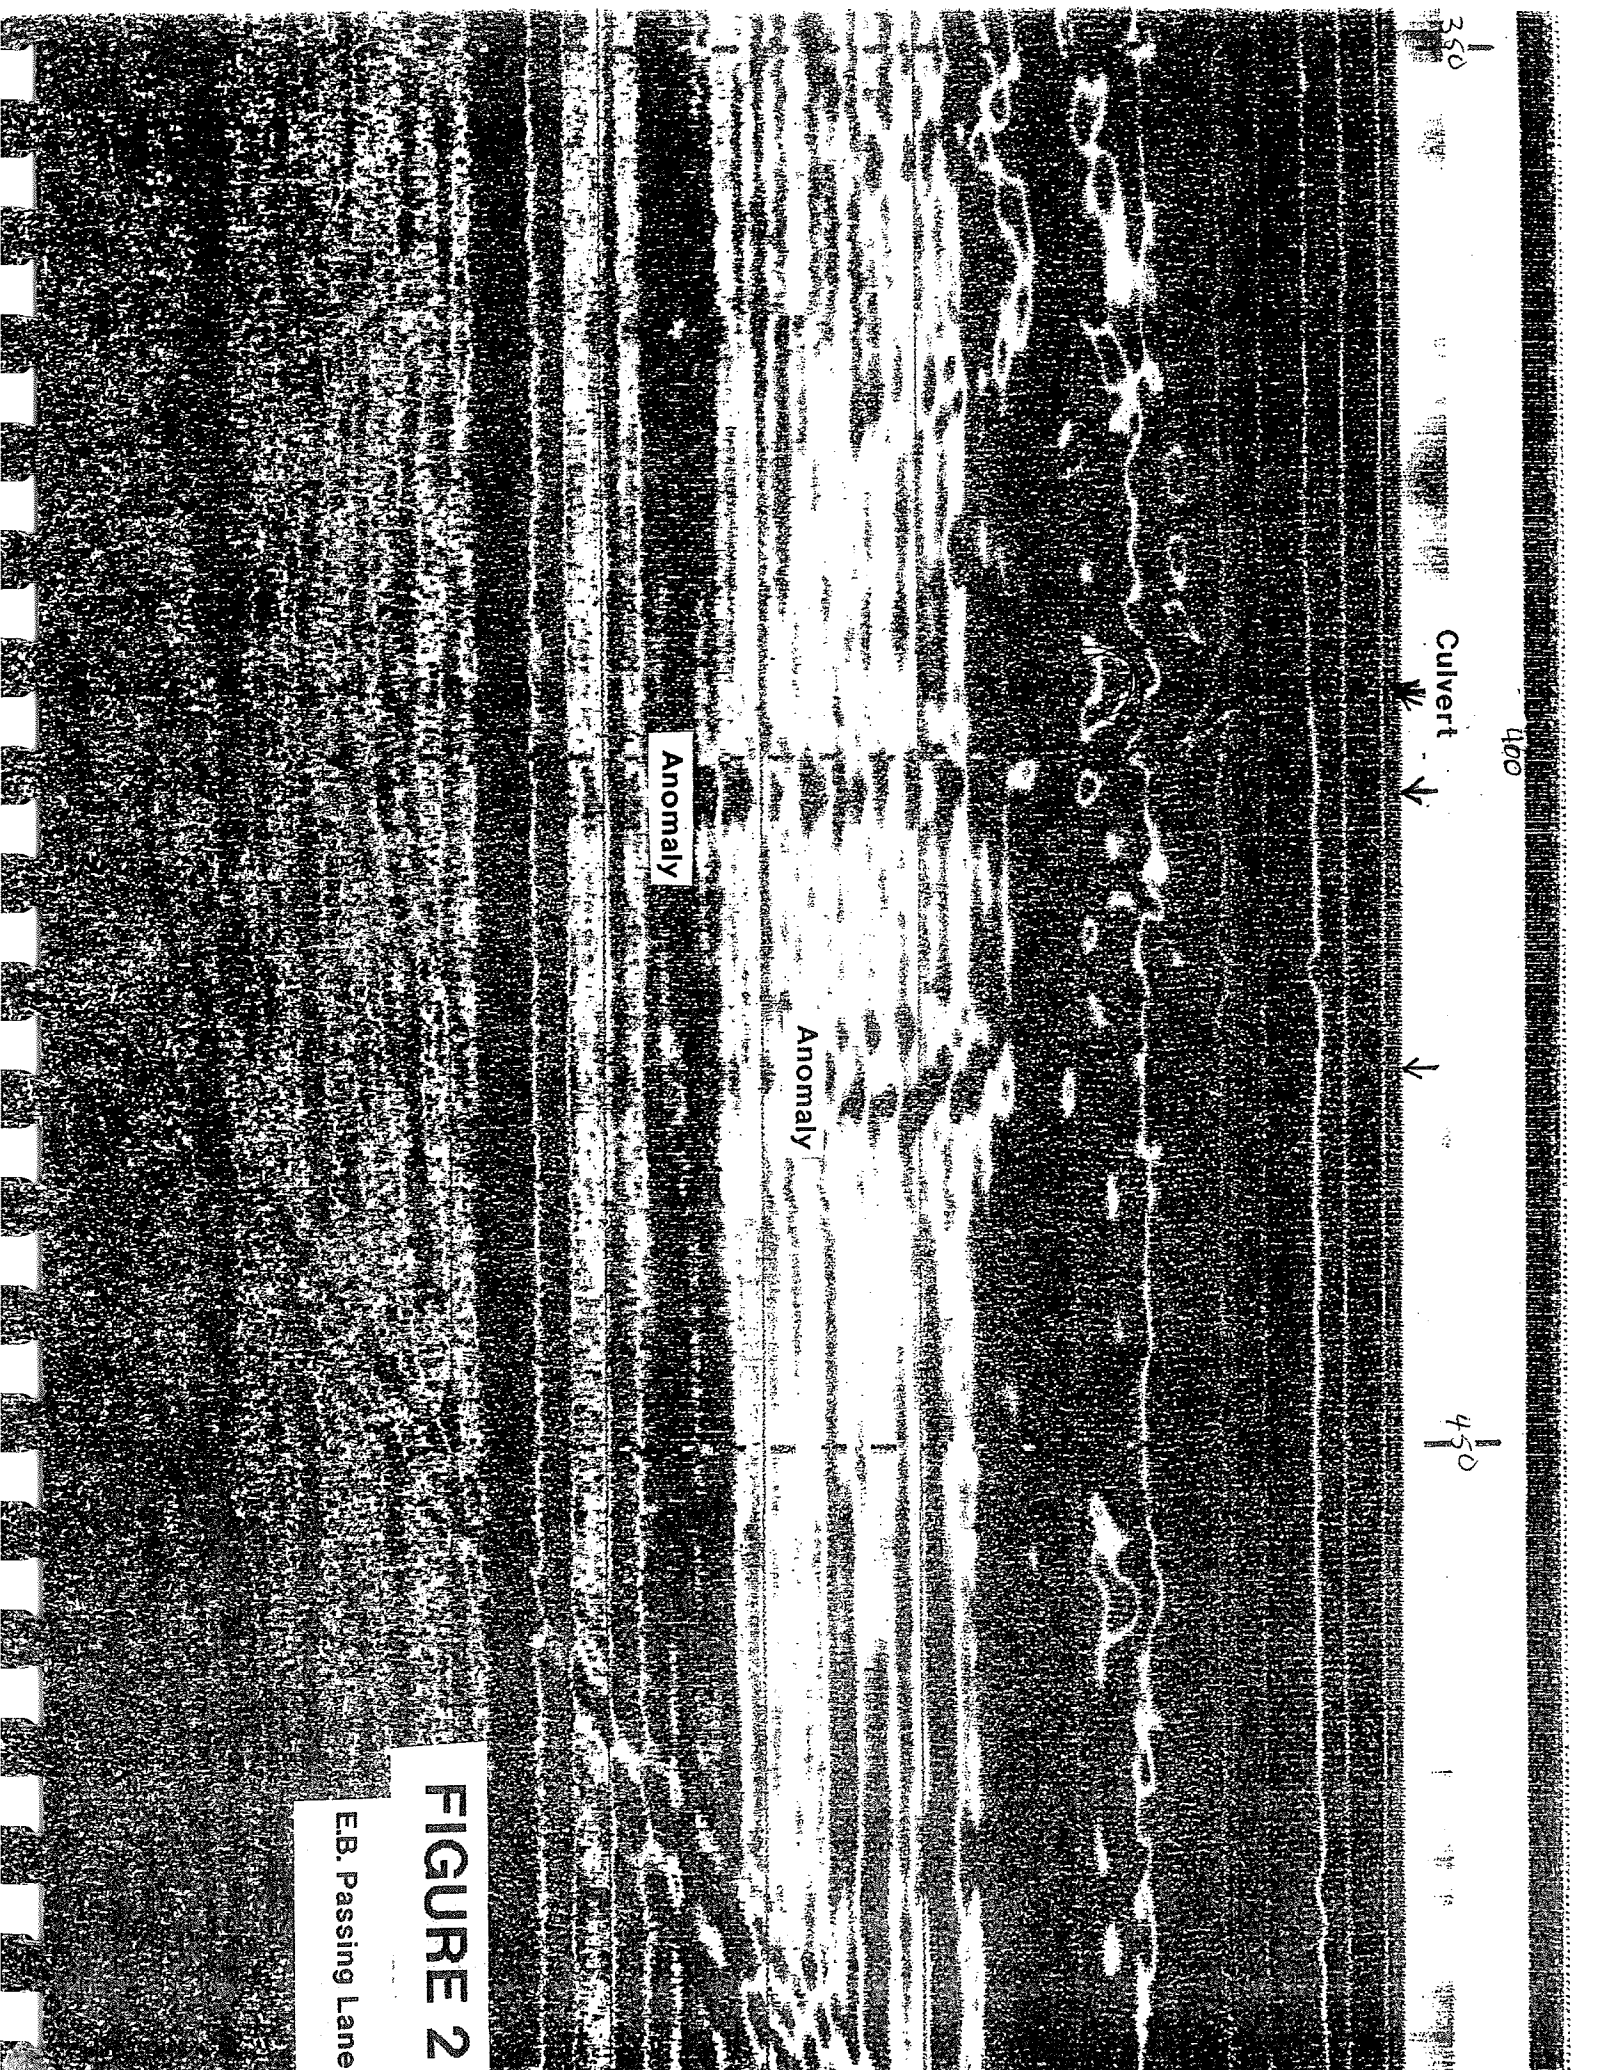
FIGURE 2

Anomaly

EB. Passing Lane

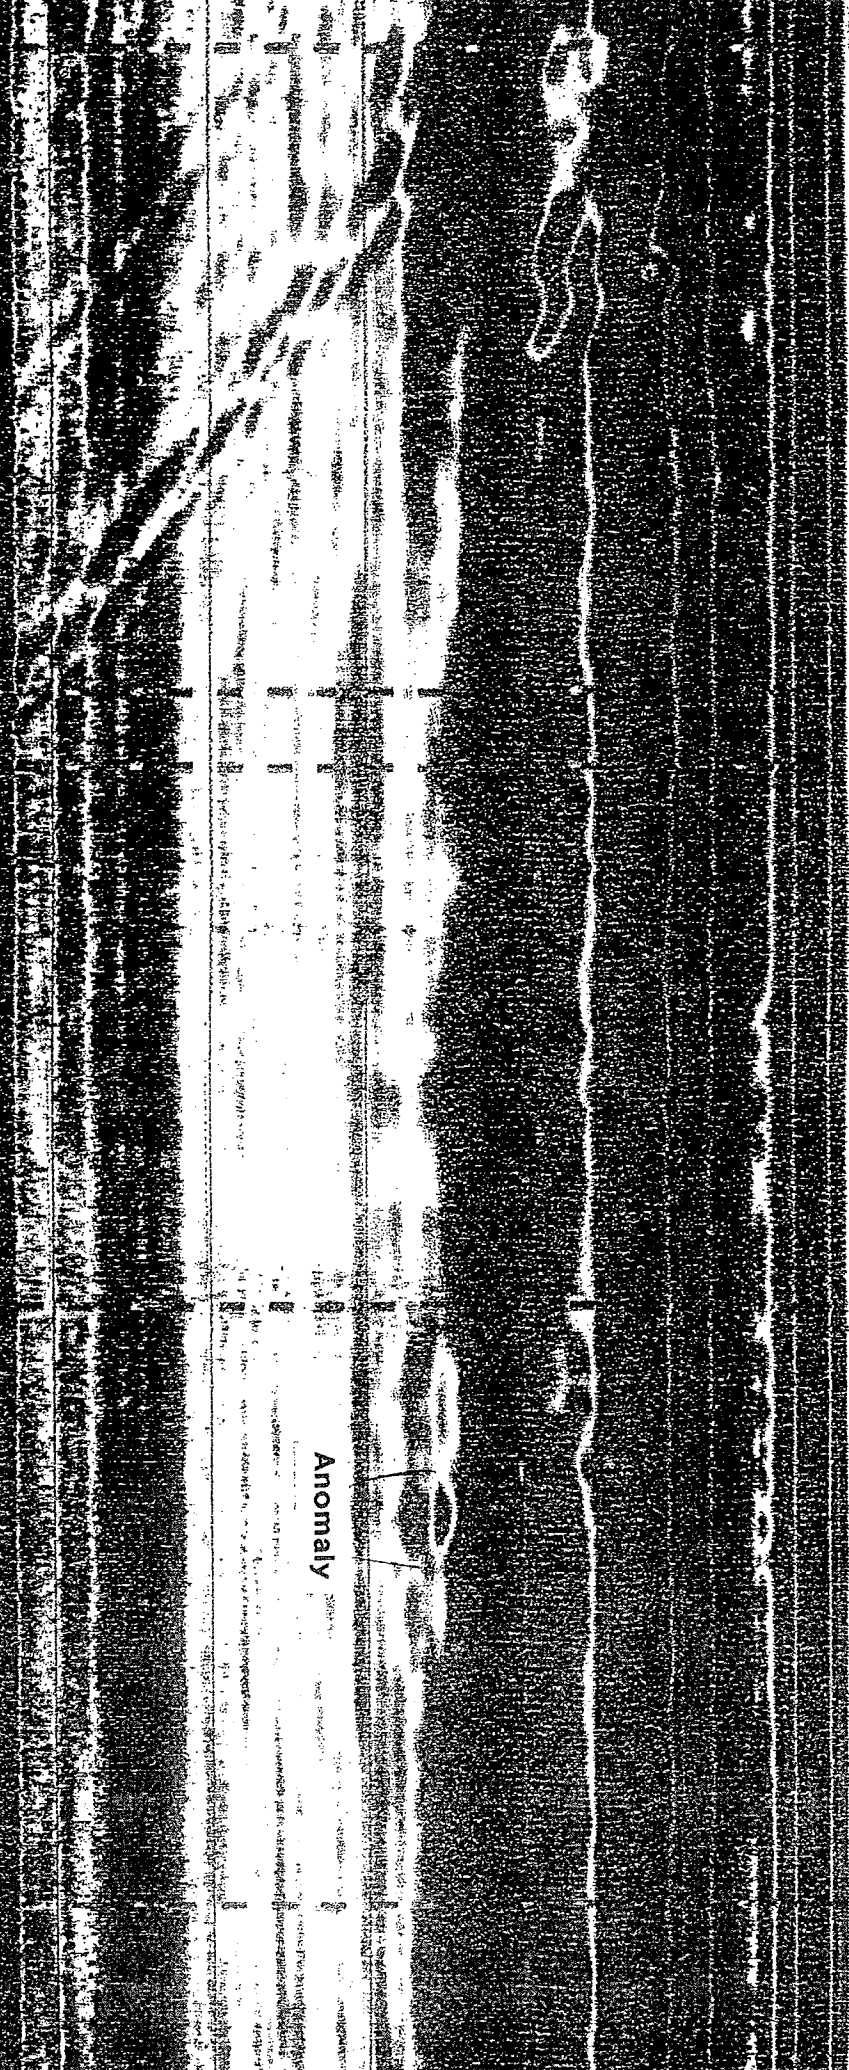
**FIGURE 3**

Anomaly

EB Passing Lane

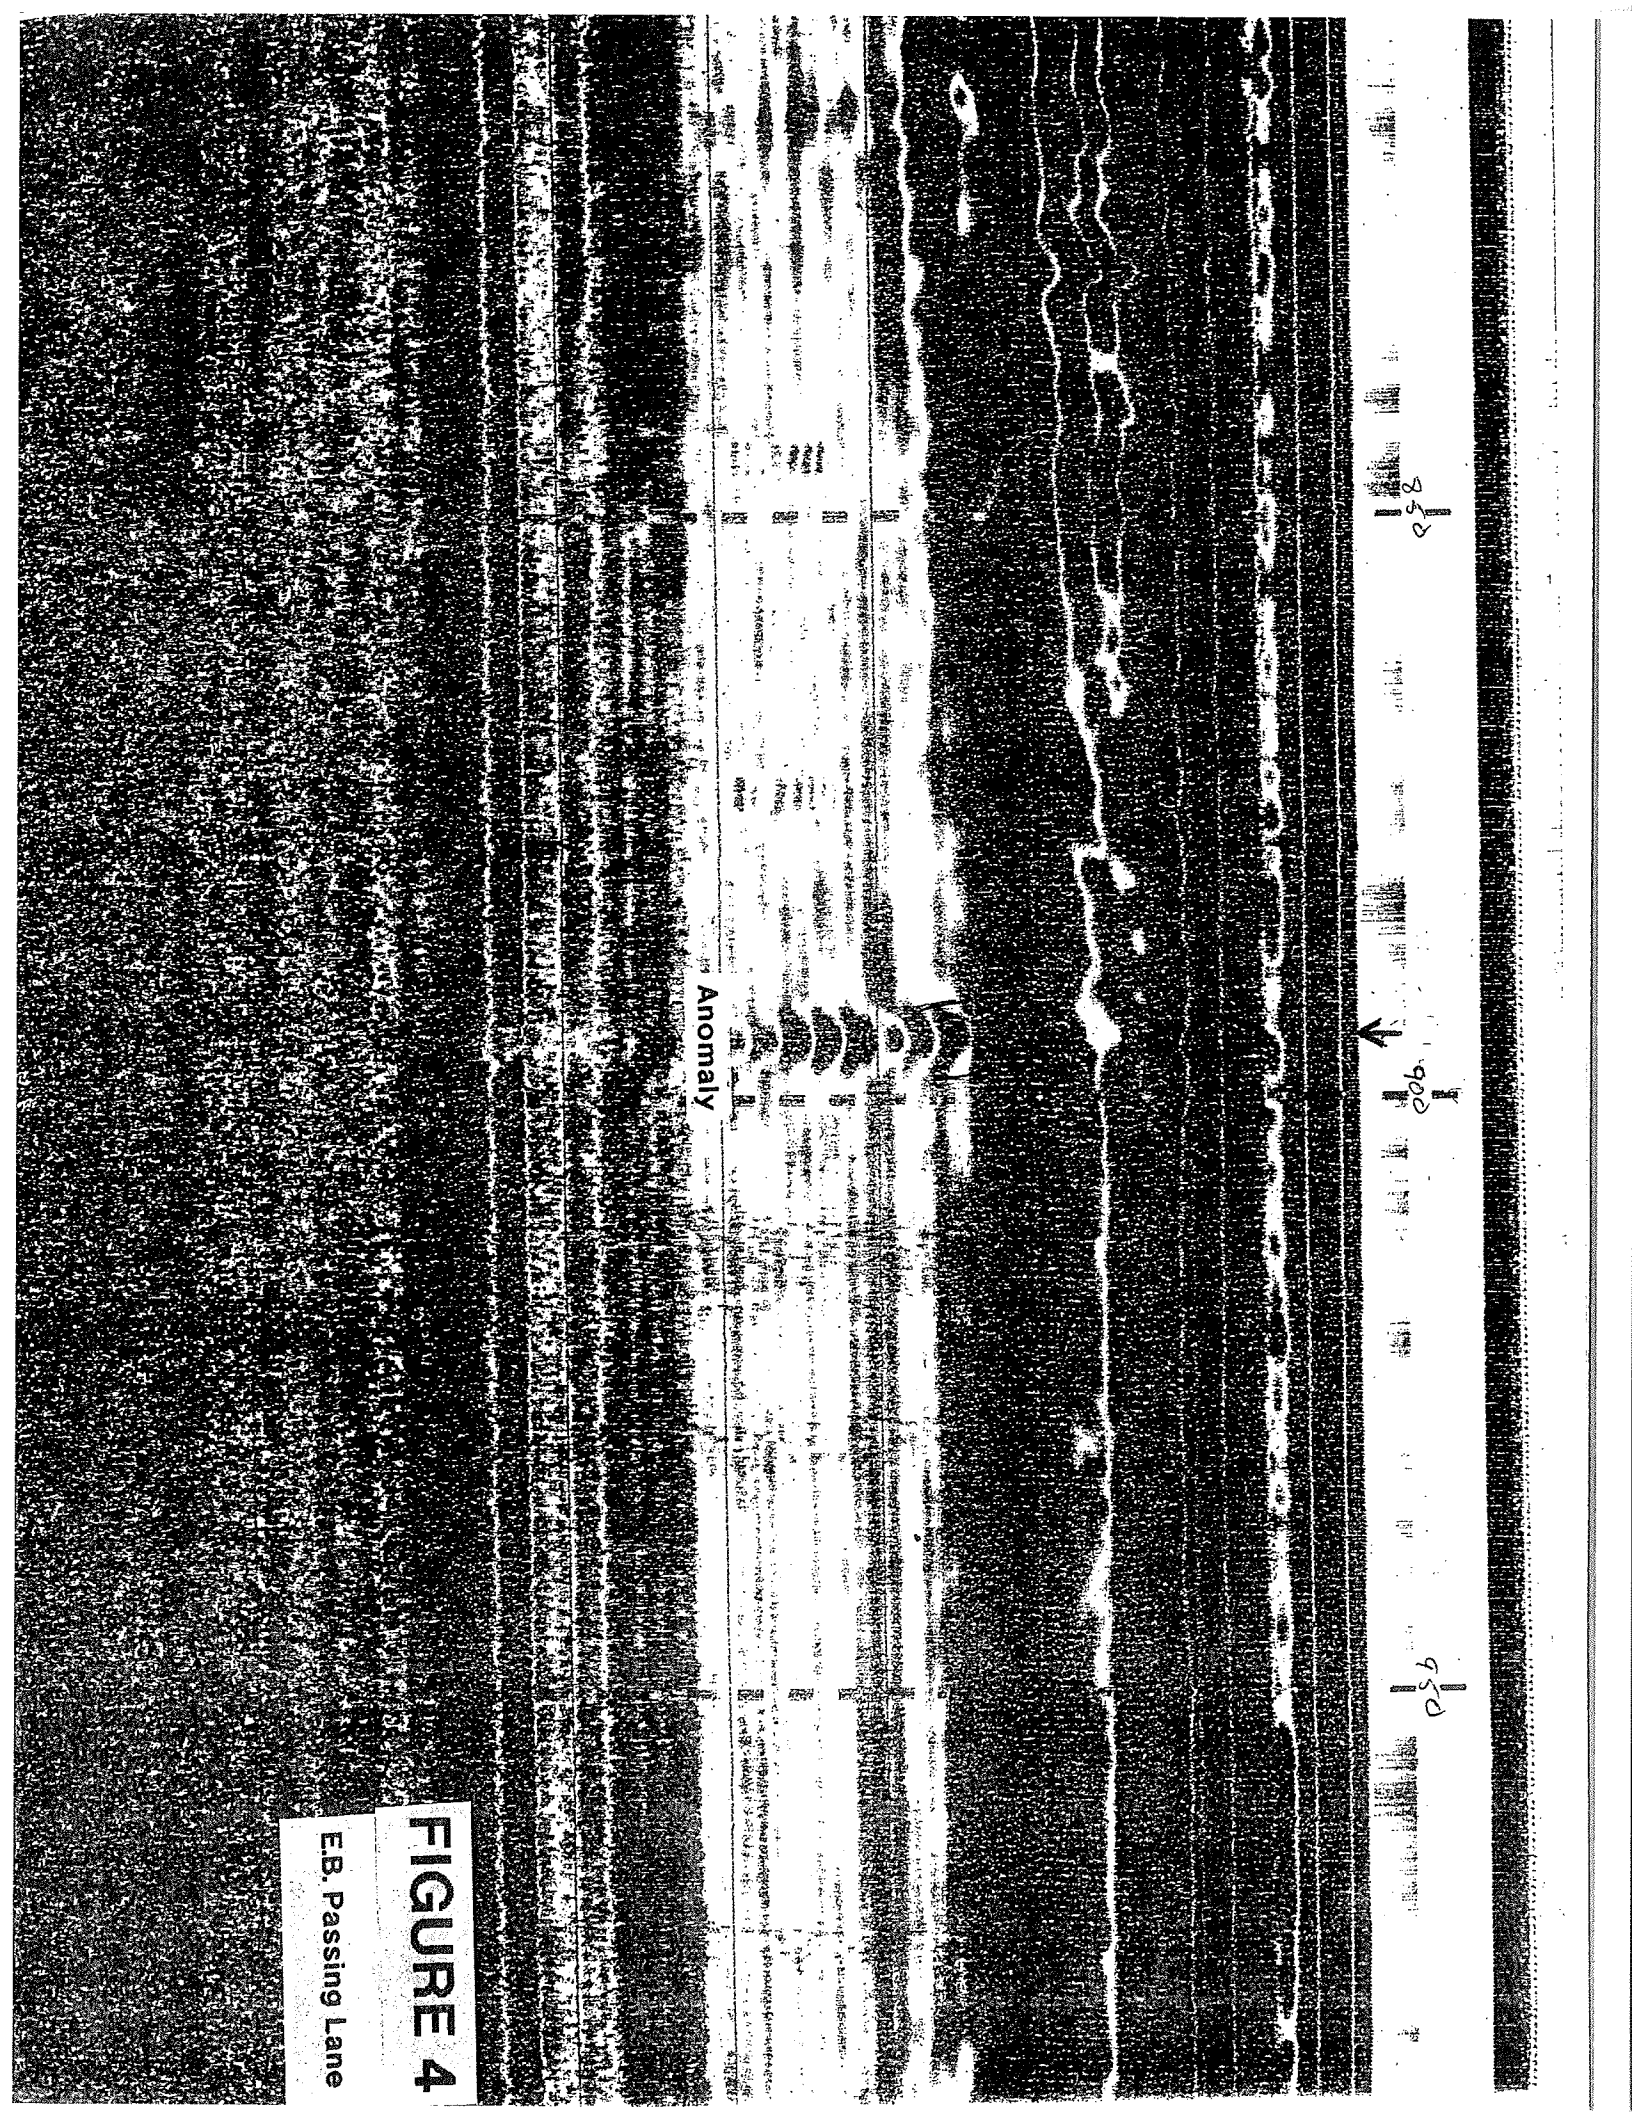
Numerous void-like anomalies were identified during the survey. At the time the survey was performed, the locations of two of the most apparent anomalies observed were painted on the pavement with green paint. These anomalies are located in the east bound travel and passing lanes at 297 and 895 feet, respectively (Figures 6 and 4).

Anomaly

**FIGURE 4**  
EB, Passing Lane

Figure 1 through Figure 9 represent sections of the GPR profiles containing anomalies of potential interest as indicated in Table 1. We believe that the anomalies identified in this report warrant verification by drilling.

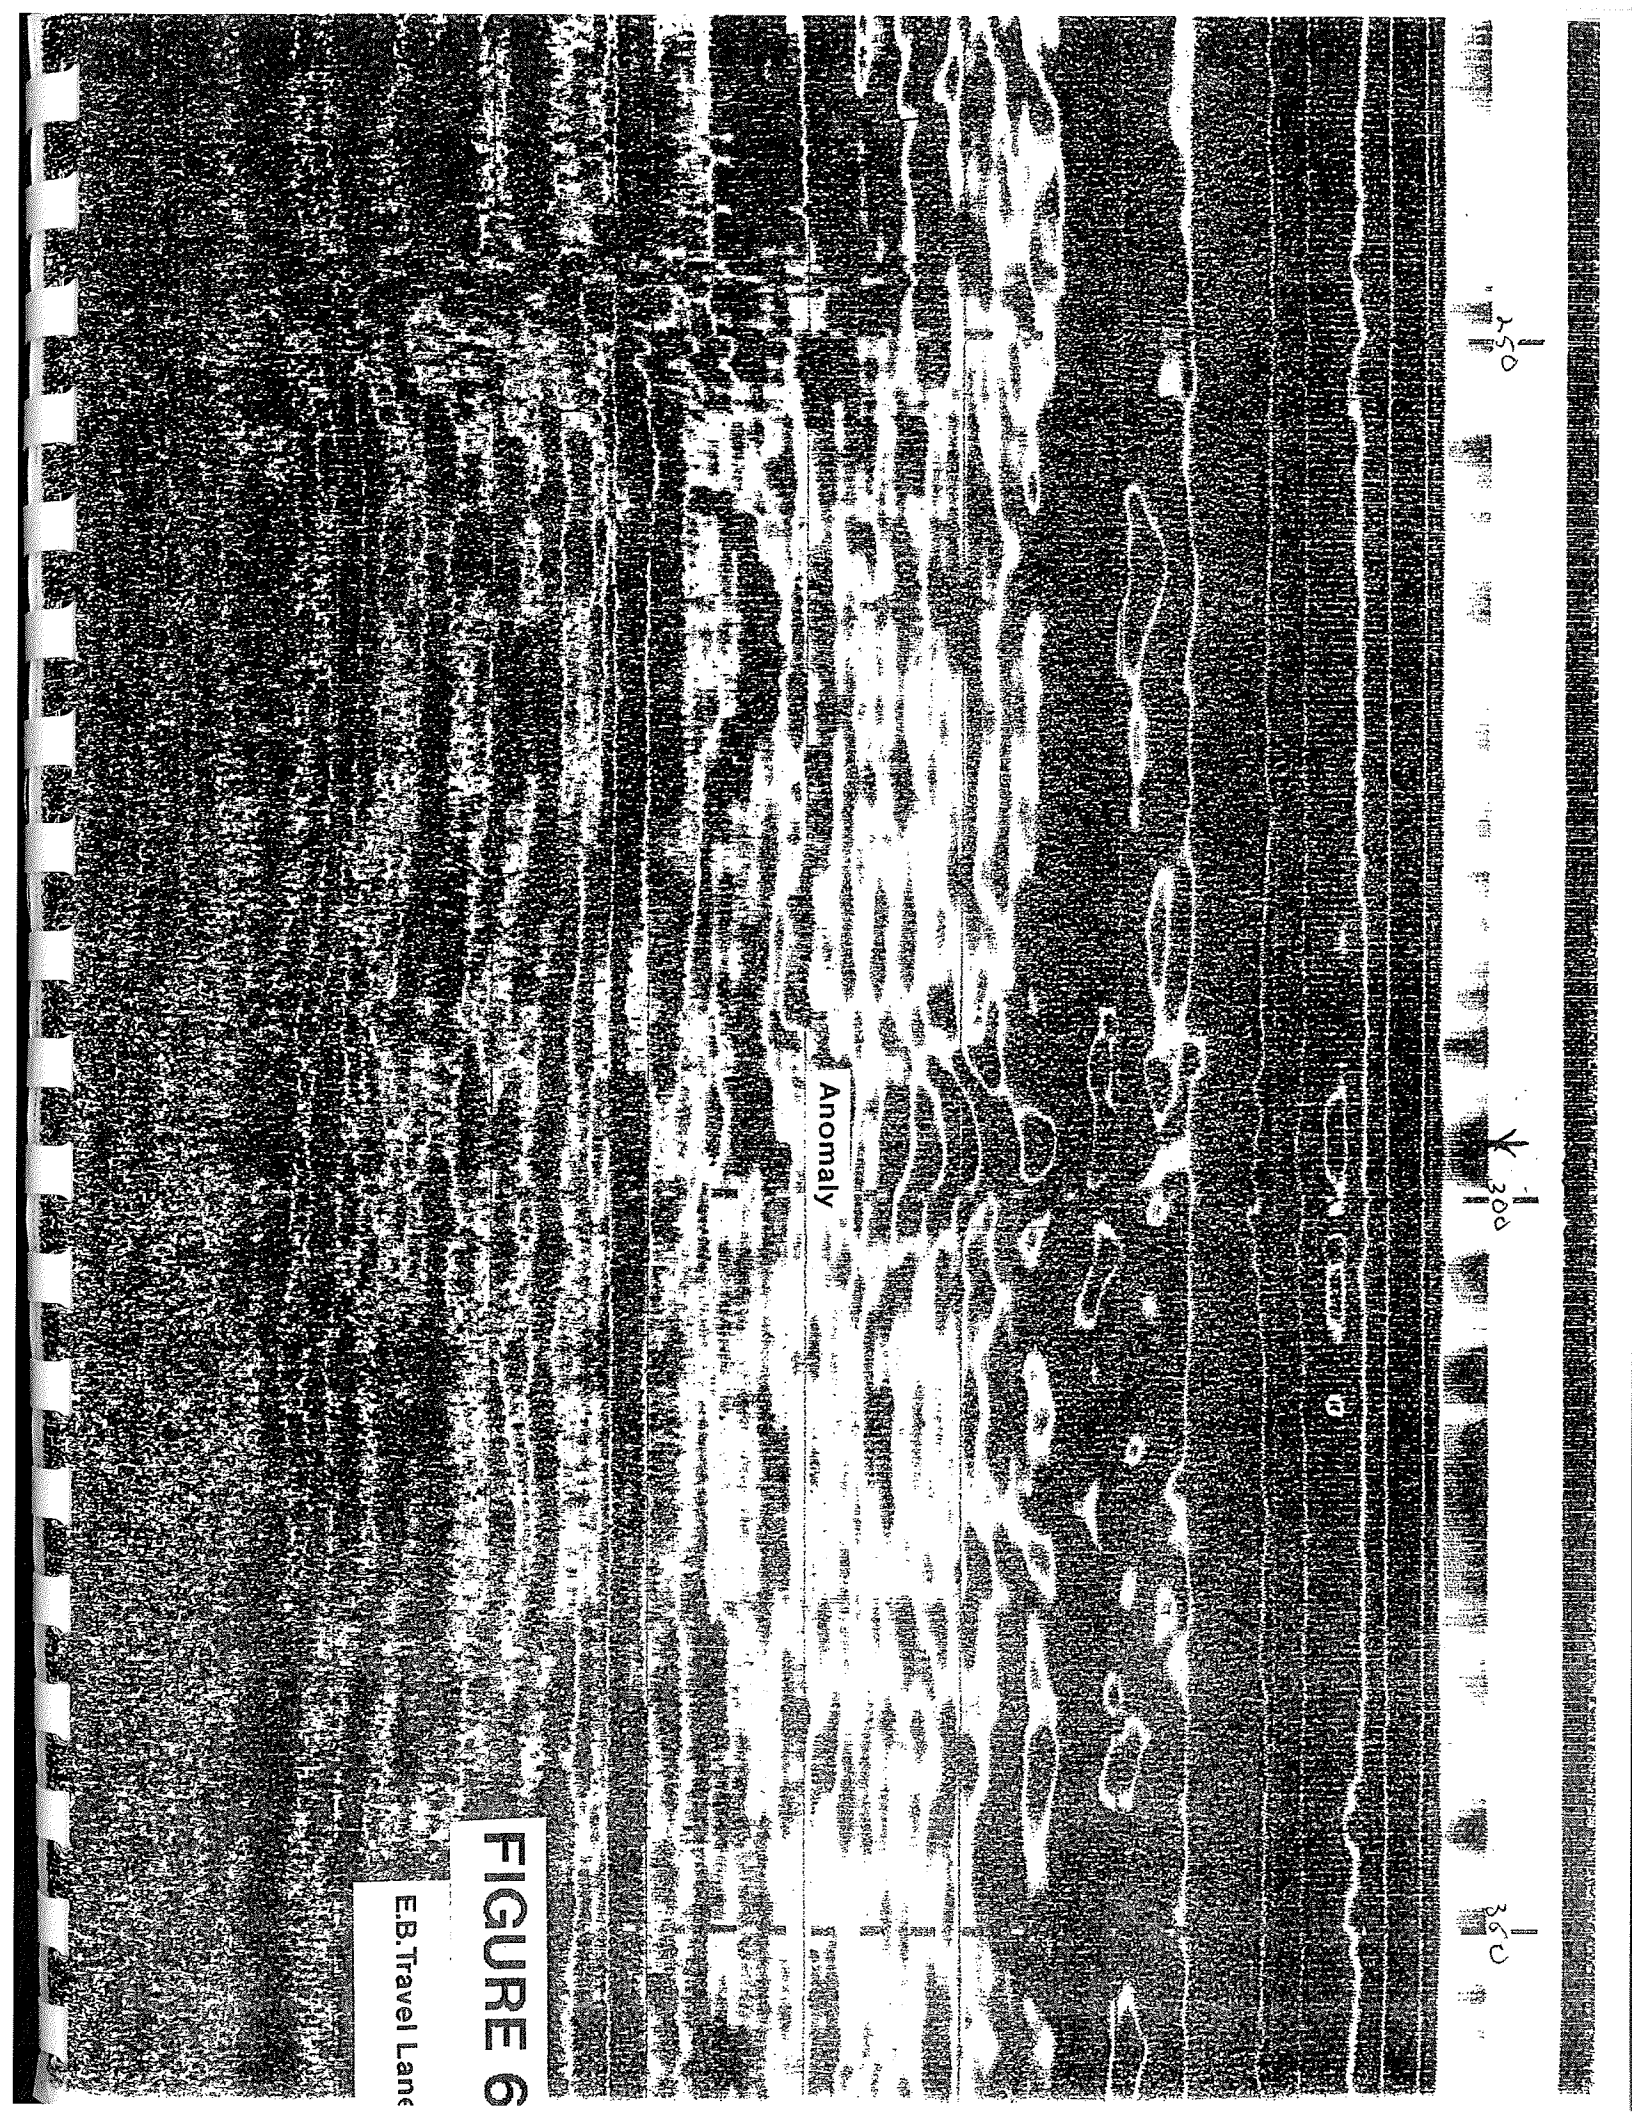
FIGURE 6

Anomaly

E.B. Travel Lane
