Twin Tunnels Environmental Assessment

Engineering Existing Conditions Summary

December 22, 2011

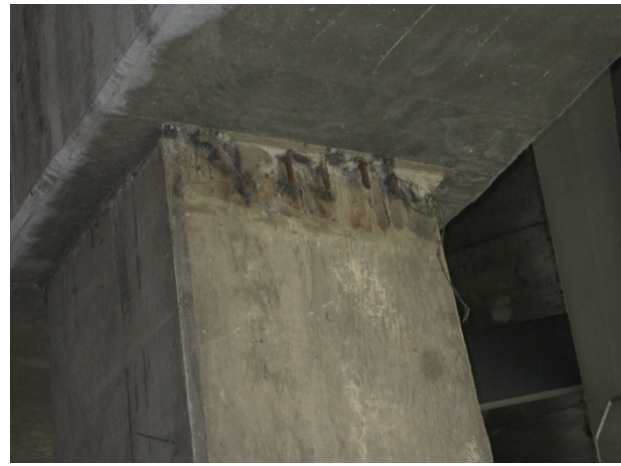
Vertical exposed reinforcement and efflorescence were seen near a pier cap/pier column junction, as shown in Figure 8.

Figure 8. Exposed rebar in pier cap

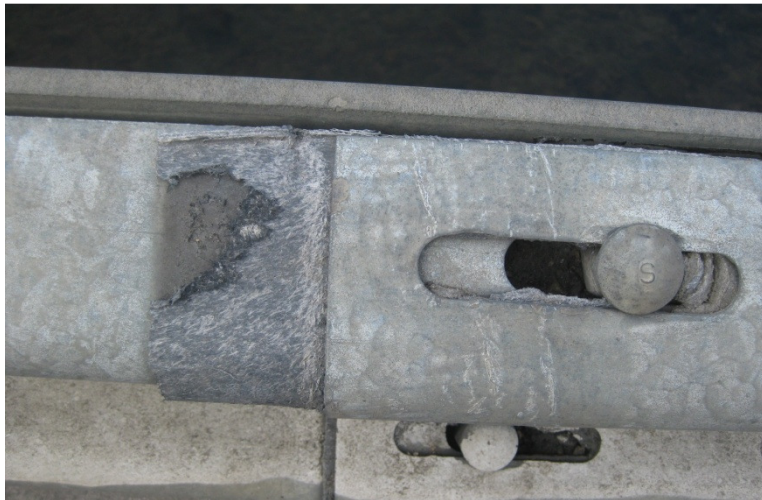
There is paper felt containing asbestos between beam elements at sliding guardrail joint connections, as shown in Figure 9; however, the paper felt is not in the fixed joint connections.

Figure 9. Bridge rail expansion joint

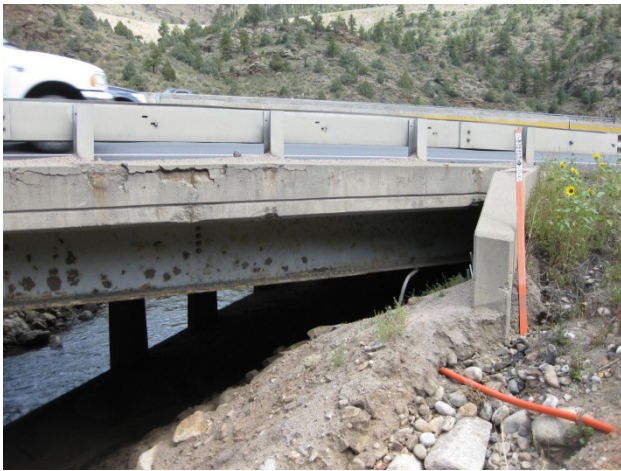
The exterior steel girder on the south side has rust in most places, requiring maintenance. Other galvanized girders are in good condition. The deck shows cracks in many places and concrete spalls with exposed reinforcement at some places. These conditions are shown in Figure 10 and Figure 11.

Figure 10. Cracks in deck near east abutment

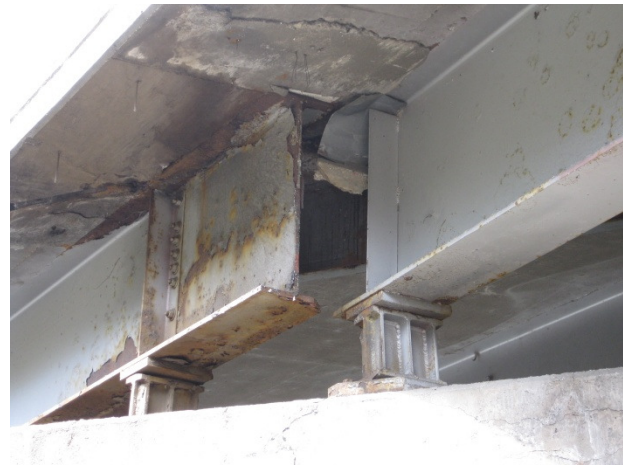
Figure 11. Rust in steel girders

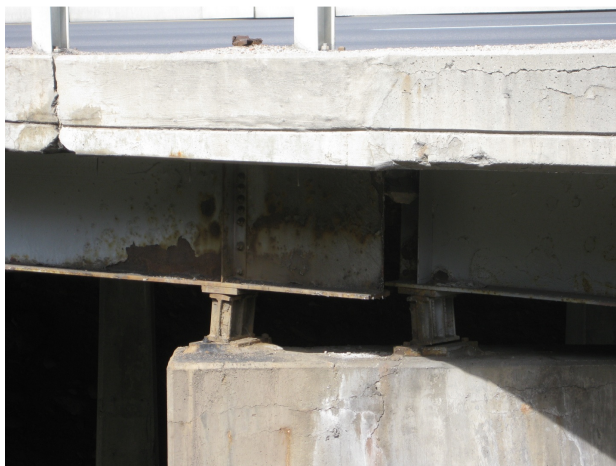
Rocker bearings are rusted and dirty and show significant rotation, as shown in Figure 12. The deck is drained by pipes installed at a 45-degree angle through an overhang, as shown in Figure 7. There is a corrugated metal pipe (CMP) drain pipe on the west abutment, as shown in Figure 13. There are steep slopes near both abutments. Overall, the bridge is in good condition.

Figure 12. Bearings in pier

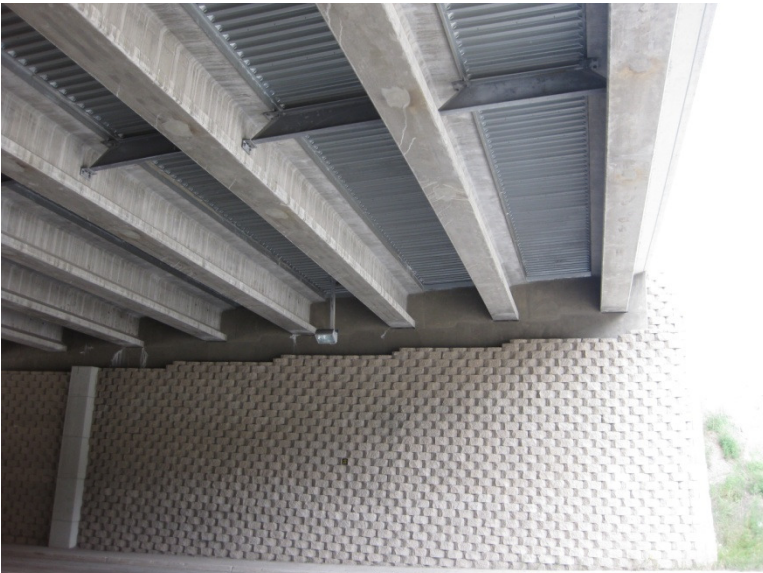
Slight efflorescence is near the bottom flange of girders, as shown in Figure 16. There is also some erosion in the southwest embankment due to a riprap rundown, as shown in Figure 17.

Figure 16. Some efflorescence in west abutment

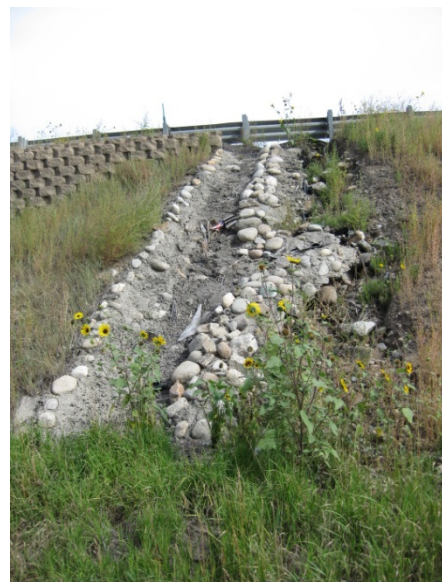
Figure 17. Southwest riprap rundown

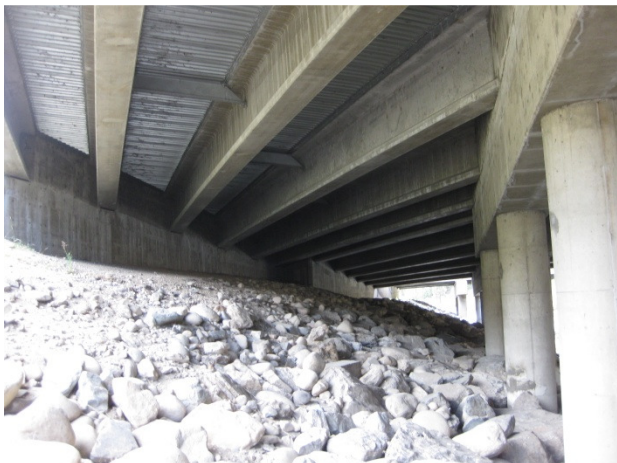
This bridge is in good condition and there is no reinforcement or concrete spalls exposure on this structure. The retaining wall is in good condition and was built with crack control and expansion joints. The stay-in-place forms and galvanized steel diaphragms are in good condition. There is some efflorescence below the pier caps, as shown in the Figure 24, as well as in the abutments, as shown in Figure 25.

Figure 24. Efflorescence in pier cap

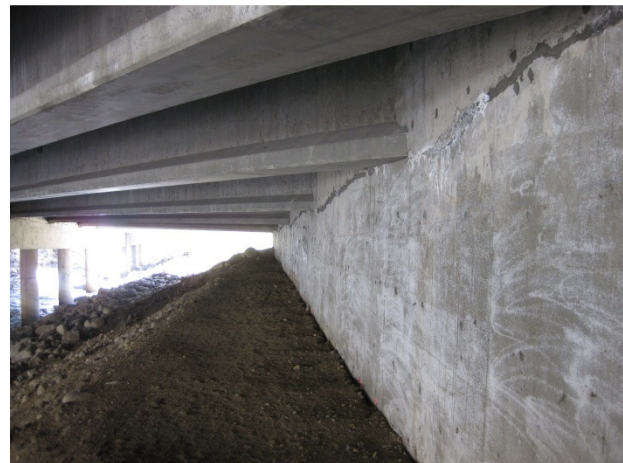
Figure 25. Efflorescence in abutment

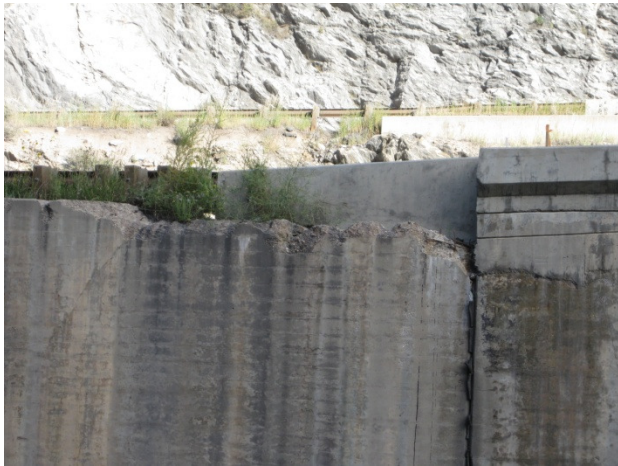
The wall between the north abutment and the adjacent pier shows deterioration on top of the wall. Reinforcement is exposed showing corrosion, as shown in Figure 26. The retaining wall has rotated approximately 1 inch at the top of the wall away from the abutment wall, as shown in Figure 27. Some efflorescence is at the bottom of the deck due to cracks, as shown in Figure 28. Leaking water caused concrete spalls and efflorescence around the expansion joint. Rebar is exposed and corroded, and horizontal cracks are seen below the bearing seat. Figure 29 shows an example of the corrosion around expansion joints.

Figure 26. Top of pier wall

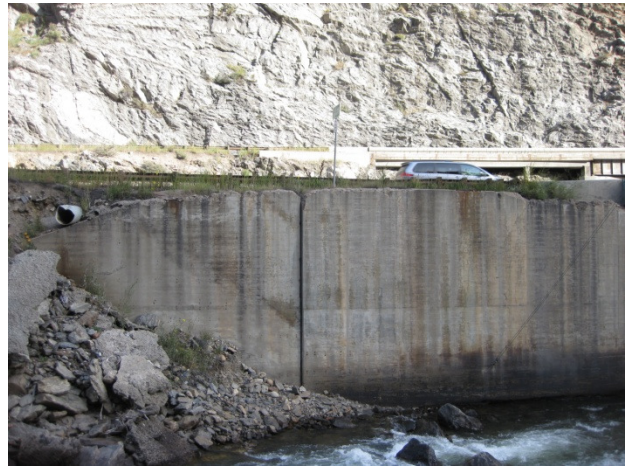
Figure 27. North abutment wing-wall

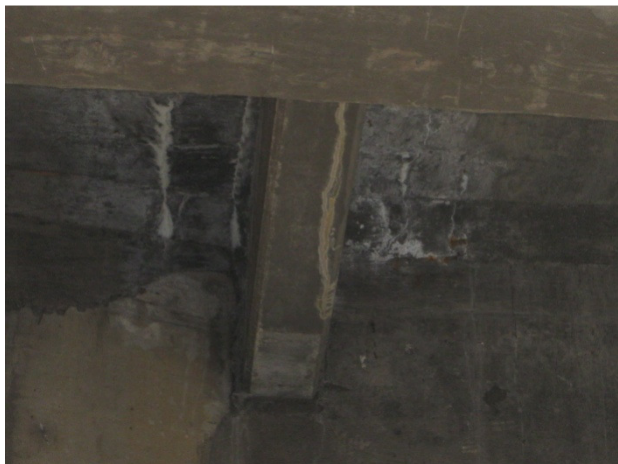
Figure 28. Efflorescence at deck bottom

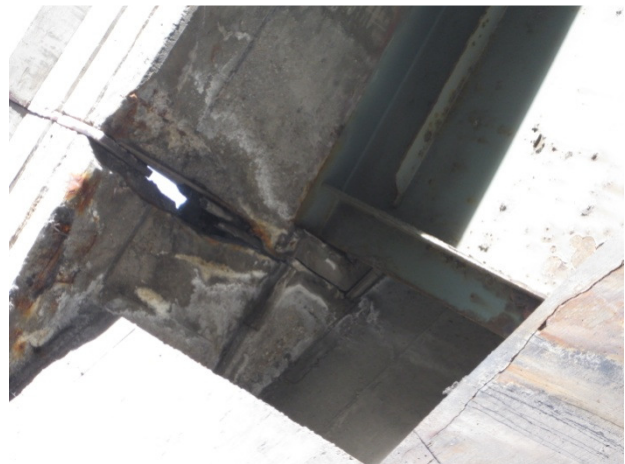
Figure 29. Corrosion around expansion joint

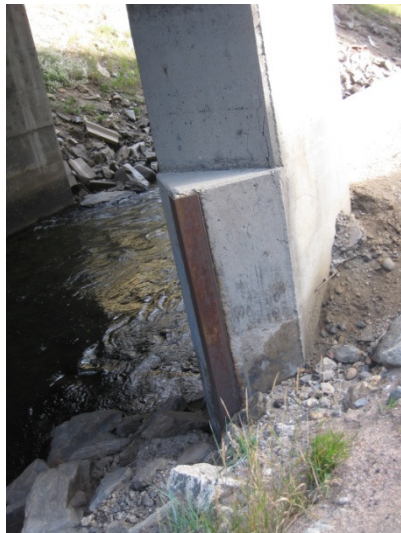
There are vertical cracks in the pier column, as shown in Figure 30. There are also spalls in concrete in the west end of the pier cap with rebar exposed. Rusting, minor cracks, and efflorescence are seen at the bottom of the pier cap, as shown in Figure 31.

Figure 30. Pier column

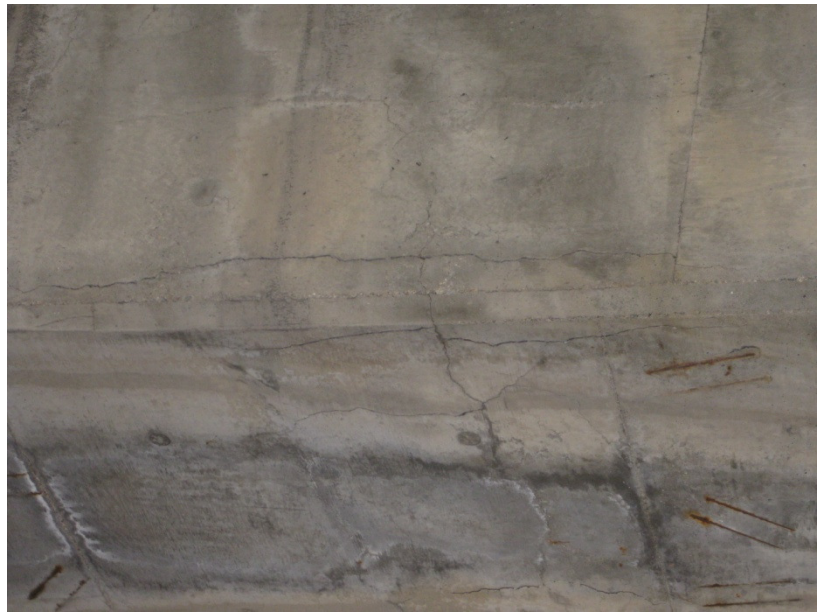
Figure 31. Bottom of pier cap

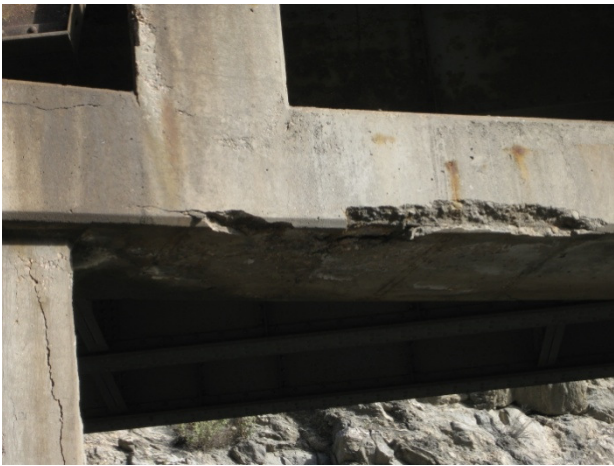
Slope paving, as shown in as-built plans, is not seen at the abutments. Piers show minor cracks and spalling of the concrete. Reinforcement is exposed and there is rust in many places, especially in the deck overhangs and pier caps, as shown in Figure 34 and Figure 35. Pier caps are strengthened and patched by fiber reinforced polymer. Efflorescence is in many places throughout the bottom of the bridge deck due to longitudinal cracks in the deck, as shown in Figure 36, and also in piers below expansion joints, as shown in Figure 37.

Figure 34. Cracks in pier cap and column

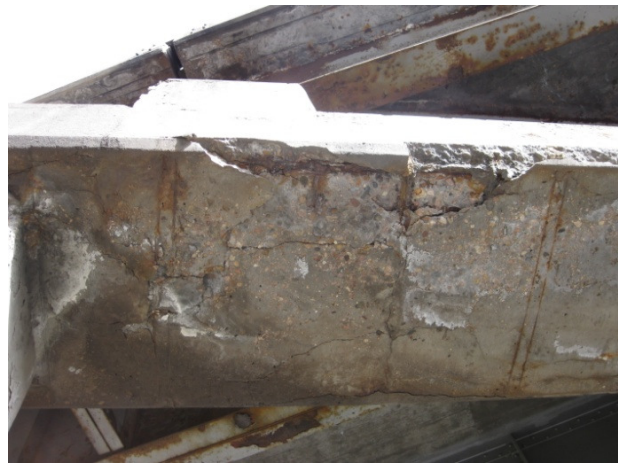
Figure 35. Exposed rebar below pier cap

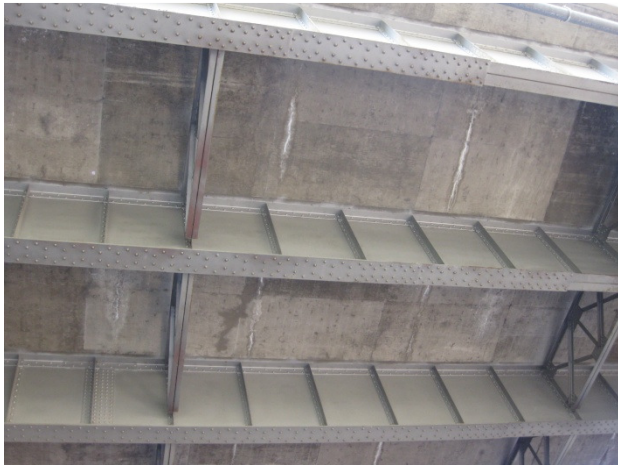
Figure 36. Bottom of bridge deck

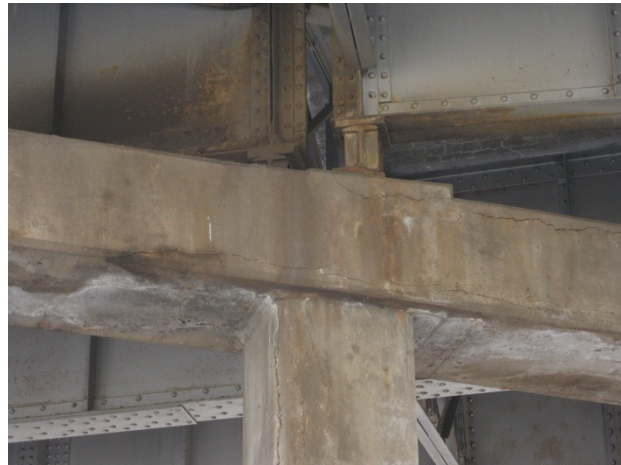
Figure 37. Pier below expansion device

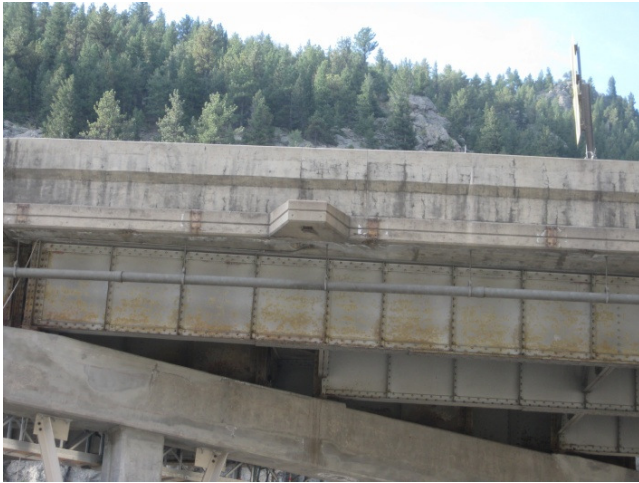
The original bridge rails and light posts are removed, and the bolts on the sides of the bridge deck show rust, as shown in Figure 38. The original bridge rail was replaced by CDOT with crash-tested concrete barrier. Steel plate girders and intermediate truss type diaphragms show rusting in many places. Abutment 1 has short wing walls and is surrounded by steep embankment with slopes closer to a 1:1 ratio. The bearings are dirty and show signs of corrosion, as shown in Figure 39. Large cracks are on the top portion of the abutment seat, as shown in Figure 40. Abutment 2 is a short seat abutment resting directly on hard bedrock.

Figure 38. North side bridge rail and deck

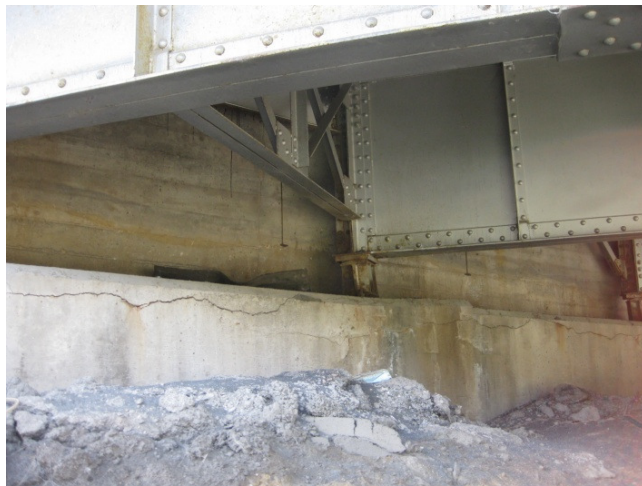
Figure 40. Cracks in south abutment

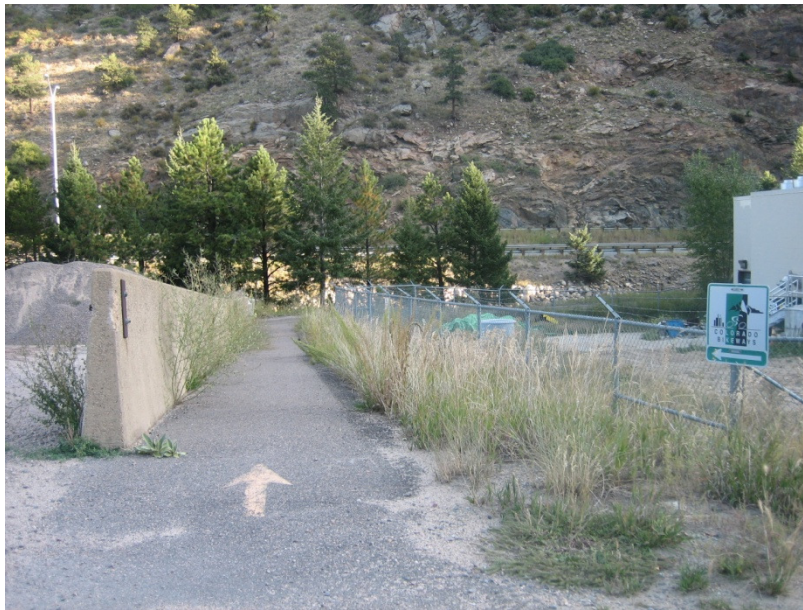
The bikeway appears to be in need of maintenance in several locations including areas of overgrown foliage and cracking pavement (see Figure 50 and Figure 51).

Figure 50. Bikeway overgrown foliage

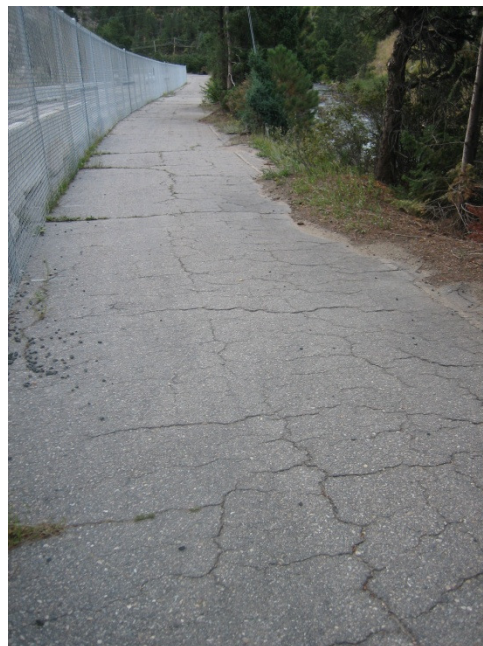
Figure 51. Bikeway cracked pavement
