SH 82 Grand Avenue Bridge Rehabilitation Feasibility Study

*The Colorado Bridge Enterprise
The Colorado Department of Transportation, Region 3*

AMEC Environment & Infrastructure, Inc.

August 2012

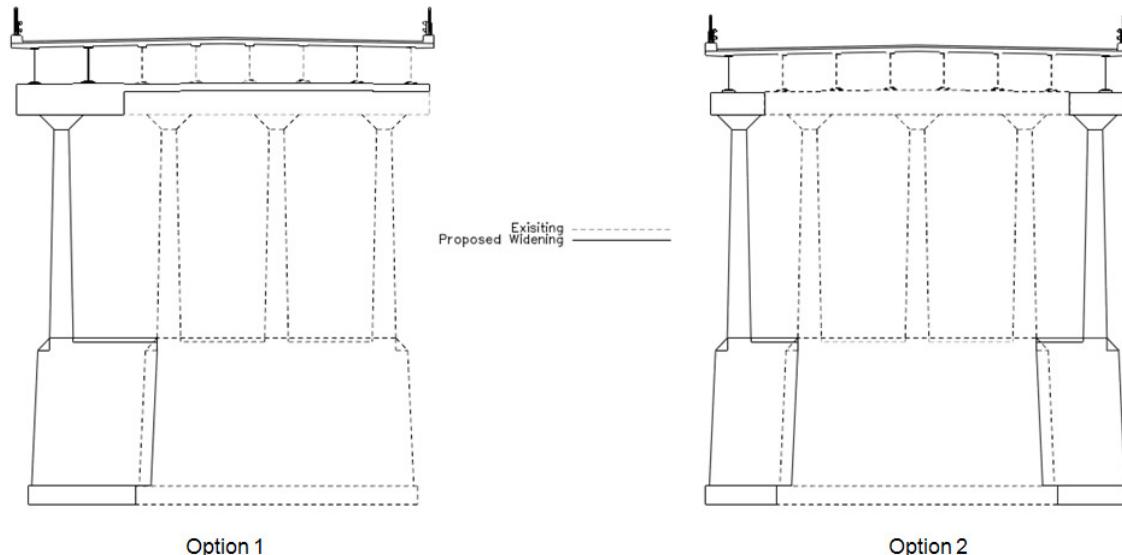
Figure 1: Widening Schematic

Rehabilitating the bridge will require that it be widened. Two options for widening the bridge are shown below in Figure 1. Both options require widening the piers, adding girders, and replacing the deck and bridge rails.

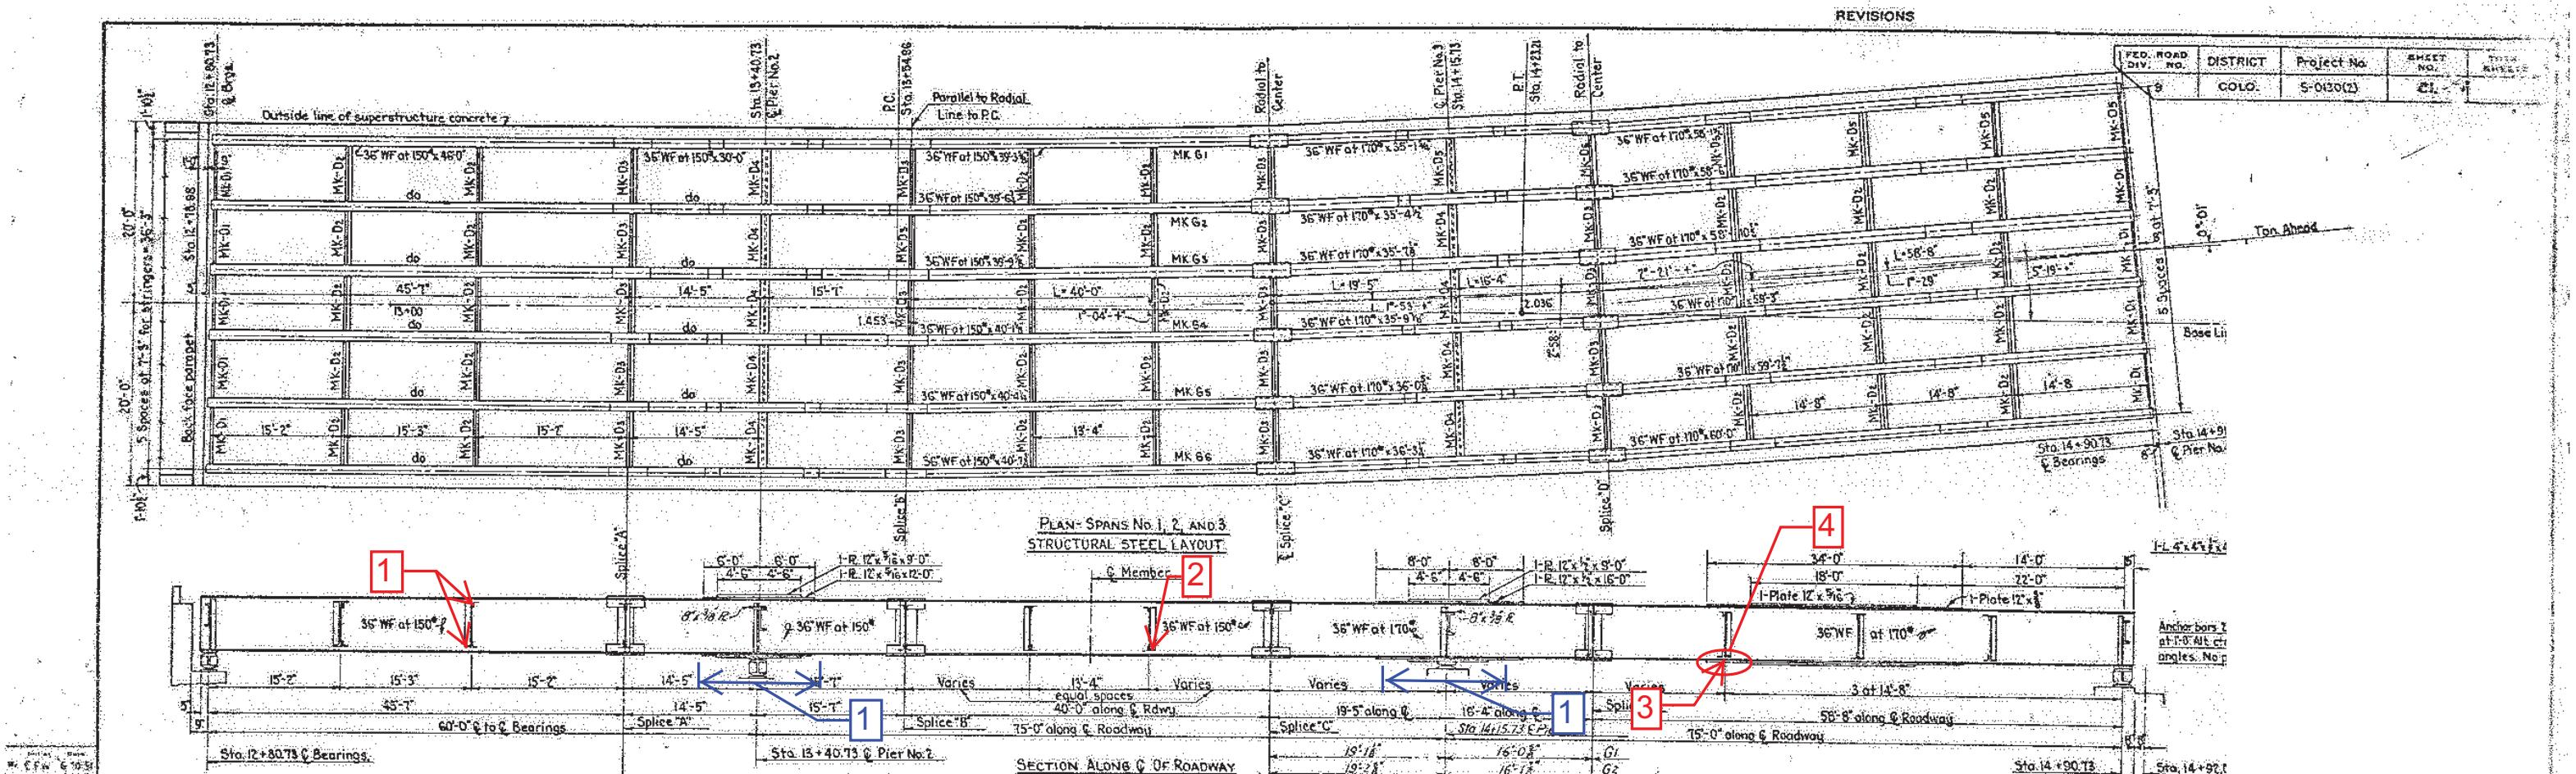
Finite Fatigue Locations Requiring Replacement/Rehabilitation

1. Base metal of net section at cross frame location was analyzed. Stress range was measured at the extreme rivet locations connecting cross frame to web.
2. Base metal of net section at cross frame location was analyzed. Stress range was measured at the extreme rivet locations connecting web to cross frame.
3. Base metal of net section at cross frame location was analyzed. Stress range was measured at the extreme fiber of flange cover plate.
4. Base metal of net section of flange cover plate region was analyzed. Stress range was measured at the extreme fiber of flange cover plate(s).

1. Sections over piers are controlled by Lateral-Torsional Buckling of the bottom flange under a rehabilitated, composite superstructure. One of the following will be required:
 - a. Supplementing existing bottom flange cover plates with additional cover plates
 - b. Replacing existing bottom flange cover plates with adequate cover plates
 - c. Decrease the bracing length by additional cross-frames or bottom flange bracing

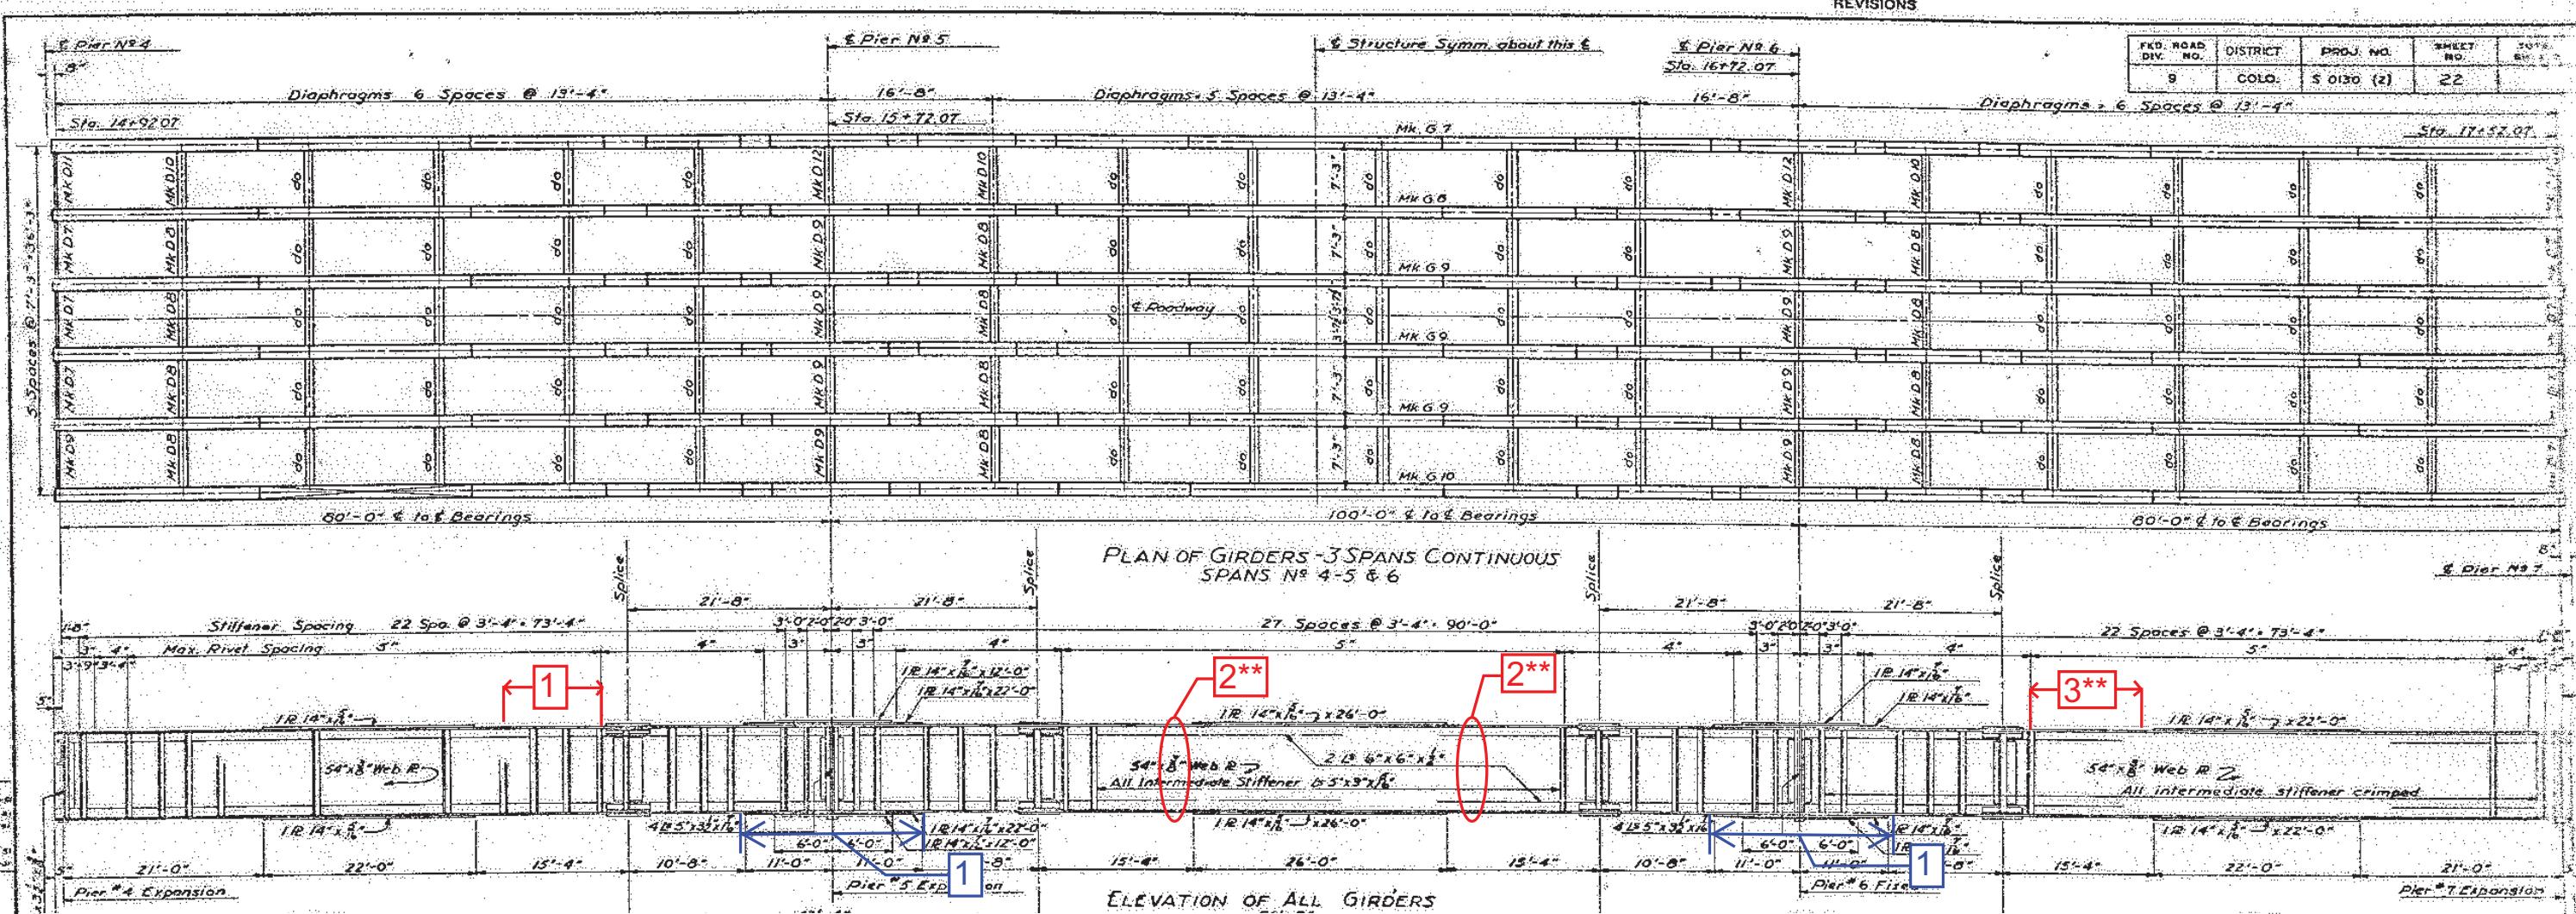
Finite Fatigue Locations Requiring Replacement/Rehabilitation

1. Base metal of net section was analyzed. Stress range was measured at the extreme rivet locations connecting web to flange angles. There is approximately 13 feet of girder within this zone where the base metal fatigue life will not extend to 2015.
2. Base metal, of net section at transverse stiffener locations, was analyzed. Stress range was measured at the extreme rivet locations connecting web to flange angles. There is one transverse stiffener at each location where the base metal of the girder will require replacement/rehabilitation.
3. Base metal of net section was analyzed. Stress range was measured at the extreme rivet locations connecting web to flange angles. There is approximately 13 feet of girder within this zone where the base metal fatigue life will not extend to 2015.

1. Sections over piers are controlled by Lateral-Torsional Buckling of the bottom flange under a rehabilitated, composite superstructure. One of the following will be required:
 - a. Supplementing existing bottom flange cover plates with additional cover plates
 - b. Replacing existing bottom flange cover plates with adequate cover plates
 - c. Decrease the bracing length by additional cross-frames or bottom flange bracing

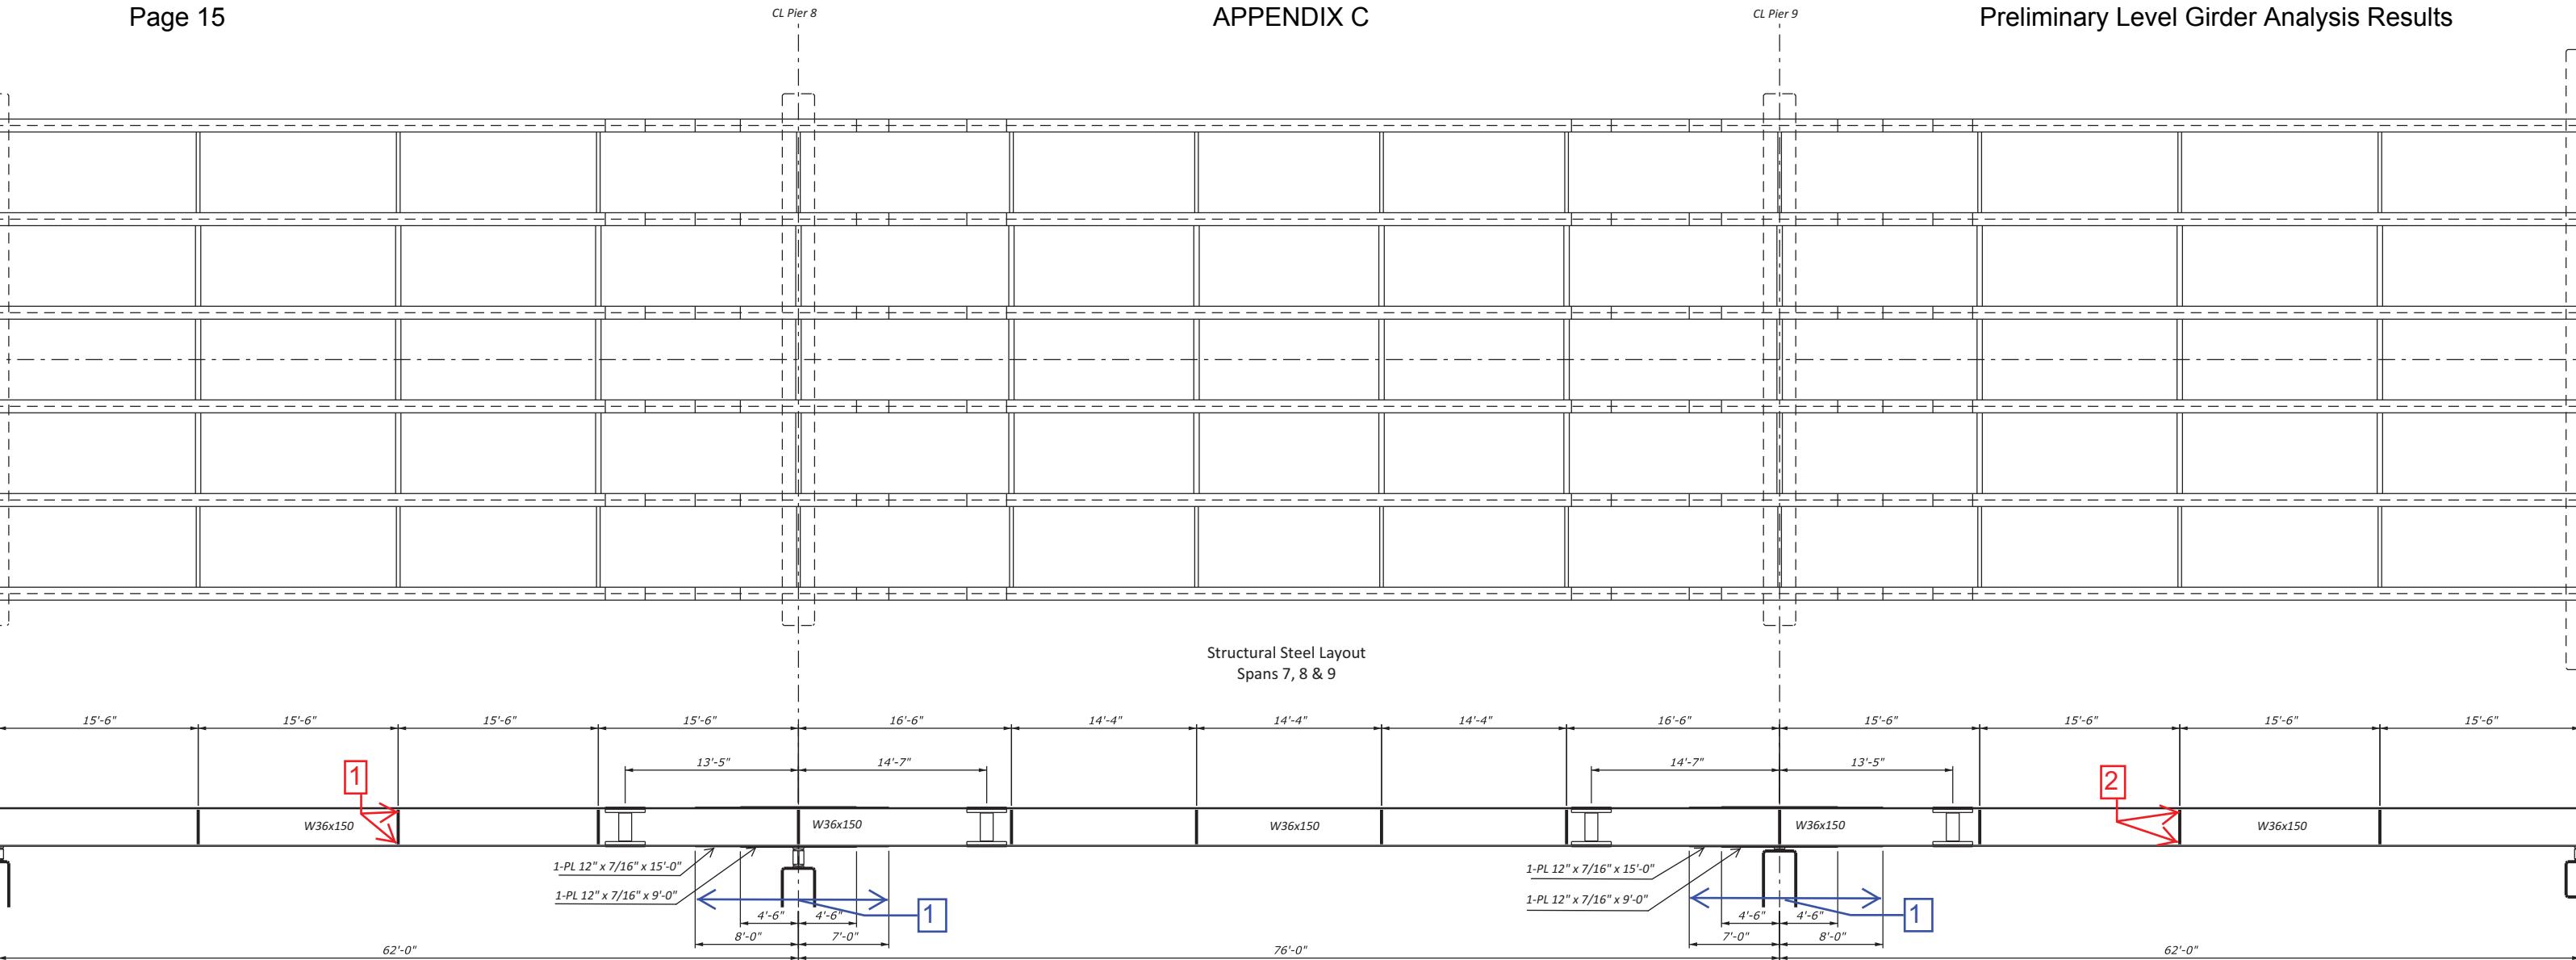
Finite Fatigue Locations Requiring Replacement/Rehabilitation

1. Base metal of net section at cross frame location was analyzed. Stress range was measured at the extreme rivet locations connecting web to cross frame.
2. Base metal of net section at cross frame location was analyzed. Stress range was measured at the extreme rivet locations connecting web to cross frame.

1. Sections over piers are controlled by Lateral-Torsional Buckling of the bottom flange under a rehabilitated, composite superstructure.
One of the following will be required:
 - a. Supplementing existing bottom flange cover plates with additional cover plates
 - b. Replacing existing bottom flange cover plates with adequate cover plates
 - c. Decrease the bracing length by additional cross-frames or bottom flange bracing
