**SH 83 Safety and Operations Analysis:
Bayou Gulch to El Paso County Line
MP 30.20 – MP 53.88
Project Code 23008**

Appendix A - Safety Assessment Report

March 2022

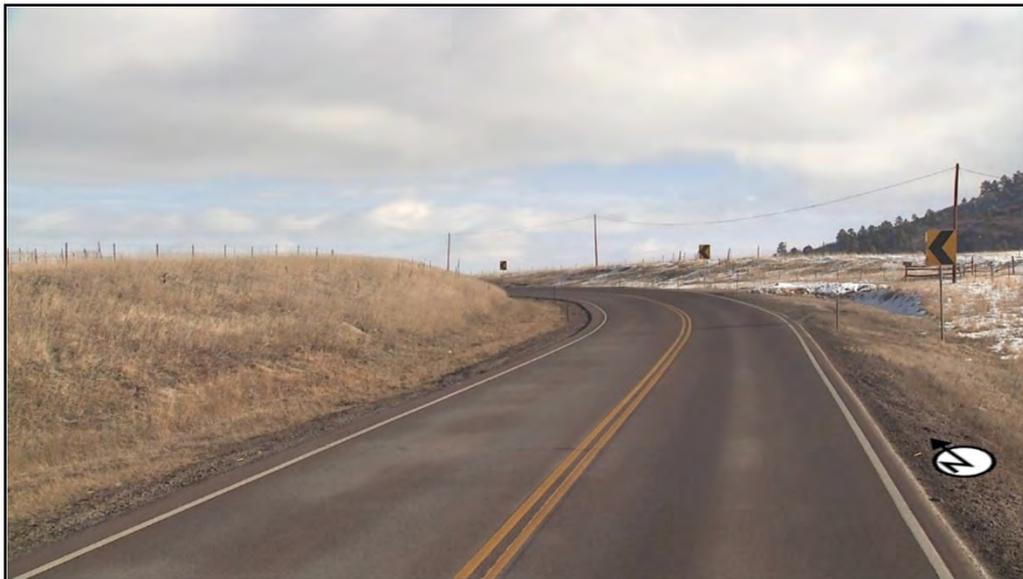
Figure A7: Northbound SH 83A at MP 32.25

There is a slight downhill grade in the northbound direction (about 2%) and the roadway is generally marked as a no-passing zone. Most occurred during daylight conditions (7 of 8) with no adverse weather or roadway conditions (7 of 8). Alcohol was involved in two of the crashes. There are advance curve warning signs with speed advisory plaques in both directions and curve chevrons in both directions. The shoulders are stabilized with approximately 1-ft of paved material as shown in **Figure A7**; there is a bit of a drop-off between the edge of pavement and stabilized material and the safety edge may be worn down in places.

Recommendation

Shoulder widening through the reverse curves would allow vehicles more opportunity to recover when running off of the right-side of the road and help reduce the frequency of run-off-road collisions. In addition, wider shoulders would allow for outside shoulder rumble strips which would further help improve safety through this area.

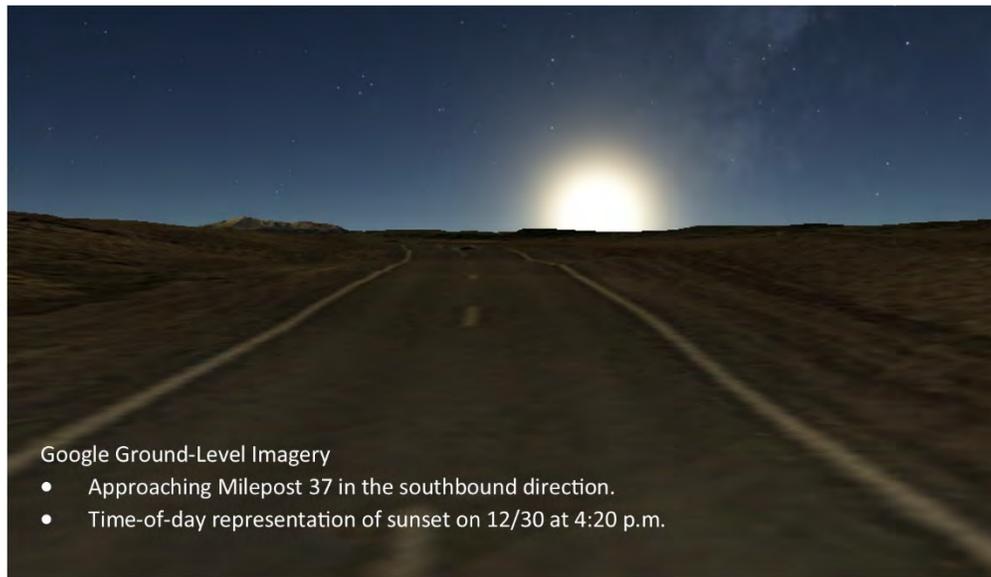
Figure A10: Ground Level Representation – Late December Sunset

One *sideswipe (opposite direction)* fatal crash occurred in December 2018 at MP 37.04. A southbound vehicle travelled off of the right-side of the road, overcorrected then lost control, crossing into the northbound lane and colliding with a northbound vehicle. A review of the crash data suggests that the crash occurred just after a slight left-hand curve in the southbound direction, on a short tangent before a second left-hand curve. Lighting was listed as “dawn or dusk” in the report and it is possible that sun-glare was a contributing factor given the date, time and direction as illustrated in **Figure A10**. The driver of the southbound vehicle was not wearing a seat-belt at the time of the collision and died after being transported to the hospital.

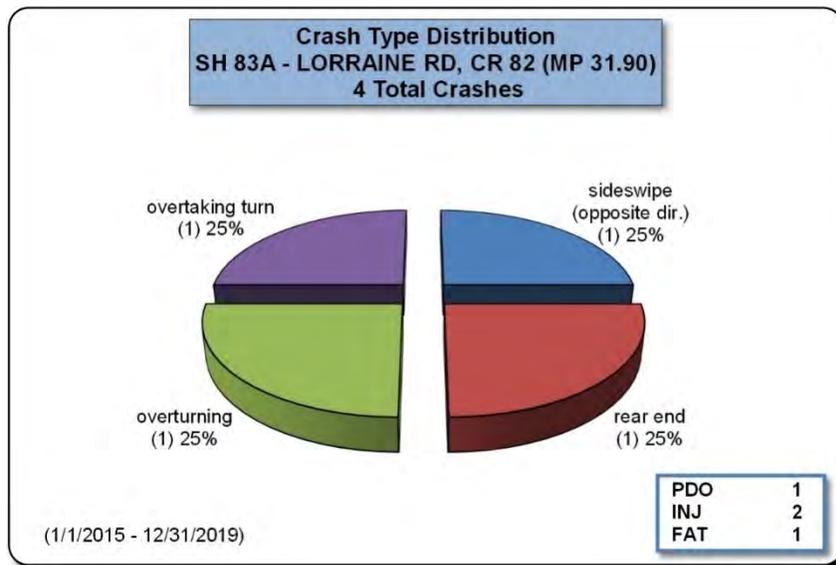
Figure A20: Lorraine Road Crash Type Distribution

There were four (4) crashes at this 2-lane undivided unsignalized 4-leg intersection, including one (1) fatal crash. The SPF analysis indicated LOSS IV for severe crashes and LOSS III for total crashes. The crash type distribution is shown in **Figure A20**.

A review of the crash data indicated that all four crashes involved northbound vehicles turning at the Lorraine Road intersection, including the fatal crash. Due to the consistency of the underlying cause of the crashes and worsening pattern at this location, consider adding left-turn lanes to allow for safer deceleration and storage for vehicles turning left at this intersection. While none of the crashes involved right-turns at this time, consider collecting traffic counts to determine if the volumes meet access code requirements for right-turn lanes and widening the shoulders in the vicinity of the intersection if the volumes are not sufficient.

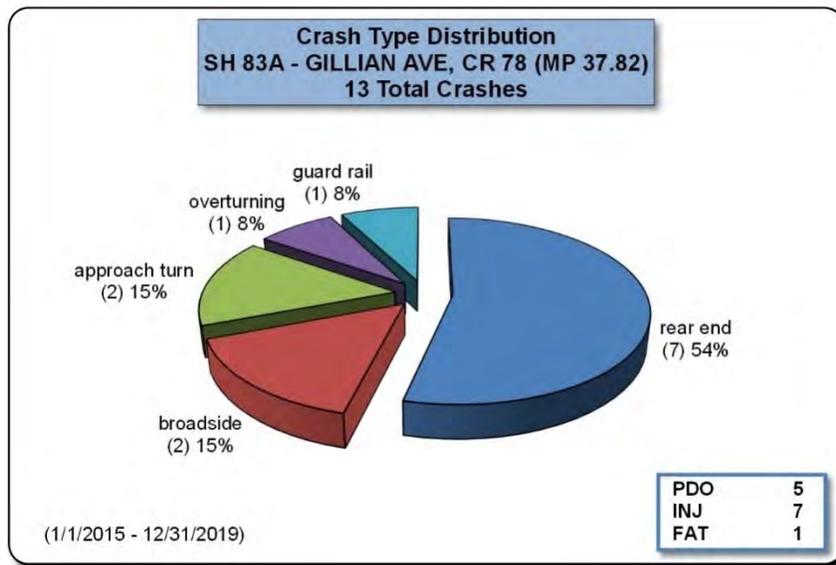
Figure A21: Gillian Avenue Crash Type Distribution

There was a fatal *broadside* type crash that occurred in May 2019. A westbound vehicle on Gillian Avenue failed to stop at the stop sign and skidded into the intersection where it was struck by a northbound vehicle at an approximate speed of 65-mph. All parties were wearing seatbelts at the time of the crash, but a passenger in the rear of the northbound vehicle died after being transported to the hospital.

A review of the crash data indicated that most of the crashes at this intersection were caused by southbound vehicles including all seven *rear end* crashes, both *approach turn* crashes, and the *overturning* type crash. Slowed or stopped traffic due to vehicles turning left onto Gillian Avenue was a significant contributing factor. Adding a southbound left-turn lane would provide space to allow for deceleration and storage for turning vehicles. This will allow vehicles to complete their turns in a safer manner and should help reduce the frequency of *rear end* crashes and reduce the likelihood of *approach turn* type crashes as drivers can focus on gaps in oncoming traffic with less risk of being struck from behind while waiting.

Also consider reviewing the traffic volumes to determine if a left-turn acceleration lane is warranted as per the access code for this type of facility. This would help improve the safety and operation for westbound vehicles turning left from Gillian Avenue though only one of the *broadside* type crashes occurred due to a vehicle failing to yield the right-of-way. Stop sign enhancements, such as flashing LED borders, should also be considered as the fatal *broadside* type crash occurred when a vehicle failed to stop for the stop-sign.
