November 7, 2022

Project No. 222-059

**Subject: Memorandum for Geotechnical Engineering Services
Cottonwood Pass Concept Design
Garfield and Eagle Counties, Colorado**

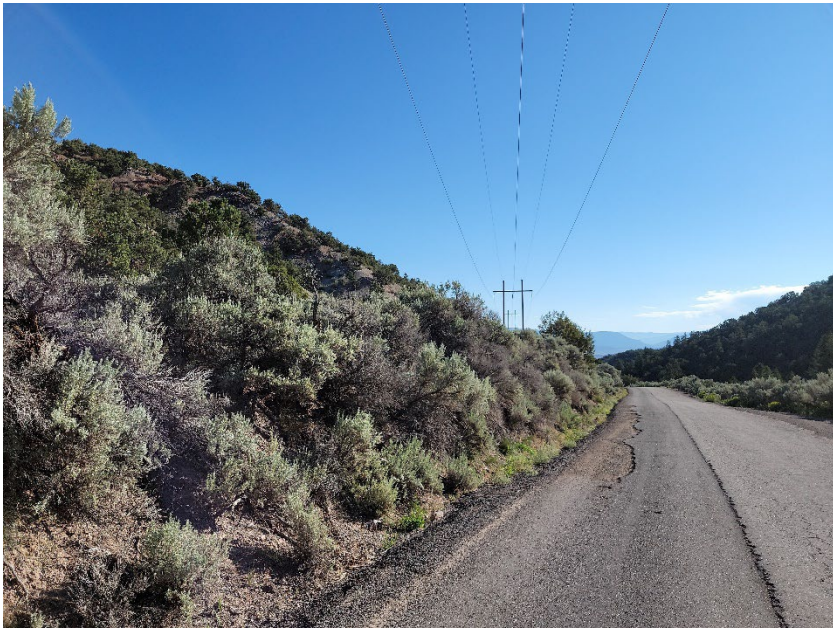
Photo 1. Existing hillside covered in vegetations

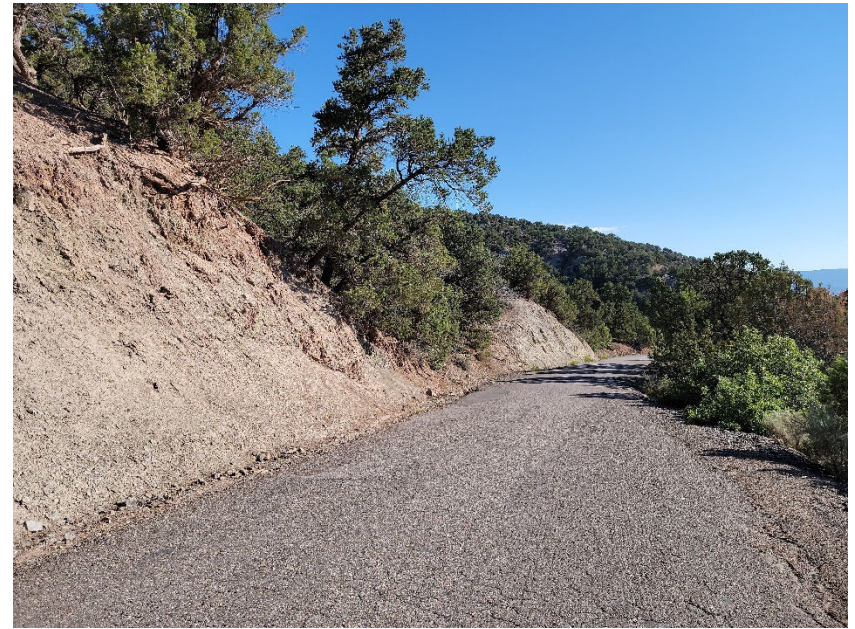
Photo 2. Steep slopes with weakly cemented surficial soils

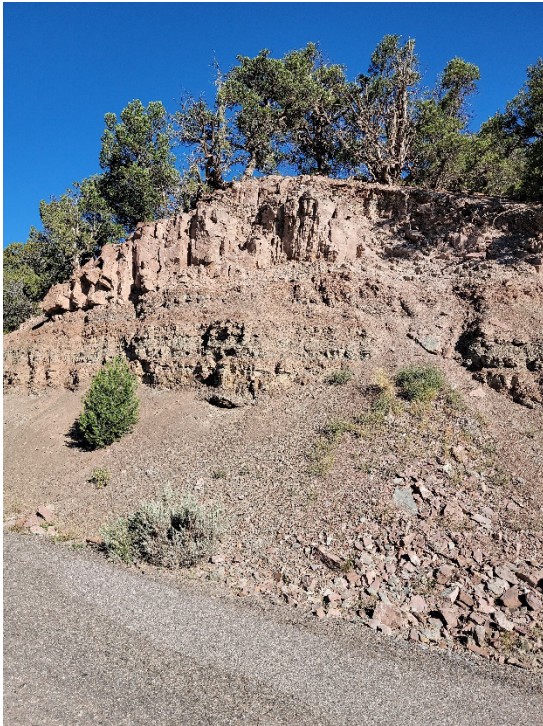
Photo 3. Rock outcrop

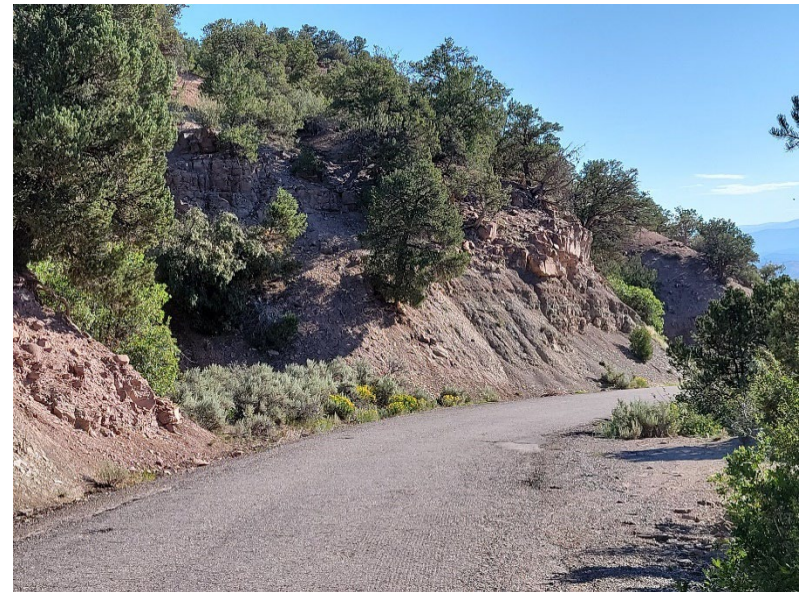
Photo 4. Rock outcrop and weakly cemented surficial soils

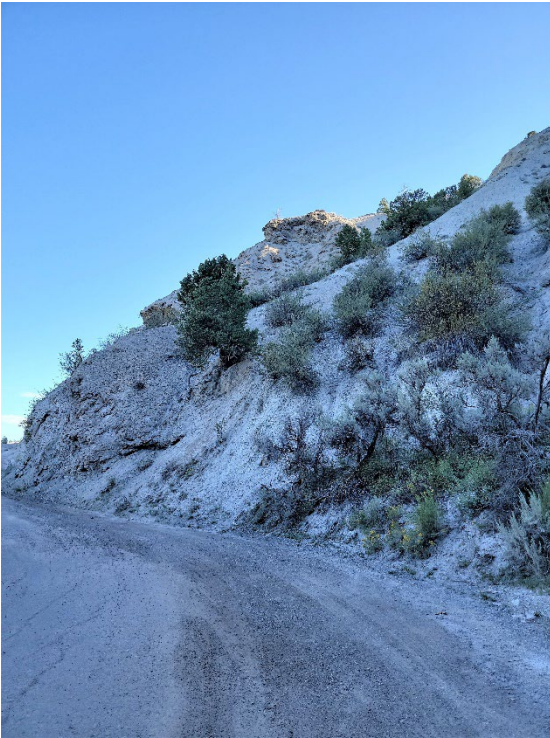
Photo 5. Steep slope with weakly cemented surficial soils

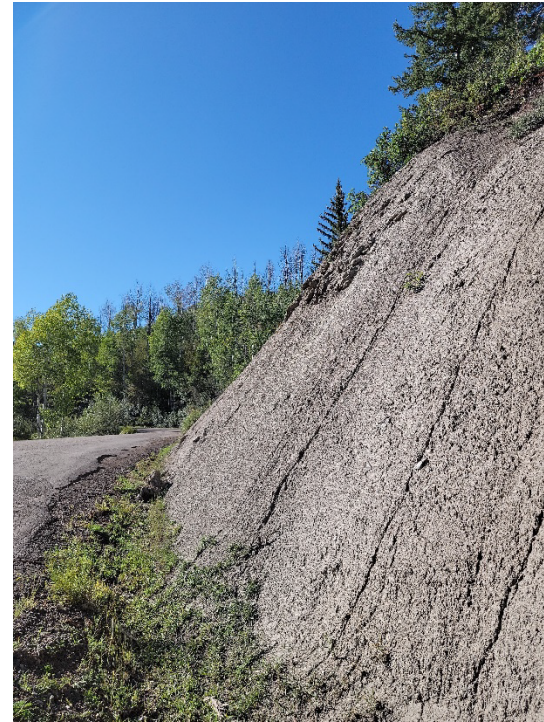
Photo 6. Closer look at steep slope surficial conditions. Note the erosion from surface runoff.

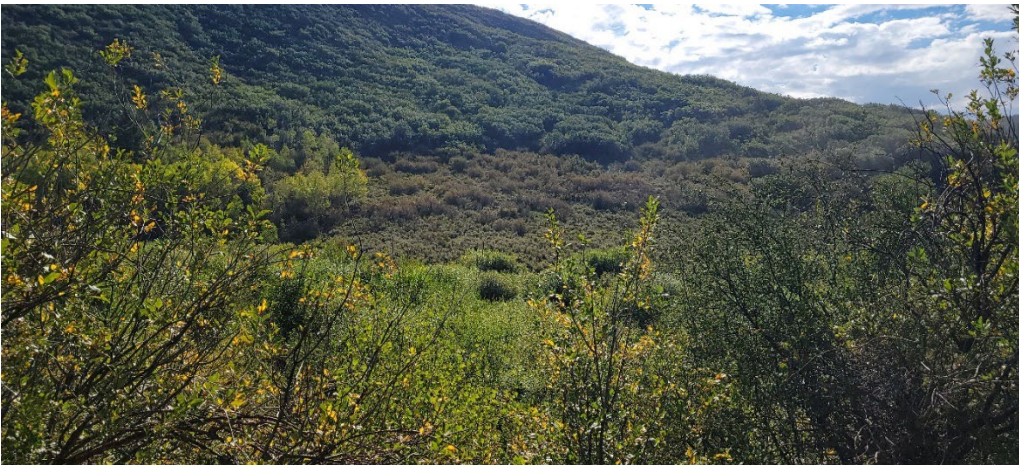
Photo 7. Landslide deposit covered with vegetation

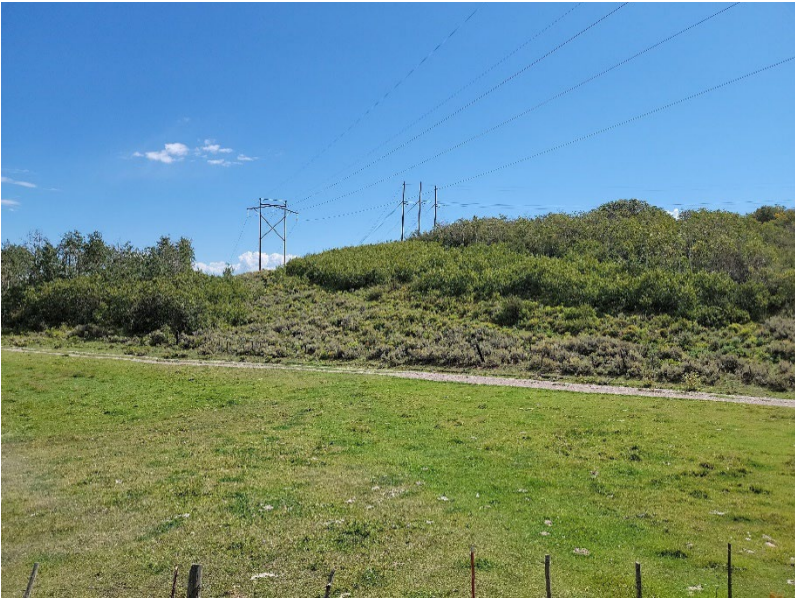
Photo 8. Toe of the landslide mass

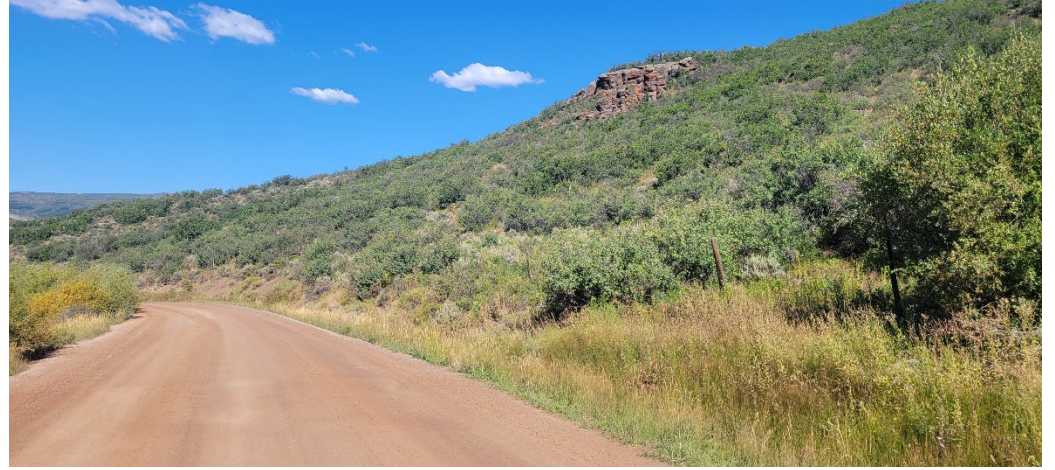
Photo 9. Rock outcrop at the top of the slope

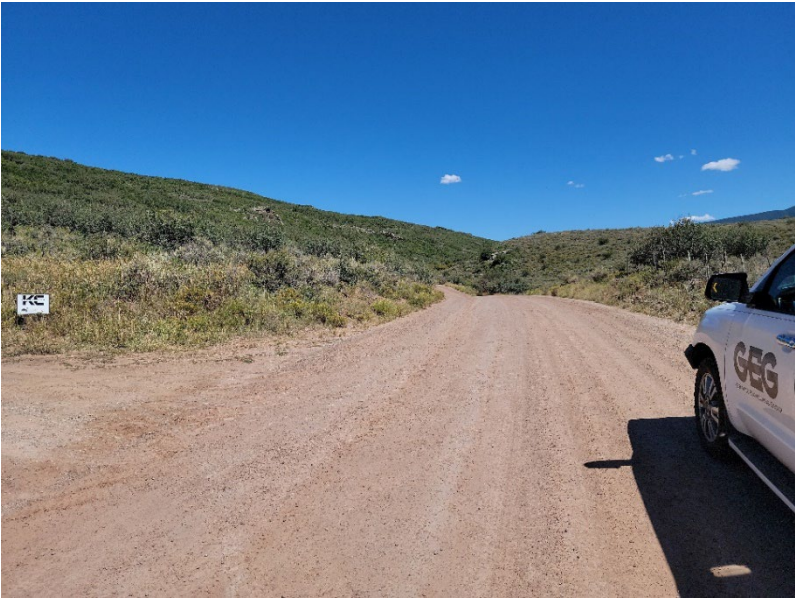
Photo 10. A very large scale landslide mass

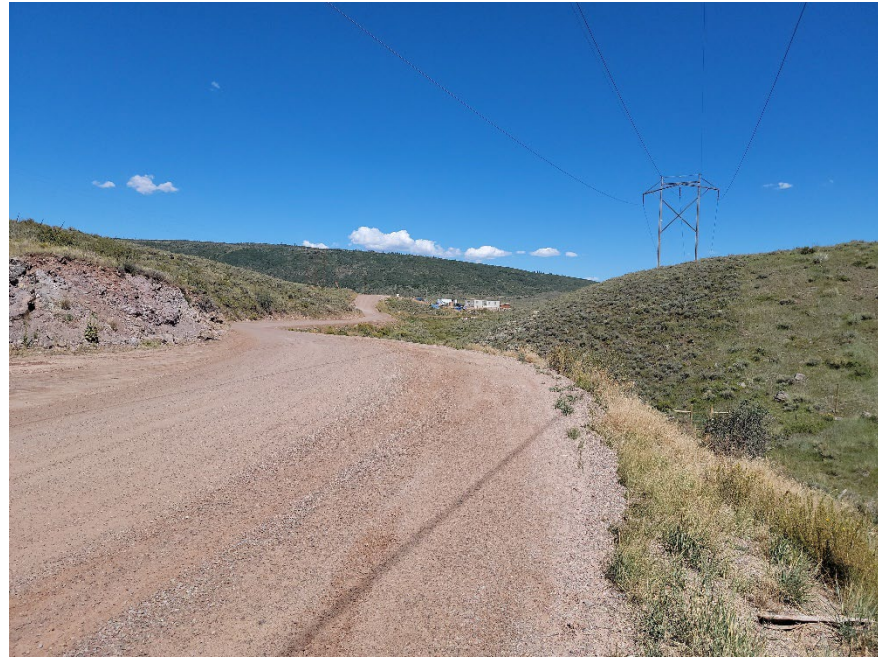
Photo 11. Rock outcrop in the potential cut section

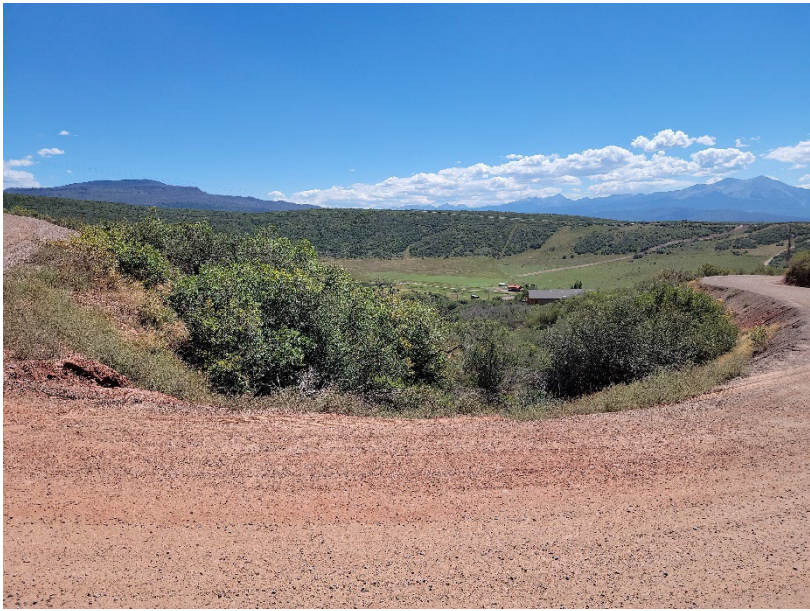
Photo 12. Structure or embankment to improve alignment

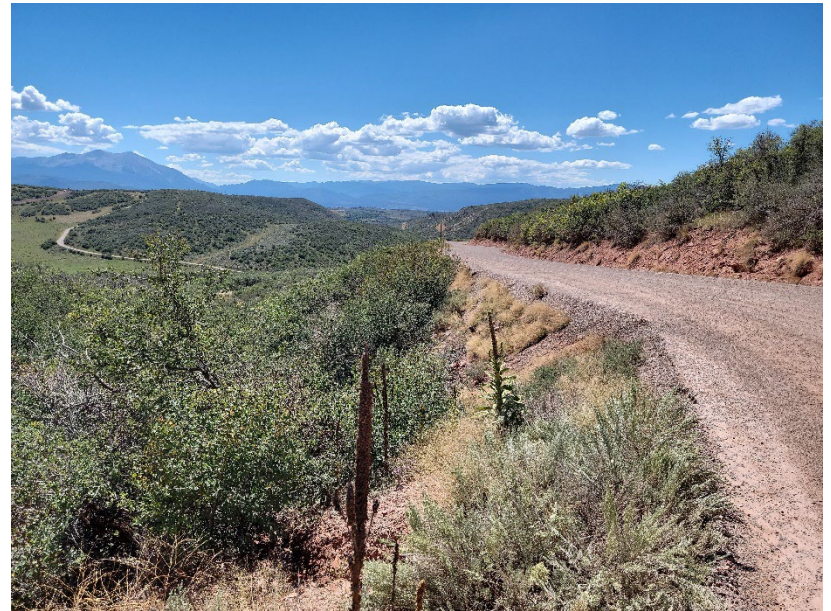
Photo 13. Side slope of the existing roadway

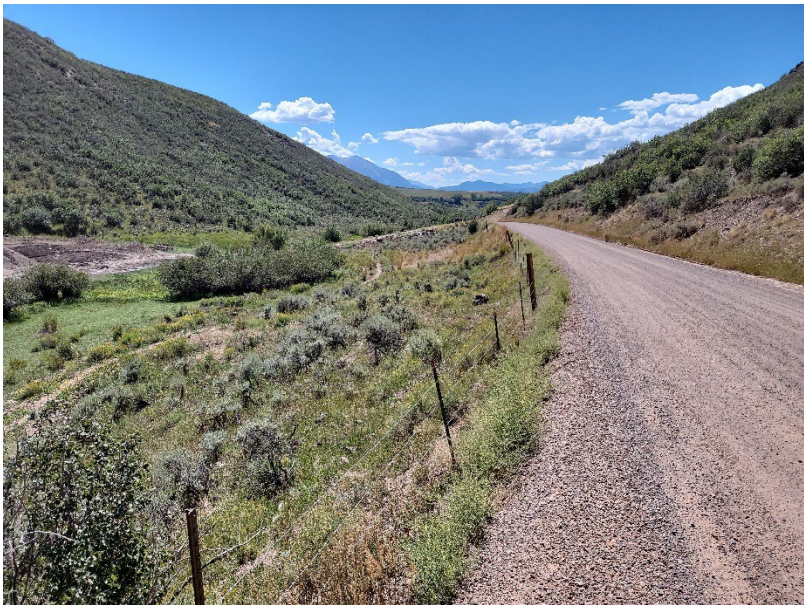
Photo 14. View of the valley

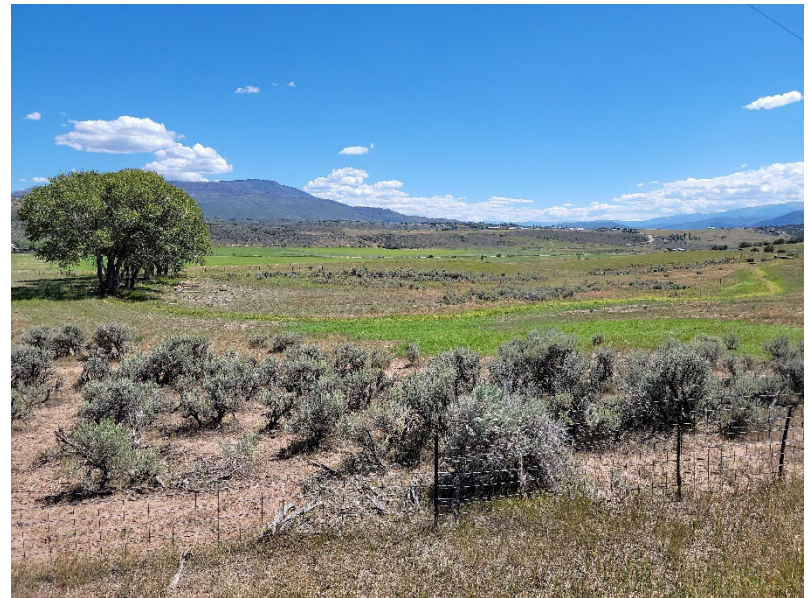
Photo 15. Potential karst in the evaporite soils

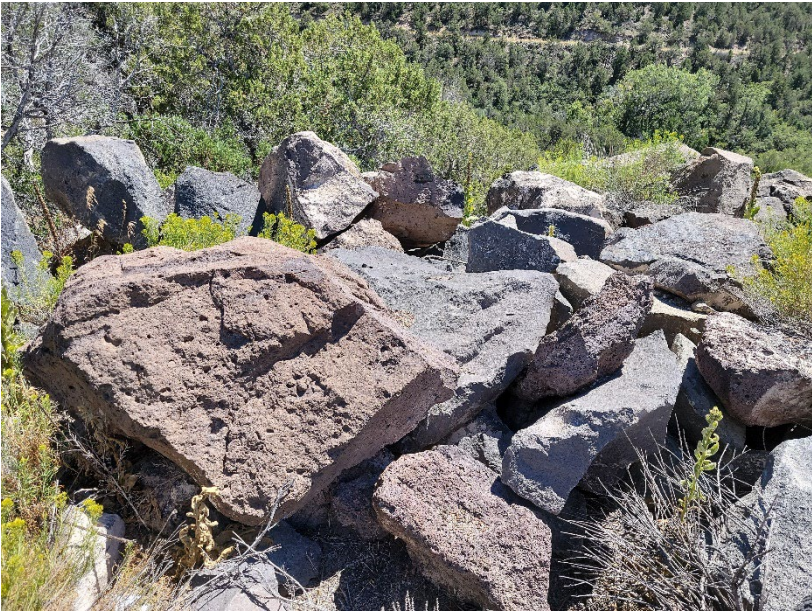
Photo 16. Volcanic rock used for embankment

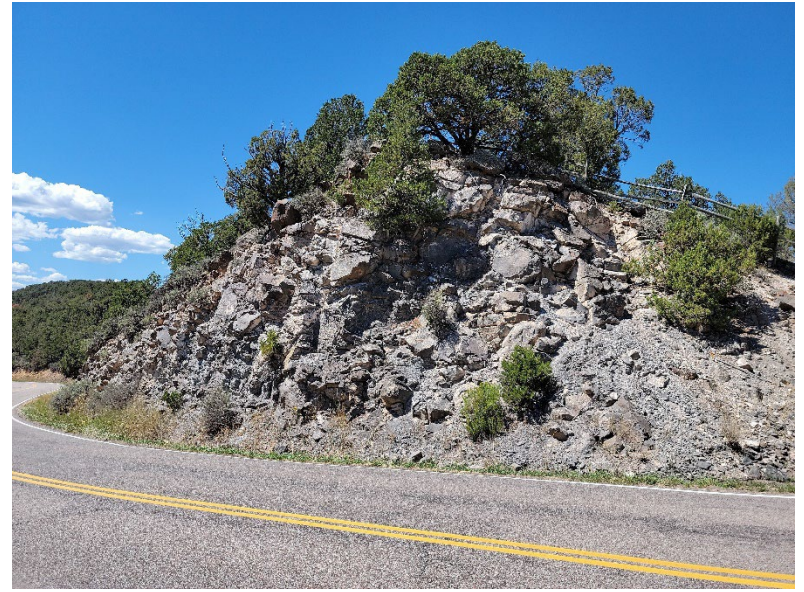
Photo 17. Rock outcrop that will require mitigation
