Bridges Technical Memorandum

July 09, 2018

The Interstate 25 (I-25) Central Planning and Environmental Linkages (PEL) Study includes approximately four and one-half miles of highway and nine interchanges through one of the most congested segments of interstate in Colorado. Many factors contribute to this congestion, including traffic volumes, vehicle mix (high truck percentage), and deficient roadway geometrics. Roadway geometrics include design elements such as horizontal alignment, vertical alignment, stopping sight distance, ramp spacing, etc. Deficient elements within the corridor can cause traffic operation and safety issues. An evaluation of the existing I-25 mainline and ramp conditions within the project limits has been performed and is documented in this technical memorandum.

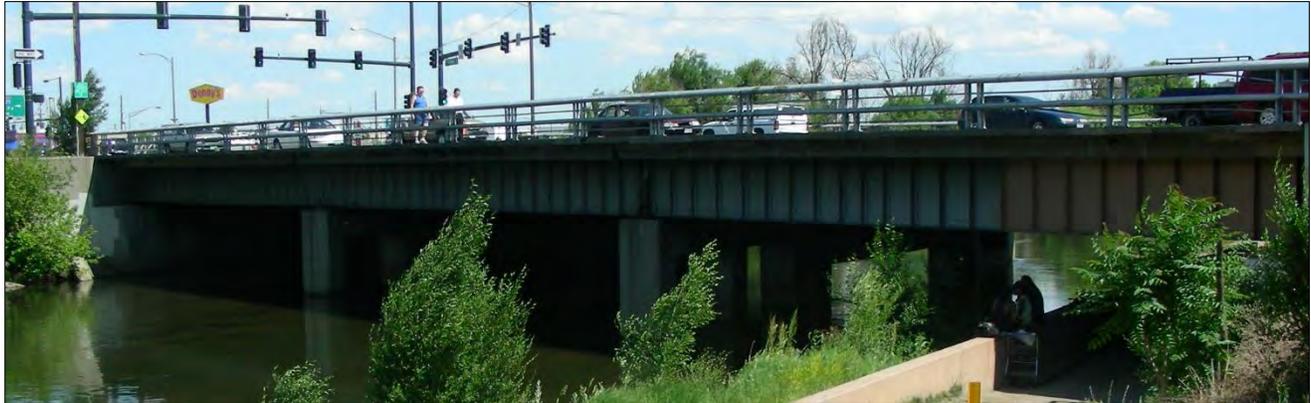
Numerous locations of heavy concrete cracking and spalling throughout substructure and deck overhang.

Widening to north and south was completed in 1959. Concrete repairs to deck overhang were completed in 2006. South bridge rail rehab completed in 2010.

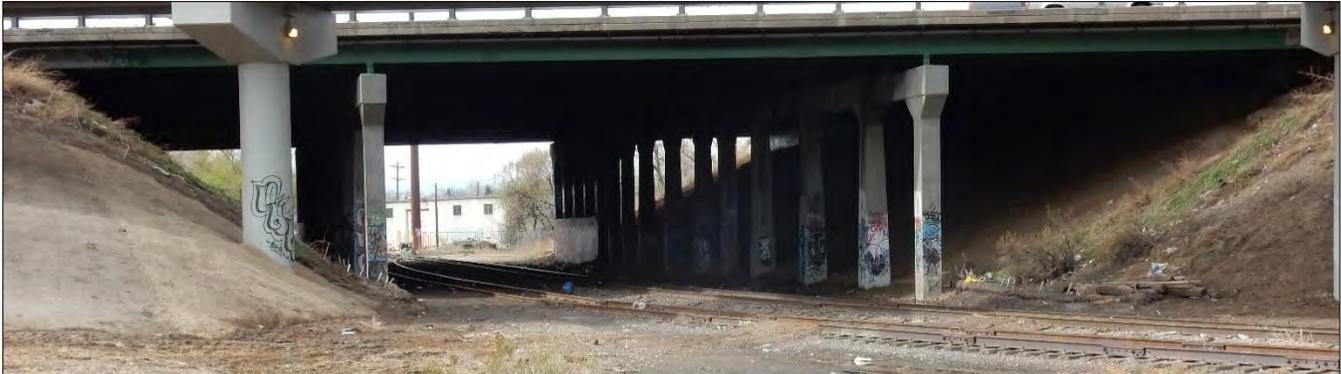
Actively leaking longitudinal construction joints in deck.

Concrete repair to deck and abutments completed and new expansion joint installed in 1998.

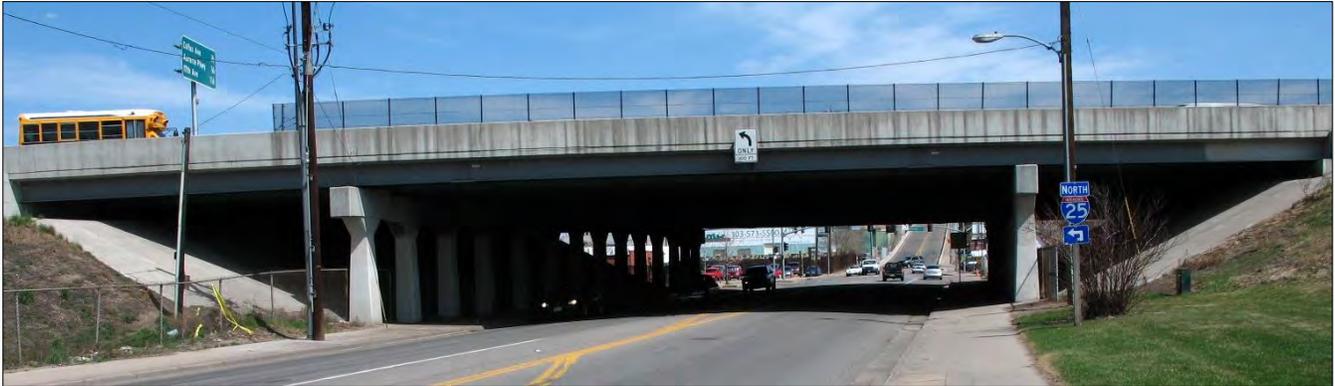
Indications found in two pins at Girder E near Pier #2 at the pin and hanger connections.

Original bridge consisted of two twin 40-foot wide structures. A major widening was completed in 1974 to join the two bridges and increase width to 166 feet. Another widening was completed in 1987 to bring the structure width to what it is today. Rehab work was completed in 2010 to repair longitudinal and transverse joints in the bridge deck.

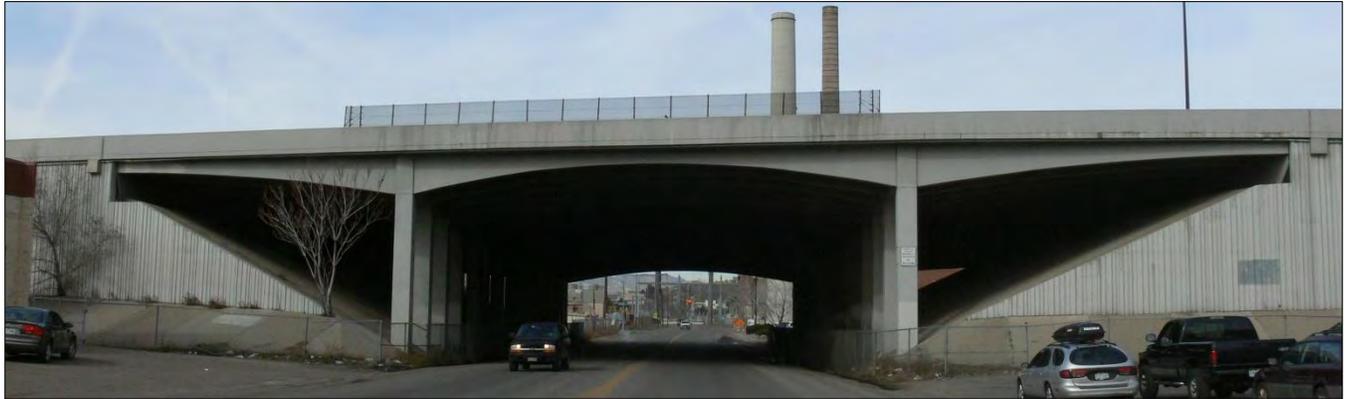
About 10 percent of deck contains spalled concrete with exposed rebar. Steel piles are exposed at abutments.

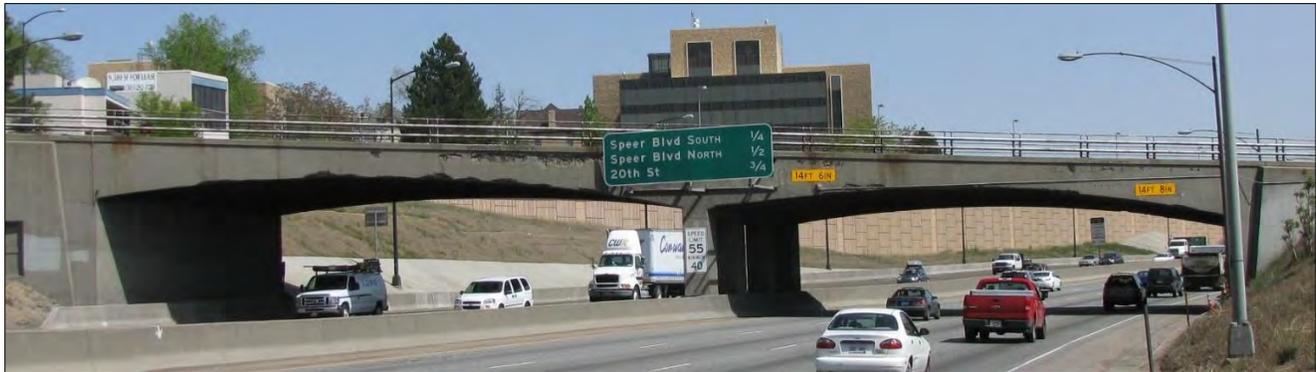
Structure has experienced multiple vehicular impacts resulting in damaged girders and exposed primary reinforcing. Cracking, heavy efflorescence, and spalled concrete with exposed rebar present throughout concrete deck.

Girder concrete was previously patched where impacted by vehicles but additional vehicular impacts to the patched areas have caused spalling of the patch concrete.
