COLORADO
Department of Transportation

CDOT R1 I-70 WB BAKERVILLE TO EJMT CLIMBING LANE EXISTING CONDITIONS REPORT

NHPP 0703-502 ▪ PCN 24808 ▪ Revision: May 19, 2023

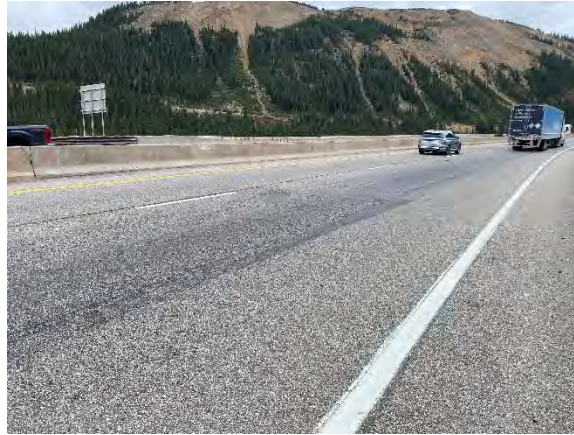
The driving surface of the deck has a 3-inch-thick asphalt overlay. The top of the concrete deck is not visible. Several patches of asphalt exist throughout the overlay and there are several areas of potholing and delamination of the top layer of asphalt. The asphalt is cracked the entire width of the roadway at both abutments and Pier 3.

Figure 7. Asphalt patches in wearing surface.

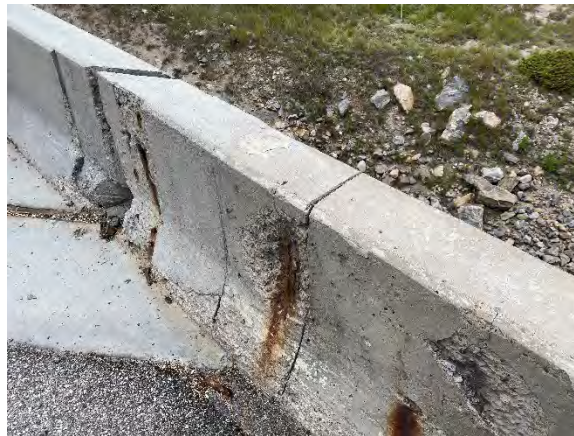
The bridge rail is concrete barrier. The bridge rail on the right side of the traveled way is not attached to structure F-13-0 but is attached to F-13-P and acts as a median barrier. Spalls with exposed, corroded reinforcement is present throughout much of the length of the left bridge rail.

Figure 8. Typical deterioration of outside bridge rail

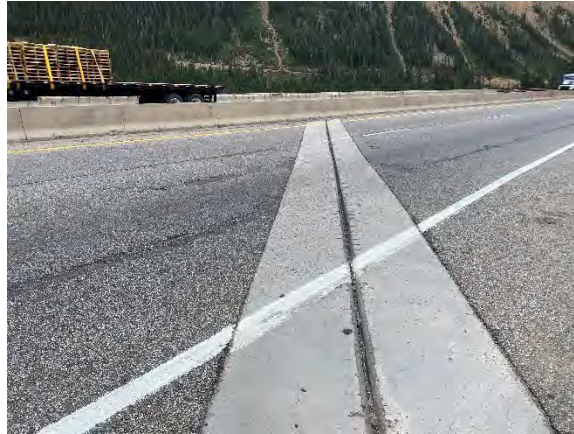
Original plans show expansion joints at both Piers, but there is only an expansion joint at Pier 2. It is likely Pier 3 expansion joint has been paved over.

Figure 9. Expansion joint at Pier 2

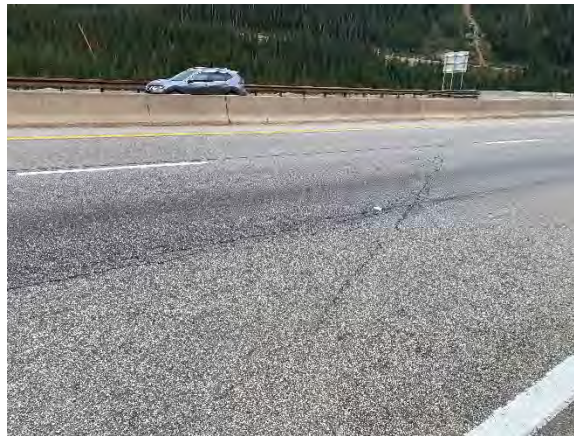
Figure 10. Transverse cracking of asphalt over Abutment 1

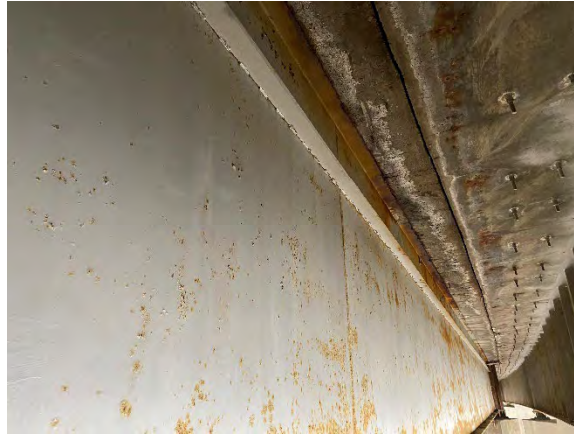
The left edge of the deck has several areas of spalling with exposed and corroded reinforcement. The right edge of the deck along the expansion joint is in good condition, however the joint with bridge F-13-P allows water through and collects on Girder E.

Figure 11. Drainage through longitudinal joint with F-13-P on to Girder E, corrosion on top flange of Girder E

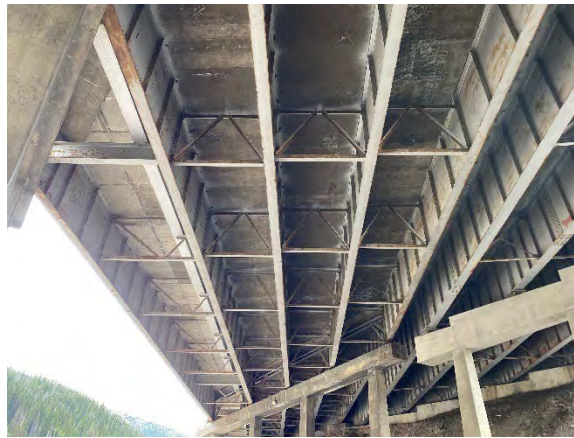
The underside of the deck has several areas that have had full depth concrete repairs. Several locations existing with patches less than 2 square feet in area in Bays 1B, 1D, 2B, and 3C. Some patches are cracked with efflorescence. There are also several areas of map cracking with efflorescence, scattered throughout the deck. Areas with efflorescence and patch account for 10% of the deck area.

Figure 12. Typical view of underside of deck showing areas of patch and cracking with efflorescence

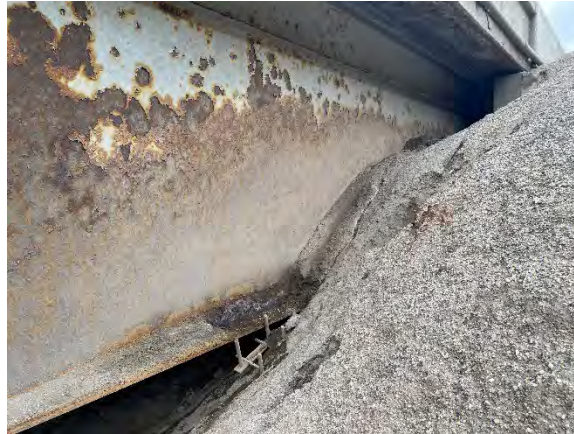
Girder 1A is buried in 4ft of gravel and other debris for 10ft of its length at Abutment 1. The material is unable to be removed with hand tools. In areas where Girder 1A was uncovered and cleaned, only surface rust was observed. A complete uncovering and cleaning of Girder 1A is required to fully document its condition.

Figure 13. Debris on Girder 1A with uncovered area

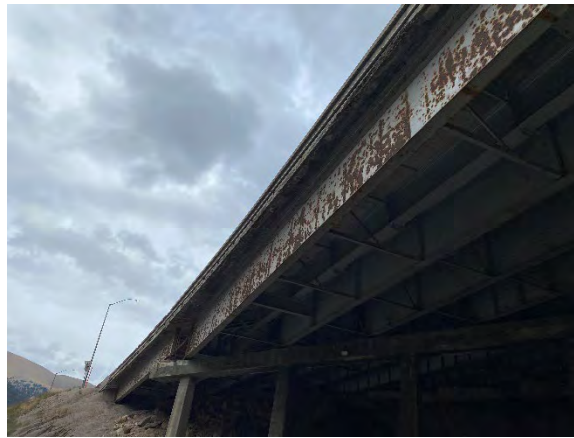
Throughout the girders, cross frames, bearings, and other steel components the paint has failed and there are areas of surface corrosion. The corrosion is most severe on the exterior faces of the exterior girders and at the girder ends underneath the deck joints. Girder E has pitting the full length along the top flange and web and has 30% section loss of its web at Abutment 1.

Figure 14. View showing general condition of superstructure paint and corrosion on girders

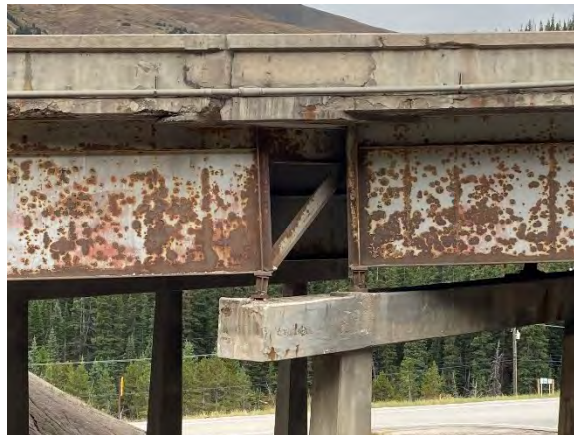
The fixed bearings at both abutments are corroded and covered by debris. The movable rocker bearings are also corroded with debris on them from the deck joints above.

Figure 15. Typical condition of movable bearings, Pier 2 Girder A

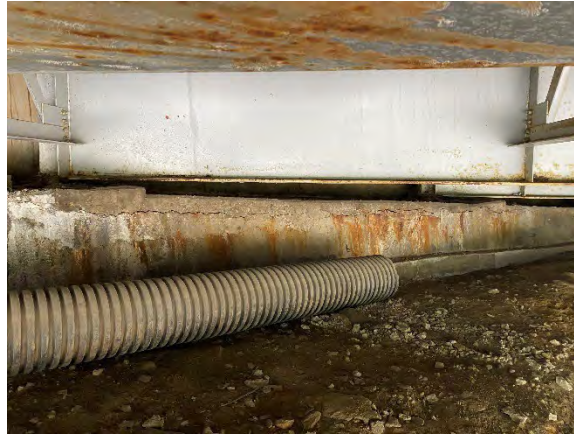
Both abutments are in fair condition. At Abutment 1, there are delaminations running the length of the front of the girder seats under Girders C, D, and E. Some areas of the delamination exhibit rust staining. Water drains

Figure 16. Delamination and rust staining on Abutment 1 girder seat

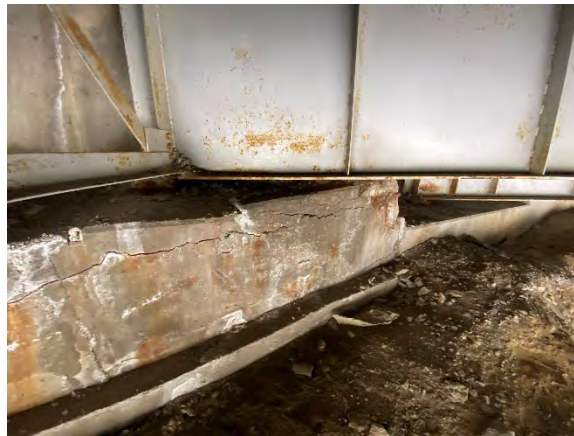
Abutment 4 has similar delaminations and rust staining to Abutment 1 under Girders D and E. A previously patched area at the right end of Abutment 4 has failed and is now spalled with exposed, corroded reinforcement.

Figure 17. Delamination, rust staining, and failed patch at right end of Abutment 4

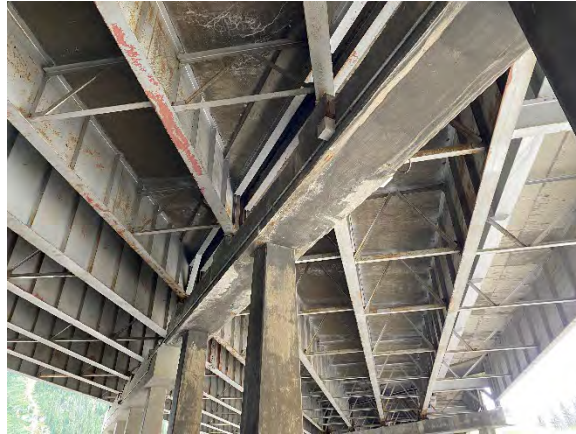
The piers are in overall fair condition. There are patches throughout both pier caps. Many patches are cracked and are unsound. There are spalls with exposed reinforcement along the bottom edges and ends of both pier caps. All pier columns have chips near their bottoms throughout as well insignificant width cracks.

Figure 18. Failing, cracked patches on bottom edges of Pier 3

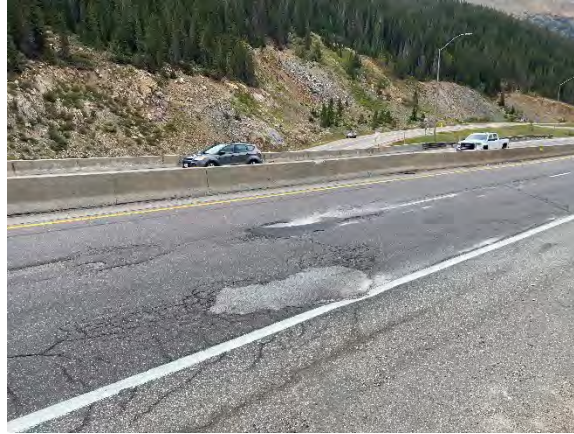
Figure 20. Typical potholes in asphalt wearing surface

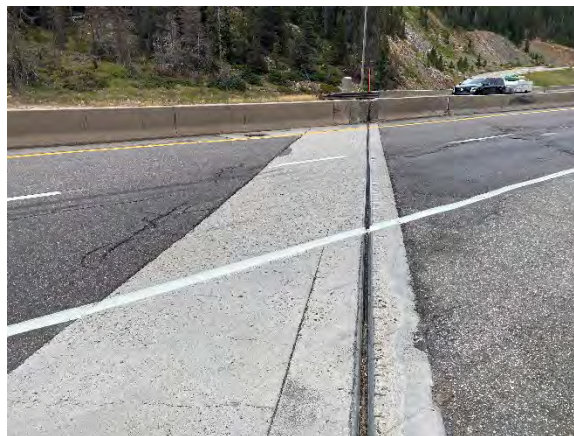
A strip seal expansion joints is located at Abutment 1. The concrete joint header is abraded in the traffic lanes exposing aggregate. The anchors for the joint rail are also exposed through top of the header; no metal sections appear to be protruding from the header. The seal is impacted with debris most of its length.

Figure 21. Expansion joint at Abutment 1

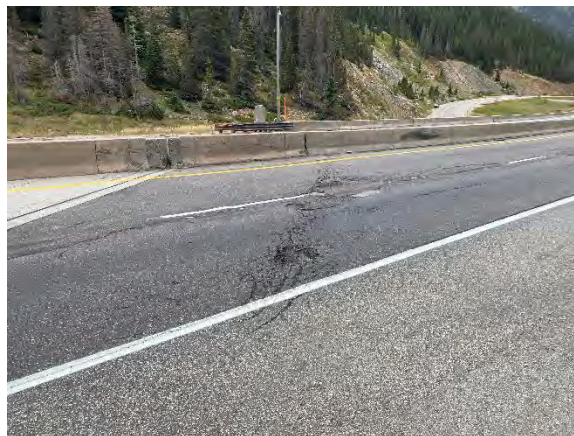
Figure 22. Transverse cracking in asphalt wearing surface over Abutment 1

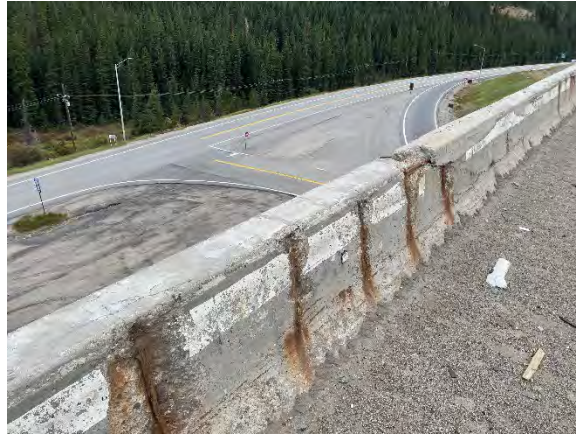
Figure 23. Typical spalling with exposed corroded reinforcement in the concrete barriers

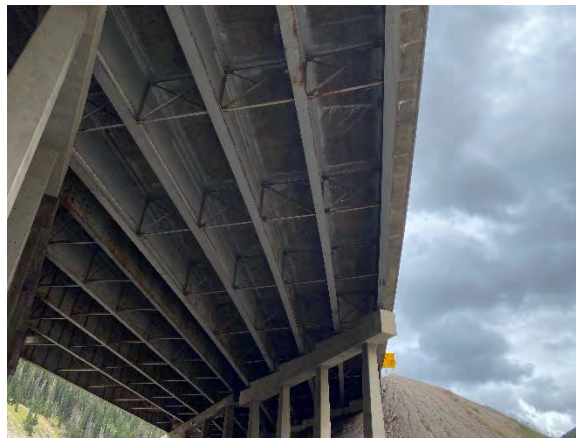
The underside of the deck has scattered areas of transverse cracks with efflorescence. A few locations with map cracking with efflorescence exist, Bay 1B near Abutment 1 and Bay 3C and 3B near Abutment 4. The underside of the joint headers at the abutments both have cracking with efflorescence throughout.

Figure 24. Typical view of underside of deck showing areas of cracking with efflorescence

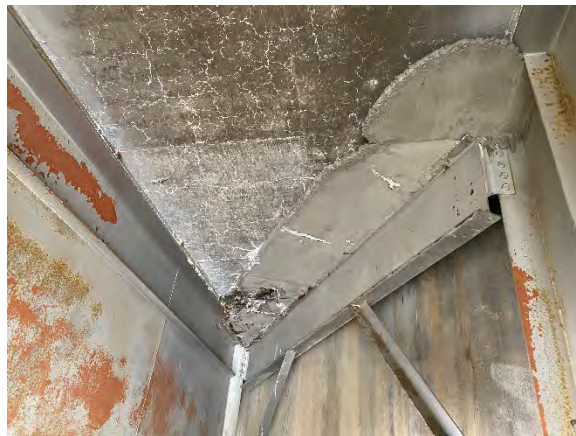
Figure 25. Cracking with efflorescence on underside of joint header at Abutment 4

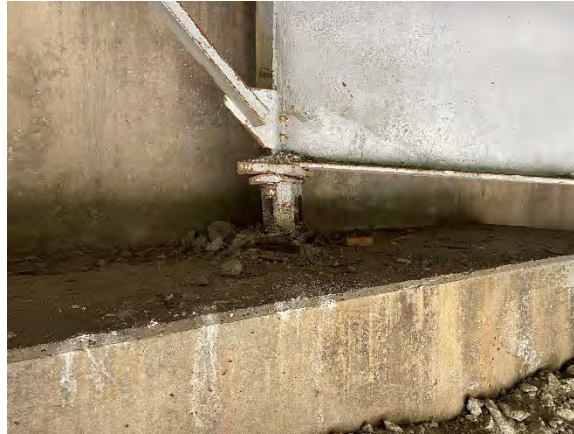
The bearings at both abutments are covered in debris, which may be restricting movement.

Figure 26. Typical condition of movable bearings, Abutment 1 Girder B

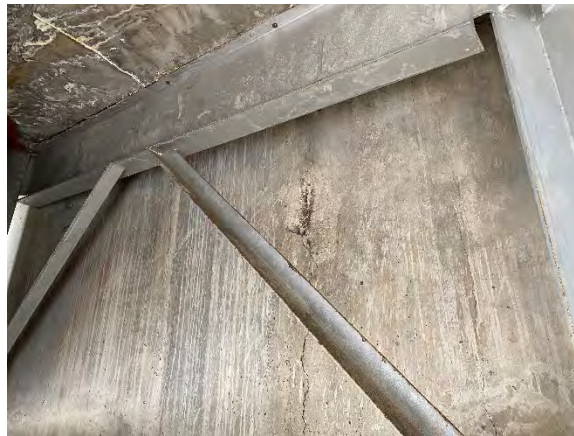
Both abutments are in good condition. There are scattered vertical insignificant width cracks throughout both abutment backwalls. There is one spall with exposed reinforcement on Abutment 1 in Bay D. The girder seats for both abutments are covered in debris.

Figure 27. Spall with exposed reinforcement on Abutment 1, Bay D

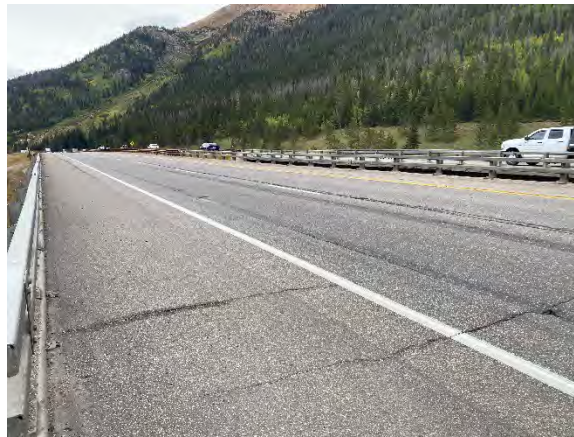
Figure 29. Asphalt rutting in driving lane

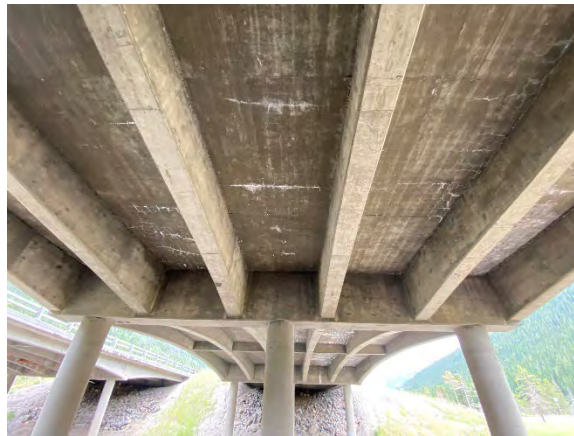
Map cracking with efflorescence is present in all spans and girder bays, with the most severe conditions present in Girder C, D, and E. Throughout the efflorescence, isolated spots of rust staining are present. Discoloration of the concrete, separate from efflorescence, is also present throughout the underside of the deck indicating water can infiltrate and move through the deck. Large areas of “permanent” form work is present in Bay 3D from previous concrete repairs that obstructed the inspection of the area. There is also a large full depth repair in Bay 2D. Several spalls were visible with exposed corroded reinforcement at both edges of the deck.

Figure 31. General view of the underside of the deck in Span 1

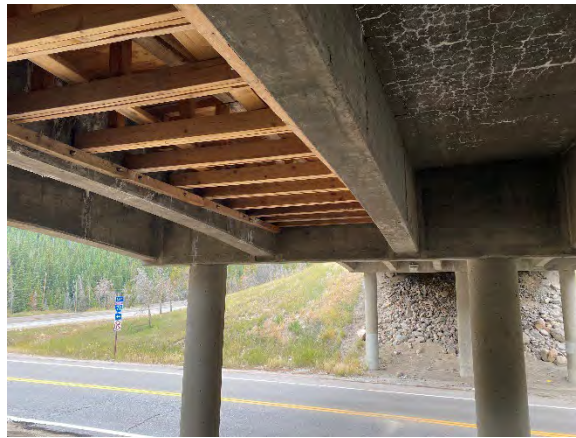
Figure 33. Permanent form work for concrete repair (Bay 3D) and map cracking with efflorescence (Bay 3C)

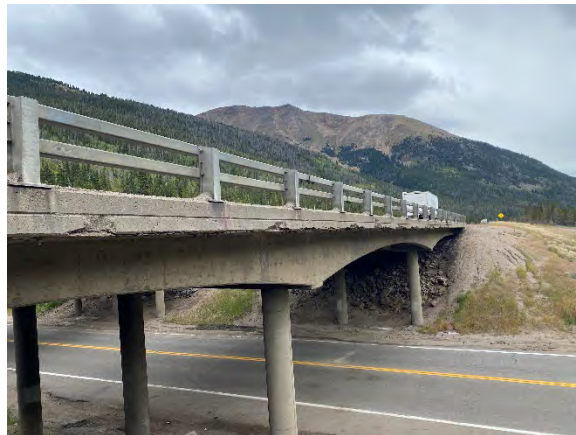
Figure 34. Typical spalling with exposed reinforcement at edges of deck

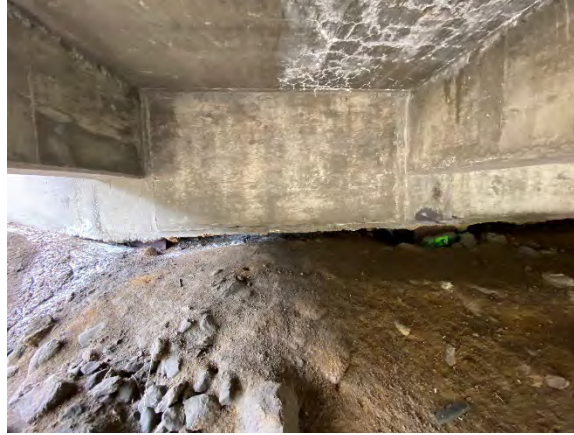
Both abutments are in fair condition. A few vertical cracks less than 0.012 inches wide are present in both abutments. At both abutments the berms have settled or eroded exposing the piles. Piles are exposed 8 inches and 3 inches at Abutment 1 and 4 respectively. Probing underneath Abutment 1 indicated there may be a 2- to 5-inch-wide void behind majority of the length of the abutment. It is also noted at Abutment 1 the pile under Girder C is not centered in the abutment cap and pile flange is visible and near flush with the front face of the abutment.

Figure 35. Exposed piles at Abutment 1

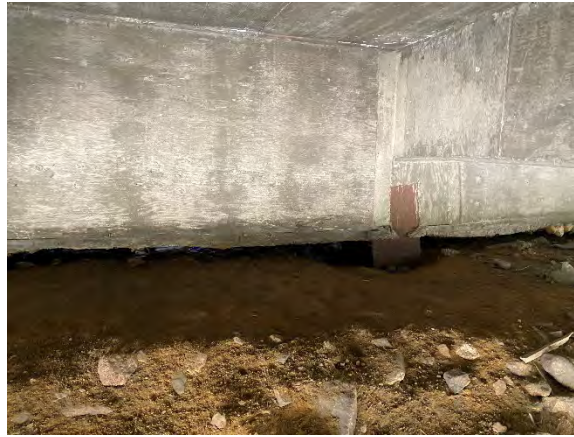
Figure 36. Off-center pile under Girder C at Abutment 1

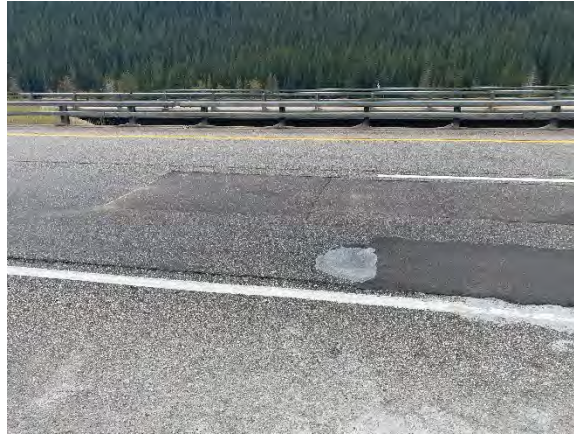
Figure 39. Asphalt patches in wearing surface

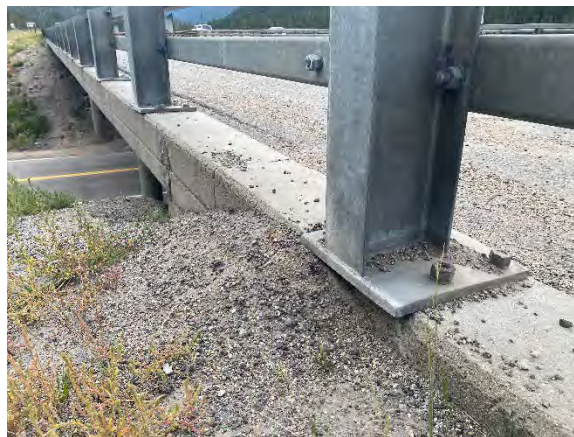
Figure 40. Disengaged nuts on bridge rail anchors

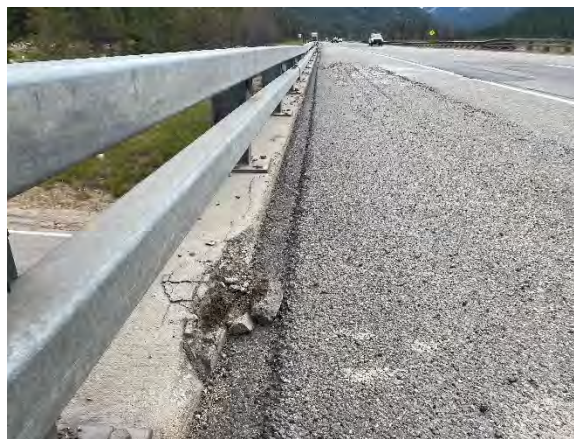
The front face of both curbs is mostly hidden by the asphalt wearing surface, but localized areas of cracking and delamination are visible. Spalls, some with exposed reinforcement, are present under several rail posts.

Figure 41. Delamination and spalls on the front face of the curbs

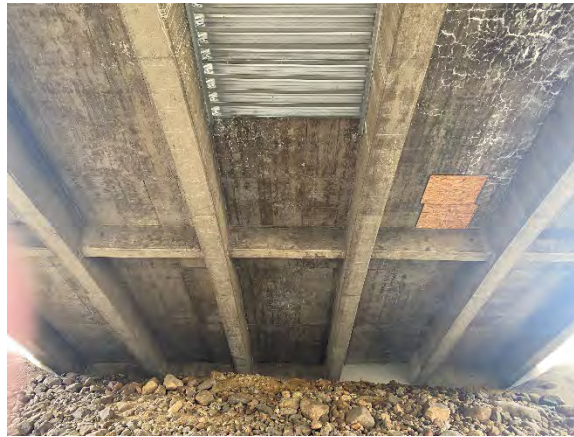
Map cracking with efflorescence is present in all spans and girder bays, with the most severe areas shown in Girder Bays A, B, and C. Throughout the efflorescence, isolated spots of rust staining are present. Discoloration of the concrete separate from efflorescence is also present throughout the underside of the deck indicating water can infiltrate and move through the deck. Large areas of “permanent” form work are present in Bays 1C, 2B, and 2C from previous concrete repairs. These repairs obstruct the inspection of these areas. In accessible areas near the abutments, delamination of the deck was detected using a hammer to sound the concrete at a few locations near Abutment 1. Several spalls with exposed corroded reinforcement are visible at both edges of the deck.

Figure 42. General view of the underside of the deck in Span 1

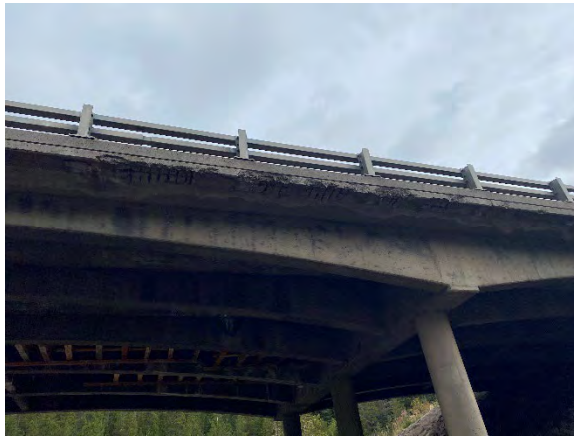
Figure 45. Typical spalling with exposed corroded reinforcement at edges of the deck

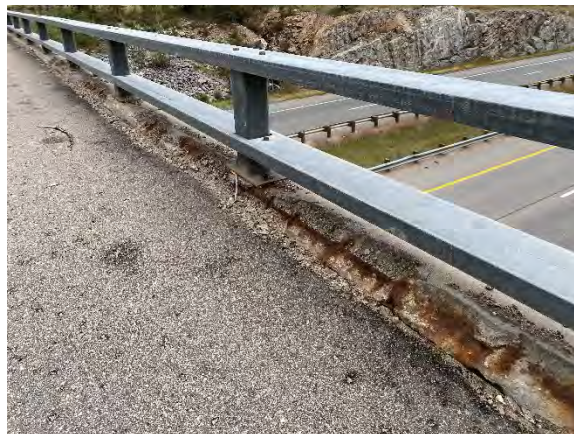
The concrete protective coating applied to the deck overhangs and curbs is peeling or failed at most locations.

Figure 47. Typical spalls with exposed corroded reinforcement in curbs and “Type N” bridge rail

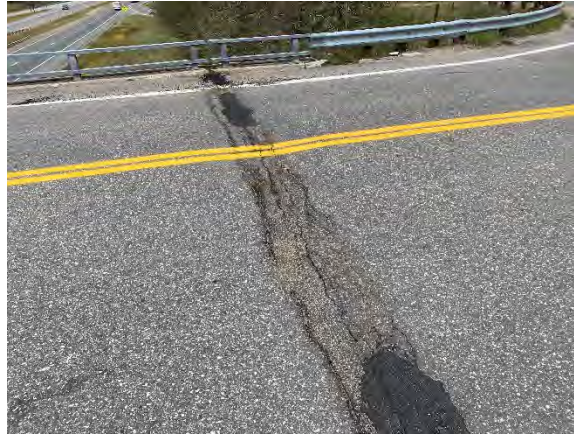
Figure 48. Transverse cracking of asphalt over compression joint at Abutment 3

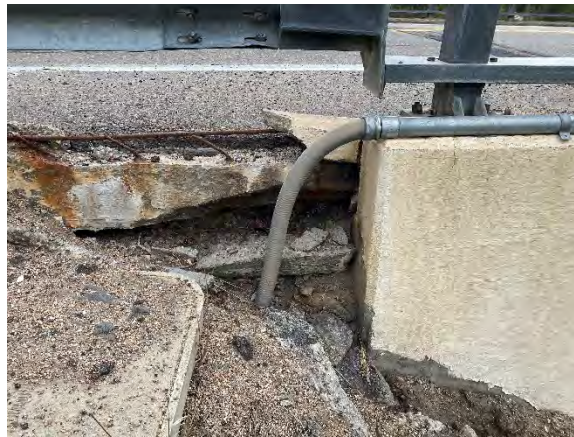
Figure 49. Typical undermining of approach slabs and damage to curbs on approach slabs. Right side of rear approach slab

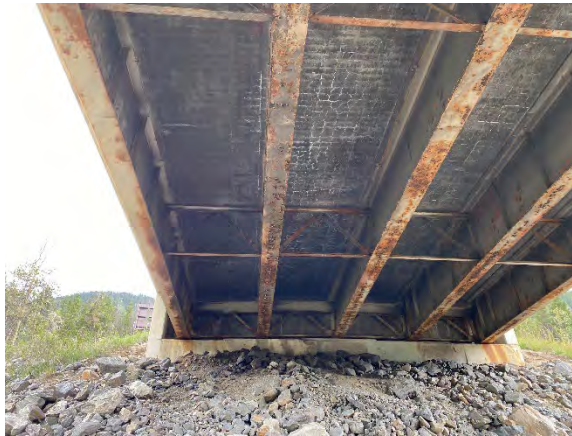
The underside of the deck has large areas of transverse and map cracks, with efflorescence. The largest concentrations of the map cracking are in Bays 2B and 2C near Abutment 3 and in both spans near Pier 2. The transverse cracks are scattered throughout. A few spalls less than 6 inches in diameter, some with exposed reinforcement, are present on the left edge of the deck above eastbound I-70.

Figure 50. Typical view of underside of deck showing areas of cracking with efflorescence, Span 2 at Abutment 3

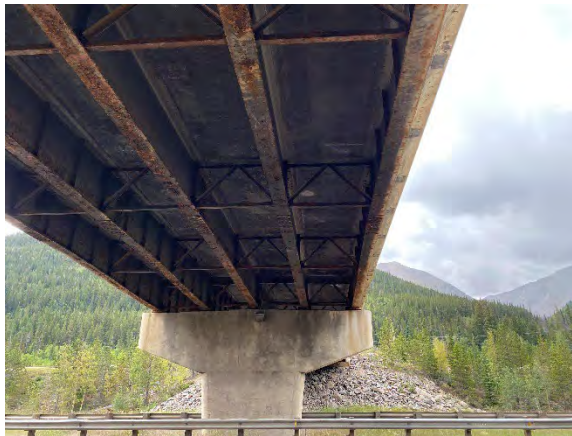
Figure 51. View showing general condition of superstructure paint and corrosion on girders

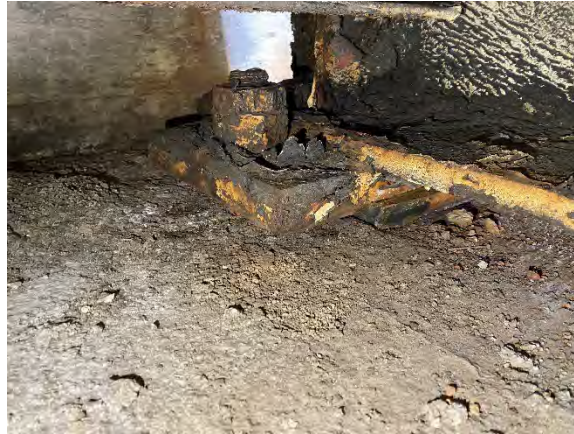
The elastomeric bearings at the abutments are crushing and bulging. Bearing 3E is the most severe, crushed approximately 15% of its depth and bulged approximately 10% of its thickness. The abutment bearings are all covered in debris and have surface corrosion on the bearing plates.

Figure 52. Crushing and bulging of bearing pad 3E

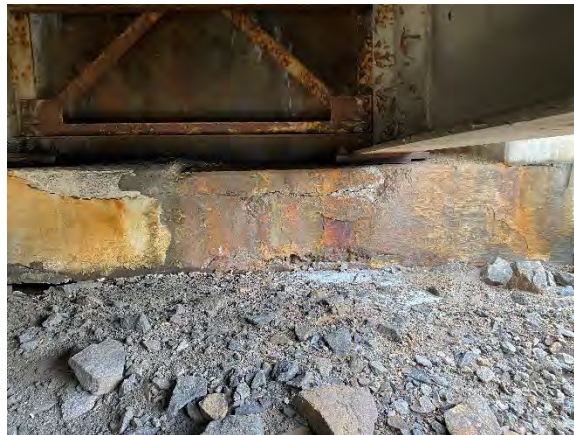
The concrete protective coating applied to the abutments and wingwalls is peeling or failed at most areas across the girder seats and abutment backwalls.

Figure 53. Typical delamination and rust staining on girder seats, Abutment 1 Bay A

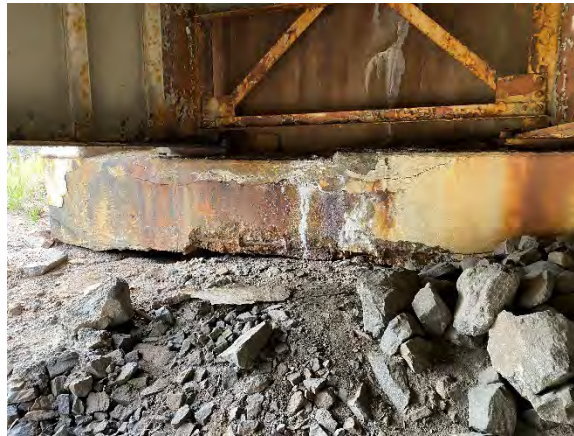
Figure 54. Failed patch exposing corroded reinforcement, Abutment 1 Bay D

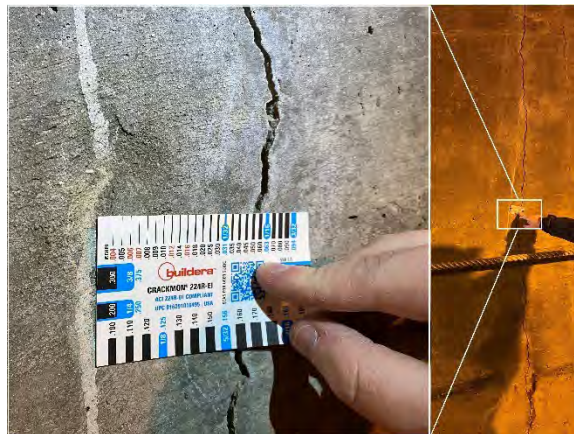
Figure 58. Typical wide width circumferential crack in culvert barrel

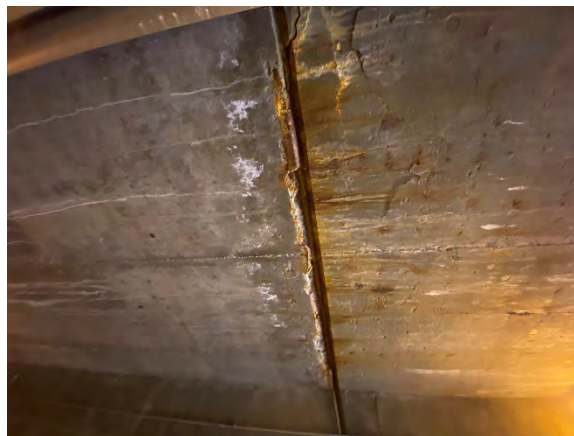
Figure 59. Spalling, leakage, and efflorescence at construction joint 32 feet from outlet

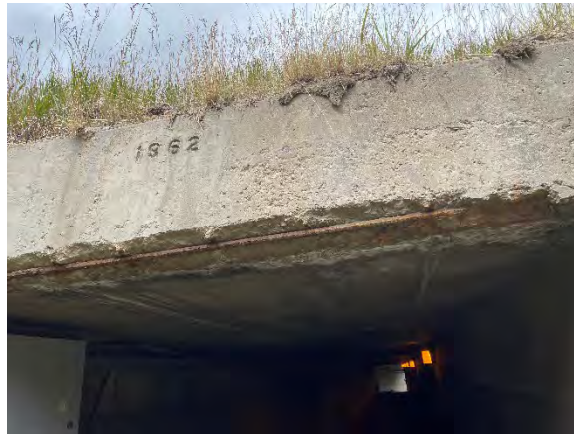
At the outlet (south) end of the culvert, the leading edge of the top slab is spalled with exposed reinforcement the entire width of the barrel. Both wingwalls are also leaning towards the inside of the barrel. The southeast wingwall is leaning 8 inches at its top, the southwest wingwall is leaning 4 inches at its top. At the culvert inlet (north end), there are four exposed rebars in the headwall due spalling and a lack of concrete cover.

Figure 60. Spall with exposed rebar at outlet

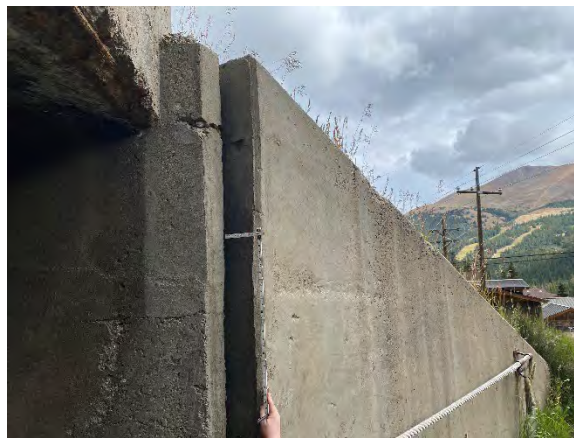
Figure 61. Leaning of southeast wingwall
