# CDOT R1 I-70 BAKERVILLE TO EJMT WB AUX LANE EXISTING CONDITIONS REPORT

NHPP 0703-502 ▪ PCN 24808 ▪ Revision: December 7, 2022

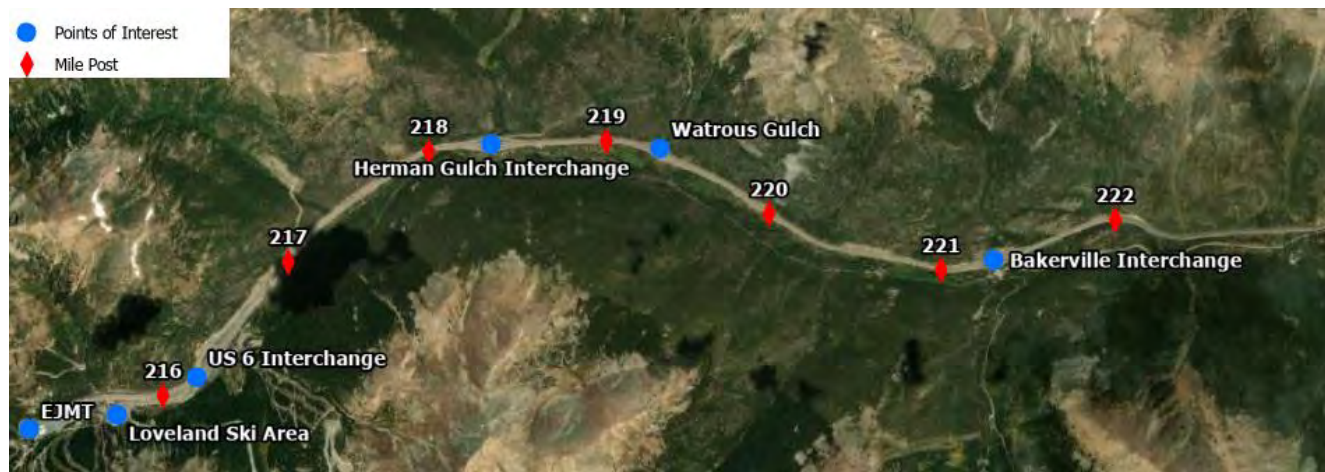
Figure 1. Project overview map

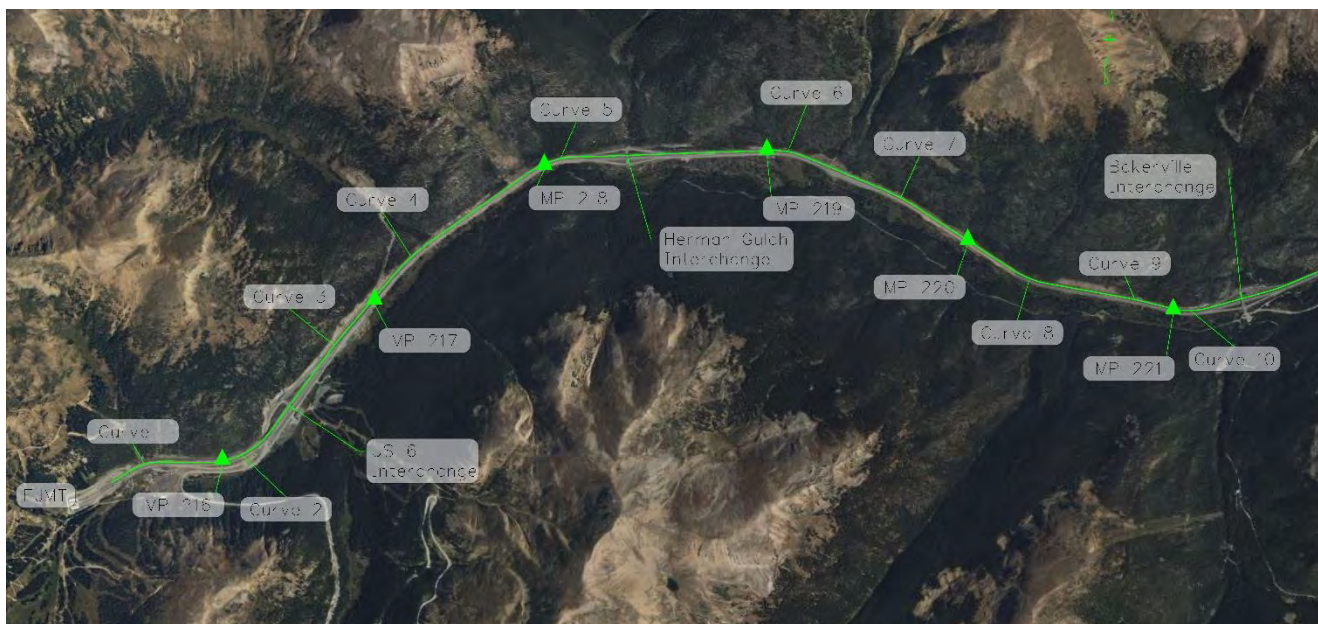
Figure 2. Overview of curve locations

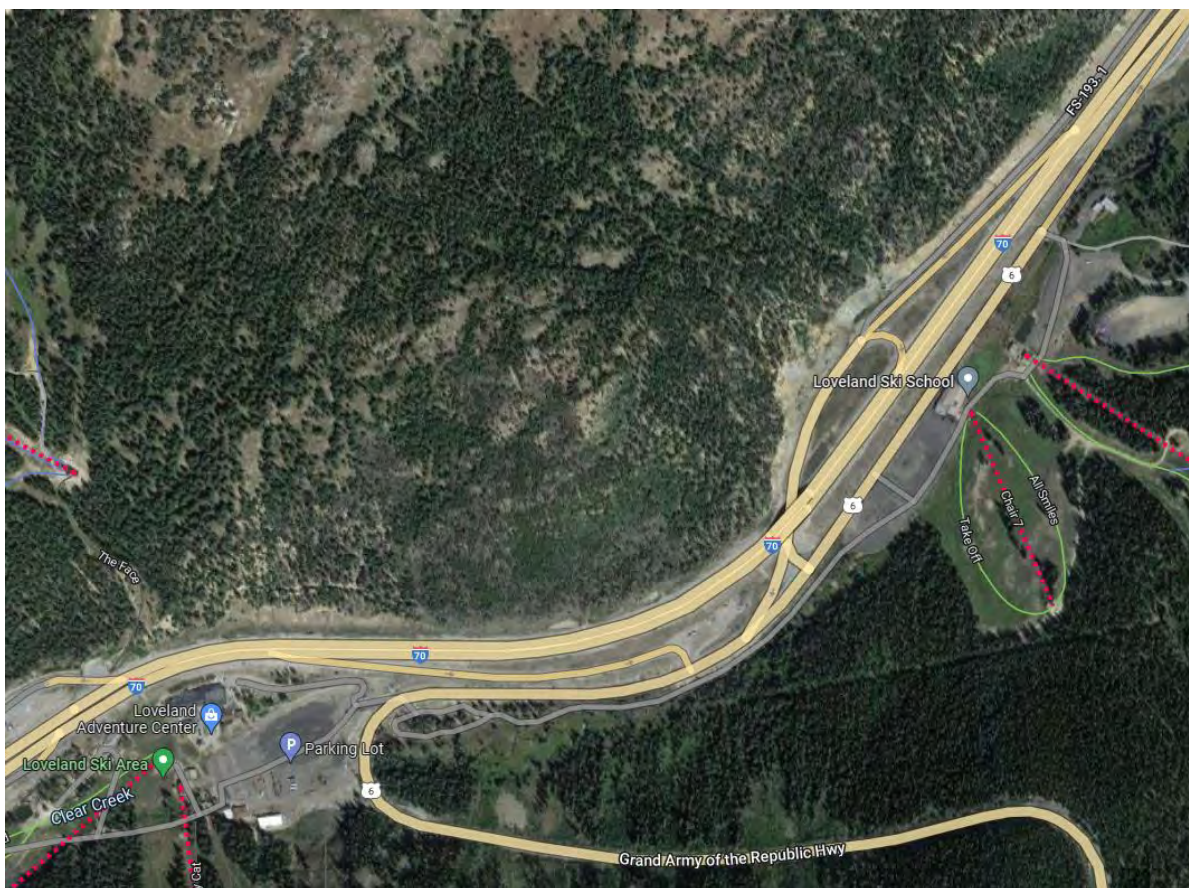
**Figure 3.** Aerial view of I-70 at the US 6 Interchange and Loveland Ski area

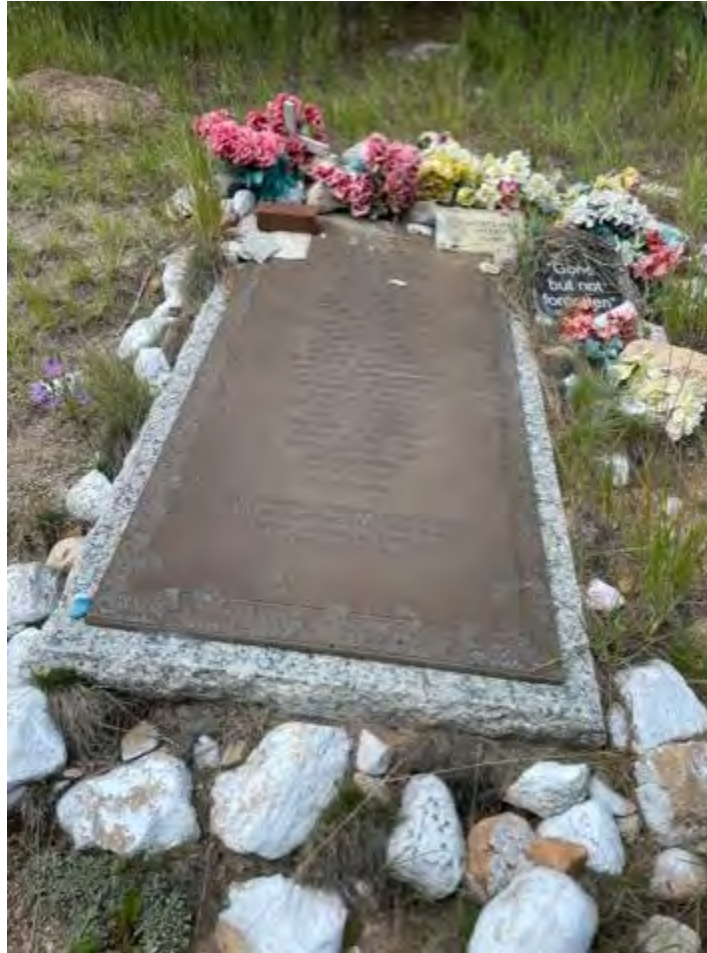
Figure 4. Roadside memorial at MP 217.3

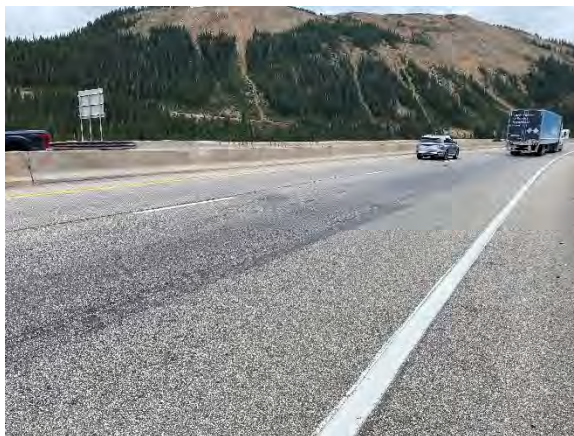
Figure 7. Asphalt patches in wearing surface

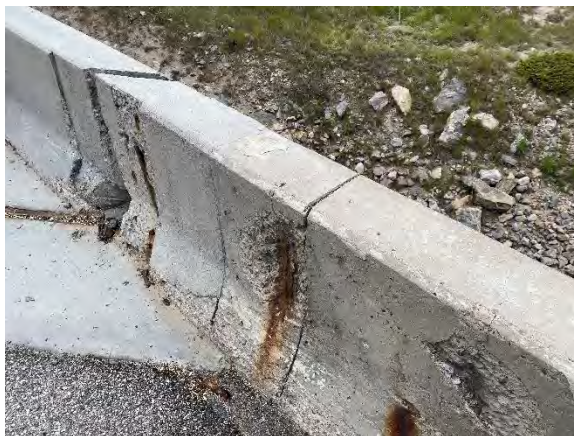
Figure 8. Typical deterioration of outside bridge rail

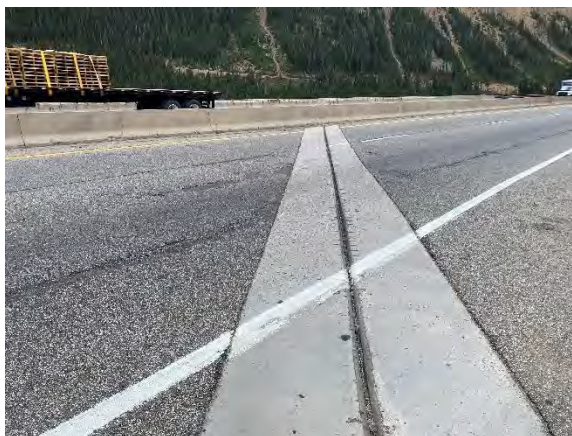
Figure 9. Expansion joint at Pier 2

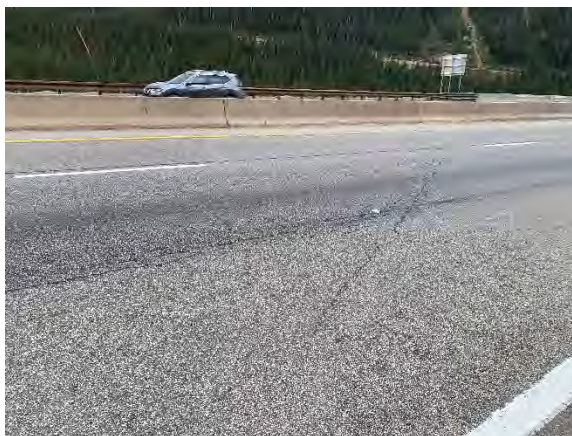
Figure 10. Transverse cracking of asphalt over Abutment 1

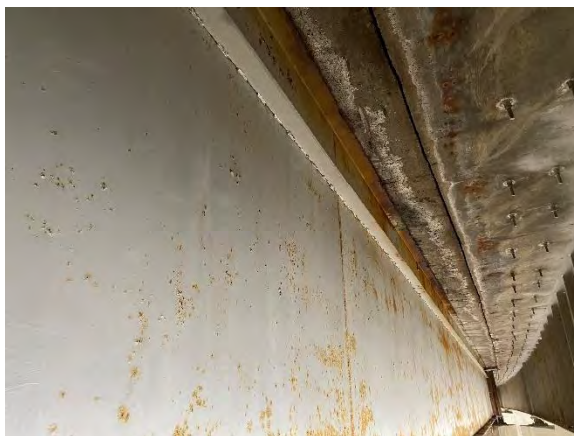
Figure 11. Drainage through longitudinal joint with F-13-P on to Girder E, corrosion on top flange of Girder E

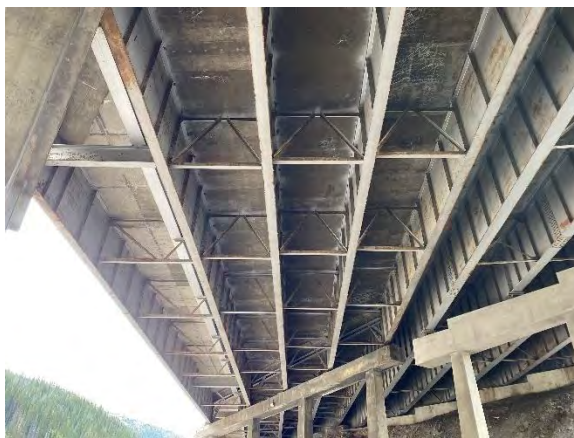
Figure 12. Typical view of underside of deck showing areas of patch and cracking with efflorescence

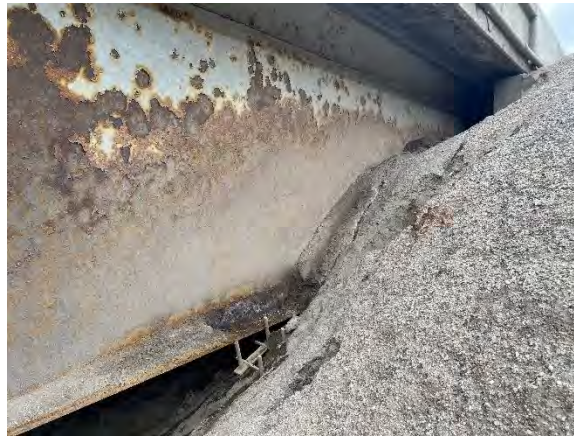
Figure 13. Debris on Girder 1A with uncovered area

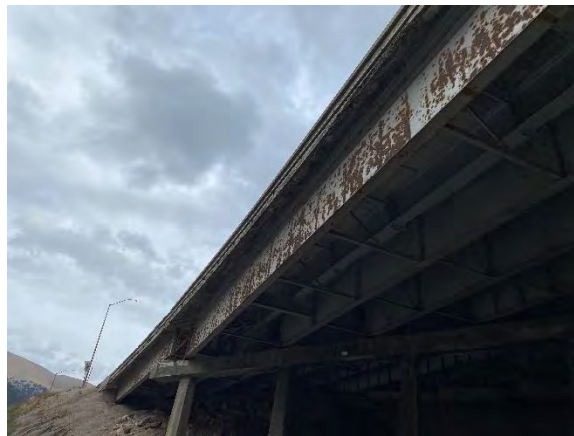
Figure 14. View showing general condition of superstructure paint and corrosion on girders

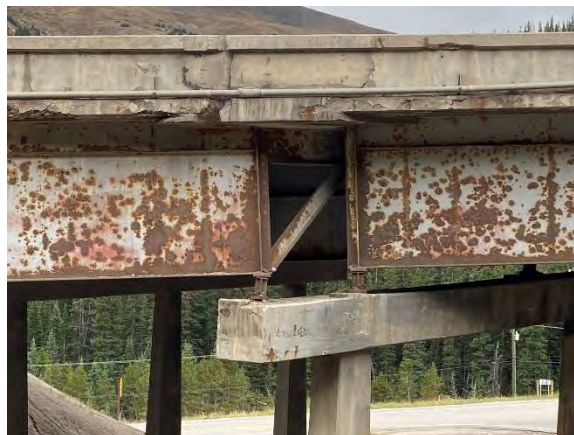
Figure 15. Typical condition of movable bearings, Pier 2 Girder A

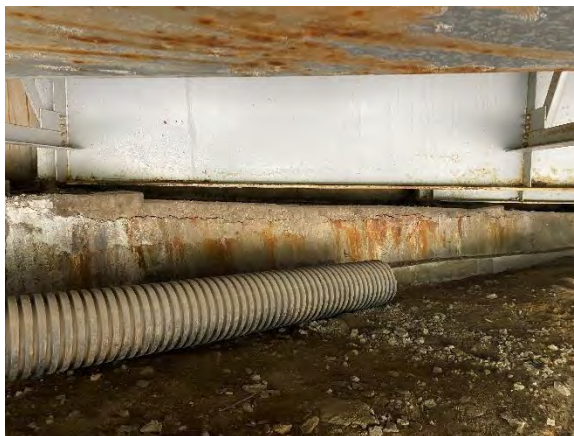
Figure 16. Delamination and rust staining on Abutment 1 girder seat

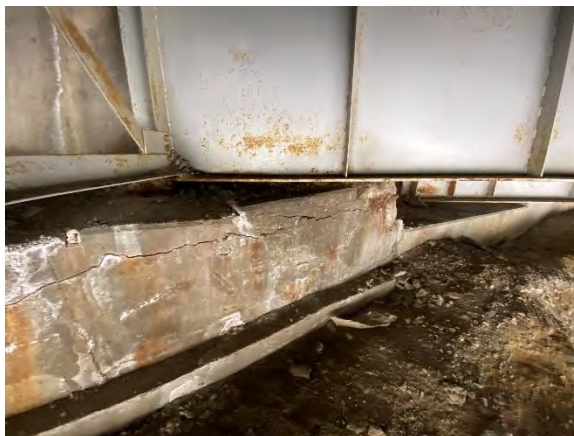
Figure 17. Delamination, rust staining, and failed patch at right end of Abutment 4

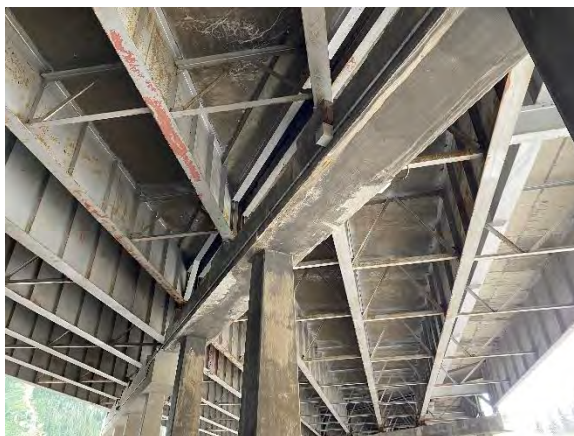
Figure 18. Failing, cracked patches on bottom edges of Pier 3

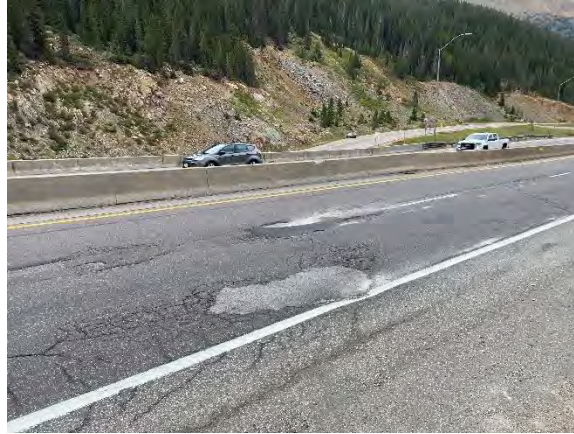
Figure 20. Typical potholes in asphalt wearing surface

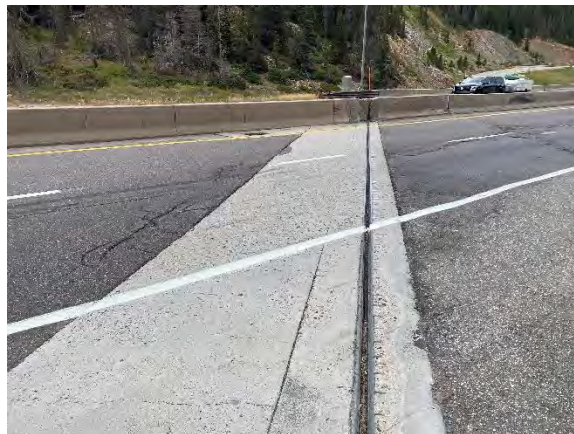
Figure 21. Expansion joint at Abutment 1

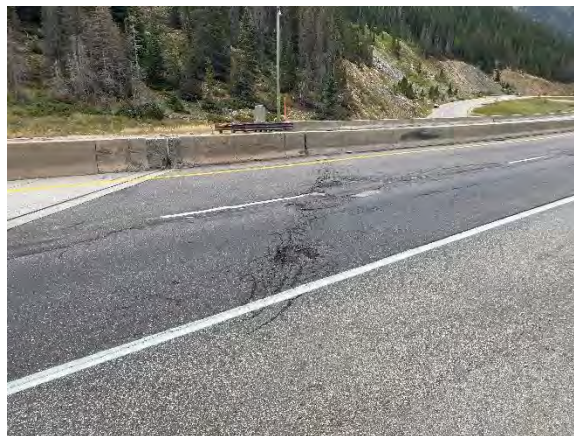
Figure 22. Transverse cracking in asphalt wearing surface over Abutment 1

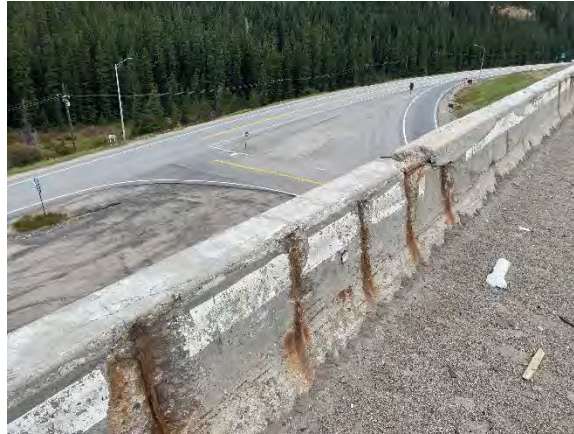
Figure 23. Typical spalling with exposed corroded reinforcement in the concrete barriers

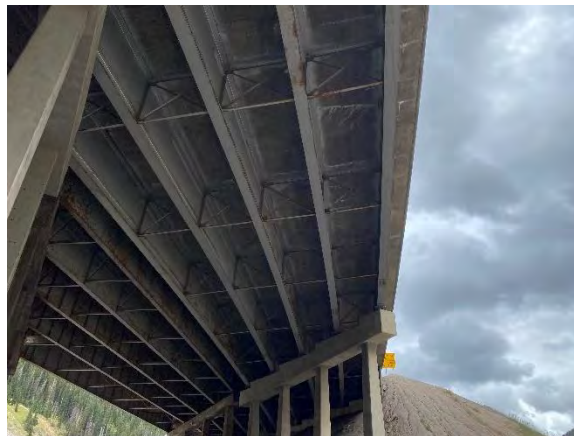
Figure 24. Typical view of underside of deck showing areas of cracking with efflorescence

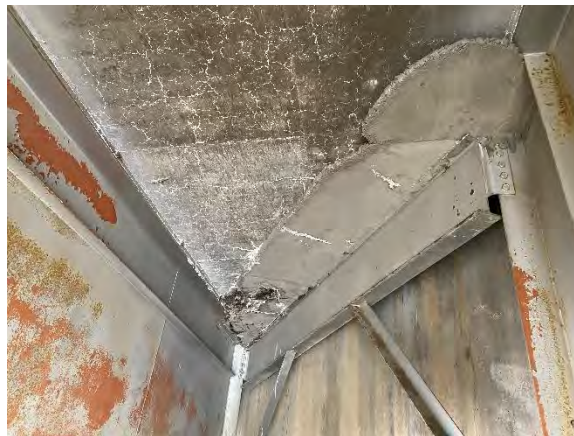
Figure 25. Cracking with efflorescence on underside of joint header at Abutment 4

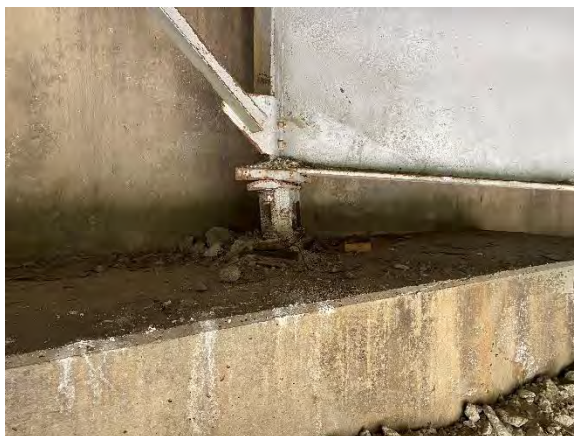
Figure 26. Typical condition of movable bearings, Abutment 1 Girder B

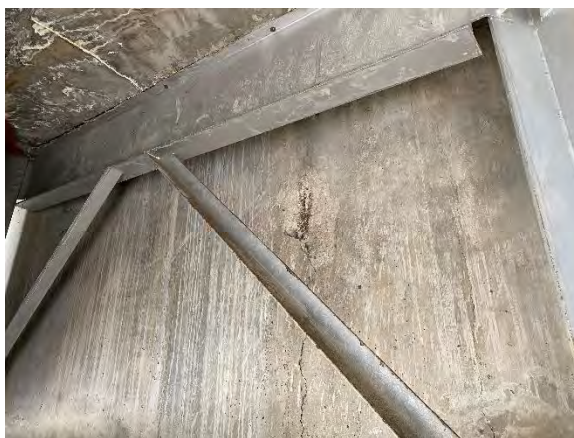
Figure 27. Spall with exposed reinforcement on Abutment 1, Bay D

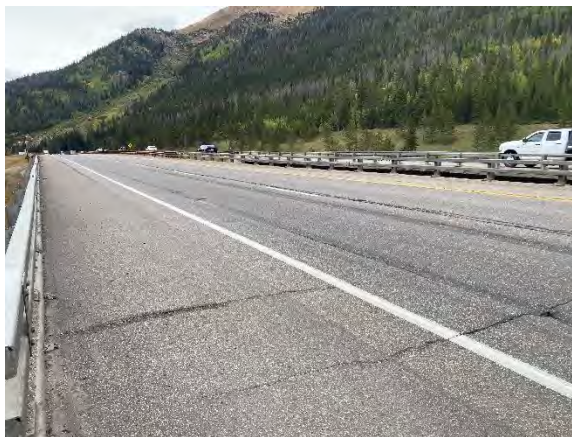
Figure 29. Asphalt rutting in driving lane

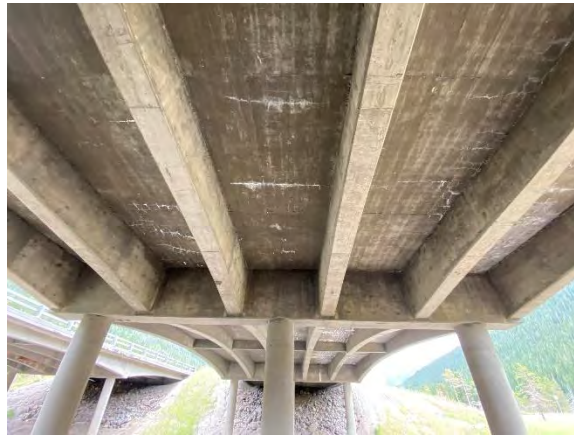
Figure 31. General view of the underside of the deck in Span 1

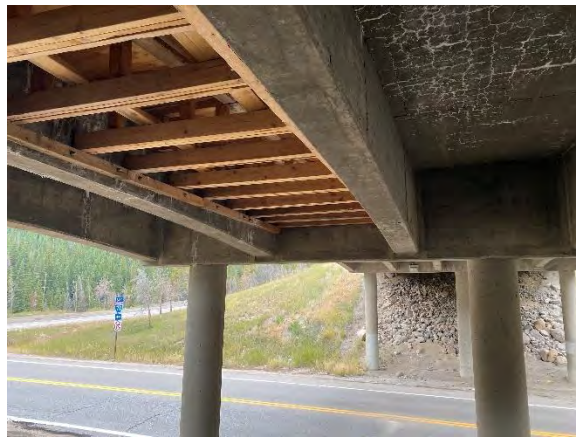
Figure 33. Permanent form work for concrete repair (Bay 3D) and map cracking with efflorescence (Bay 3C)

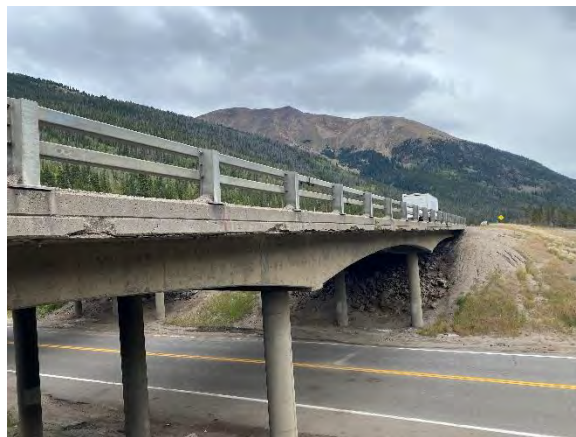
Figure 34. Typical spalling with exposed reinforcement at edges of deck

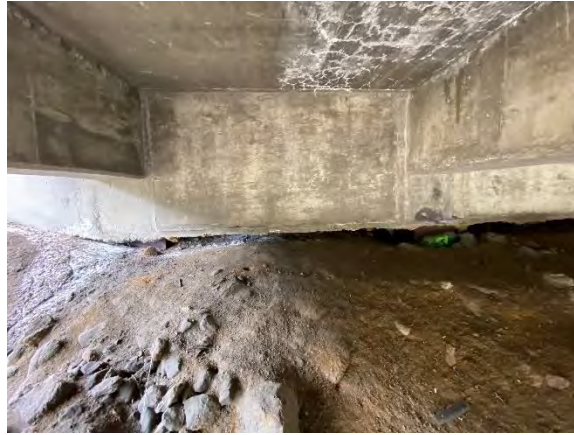
Figure 35. Exposed piles at Abutment 1

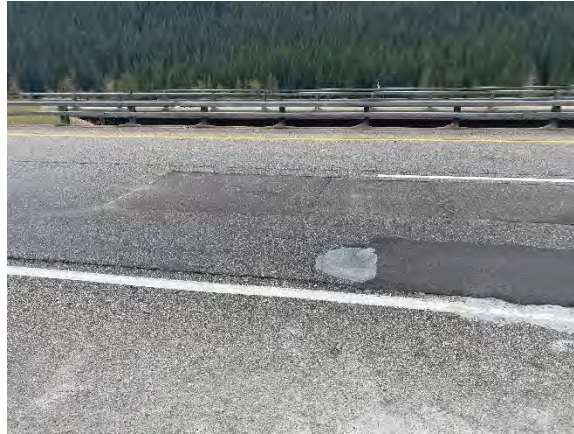
Figure 39. Asphalt patches in wearing surface

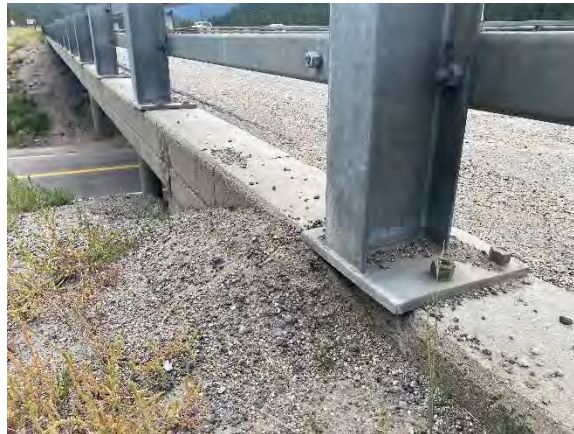
Figure 40. Disengaged nuts on bridge rail anchors

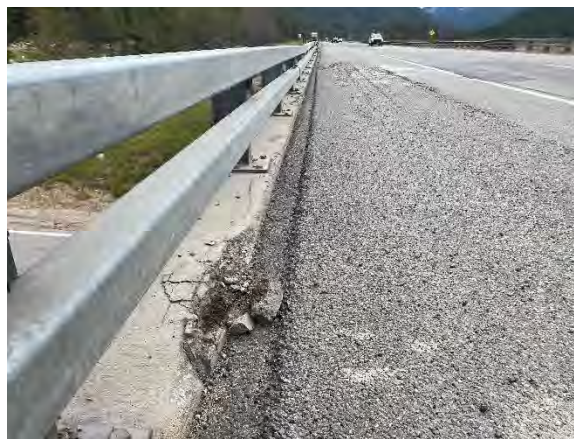
Figure 41. Delamination and spalls on the front face of the curbs

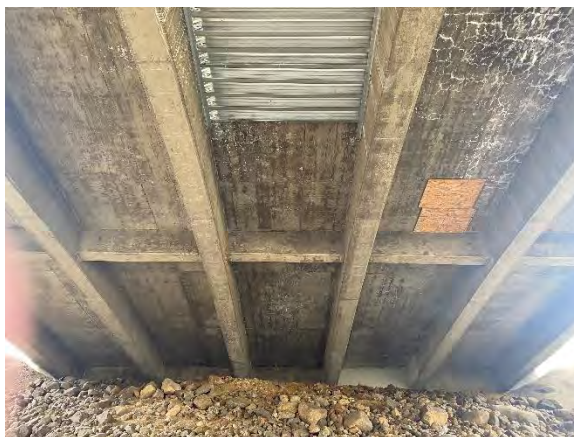
Figure 42. General view of the underside of the deck in Span 1

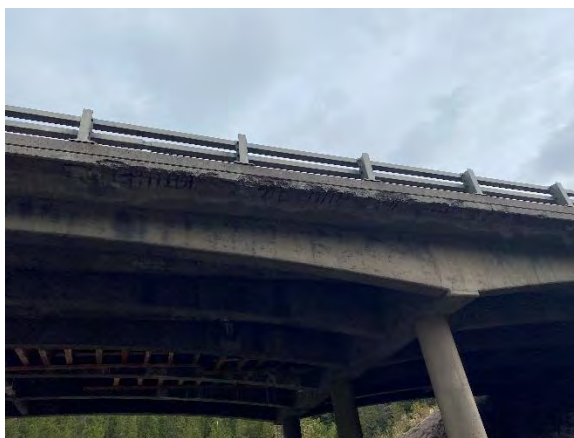
Figure 45. Typical spalling with exposed corroded reinforcement at edges of the deck

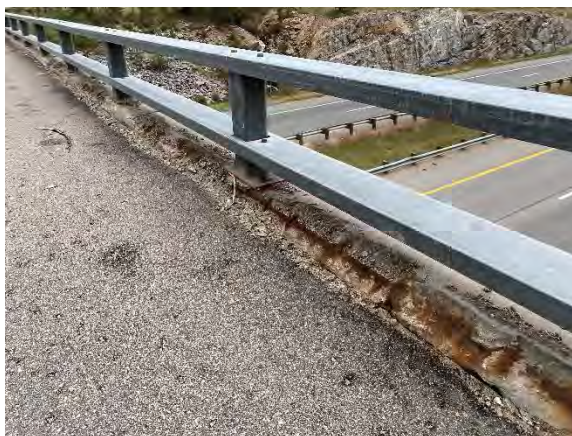
Figure 47. Typical spalls with exposed corroded reinforcement in curbs and “Type N” bridge rail

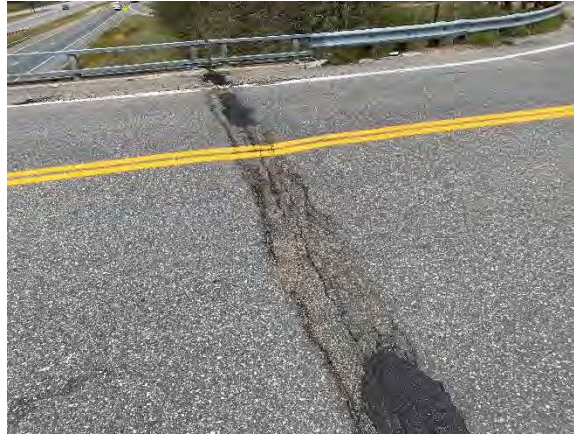
Figure 48. Transverse cracking of asphalt over compression joint at Abutment 3

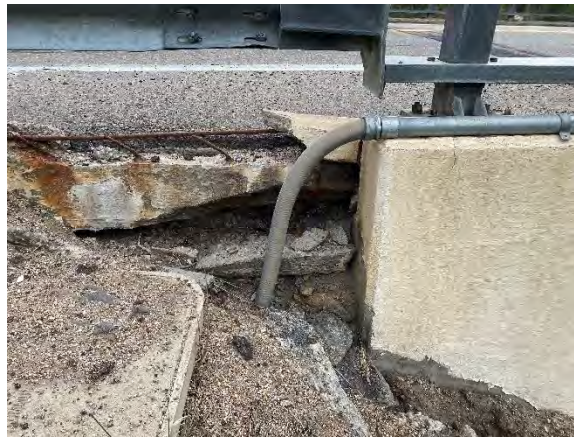
Figure 49. Typical undermining of approach slabs and damage to curbs on approach slabs. Right side of rear approach slab

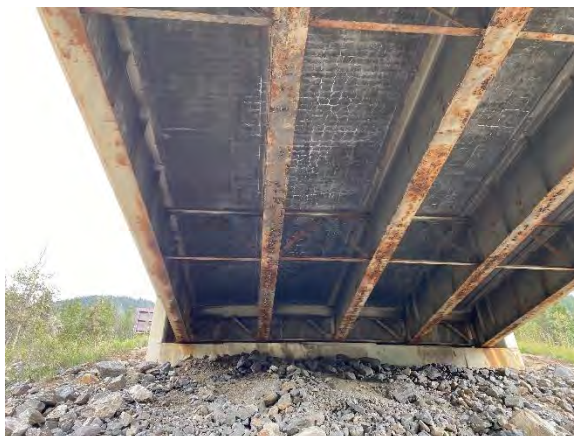
**Figure 50.** Typical view of underside of deck showing areas of cracking with efflorescence, Span 2 at Abutment 3

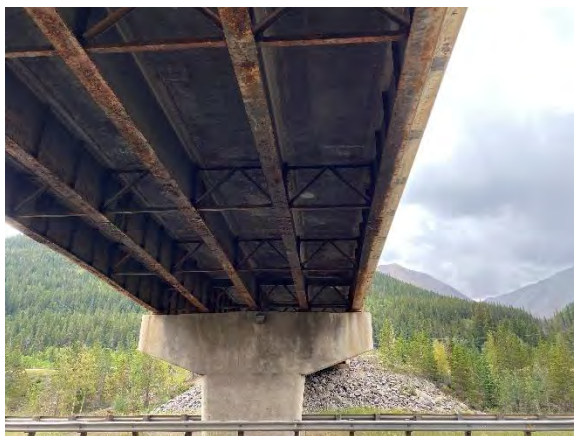
**Figure 51.** View showing general condition of superstructure paint and corrosion on girders

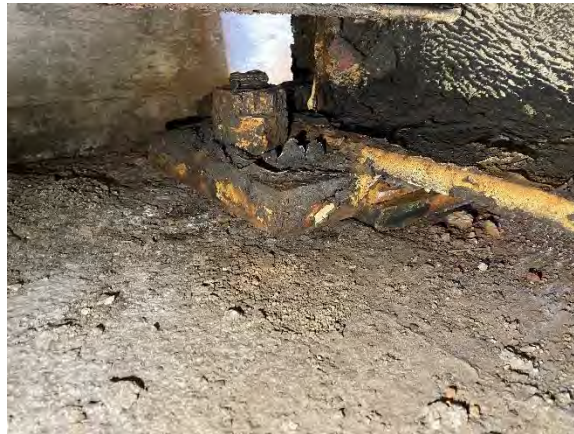
Figure 52. Crushing and bulging of bearing pad 3E

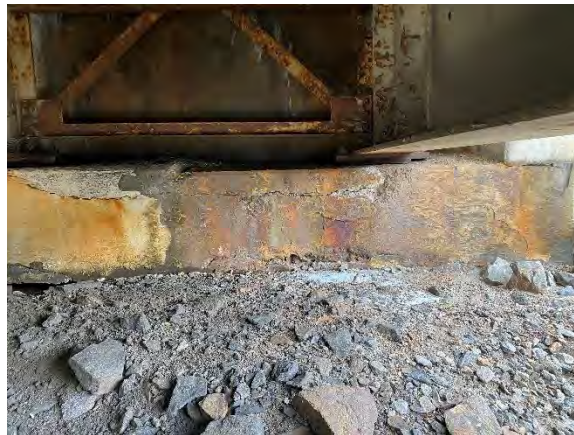
Figure 53. Typical delamination and rust staining on girder seats, Abutment 1 Bay A

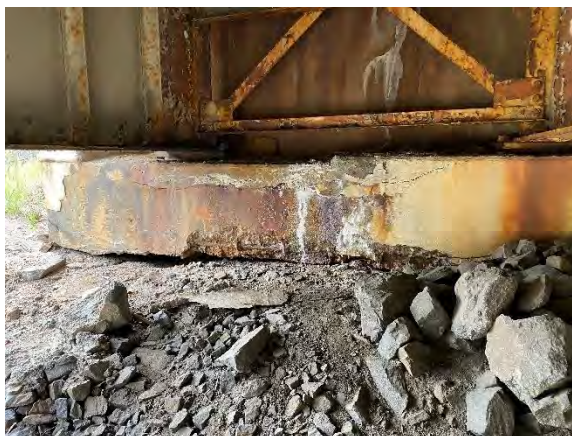
Figure 54. Failed patch exposing corroded reinforcement, Abutment 1 Bay D

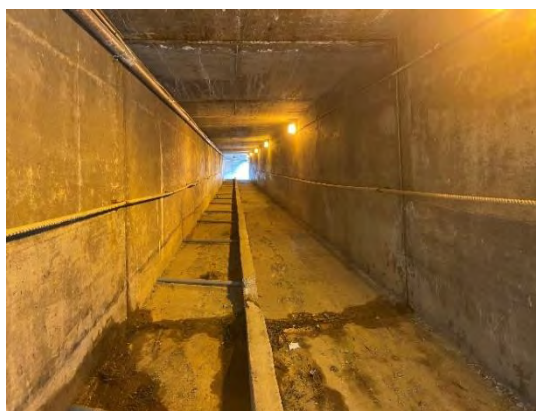
Figure 57. General view through culvert barrel

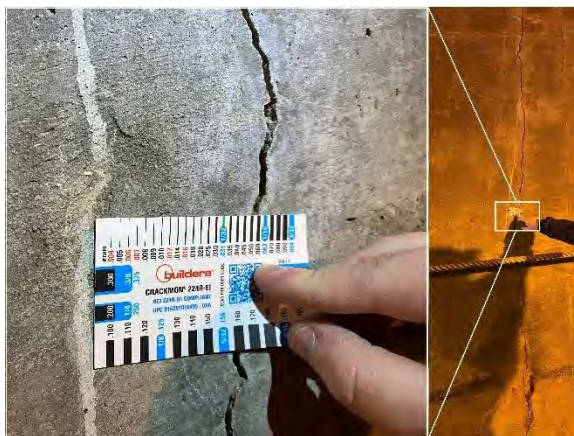
Figure 58. Typical wide width circumferential crack in culvert barrel

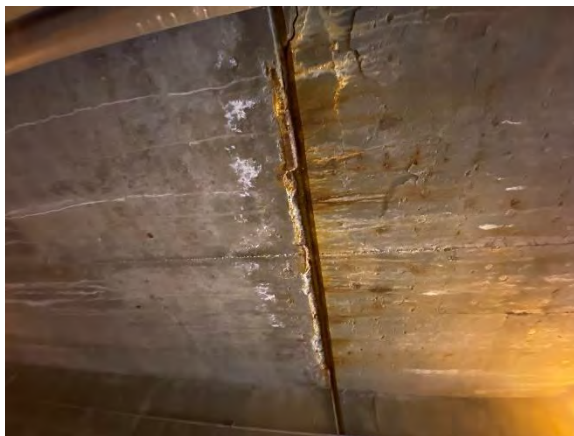
Figure 59. Spalling, leakage, and efflorescence at construction joint 32 feet from outlet

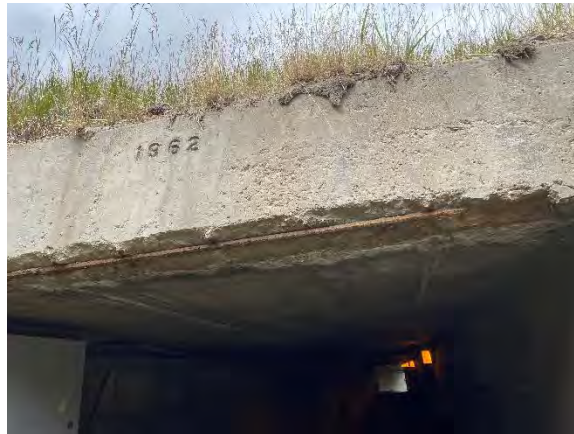
Figure 60. Spall with exposed rebar at outlet

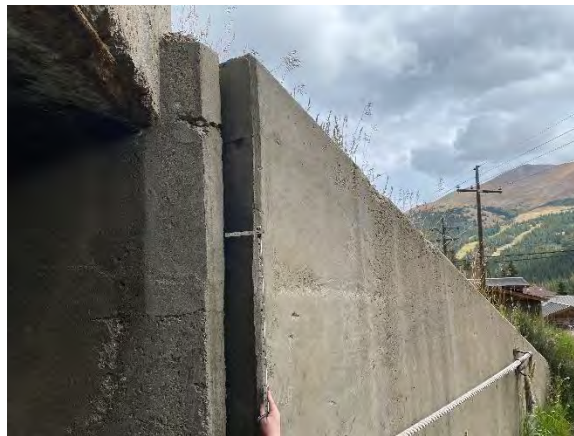
Figure 61. Leaning of southeast wingwall

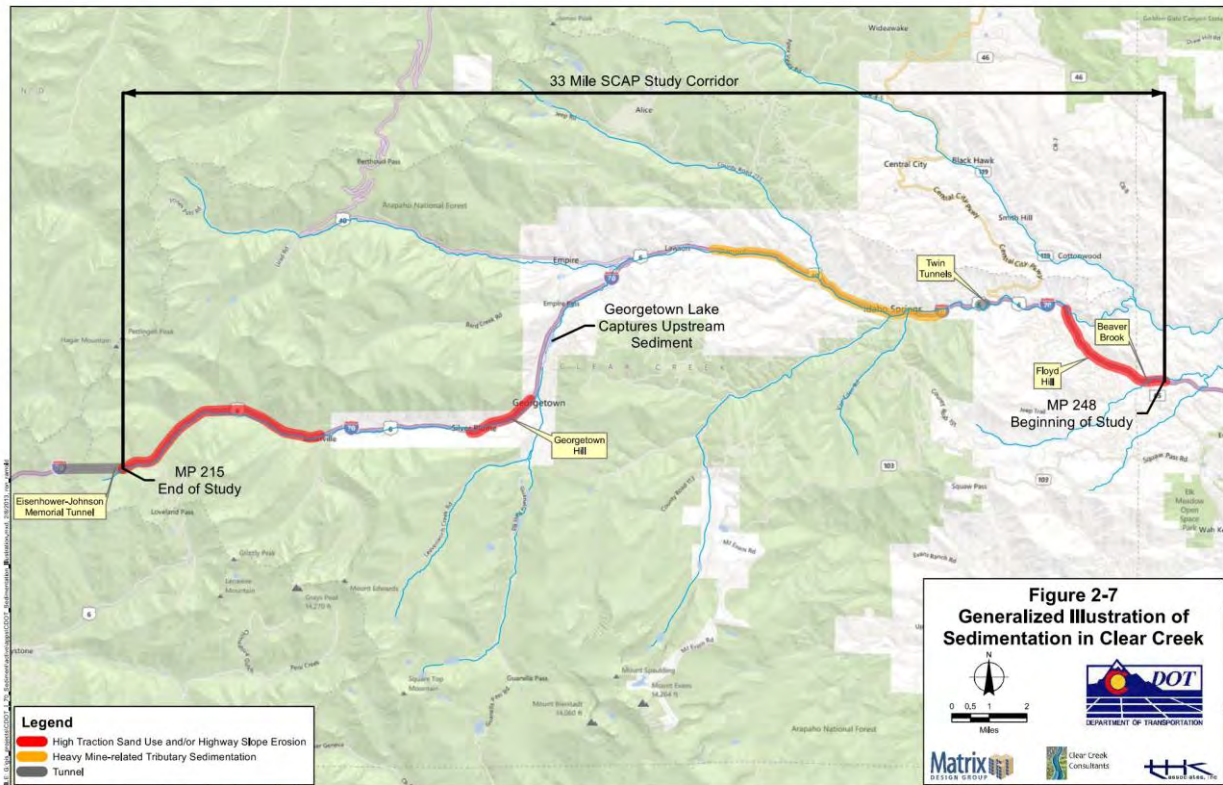
Figure 67. Sedimentation along I-70

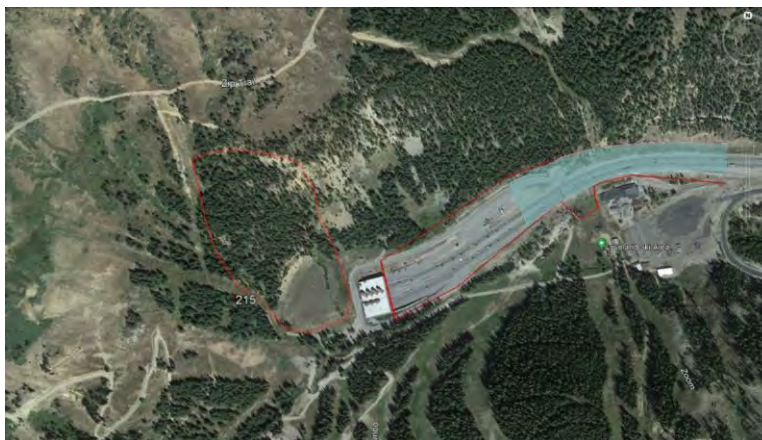
Figure 68. Historic EJMT landslide area and buttress located at MP 215

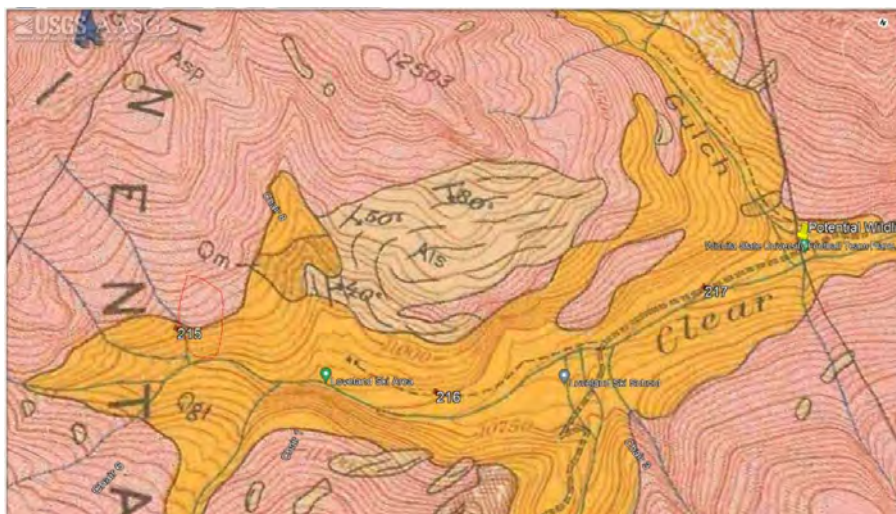
Figure 69. USGS Mapped landslide area above I-70 from MP 215.5 to 216.4

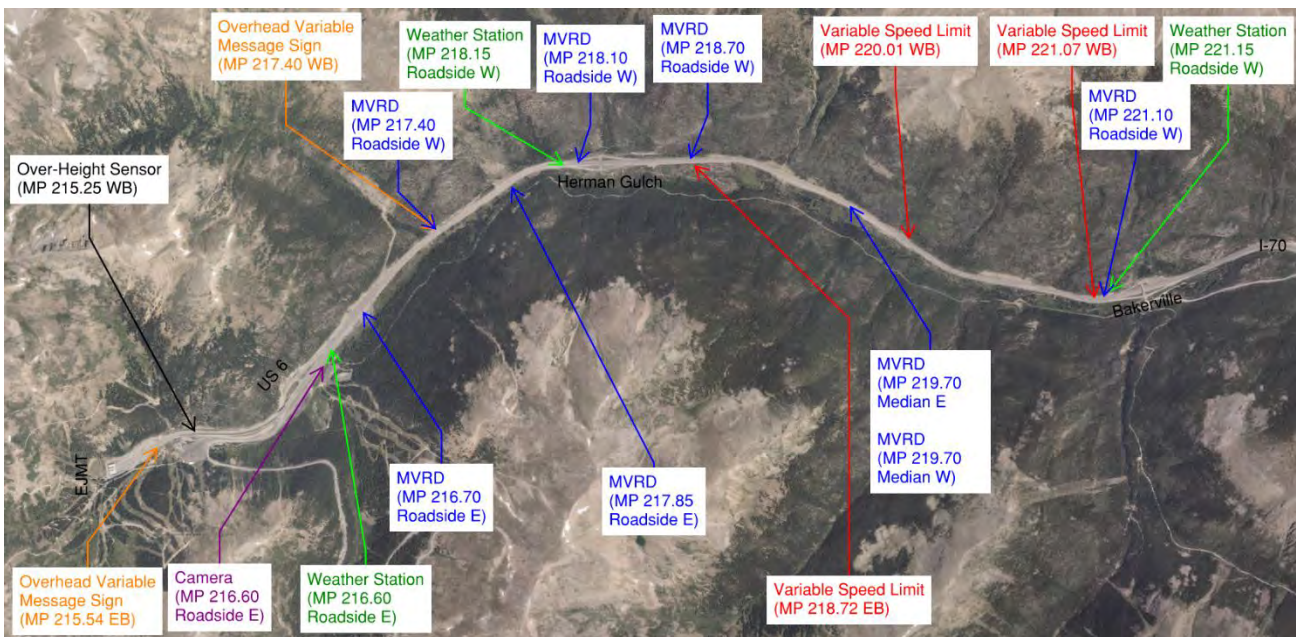
Figure 81. Existing ITS devices

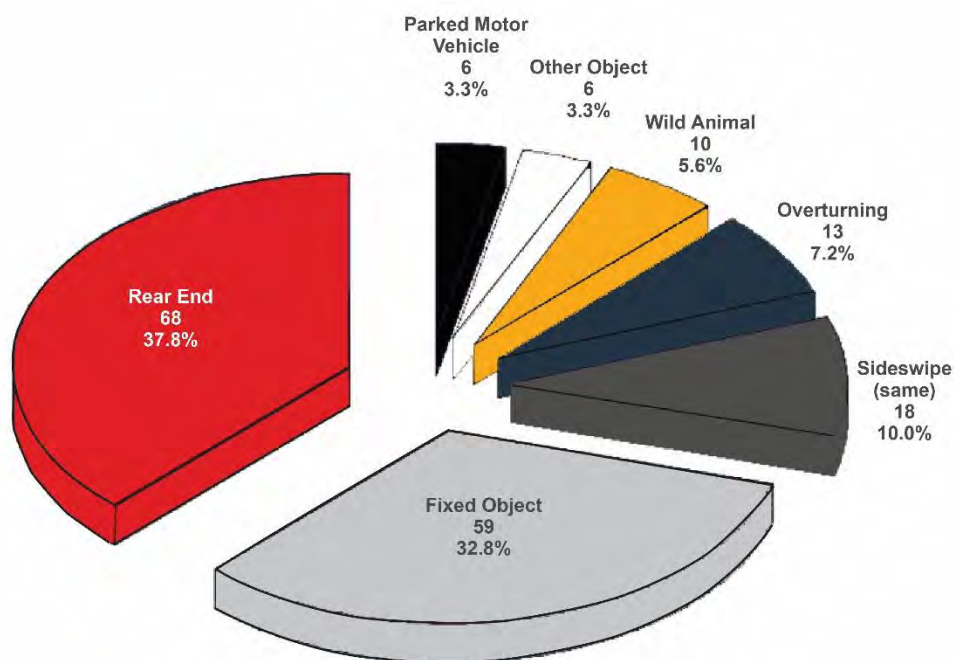
(Source: *DRAFT I-70 Directional Safety Assessment Report: MP 215.30 to MP 221.50 Bakerville Interchange to Eisenhower Tunnel East Portal* (DiExSys 2022))

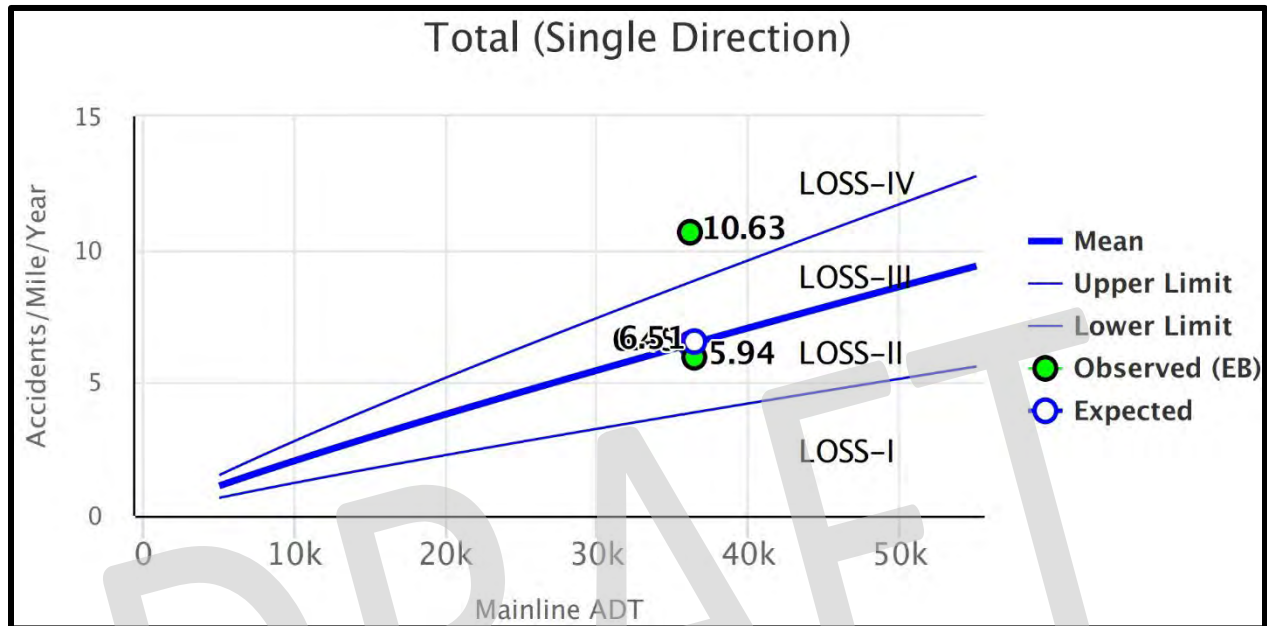
**Figure 6: EB Corrected Segment Safety Performance, Total Crashes I-70 Mainline EASTBOUND ONLY**

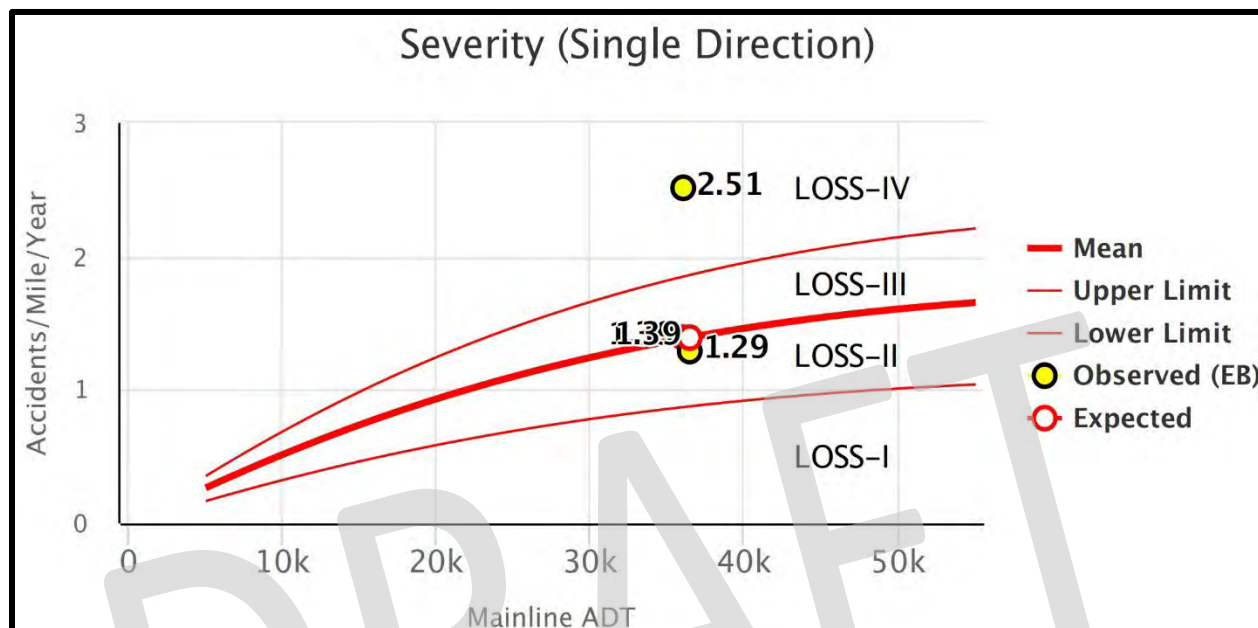
**Figure 7: EB Corrected Segment Safety Performance, INJ + FAT Crashes I-70 Mainline EASTBOUND ONLY**

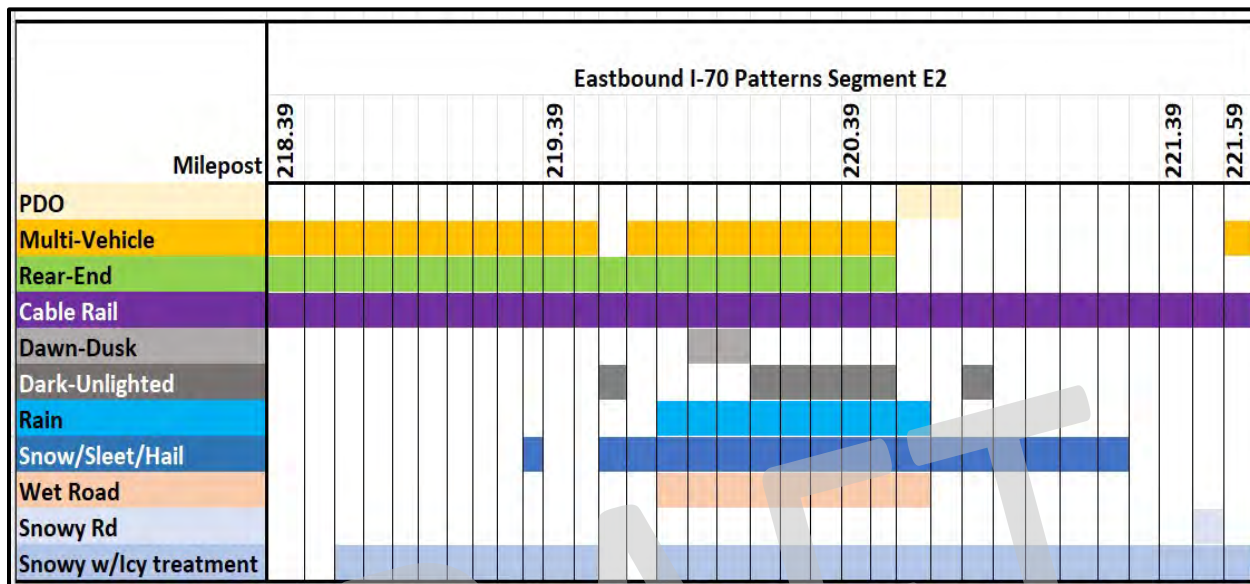
**Figure 17: Mainline Crash Patterns, Eastbound I-70 Segment E2, MP 218.39 – 221.50**

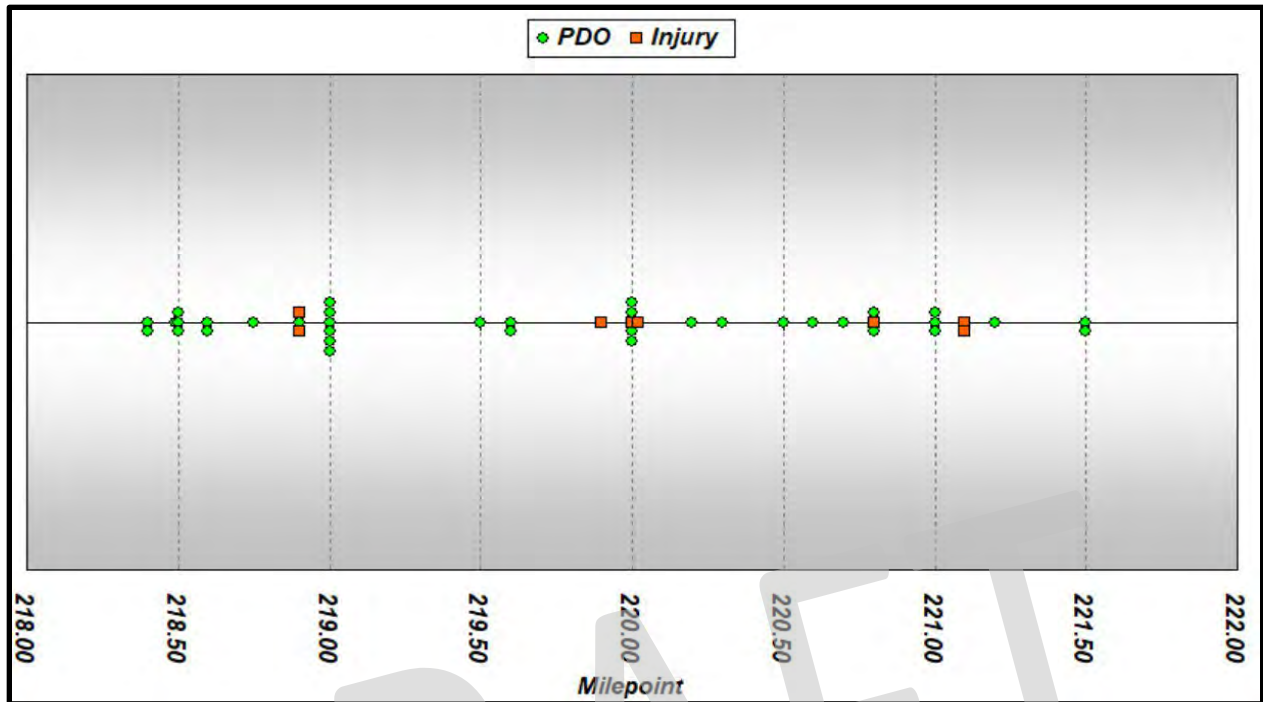
Figure 18: Straight Line Diagram for Rear-Ends Segment E2

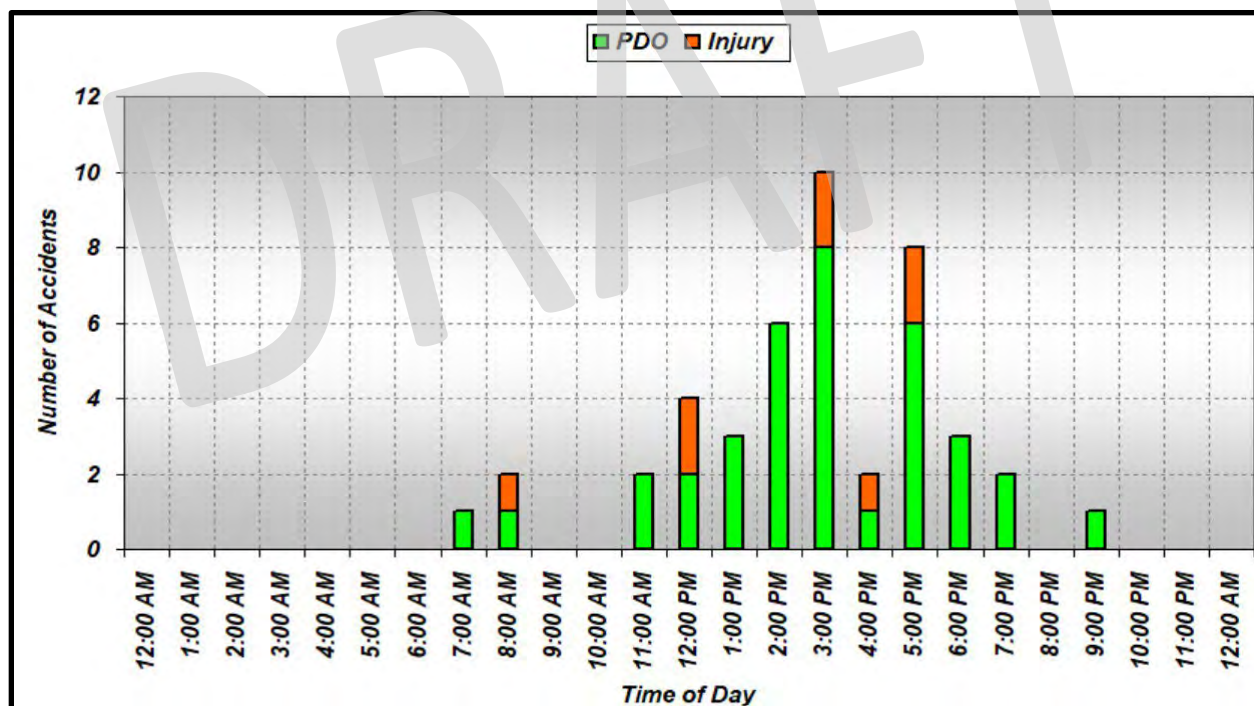
**Figure 20: Rear-Ends by Time of Day EB I-70 Segment E2**

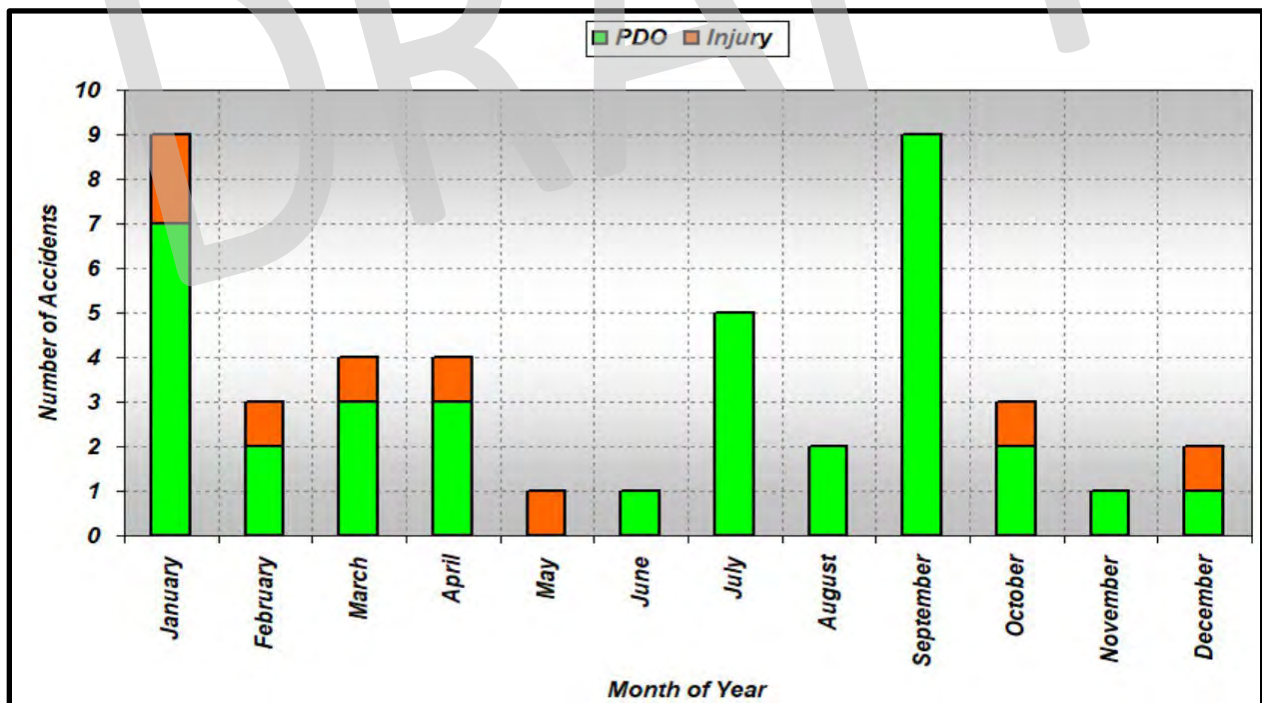
Figure 22: Rear-Ends by Month of Year EB I-70 Segment E2
