# CDOT R1 I-70 BAKERVILLE TO EJMT WB AUX LANE EXISTING CONDITIONS REPORT

NHPP 0703-502 ▪ PCN 24808 ▪ Revision: December 7, 2022

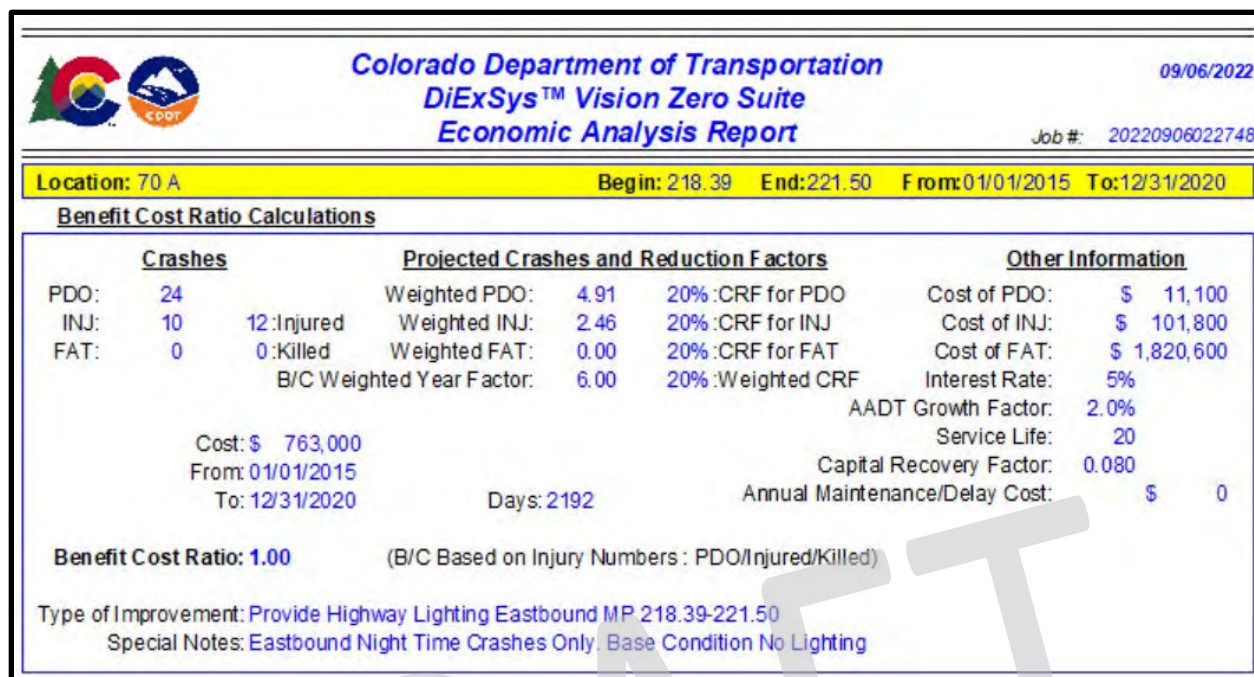
**Table 7: B/C Analysis for Eastbound Highway Lighting for Segment E2**

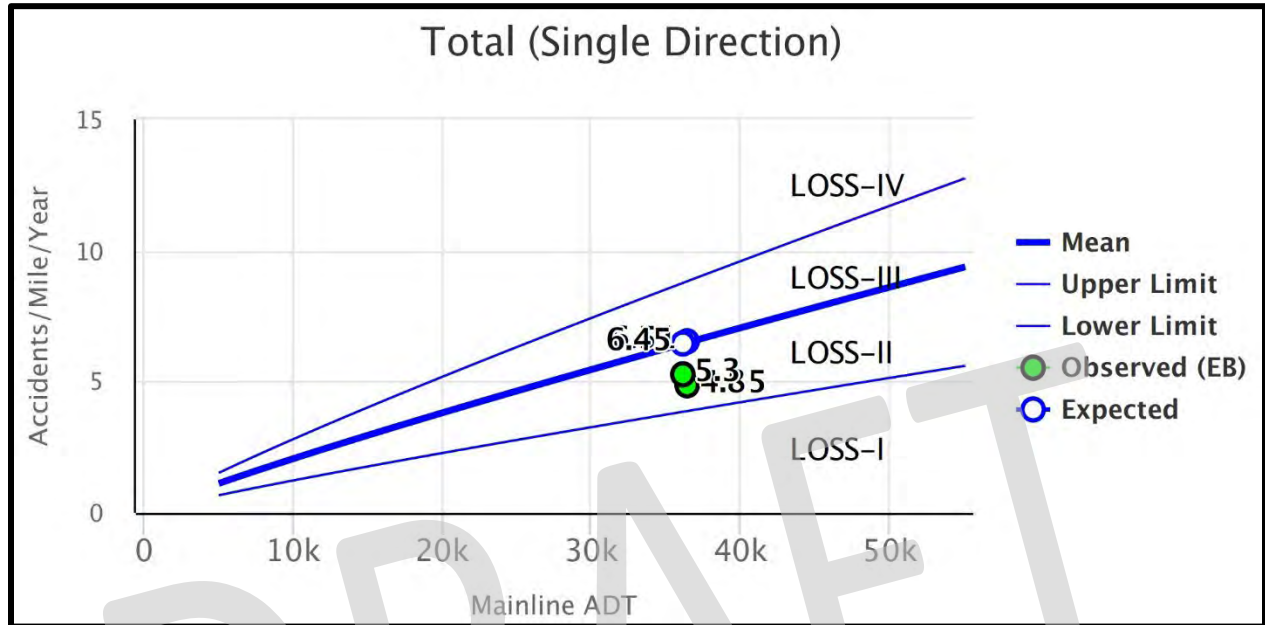
**Figure 24: EB Corrected Segment Safety Performance, Total Crashes I-70 Mainline WESTBOUND ONLY**

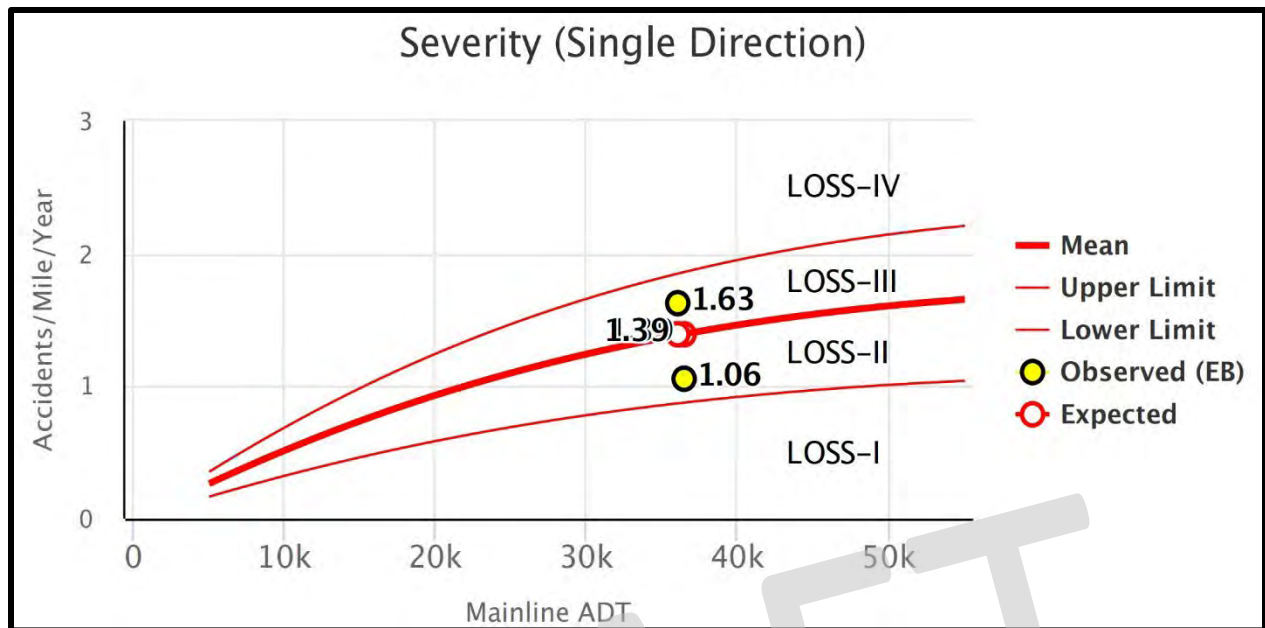
**Figure 25: EB Corrected Segment Safety Performance, INJ+ FAT Crashes I-70 Mainline WESTBOUND ONLY**

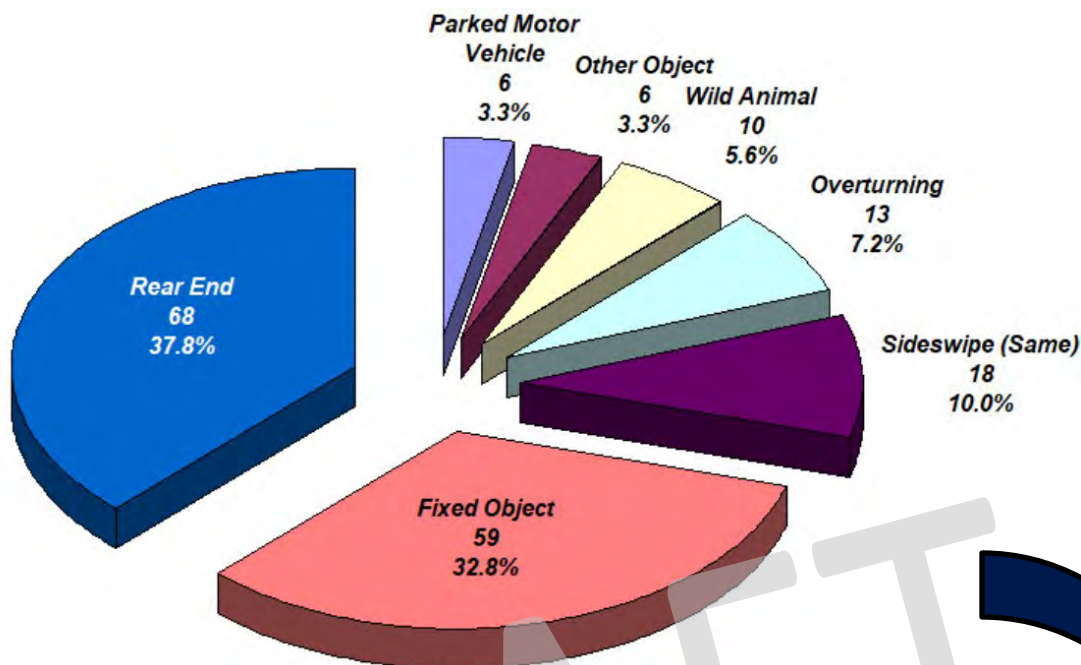
**Figure 26: Westbound I-70 MP 215.30-221.50 Mainline Crash Type Distribution**

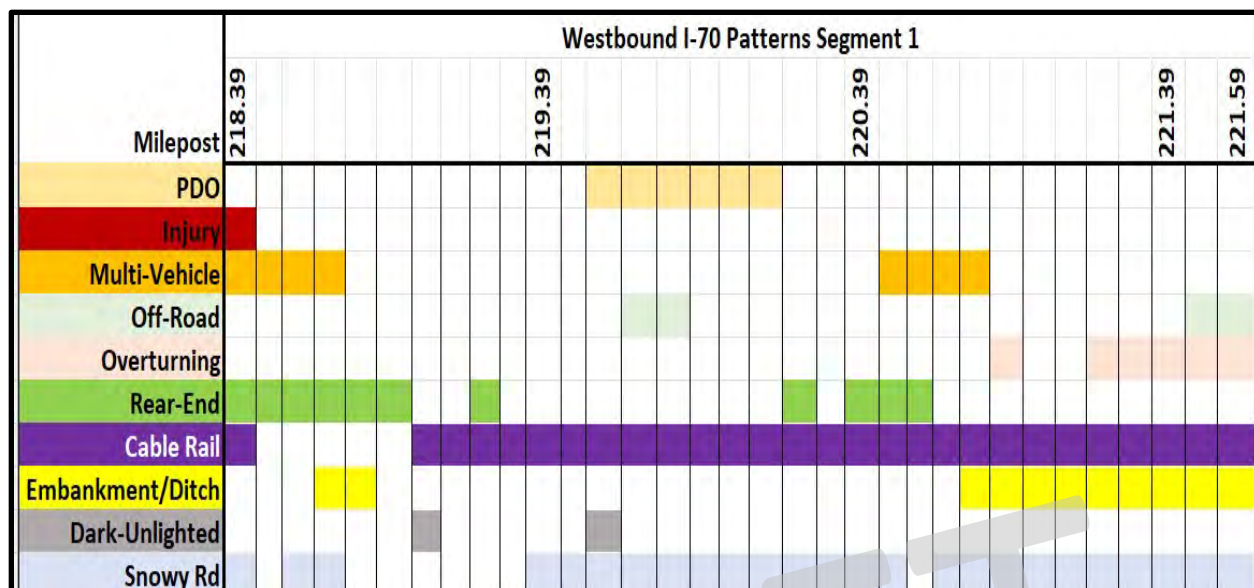
Figure 28: Mainline Crash Patterns, Westbound I-70 Segment 1, MP 218.39-221.50

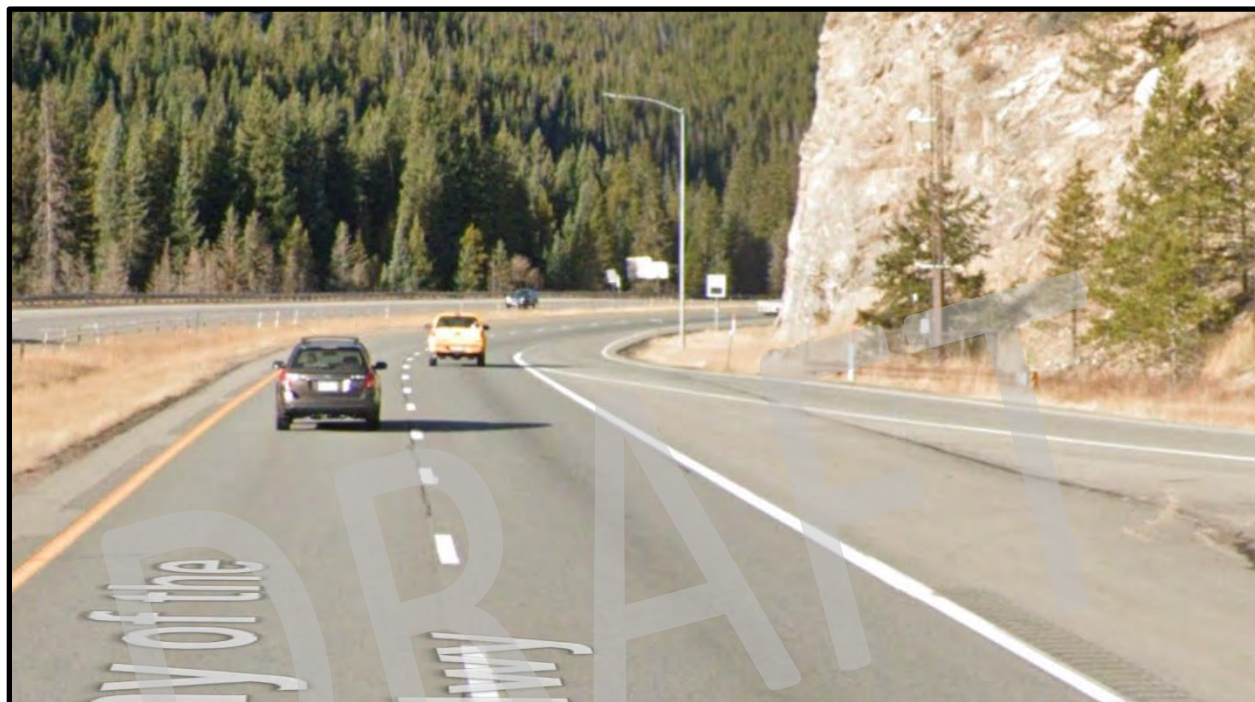
**Figure 30: Westbound I-70 Cross Section near MP 221**

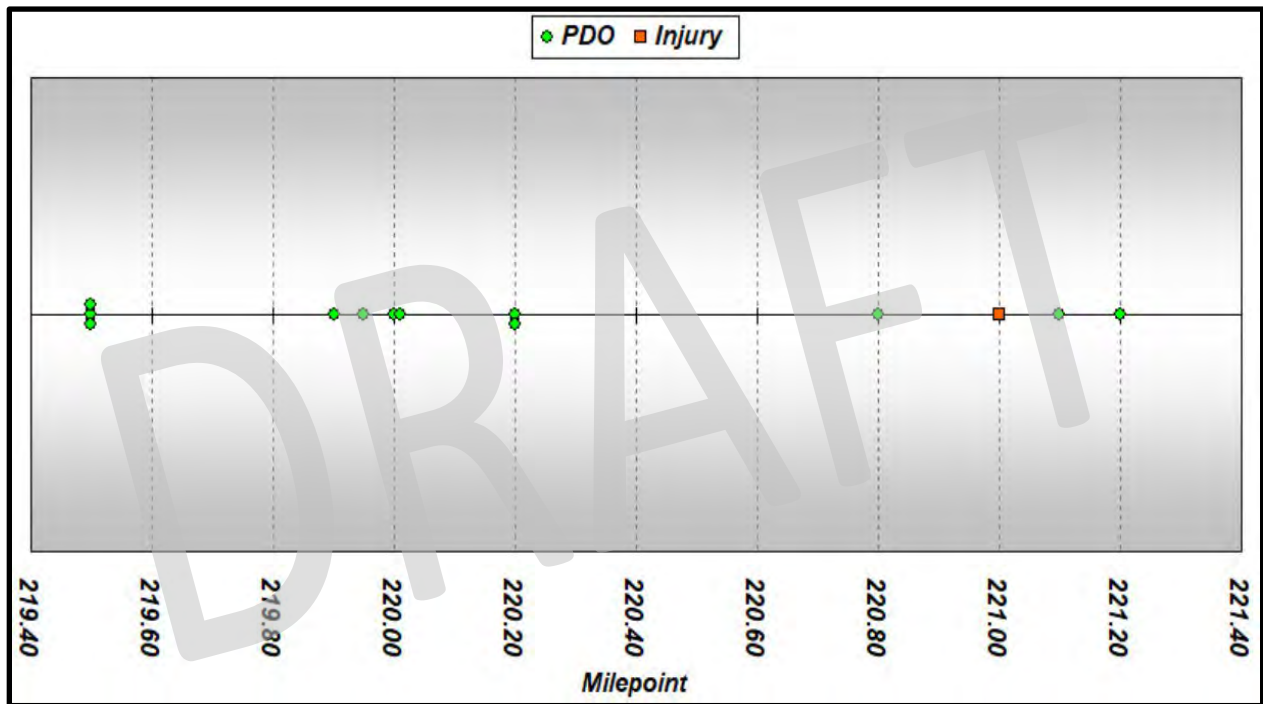
**Figure 31: Straight Line Diagram for Cable Rail Crashes Segment W1**

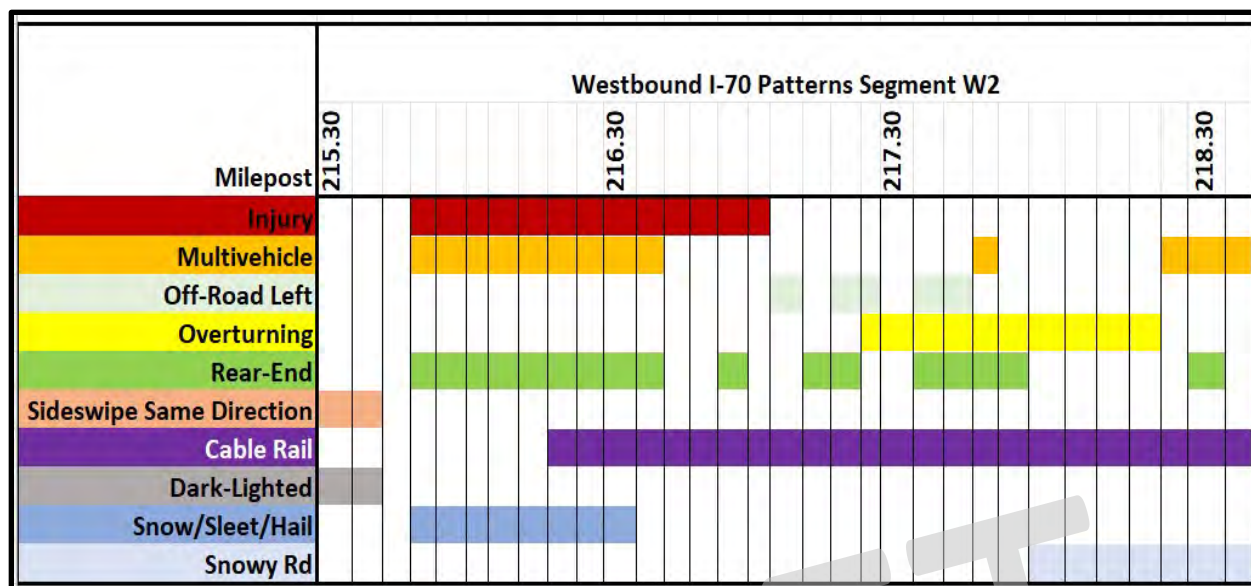
**Figure 33: Mainline Crash Patterns, Westbound I-70 Segment 2, MP 215.30-218.38**

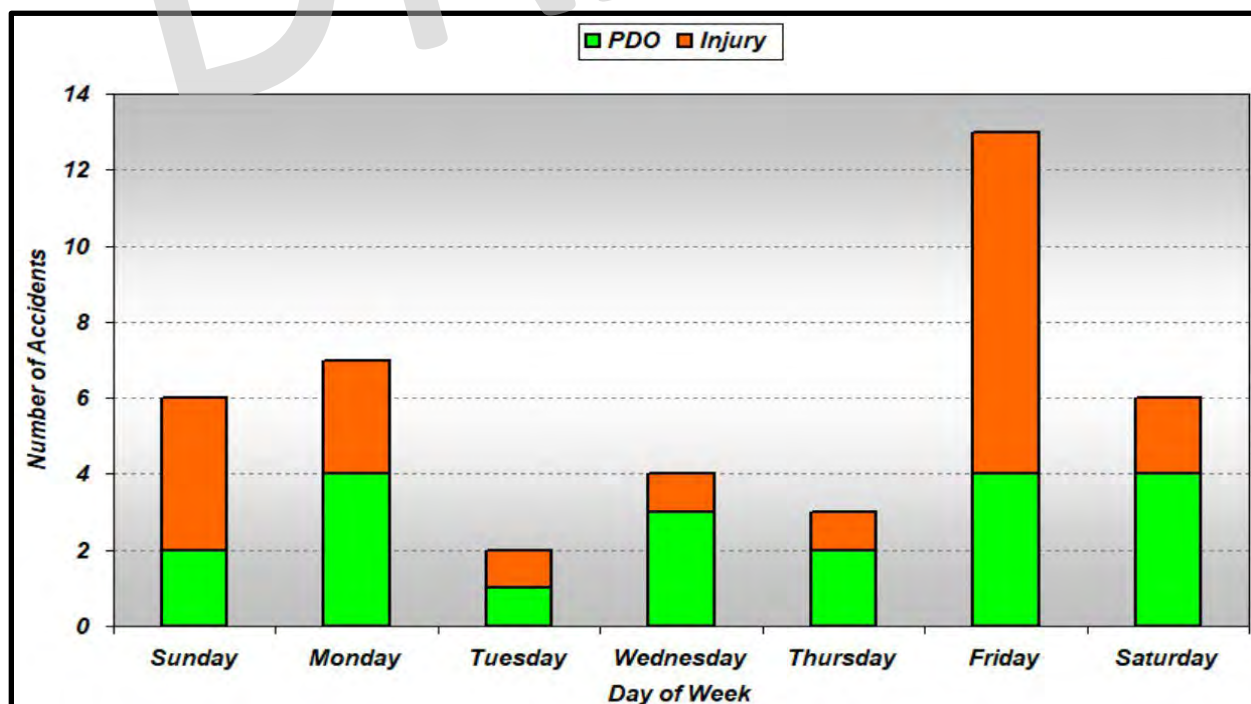
Rear-end crashes are multivehicle crashes by nature which is why we see the overlap in patterns here. The presence of multivehicle rear-end crashes westbound at the west end of the corridor are observed to be concentrated on Fridays (see **Figure 34**), with crashes elevated throughout the day from 9 A.M. to 5 P.M. (see **Figure 35**). Crashes show spikes in the months of March, August and October (see **Figure 36**), which can be popular times for seasonal recreational travel to mountainous destinations west of the Denver metro area.

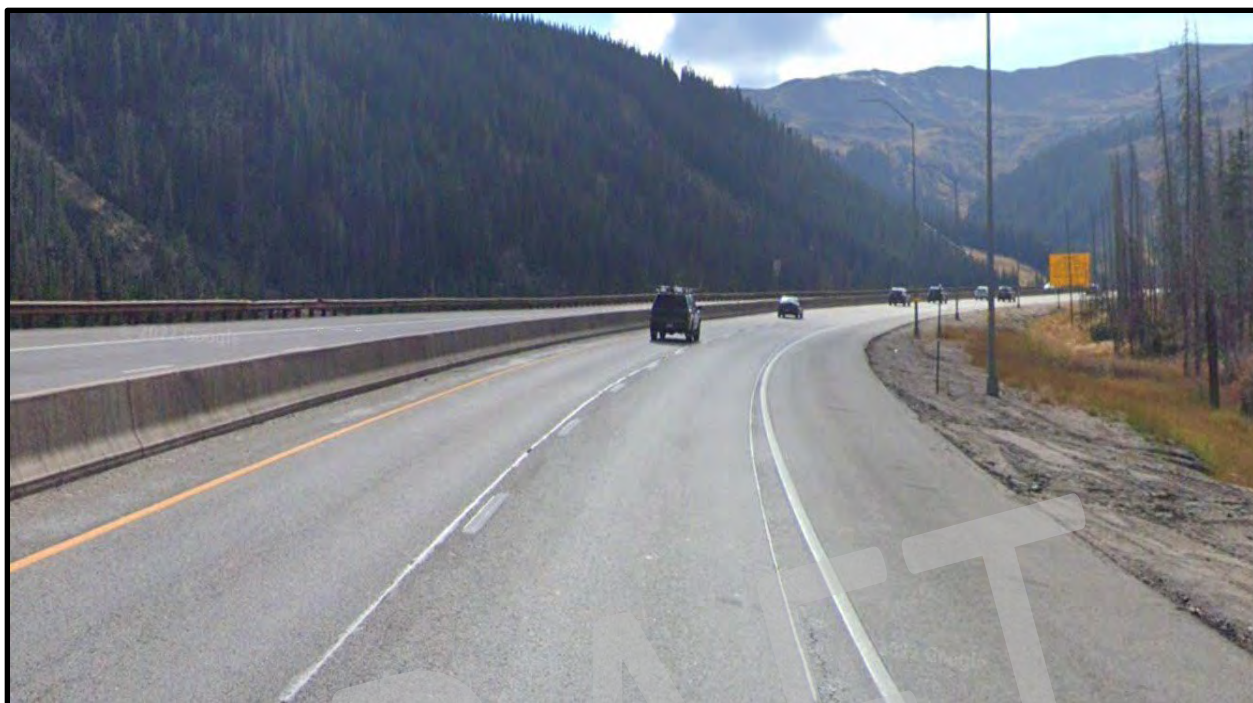
**Figure 38: View approaching tunnel near MP 216 Westbound I-70 Segment 2**

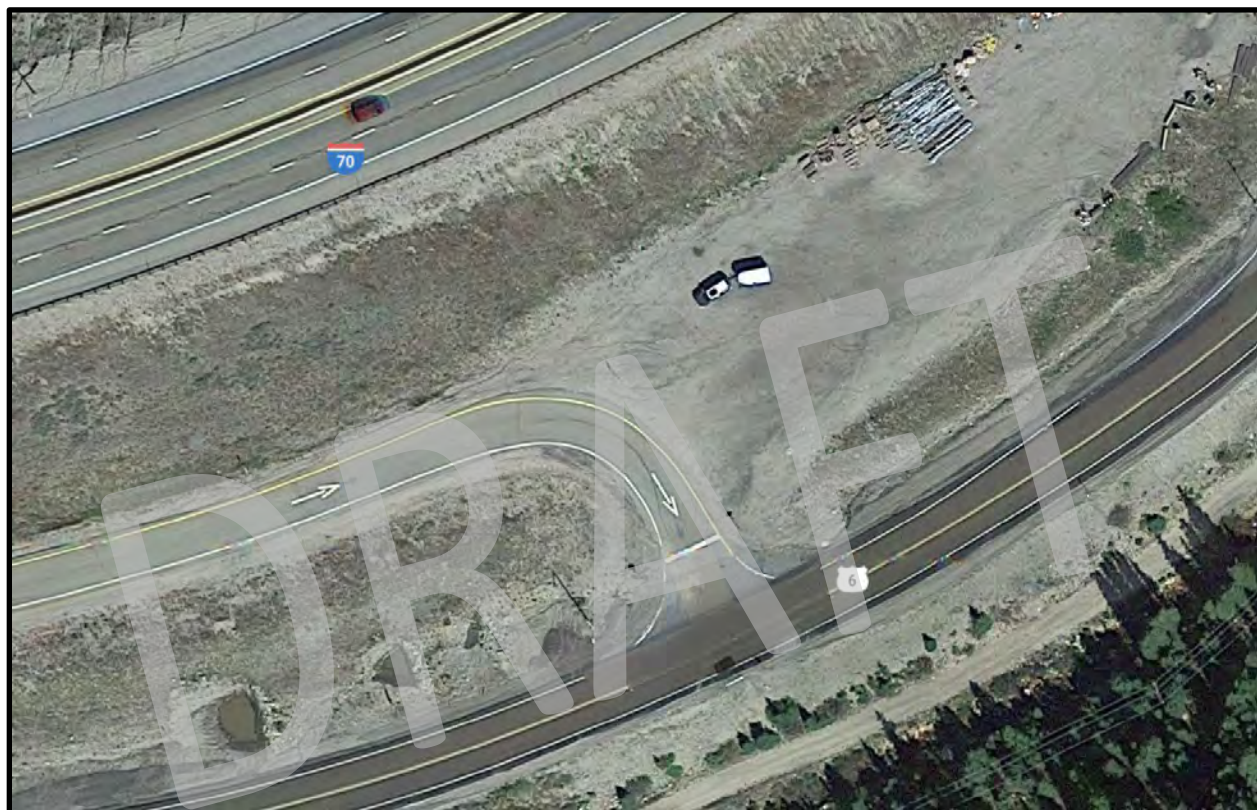
**Figure 39: I-70 Eastbound Off-Ramp to US-6/Loveland Interchange, Exit 216**

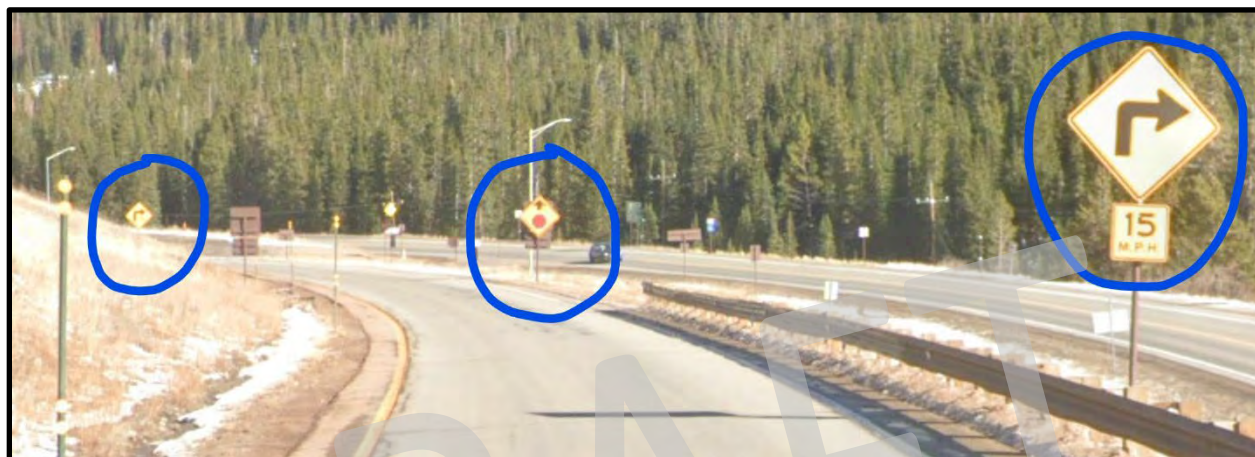
Figure 40: Exit 216 EB, US-6/Loveland Interchange Off-Ramp

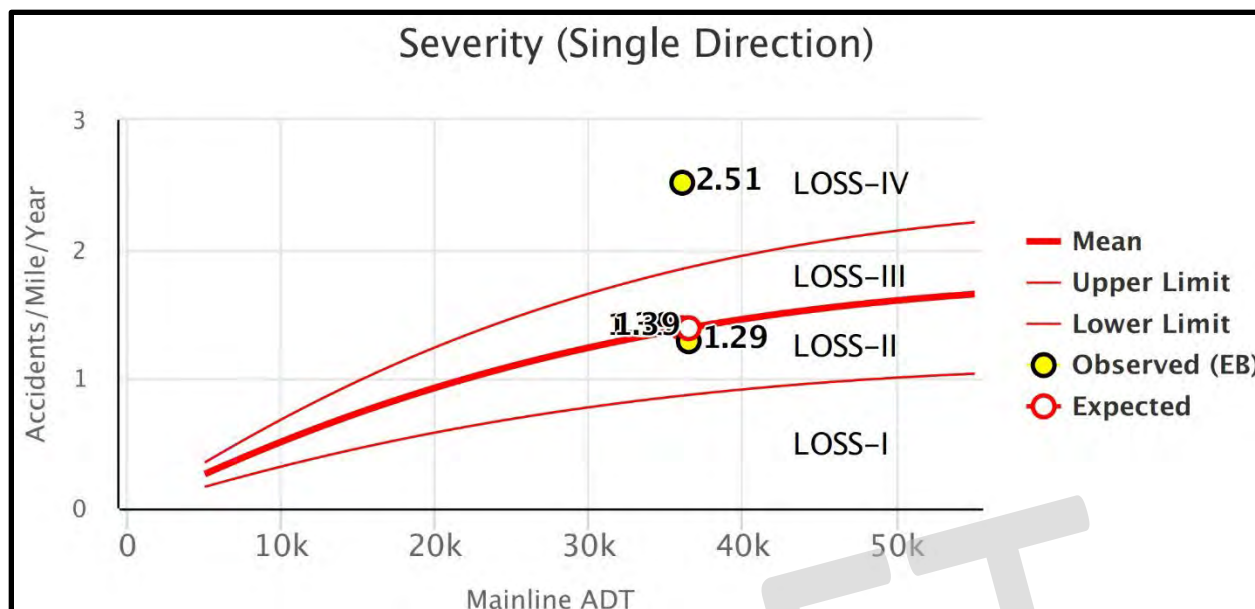
**Figure 42: SPF INJ+FAT Crashes I-70 Eastbound Segment E1 and E2**

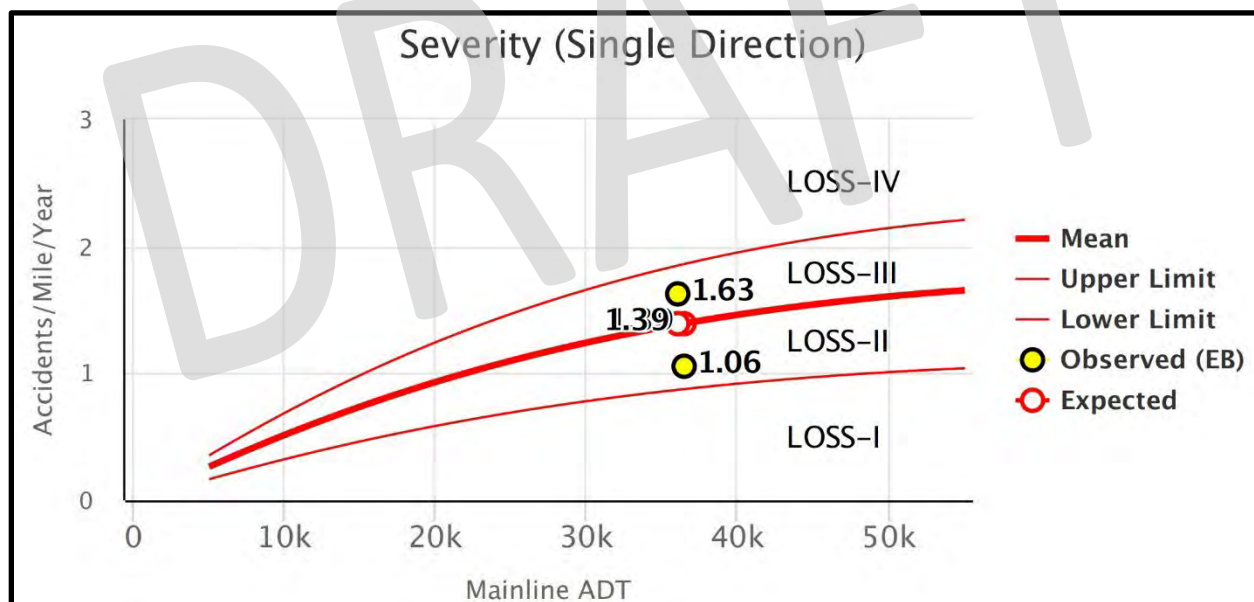
**Figure 44: SPF INJ+FAT Crashes I-70 Westbound Segment W1 and W2**
