## **Close Out Documents**

**AP-75: 4620 Clayton St.**

Structural Demolition

## **Structure Survey Assessment Report AP-75**

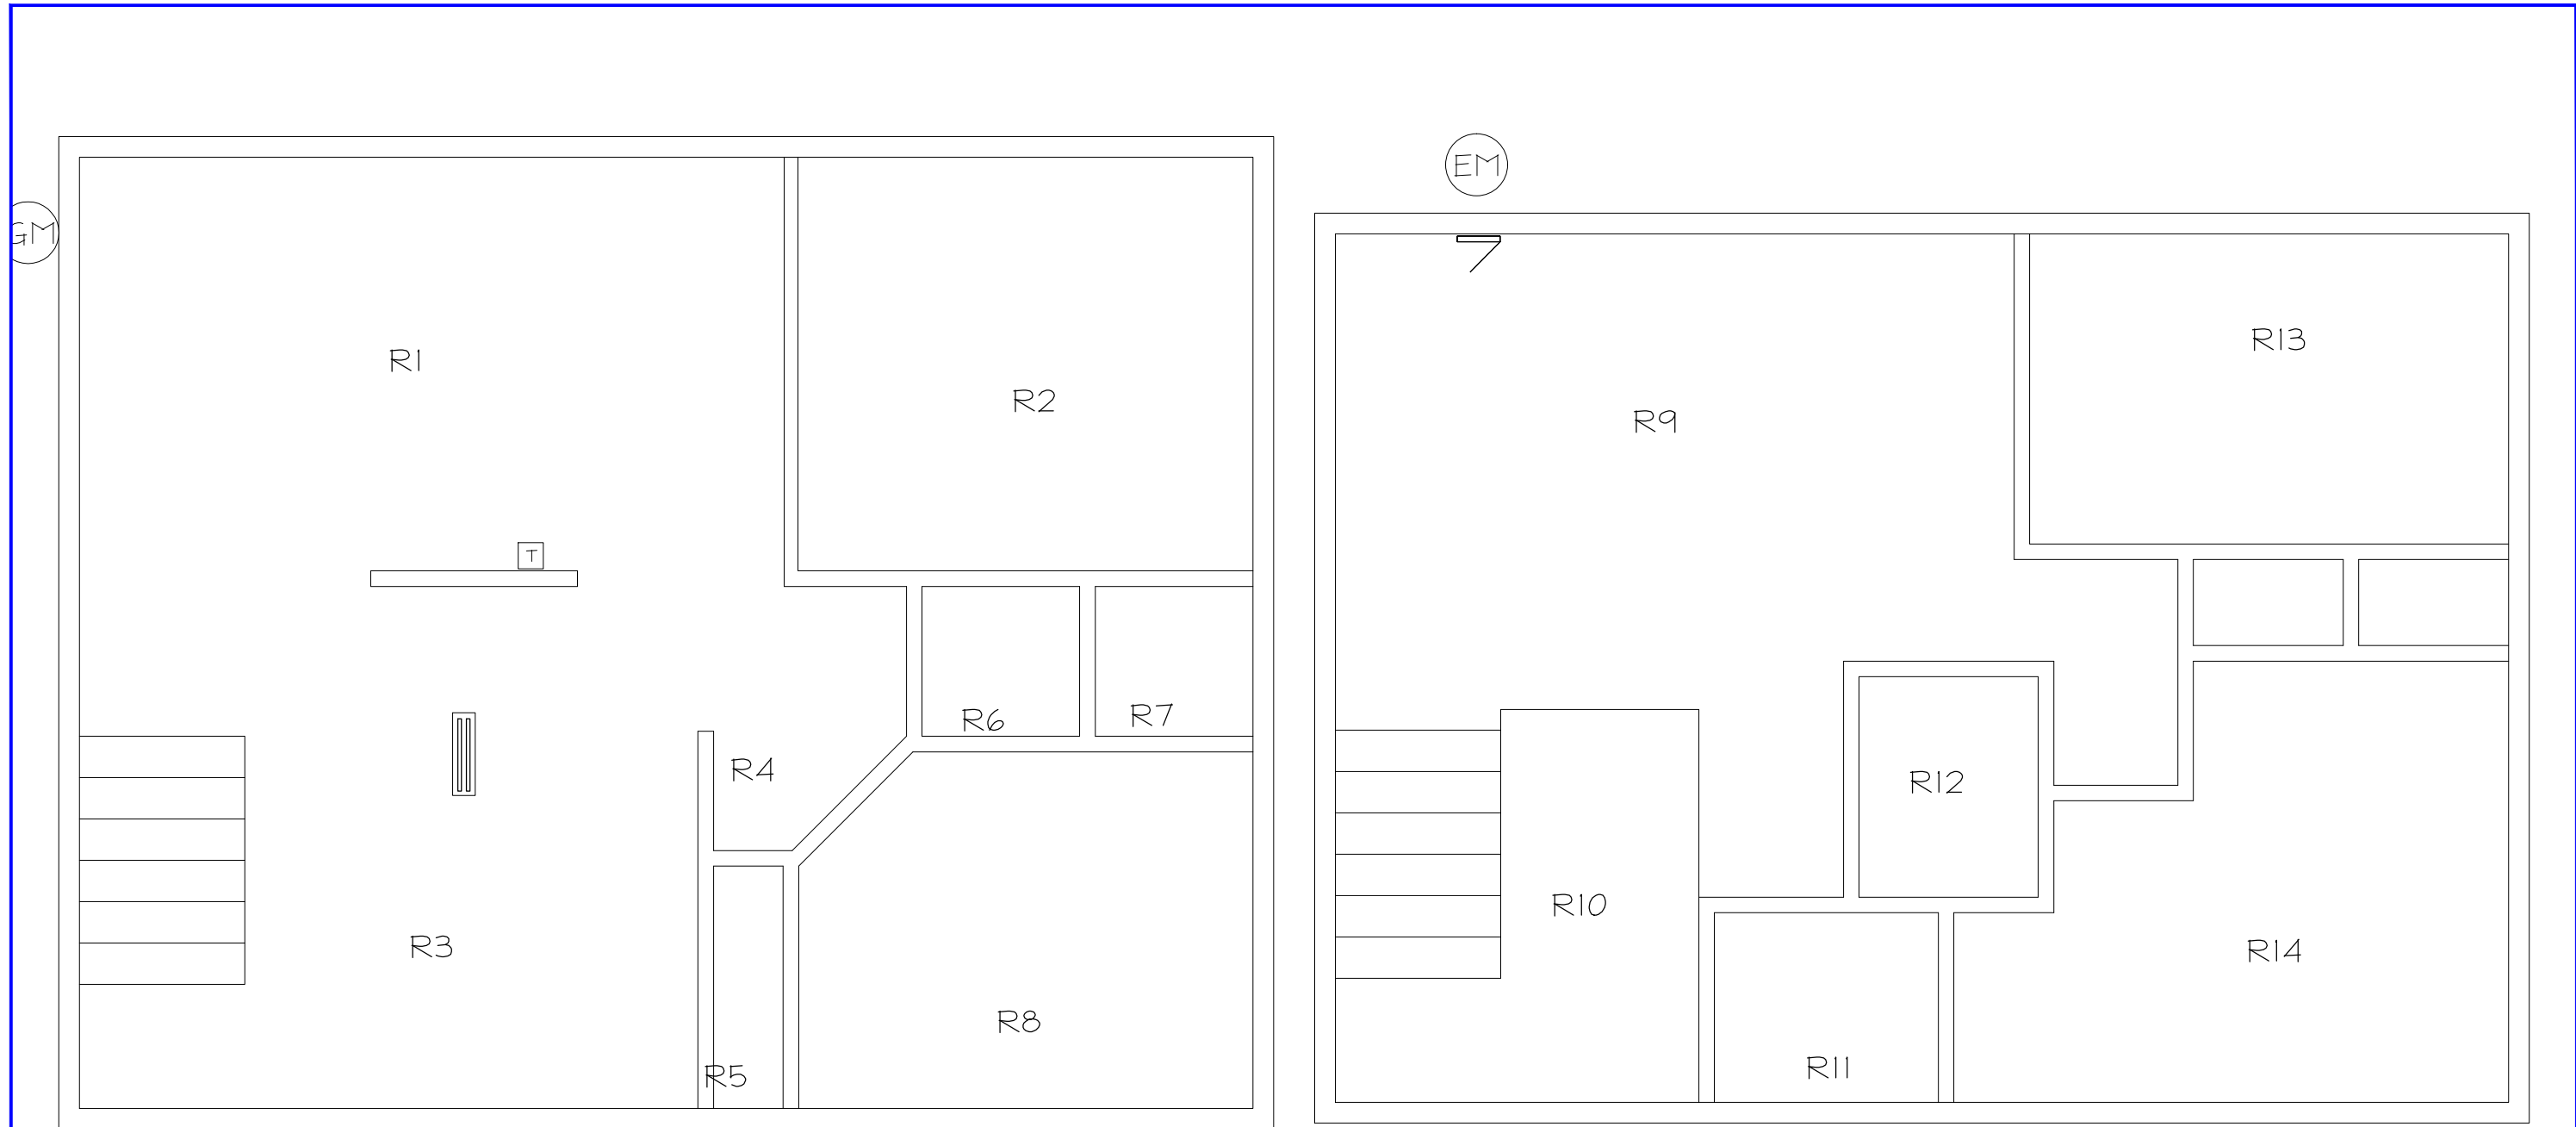
**FIGURE 4 - Regulated Building Material**  
 CENTRAL 70 - Structure Survey Assessment Map  
 AP-75  
 4620 Clayton St., Denver, CO  
 April 27, 2018  
 APEC #: 18-3066

Several suspect RBMs were visually identified throughout the structure. RBMs that are a cause of concern, when discovered, are discussed below. A complete list of the RBMs is presented in Table 3-3, and selected locations of the RBMs are depicted in Figure 4.

Materials found during the regulated materials inventory within the building may require special handling or disposal prior to demolition activities. If abatement is needed, APEC recommends that the asbestos contractor or general contractor selected by the client properly dispose of these regulated materials, per applicable regulations.

With regards to RBMs, if listed, it is likely that the ballasts in the fluorescent light fixtures do contain PCBs. Where a manufacturer's label is present indicating "no PCBs", the ballast can be disposed of with recyclable metal or with other municipal waste. During removal for disposal as part of the demolition activities, each ballast should be visually inspected for the manufacturer's label indicating "no PCBs". If the label does not have this notation, the ballast should be considered PCB-containing and should be disposed of as a hazardous waste in accordance with local, state, and federal regulatory guidelines. Refrigerators and air conditioning units contain freon which will need to be reclaimed or taken to a facility capable of this activity. Mercury containing thermostats will need to be disposed of at a facility certified to take this type of material. The contractor should also carefully remove all associated fluorescent light tubes and compact fluorescent lights and recycle or dispose of these materials according to applicable regulations.

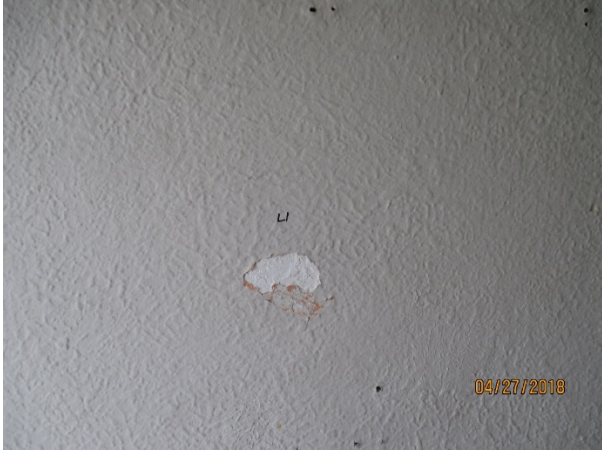
Sample Represented –  
4620CL-1L

Two lead samples (4620CL-1L & 4620CL-4L) are found to be greater than 0.06% by weight and less than 0.5% by weight and is considered LCP (Table 3-2). Two samples (4620CL-8L & 4620CL-9L) had lead concentrations greater than 0.5% by weight and is considered LBP. The remaining 5 sample results were less than the LCP and LBP thresholds, and are considered non-lead containing paint (NLC). The laboratory analytical report is included in Appendix D.

**LCP – White**

While the TCLP results indicate that the waste stream is not characteristically hazardous with respect to lead content, LCP and LBP are still present in the building materials. Therefore, the contractor responsible for demolition of this structure is notified with receipt of this report of the presence or potential presence of LCP and/or LBP in the building materials that comprise the building. The contractor should also notify their employees of the presence of LCP or LBP prior to any disturbance, and make the US Department of Labor Occupational Safety and Health Administration publication number 3142-12R 2004 available to their workers. (“Lead in Construction”, <http://www.osha.gov/Publications/osha3142.pdf>). The standards address topics such as permissible exposure limits (PELs) for workers, exposure assessment, protection of employees during assessment of exposure, employee notification, PPE, medical surveillance, along with other topics related to working with LCP and LBP.

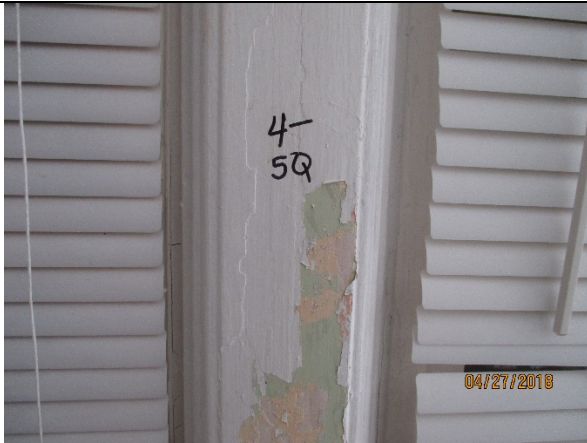
Sample Represented –  
4620CL-4L

**LBP – Brown (behind siding on House)**

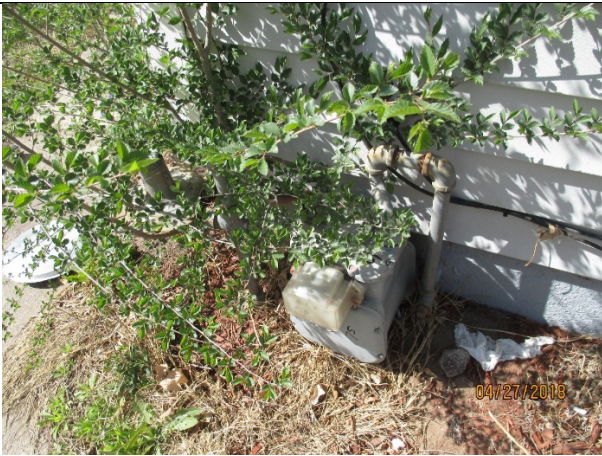
Sample Represented –  
4620CL-8L

**LCP – White**

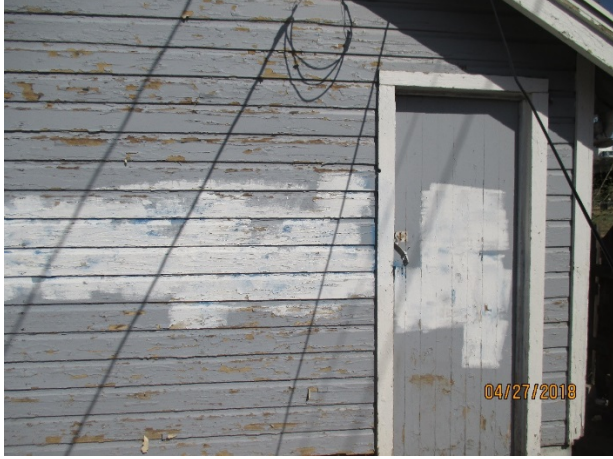
Sample Represented –  
4620CL-9L

**LBP – Gray (Garage)**
