## **Close Out Documents**

#### **AP-79 – 4605 Fillmore St.**

Asbestos Abatement and Structural Demolition

Re: SSCR AP-79 4605 Fillmore St.

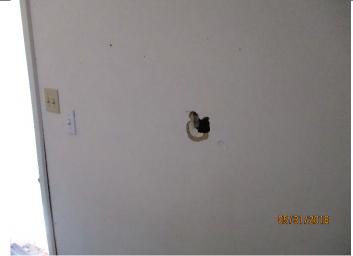
Samples Represented –
4605F-R5-TD2A
4605F-R8-TD2B
4605F-R3-TD2C
4605F-R4-TD2D
4605F-R4-TD2E
4605F-R6-TD2F
4605F-R7-TD2G

Light Textured Drywall

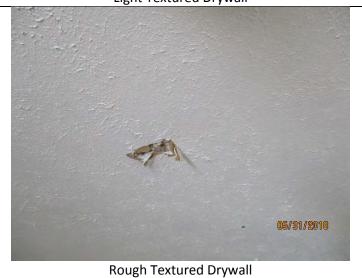
Samples Represented – 4605F-R5-TD3A 4605F-R3-TD3B 4605F-R5-TD3C

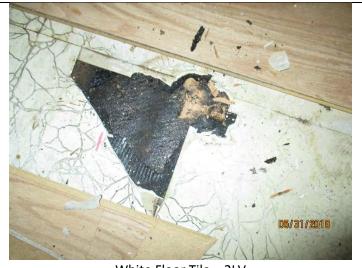
Samples Represented – 4605F-R6-FT8A 4605F-R6-FT8B 4605F-R6-FT8C

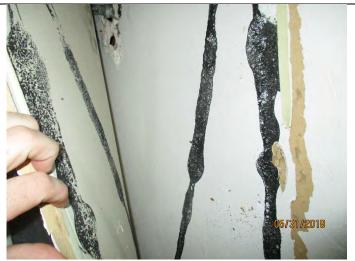
Samples Represented – 4605F-R6-M9A 4605F-R6-M9B 4605F-R6-M9C

Mastic

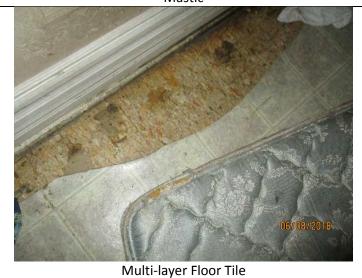
Samples Represented – 4605F-R8-FT10A 4605F-R3-FT10B 4605F-R3-FT10C

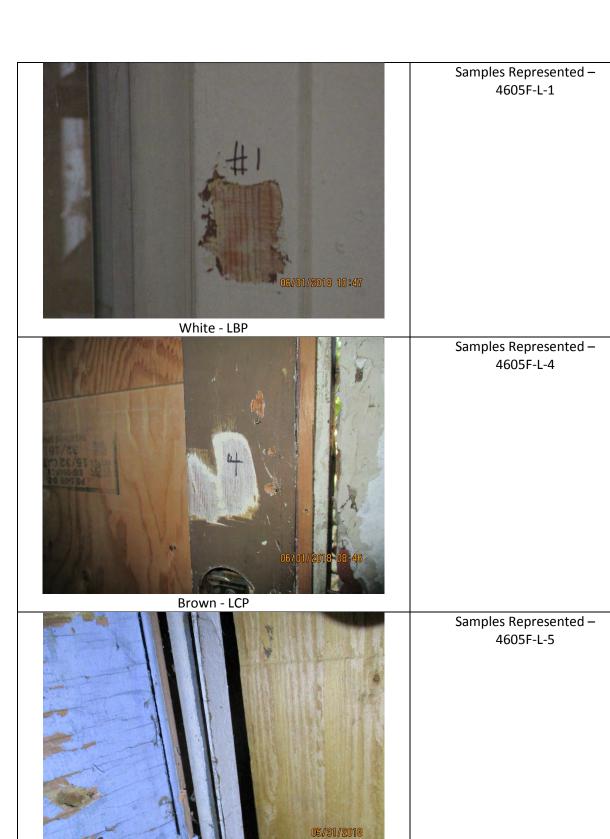
Light Blue - LCP

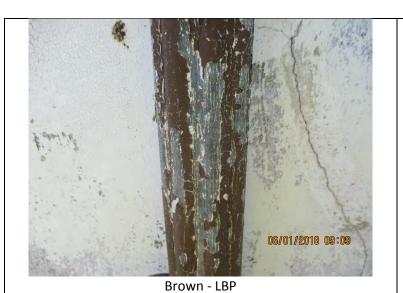
Samples Represented – 4605F-L-7
