FIGURE 4-2
I-70 PEIS SWEEP
Stream Segment 2
Clear Creek County

4.1 Water Resource-related Categories – Existing Conditions

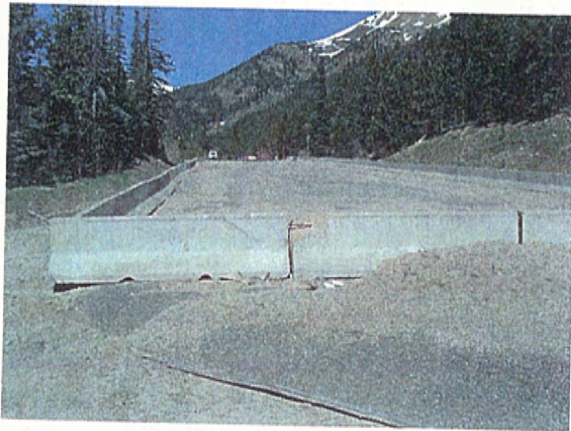
1 *Sedimentation:* Traction sand storage area at Herman Gulch.

CDOT currently operates and maintains a road sand storage facility immediately downstream from Herman Gulch on the north side of I-70. Sediment control measures have been implemented at this facility and CDOT has established a series of sediment control ponds immediately downgradient. Additional sediment control ponds have been established on the south side of I-70.

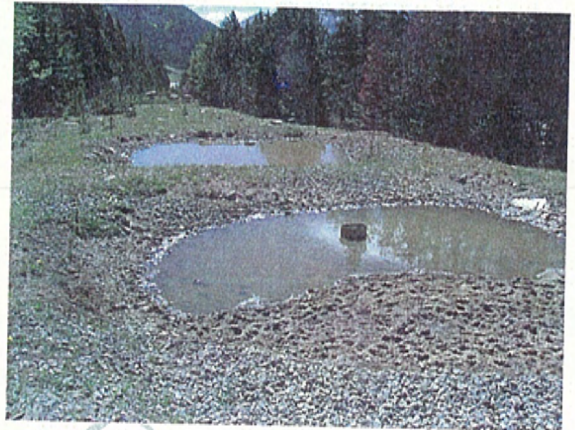
2 *Sedimentation:* CDOT sediment retention ponds at Herman Gulch.

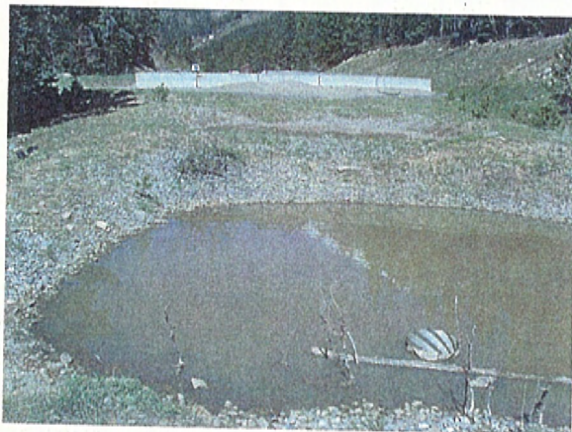
3 *Sedimentation:* CDOT sediment retention ponds at Herman Gulch.

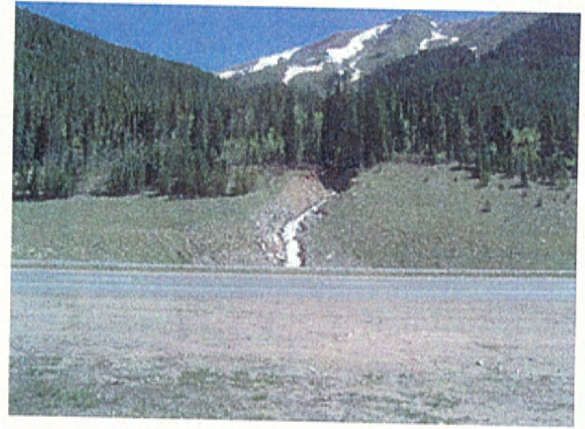
4 *Downcutting:* Wood's Mountain Flood Wash downcutting

A large natural landslide area is located on the north side of I-70 below Herman Gulch (near MP 219). This landslide area is not related to I-70, however, the cutslope created by I-70 has locally increased the channel gradient resulting in channel erosion. During intense precipitation events, several drainages (e.g., Wood's Mountain flood wash) in this area contribute total suspended solids and sediment to Clear Creek.
