# MT. GARFIELD CULVERT STUDY

Colorado Department of Transportation

February 2021

# Executive Summary

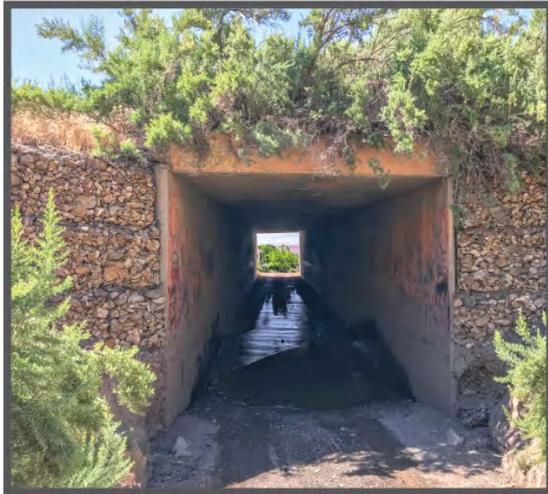
Although the drainage basin feeding into this culvert is relatively small, the adverse slope within the box culvert caused by differential settlement often causes stormwater to be trapped, which results in ponding. This reduces the box culvert's function and limits access by low clearance vehicles. More detail regarding the drainage characteristics of the culvert can be found in Appendix C.

STANDING WATER IN LOW POINT CAUSED BY DIFFERENTIAL SETTLEMENT

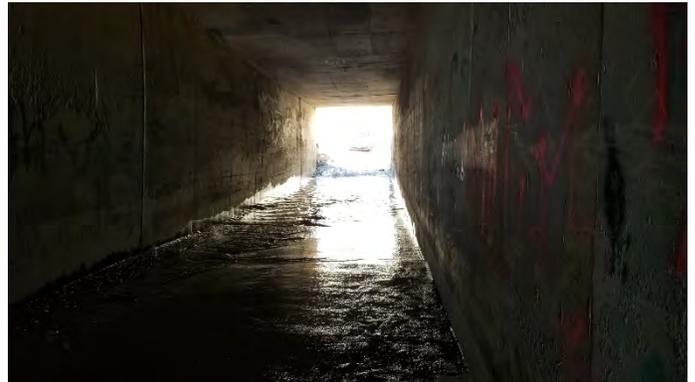
Figure 1 - Existing Culvert: Coal Mine Road Under I-70

CR 35 8/10 Road passes under I-70 at Mile Posting 39.961 in Mesa County with the use of a concrete box culvert. The culvert primarily provides single lane access to the Mount Garfield Trailhead which is just north of I-70. The culvert was built as two separate structures in 1962 and was later connected under the median of I-70 in 1973. The culvert has been showing signs of deterioration since as early as 1967 and has continued to be noted in the Structure Inspection Reports.
