**SH 83 Safety and Operations Analysis:
Bayou Gulch to El Paso County Line
MP 30.20 – MP 53.88
Project Code 23008**

Appendix A - Safety Assessment Report

March 2022

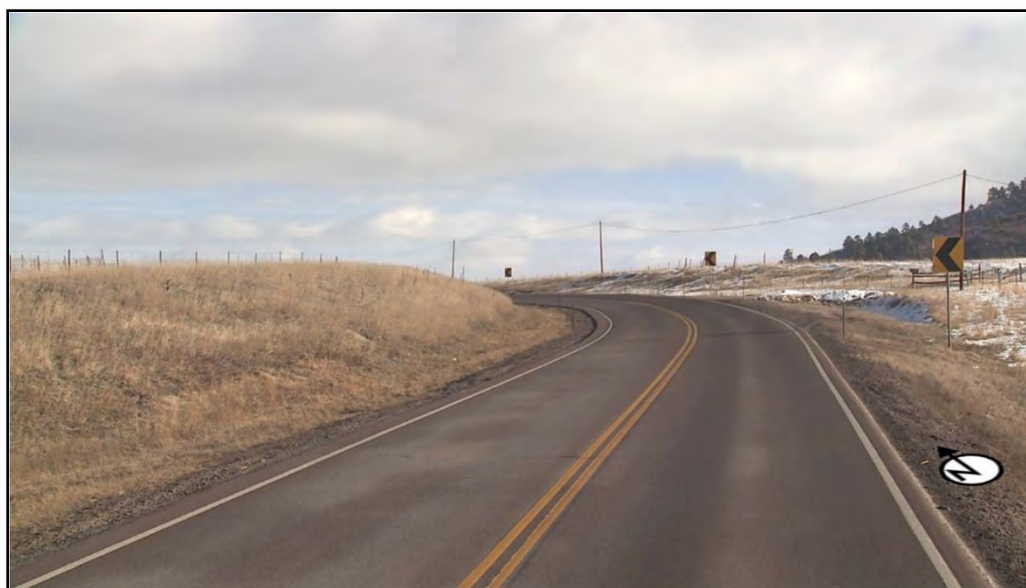
Figure A7: Northbound SH 83A at MP 32.25

There is a slight downhill grade in the northbound direction (about 2%) and the roadway is generally marked as a no-passing zone. Most occurred during daylight conditions (7 of 8) with no adverse weather or roadway conditions (7 of 8). Alcohol was involved in two of the crashes. There are advance curve warning signs with speed advisory plaques in both directions and curve chevrons in both directions. The shoulders are stabilized with approximately 1-ft of paved material as shown in **Figure A7**; there is a bit of a drop-off between the edge of pavement and stabilized material and the safety edge may be worn down in places.

Shoulder widening through the reverse curves would allow vehicles more opportunity to recover when running off of the right-side of the road and help reduce the frequency of run-off-road collisions. In addition, wider shoulders would allow for outside shoulder rumble strips which would further help improve safety through this area.

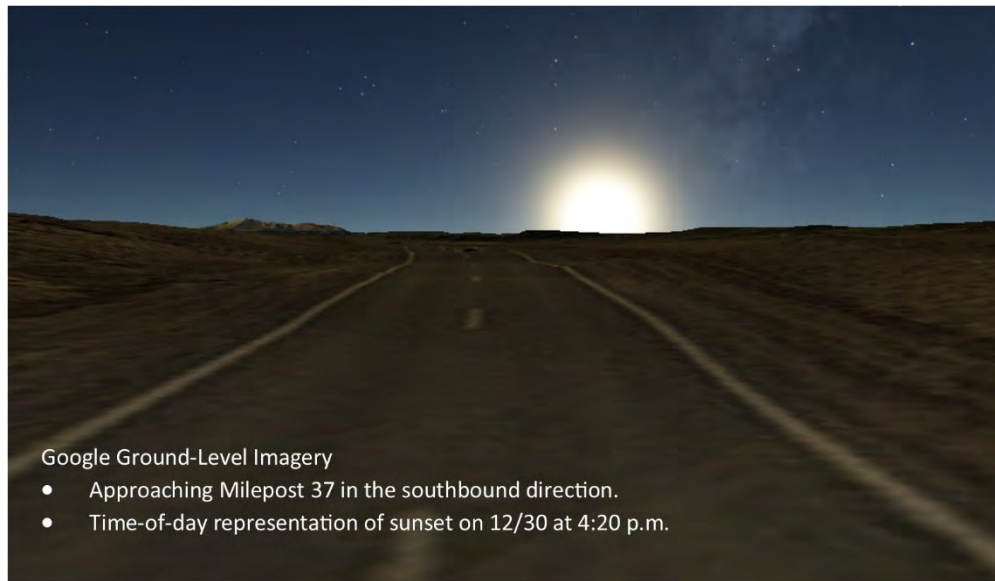
Figure A10: Ground Level Representation – Late December Sunset

One *sideswipe (opposite direction)* fatal crash occurred in December 2018 at MP 37.04. A southbound vehicle traveled off of the right-side of the road, overcorrected then lost control, crossing into the northbound lane and colliding with a northbound vehicle. A review of the crash data suggests that the crash occurred just after a slight left-hand curve in the southbound direction, on a short tangent before a second left-hand curve. Lighting was listed as “dawn or dusk” in the report and it is possible that sun-glare was a contributing factor given the date, time and direction as illustrated in **Figure A10**. The driver of the southbound vehicle was not wearing a seat-belt at the time of the collision and died after being transported to the hospital.
