I-270 Existing Safety Conditions Report

I-270 Corridor Improvements

July 2021

CDOT Project No.
STU 2706-043

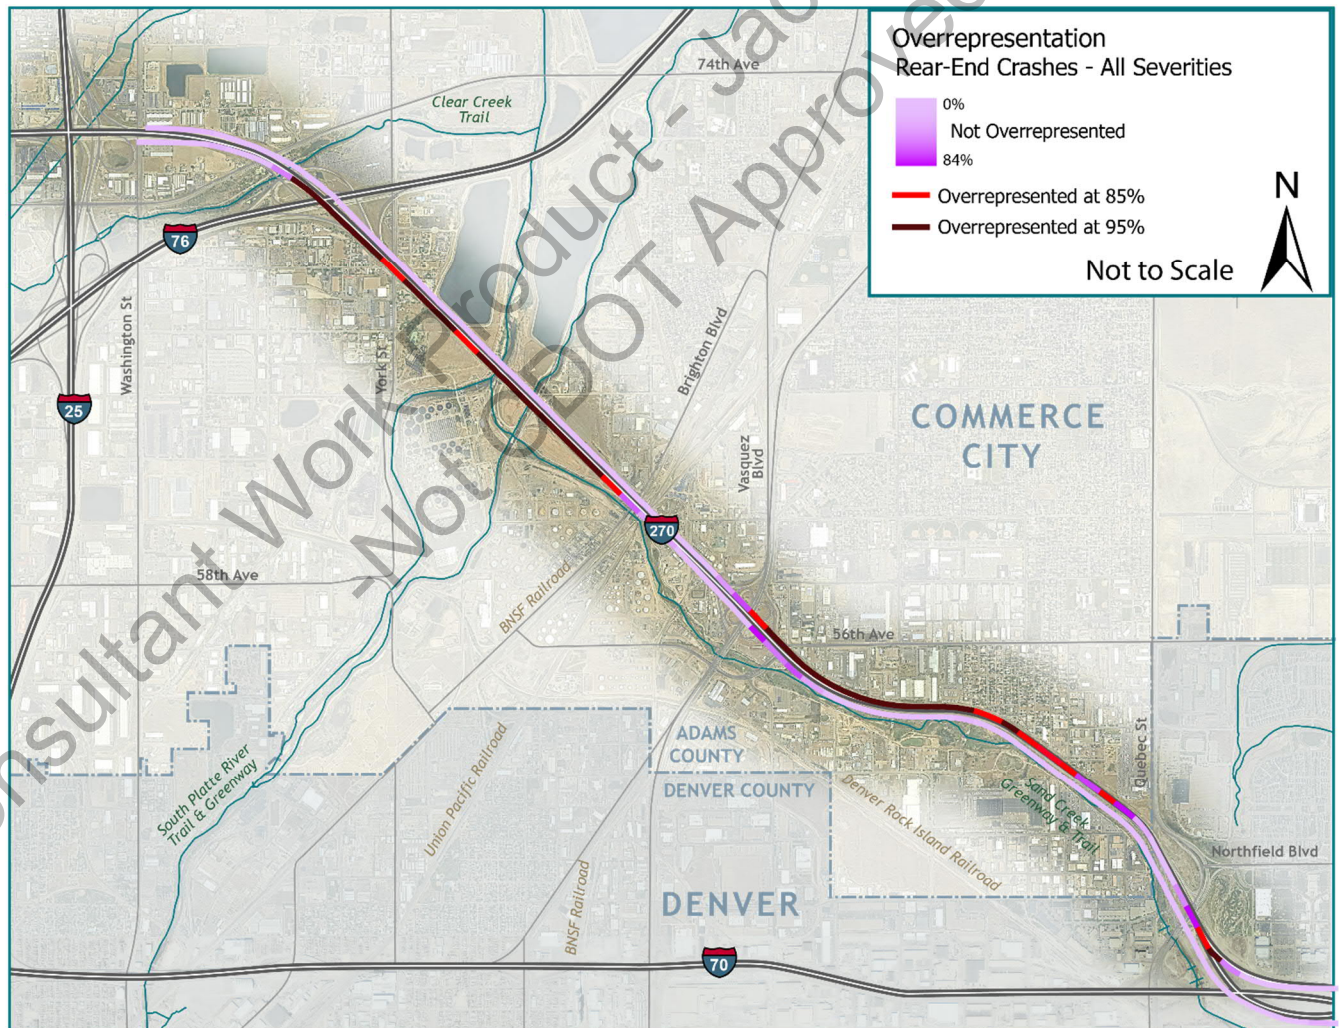
Figure 15. Overrepresentation of Rear-end Crashes – All Severities

As shown on Figure 15, overrepresented rear-end crash patterns occur in a high proportion of the I-270 mainline corridor mileage. Specifically, high segments of overrepresentation are identified in the eastbound direction from I-76 to 0.5 mile west of the Vasquez interchange. This segment overlaps hotspots 2 and 6 identified in Table 5 and on Figure 13. Additionally, in the westbound direction, there are rear-end patterns at the Quebec interchange (hotspot 4 in Table 5 and on Figure 13) and immediately east of the Vasquez interchange (hotspot 1 in Table 5 and on Figure 13). The Vasquez interchange rear-end pattern extends to about 2 miles east of the interchange, which is related to the queuing of traffic due to congestion. A review of traffic heat maps for the corridor indicates that both the a.m. and p.m. peak periods experience low traffic speeds from 10 to 30 mph from the Vasquez Boulevard on-ramp east to the Quebec Street on-ramp. Speeds in this range indicate traffic congestion.

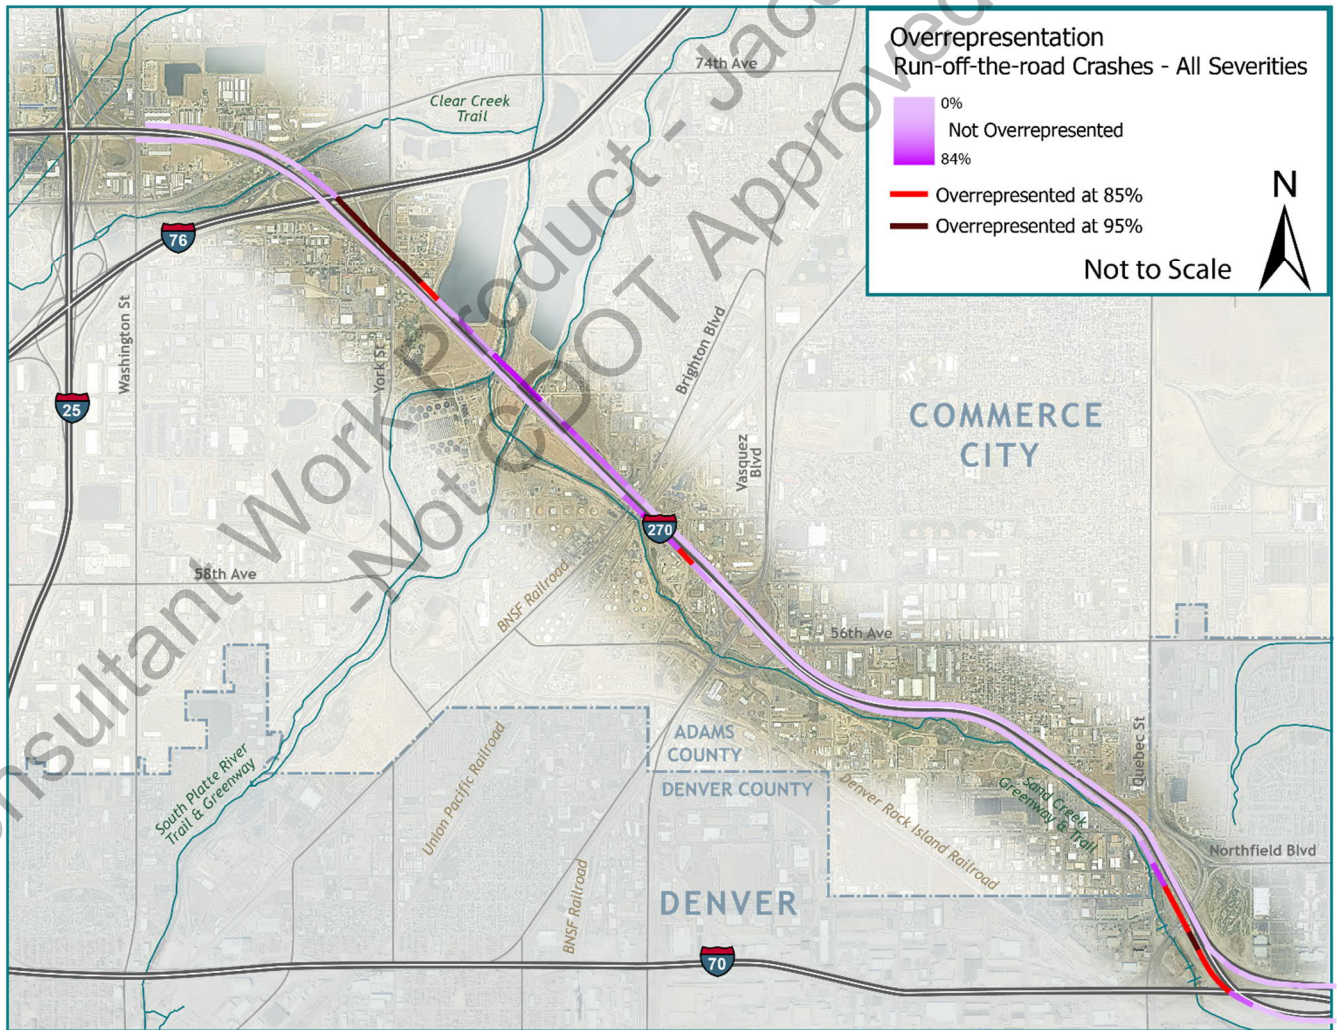
Figure 16. Overrepresentation of Run-off-the-road Crashes – All Severities
Source: Jacobs

As discussed previously, ROR crashes have the second highest proportion of mainline injury crashes (19 percent) and third highest proportion of total crashes (15 percent) for the I-270 corridor. Figure 16 shows areas of high ROR crash patterns occurring at 95 and 85 percent levels of significance. A pattern of rear-end crashes is associated with speeding, distracted driving, lighting condition, adverse weather conditions, and the lack of a shoulder area to provide recovery for vehicles. Figure 2 identifies ROR crash types that can potentially be mitigated, such as collisions with traffic barriers and other fixed objects.

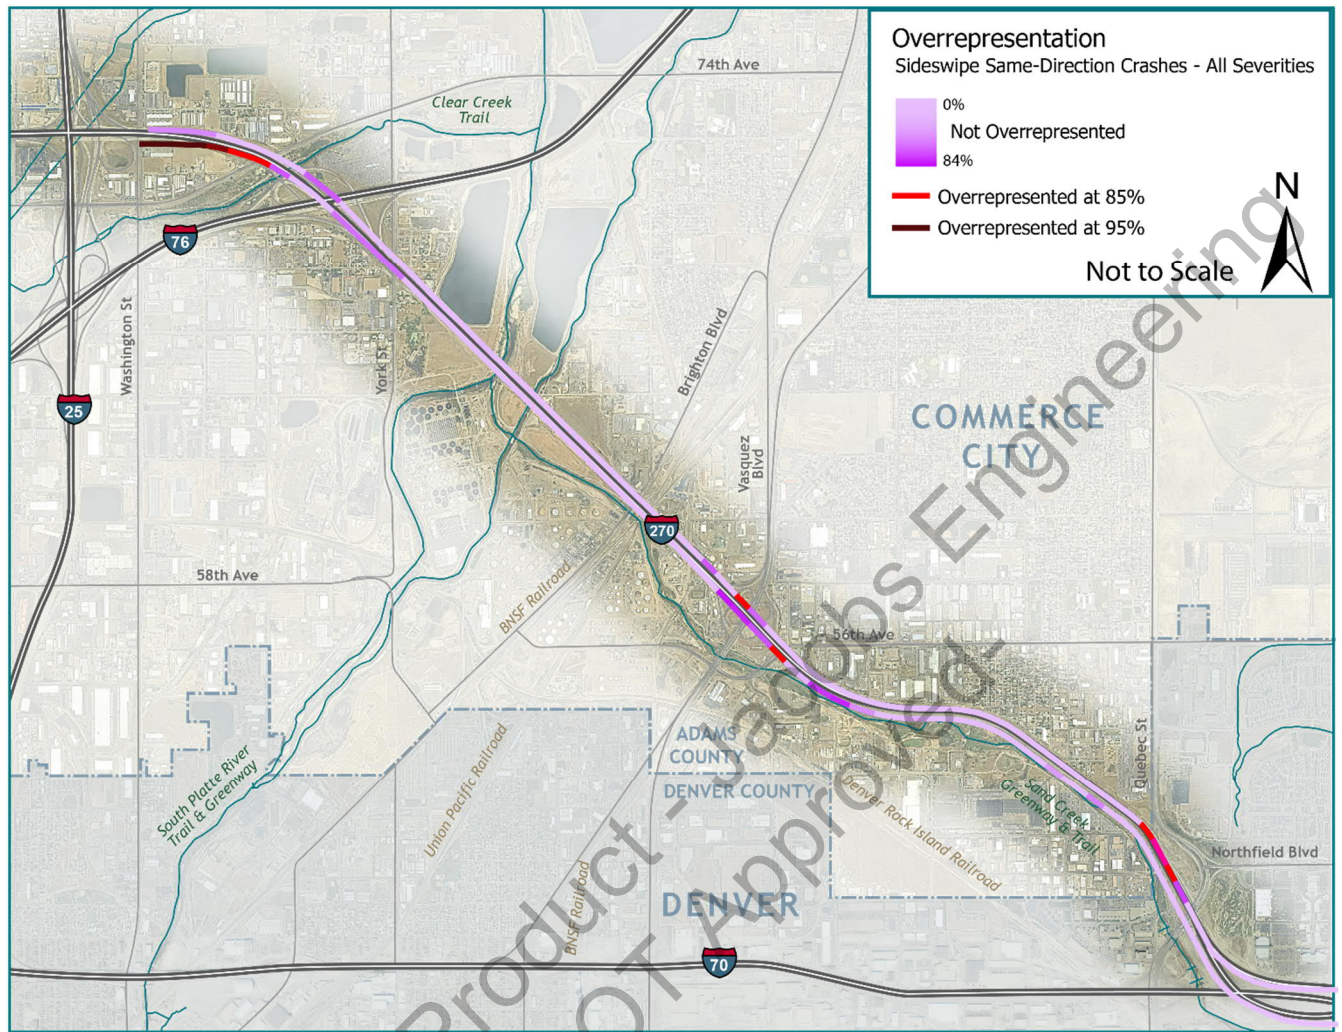
Figure 17. Overrepresentation of Sideswipe-Same-Direction Crashes – All Severities

Figure 17 shows that sideswipe-same-direction crashes are overrepresented between I-25 and I-76 in the eastbound direction, which suggests weaving and lane change issues area (hotspot 3, Figure 13). It is recommended that example countermeasures be considered to mitigate this crash type, such as geometric improvements to facilitate a more defined lane merge operation (including an added auxiliary lane), would improve lane change maneuvers. Increased merge lengths should be considered to improve weaving operations.

A related potential crash issue for this section is the presence of the left-hand entrance ramp from I-25, which is challenging and conflicts with higher-speed mainline traffic in the outside shoulder lane. Mitigation options may include added signing, lighting, and a review of lane balance. Refer to Section 4.3.1 for additional discussion.

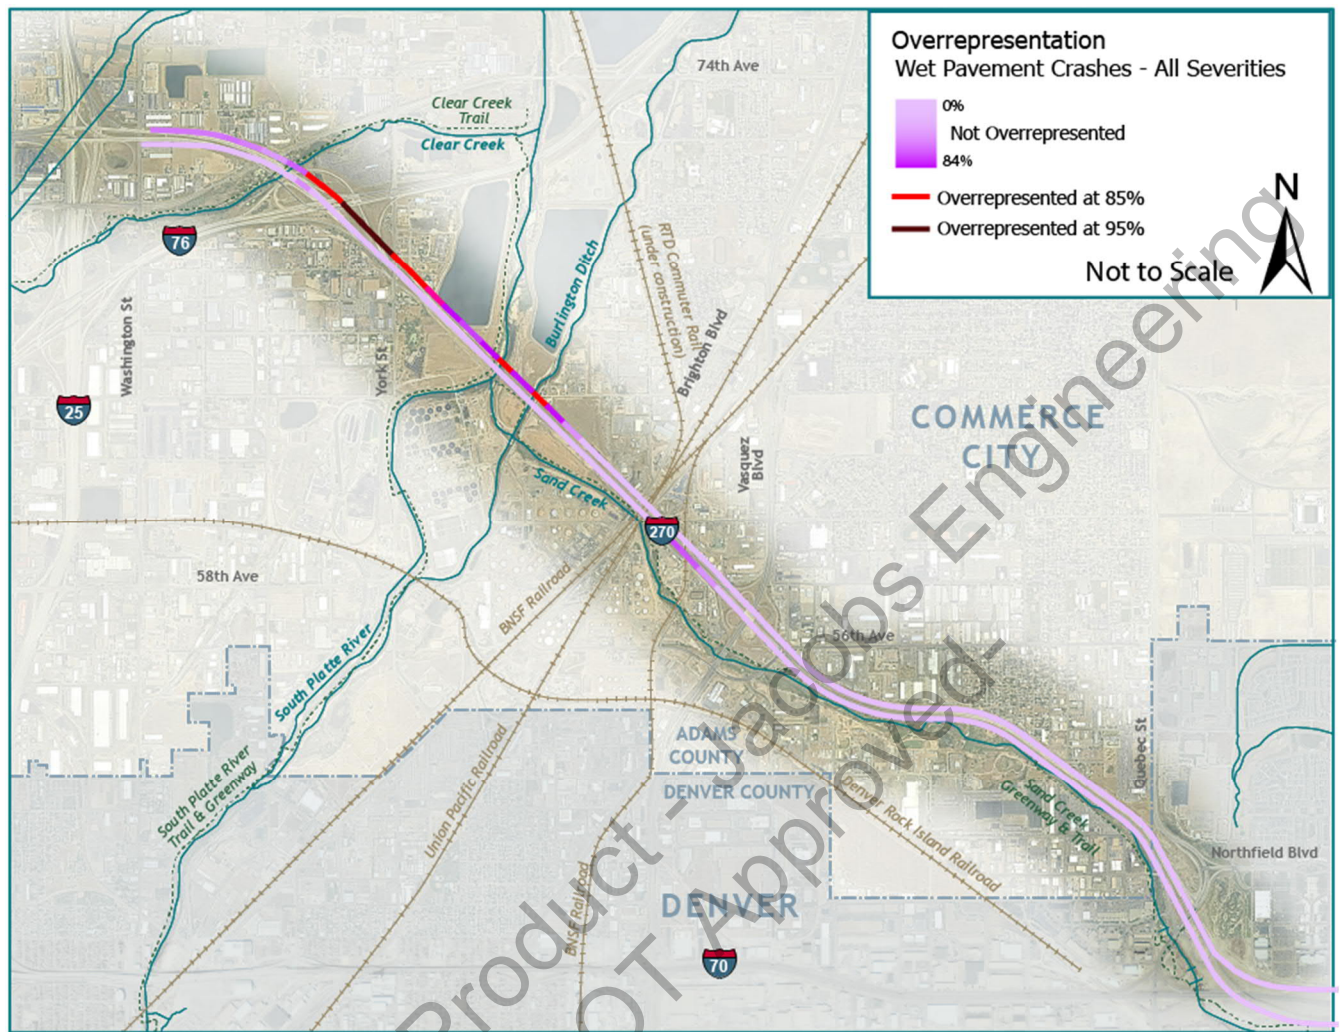
Figure 18. Overrepresentation of Wet Pavement Crashes – All Severities

As shown on Figure 18, wet-pavement crash patterns exist westbound at and prior to I-76, which also has an overrepresentation of ROR crashes and was discussed after Figure 16. For this section, the combination of these two crash types are of interest because a wet-pavement environment may be a contributing factor to ROR crashes. Thus, mitigation of wet-pavement crashes may reduce ROR crashes. This issue should be studied in more detail in the design phase because the wet-pavement crash overrepresentation may be related to such factors as drainage issues and/or reduced pavement friction.

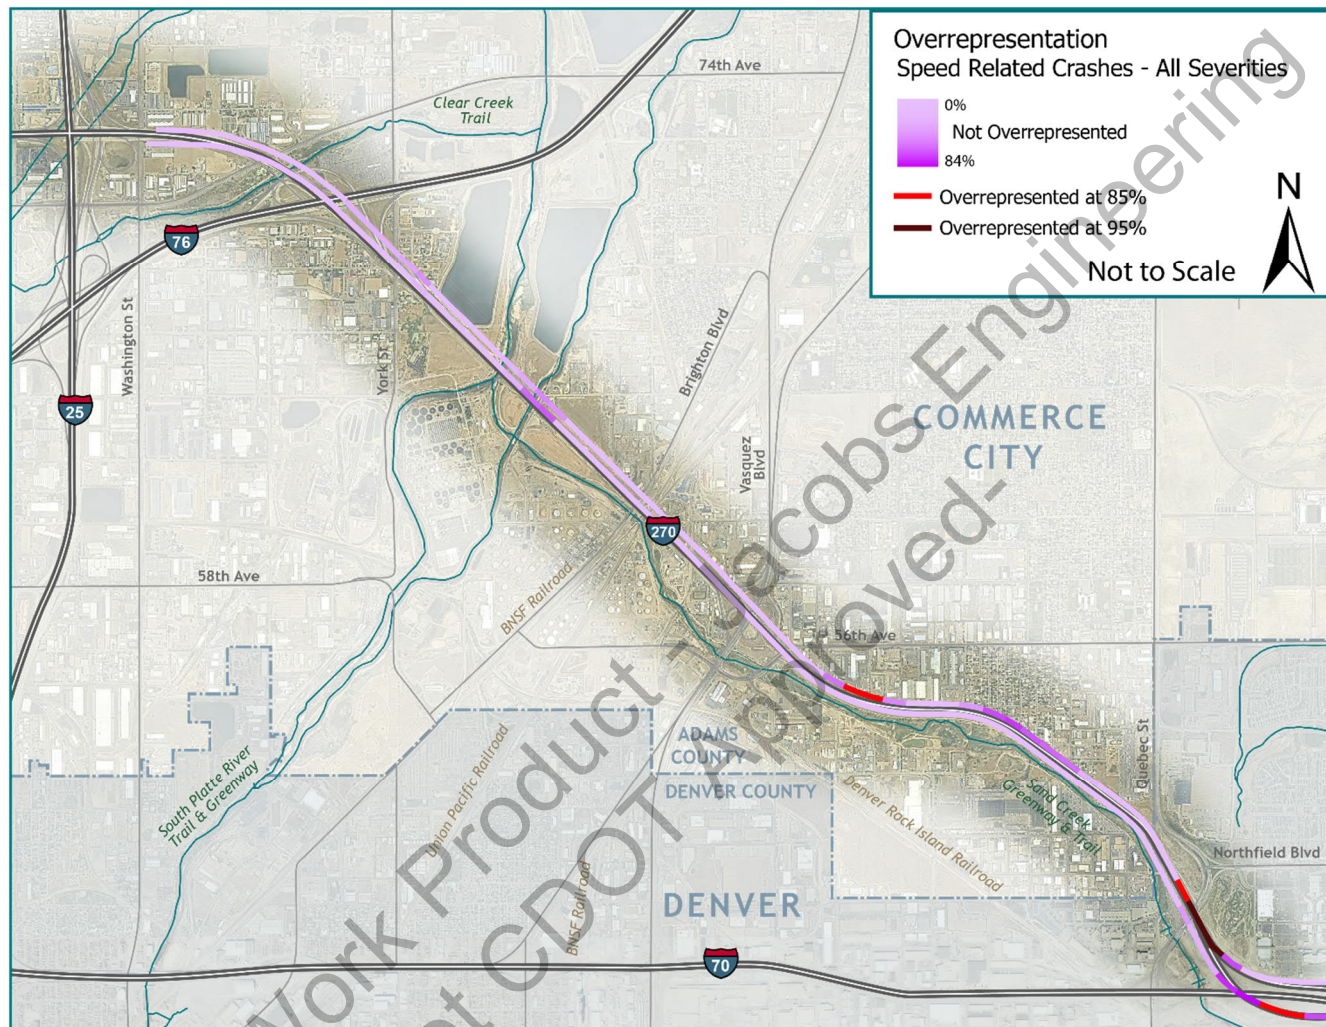
Figure 20. Overrepresentation of Speed-related Crashes – All Severities

Overrepresentation of speed-related crashes are shown on Figure 20. A speed-related crash is identified by violation codes including following too close, too fast for condition, reckless driving, and speeding – speed not specified. The only identified hotspot at a 95 percent confidence level is at the westbound Quebec interchange area, where the potentially higher-speed traffic from I-70 meets the slower traffic at Quebec interchange right after the horizontal curve.

In addition to violation codes noted above that are speed related and primarily a function of driver behavior or misinterpretation of roadway conditions, limited or inadequate stopping sight distance can be a roadway-related deficiency, which is speed related in that motorists could be exceeding the safe speed that exists for a given section of roadway. The westbound horizontal curve section described above coming from I-70 onto I-270 was studied to assess any limitation of stopping sight distance. The findings and a design countermeasure to address the situation are discussed below.

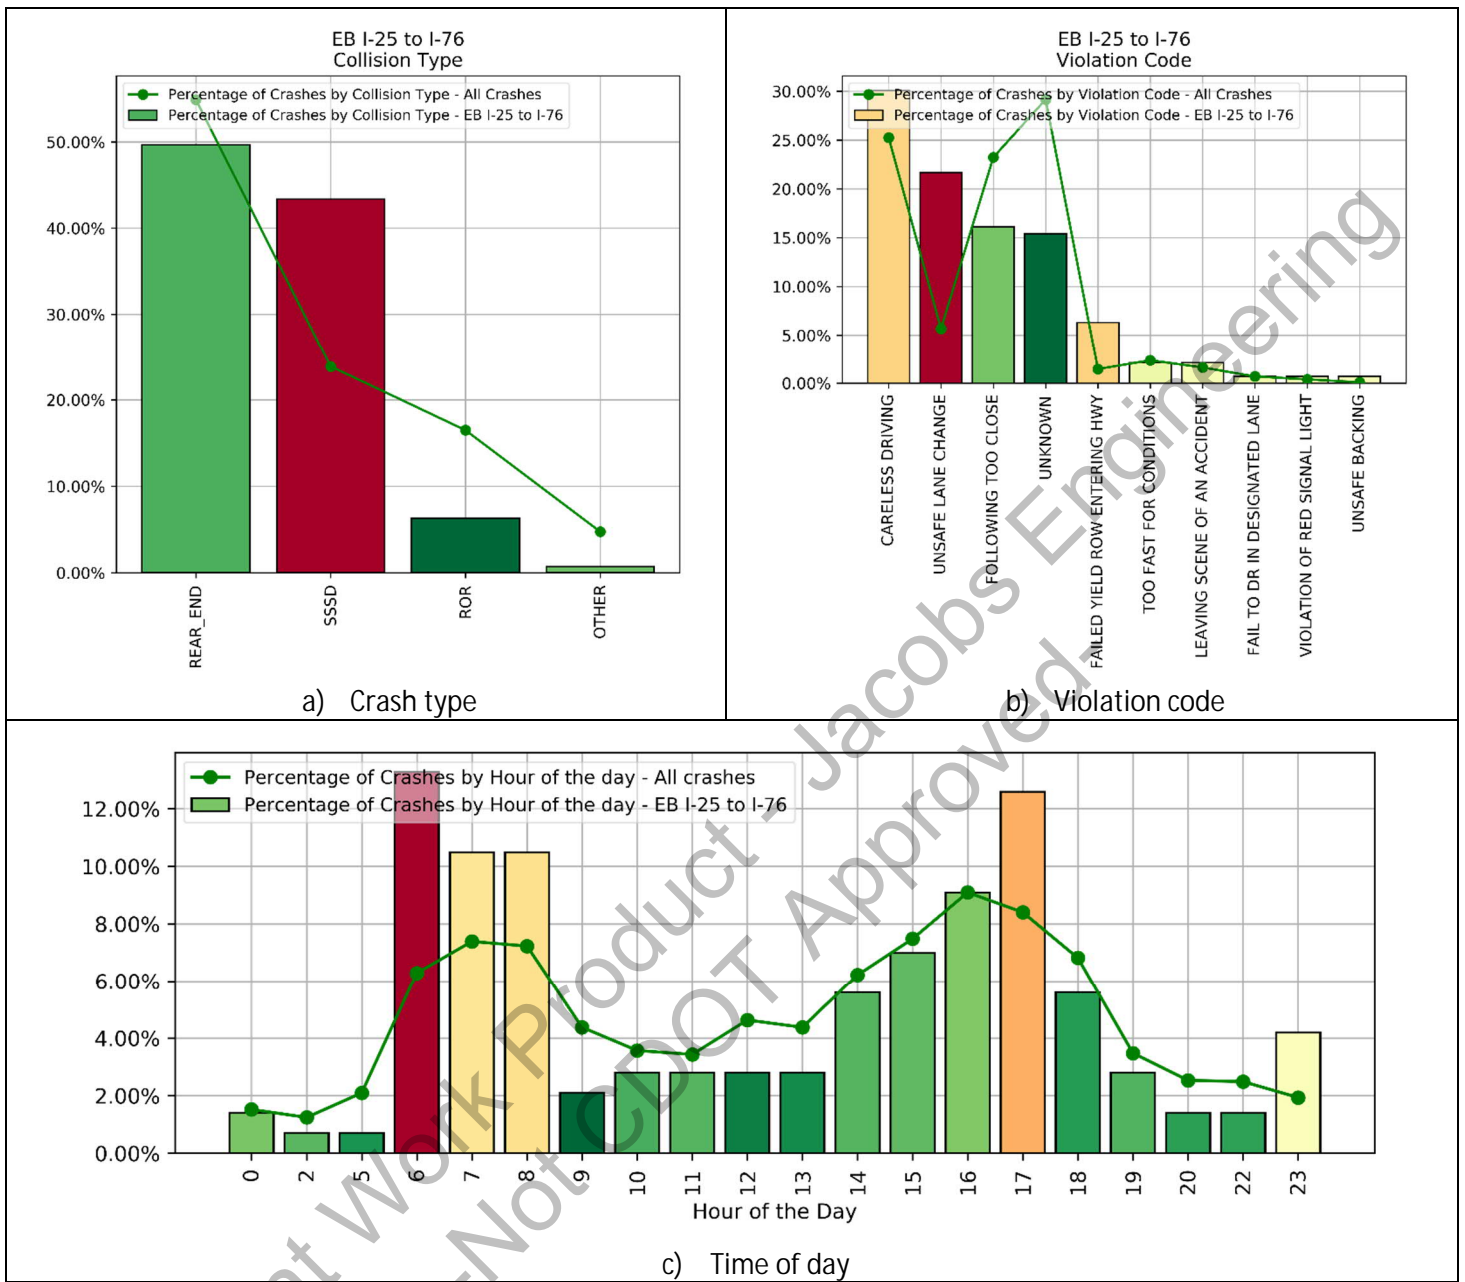
Figure 23. I-270 Mainline Eastbound from I-25 to I-76 Crash Characteristics

This location is a safety hotspot (ranked third) with a high potential for safety improvement and an overrepresented sideswipe-same-direction crash pattern (Figure 23). Responding officers coded the top two contributing factors as careless driving and unsafe lane change (Figure 23b).

Given the congested conditions during the a.m. and p.m. peak periods and the shorter weaving distance provided, there can be limited gaps in traffic for motorists to weave across the three I-270 mainline lanes to reach the downstream right-side exit. This maneuver may be particularly challenging for heavy-vehicle drivers that would need to make lane changes. A study conducted by CDOT indicated that this weaving maneuver volume from I-25 to I-76 may be relatively light; the average frequency of weaving vehicles was 66 vehicles in the a.m. peak (6 to 8 a.m.) and 36 vehicles in the p.m. peak (3 to 6 p.m.).

Overall, under current conditions, a statistically high overrepresentation of sideswipe crashes occurs (Figure 17). There is a 25 percent proportion of truck crashes, which translates to an 81 percent probability of overrepresentation at this section (Figure 19).

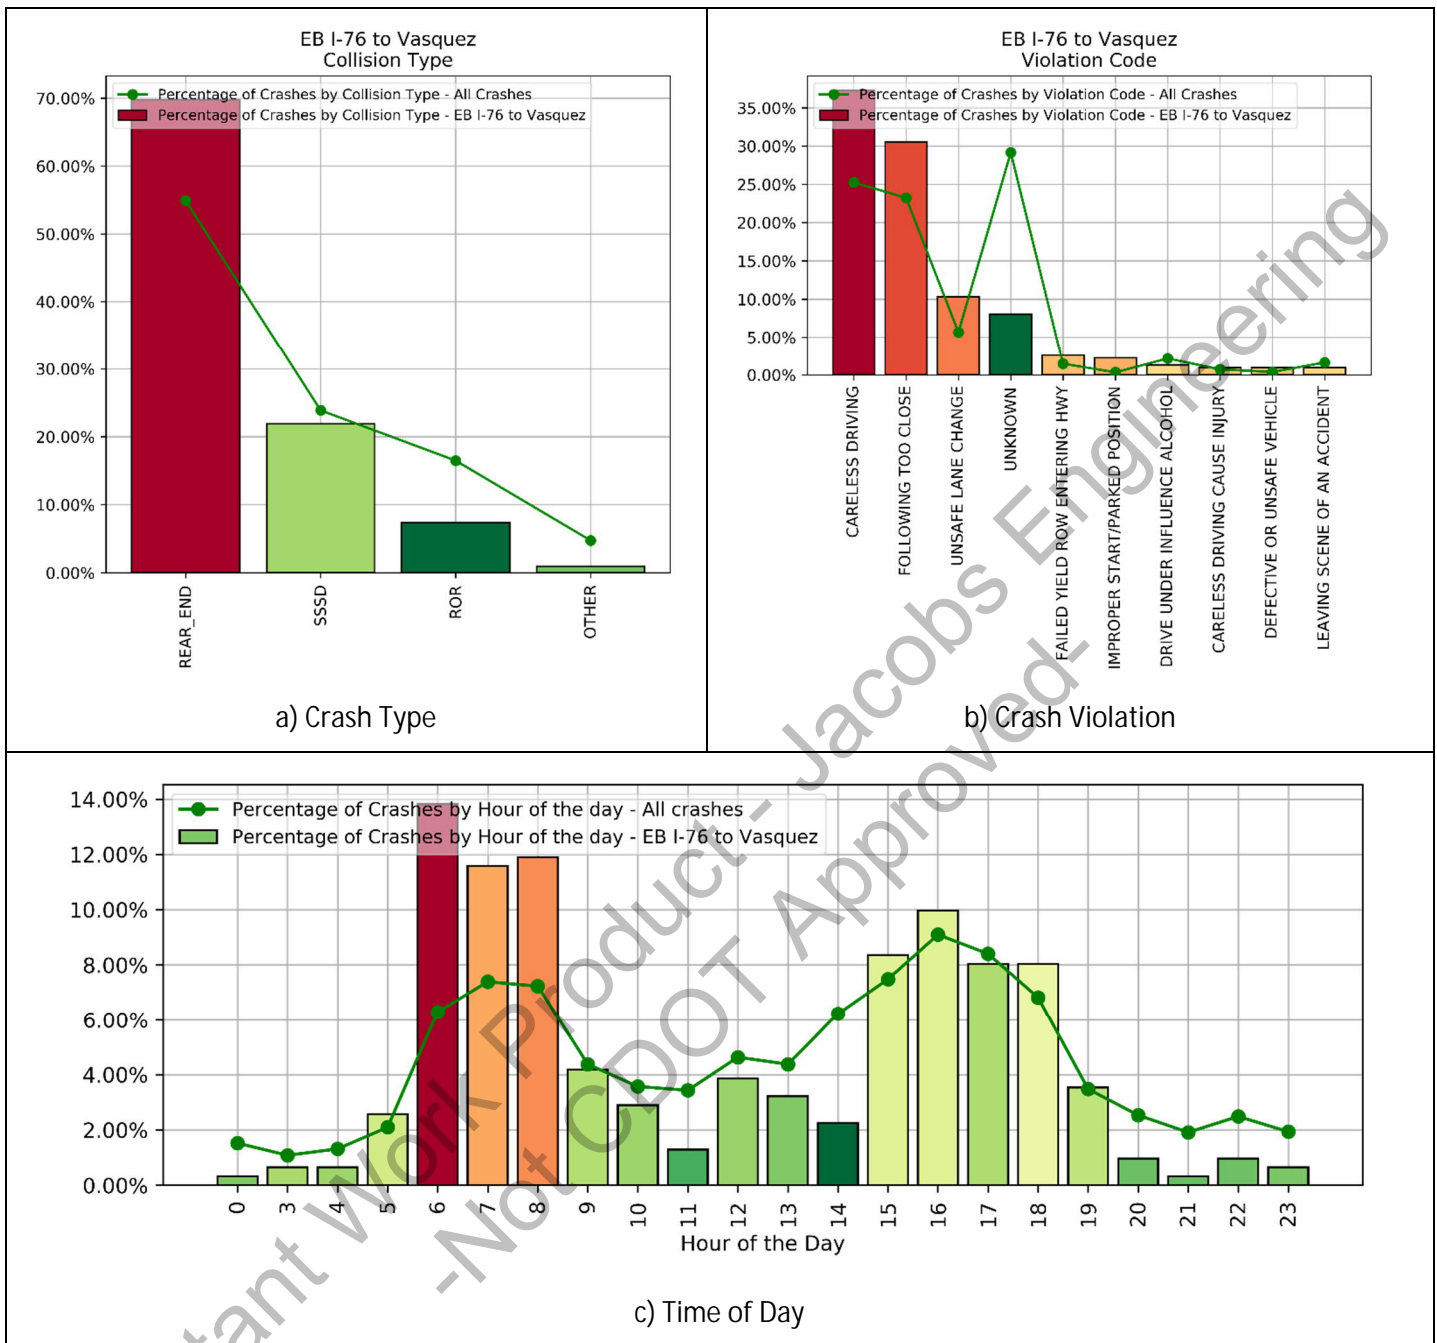
Figure 25. I-270 Mainline Eastbound from I-76 to Vasquez Boulevard Crash Characteristics

The elevated rear-end crash frequency is likely caused, at least in part, by the close proximity of the I-76 and York Street successive on-ramps in the eastbound direction, which is a site of regular traffic congestion. The largest proportion of crashes happen during the a.m. peak (Figure 25c). It is important to note this section also has a higher frequency of heavy-vehicle crashes (Figure 8) but is not considered to be overrepresented at the 85 or 95 percent levels (Figure 19).

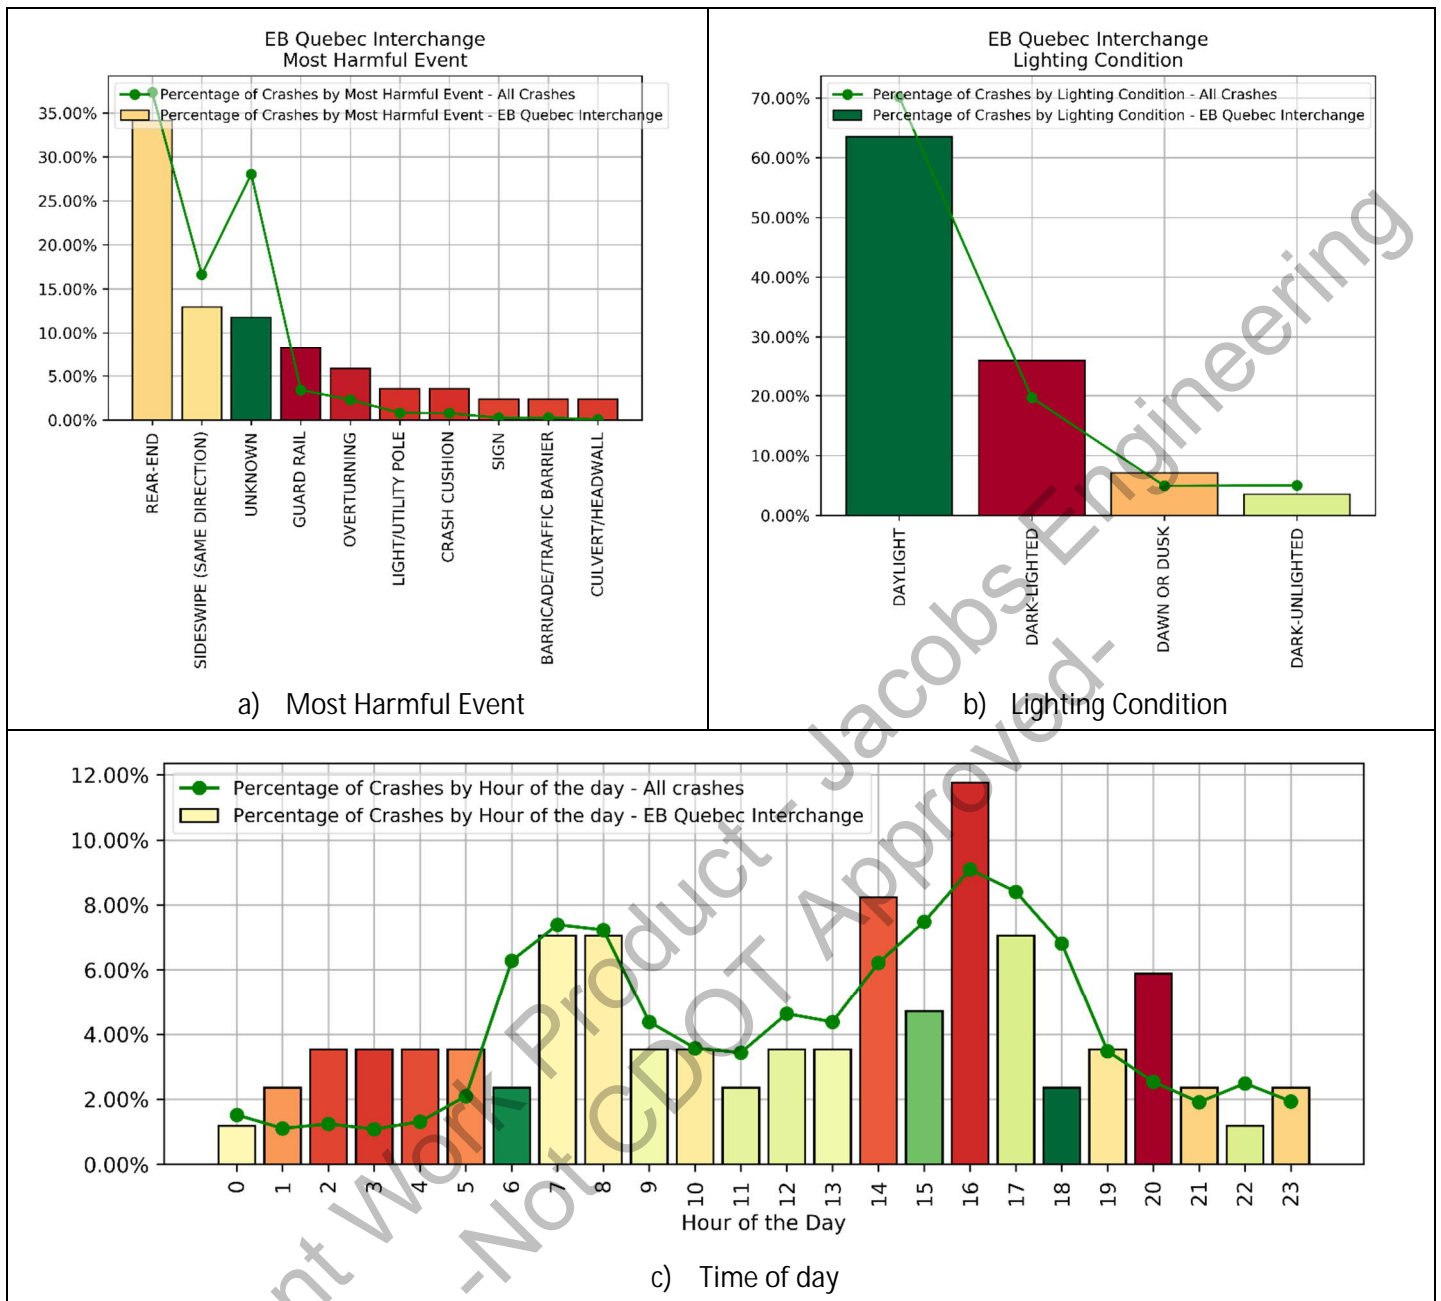
Figure 28. I-270 Mainline Eastbound Quebec Interchange Crash Characteristics

This location is a safety hotspot rank 7 out of 7, with the lowest potential for safety improvement for hotspots but a strong ROR crash pattern. Driver inexperience is coded as one of the main contributing factors, along with overrepresentation of night-time, overturn, guardrail, and utility pole crashes. However, these crash data are based primarily on the previous design for eastbound I-270 with a flyover geometry (sharper curve and narrow shoulders) that was replaced in 2019 with a new flyover structure that included wider shoulders and a flatter horizontal curve. In addition, either post reflectors or barrier reflectors should be added as needed to enhance guidance.

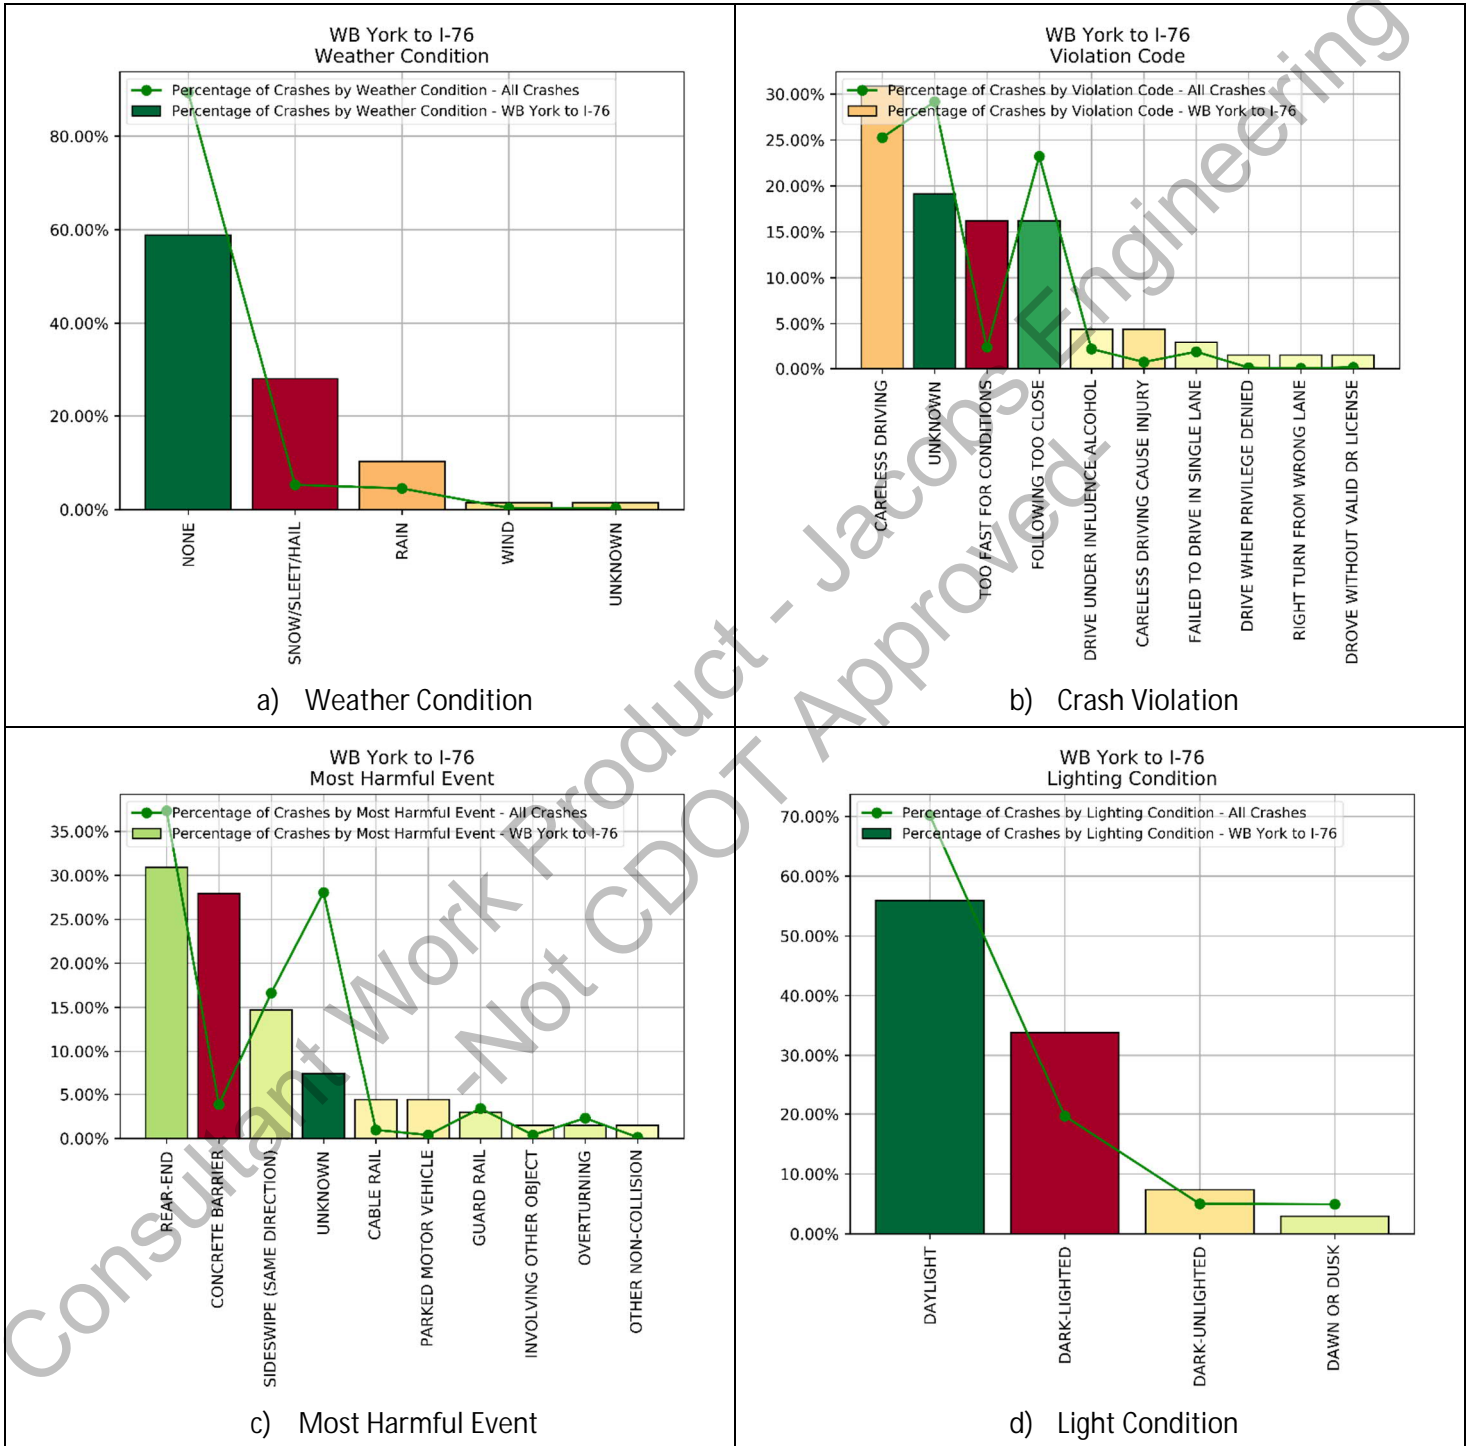
Figure 34. I-270 Mainline Westbound York Street to I-76 Crash Characteristics

This location is not a safety hotspot but shows a strong pattern of ROR (Figure 16) and wet-pavement crashes (Figure 18) happening in off-peak hours (Figure 34d). Concrete barrier crashes (Figure 34c) during snow or rain (Figure 34a) and driving too fast for conditions (Figure 34b) are identified at this location. Installing a high-friction surface and/or check for possible drainage issues could help to address safety issues at this location.

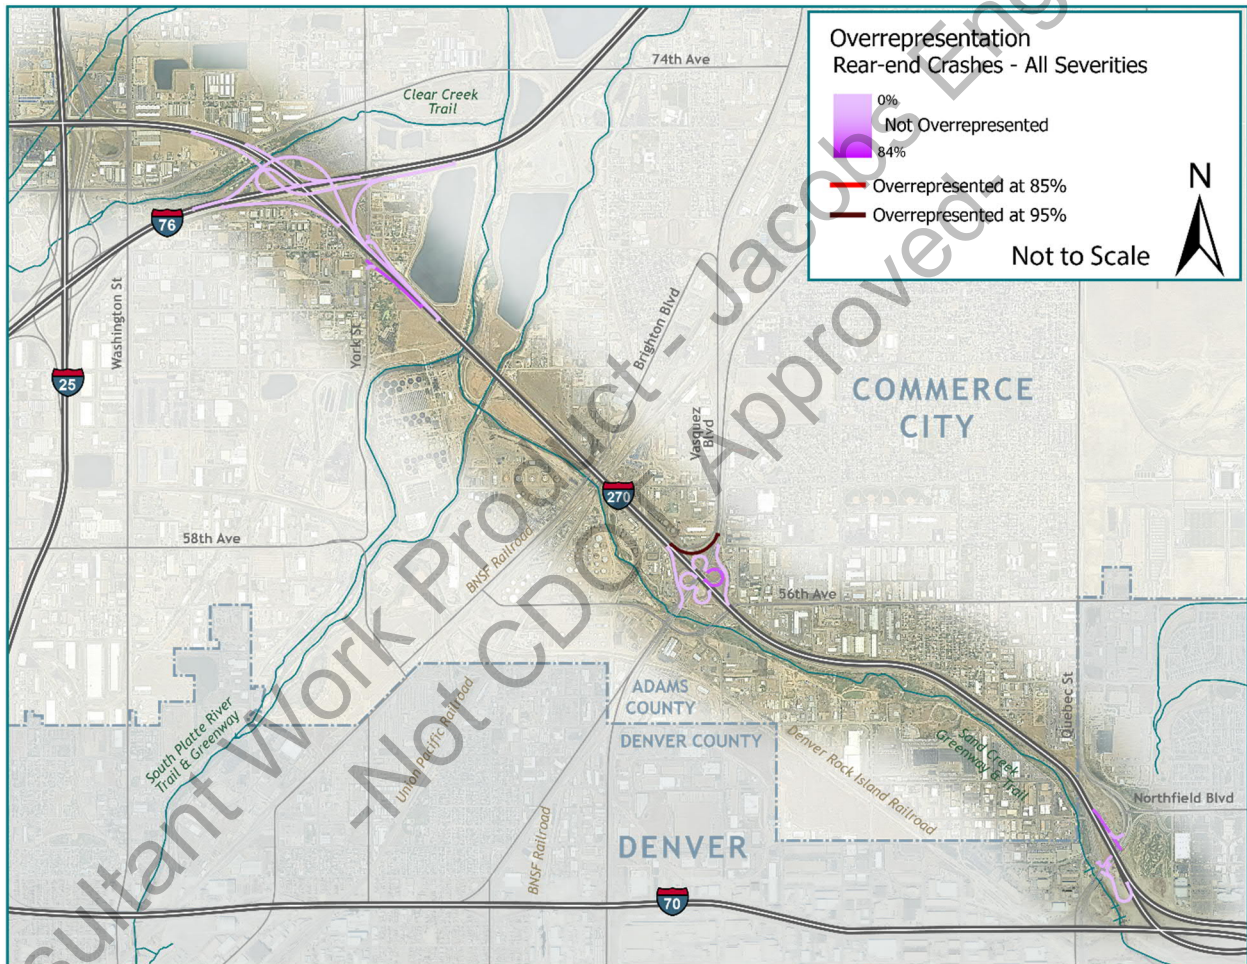
Figure 39. Overrepresentation of Rear-end Crashes for Ramps – All Severities

In addition to the Vasquez Boulevard southbound to I-270 westbound ramp, the Quebec southbound to I-270 westbound, Vasquez Boulevard northbound to I-270 westbound, and York Street to I-270 eastbound ramps also have a smaller (67 to 71 percent confidence) overrepresentation of rear-end crashes, which could be related to traffic congestion or sudden stops of vehicles in the traffic stream.

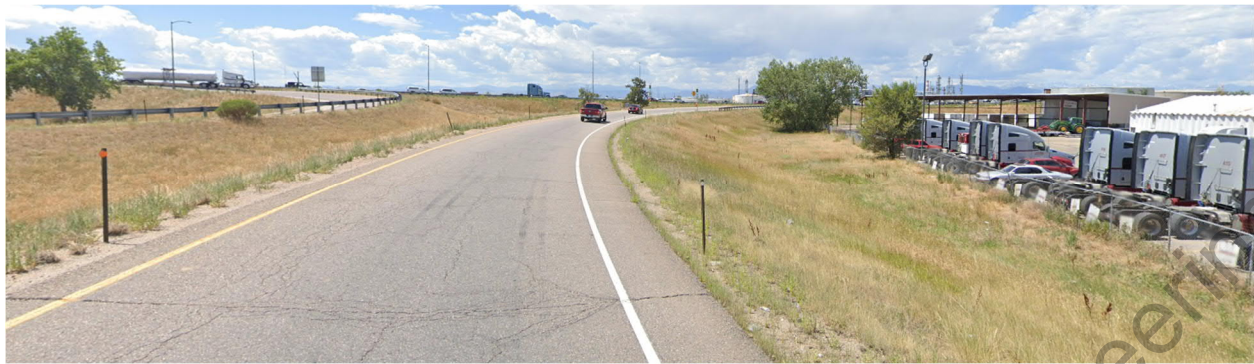
Figure 40. Vasquez Southbound to I-270 Westbound Ramp – Overrepresented for Rear-end Crashes

Figure 39 shows the overrepresentation of rear-end crashes, and the Vasquez Boulevard southbound to I-270 westbound ramp, shown on Figure 40, has an overrepresentation of 95 percent for rear-end crashes. The overrepresentation could be related to drivers not expecting stopping/slower traffic and possible traffic queuing on the ramp.
