**HAZARDOUS MATERIALS  
TECHNICAL MEMORANDUM**

**Federal Boulevard Improvements between  
West 7<sup>th</sup> Avenue and West Howard Place  
Environmental Assessment**

PINYON ENVIRONMENTAL, INC.

**October 2014**

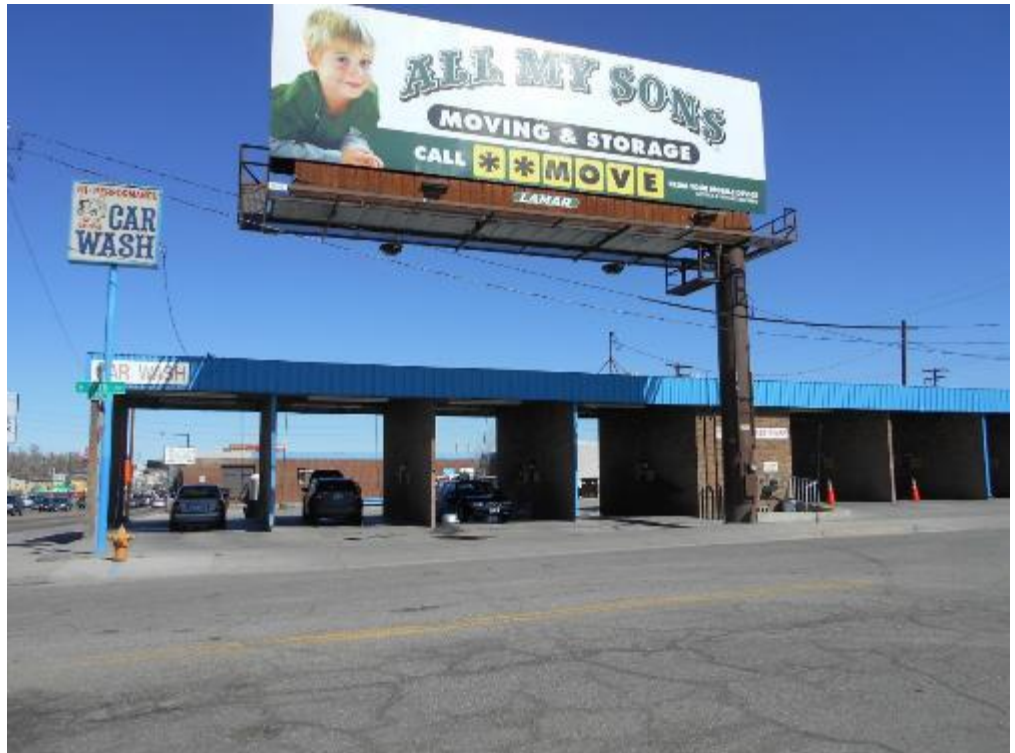
2. View of 710 Federal Boulevard (Hi-Performance Car Wash) facing northeast from the southeastern corner of the West 7<sup>th</sup> Avenue and Federal Boulevard intersection.

710 Federal Boulevard: Hi-Performance Car Wash	Located entirely within the Study Area.	<p><b>High.</b> This property consisted of an active car-wash facility at the time of the reconnaissance. Sand traps were noted to the south of the building itself, which could contain residual contaminants from the vehicle-washing bays. It is likely that the property has operated as a car wash since construction of the existing structure in 1980. The property also reportedly operated as an automotive-service facility and gasoline station from approximately 1961 to the early 1970s; however, available CDPHE or OPS records do not contain any additional information regarding the potential presence or location of any abandoned USTs or residual contamination from this previous use.</p> <p>This property would be acquired if the Proposed Action were to be implemented, and the on-site structure would likely be demolished. Improvements for the Proposed Action would likely require limited excavation (up to 6 feet bgs) for roadway widening, sidewalk construction, and utility relocation. There is a high potential for the proposed activities to encounter potential abandoned USTs or petroleum-impacted soil resulting from the historical and current uses at this parcel. Should the Proposed Action be implemented, it is recommended that a site-specific Phase I ESA or ISA be completed for the property prior to acquisition. In addition, a site investigation could be required for an evaluation of subsurface conditions at the property. Furthermore, pre-</p>

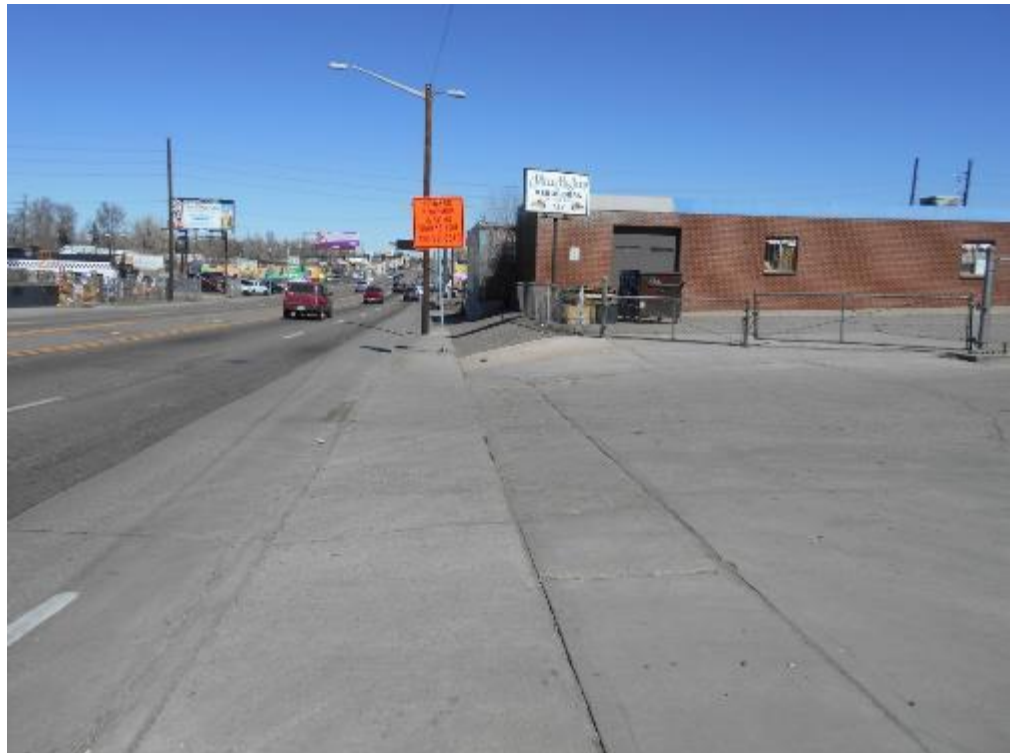
4. View of 724 Federal Boulevard (vacant service garage, formerly Mile Hi Jeep Rebuilders) facing north from the eastern side of Federal Boulevard.

724 Federal Boulevard: Vacant Service Garage (Formerly Mile High Jeep Rebuilders)	Located entirely within the Study Area.	<p><b>High.</b> This property consisted of a vacant structure at the time of the reconnaissance; however, a sign was noted indicating previous use as "Mile High Jeep Rebuilders." Material handling, storage, and disposal practices are unknown; however, the site reportedly operated as an automotive-service facility since construction of the structure in 1972.</p> <p>This property would be acquired if the Proposed Action were to be implemented, and the on-site structure would likely be demolished. Improvements for the Proposed Action would likely require limited excavation (up to 6 feet bgs) for roadway widening, sidewalk construction, and utility relocation. Given the proposed activities, there is a high potential for residual contamination to be encountered due to past uses at the parcel. Should the Proposed Action be implemented, it is recommended that a site-specific Phase I ESA or ISA be completed for the property prior to acquisition. In addition, a site investigation could be required for an evaluation of subsurface conditions at the property. Furthermore, pre-demolition surveys should be completed to address the potential presence of regulated materials prior to demolition.</p>

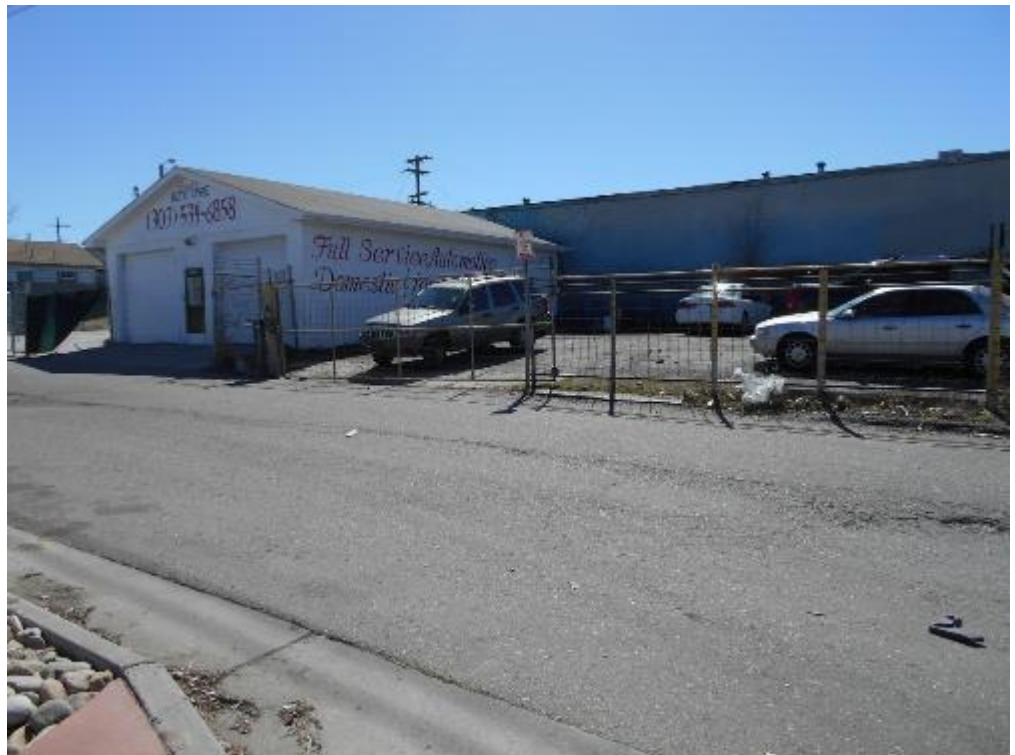
6. View of 2970 Severn Place (vacant service garage, formerly Complete Auto Care) facing southeast from the northeast corner of the Severn Place and Federal Boulevard intersection.

2970 West Severn Place: Vacant Service Garage (Formerly Complete Auto Care)	Located entirely within the Study Area.	<p><b>High.</b> This property consisted of a vacant automotive-service and maintenance structure. At the time of the reconnaissance, it appeared paved areas were being utilized for vehicle storage by the nearby automotive-sales facility, and a sign was noted depicting previous use as “Complete Auto Care.” Material handling, storage, and disposal practices are unknown; however, the structure was constructed in 1962, and the site was reportedly a scrap-metal lot from approximately 1981 to the mid-1980s.</p> <p>This property would be acquired if the Proposed Action were to be implemented, and the on-site structure would likely be demolished. Improvements for the Proposed Action would likely require limited excavation (up</p>

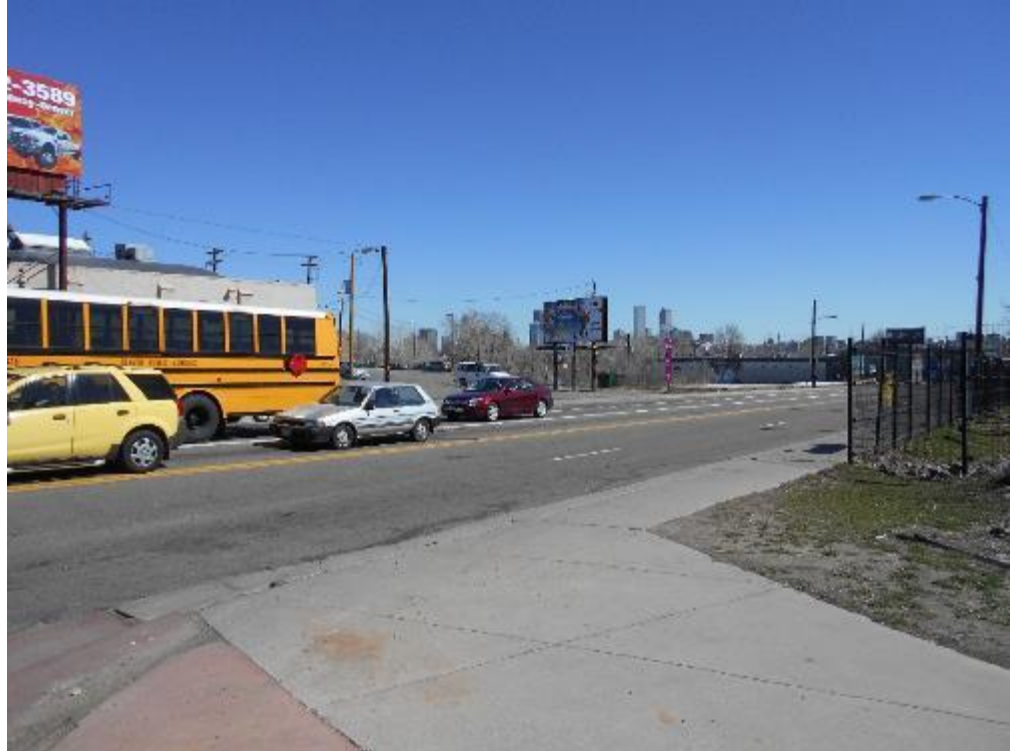
9. View of 2901 West 8<sup>th</sup> Avenue (vacant parcel) facing northeast from the southeast corner of the West 8<sup>th</sup> Avenue and Federal Boulevard Intersection.

Parcel (Facility) Address and Current Use (Figures 6 and 7)	Parcel Location and Hydrogeologic Relationship Relative to Study Area	Potential for Impacts to Study Area and Site-Specific Recommendations <sup>1</sup>
2901 West 8 <sup>th</sup> Avenue: Vacant Parcel	Located entirely within the Study Area.	<p><b>Low.</b> This property consisted of a vacant parcel, and observations made during the reconnaissance did not indicate the presence of any site-specific environmental concerns.</p> <p>This vacant property would be acquired if the Proposed Action were to be implemented. Improvements along this parcel could include excavation (up to 6 feet bgs) for roadway widening, sidewalk construction, and utility relocation. The Proposed Action also includes the construction of a water-quality pond at Weir Gulch, which could require excavation at this parcel up to 25 feet bgs. However, there is a low potential for residual contamination to be present as a result of current or past uses at this parcel, and the previously mentioned groundwater plume to the east appears to be hydrogeologically separated. Should the Proposed Action be implemented, it is recommended that a site-specific Phase I ESA or ISA be completed for the property prior to its acquisition. In addition, a site investigation could be required for an evaluation of subsurface conditions at the property based on the findings of the Phase I ESA or ISA.</p> <p>If the No-Action Alternative were to be implemented, no improvements would be made, and there would be no impact to this property. Therefore, no hazardous materials would be encountered.</p>

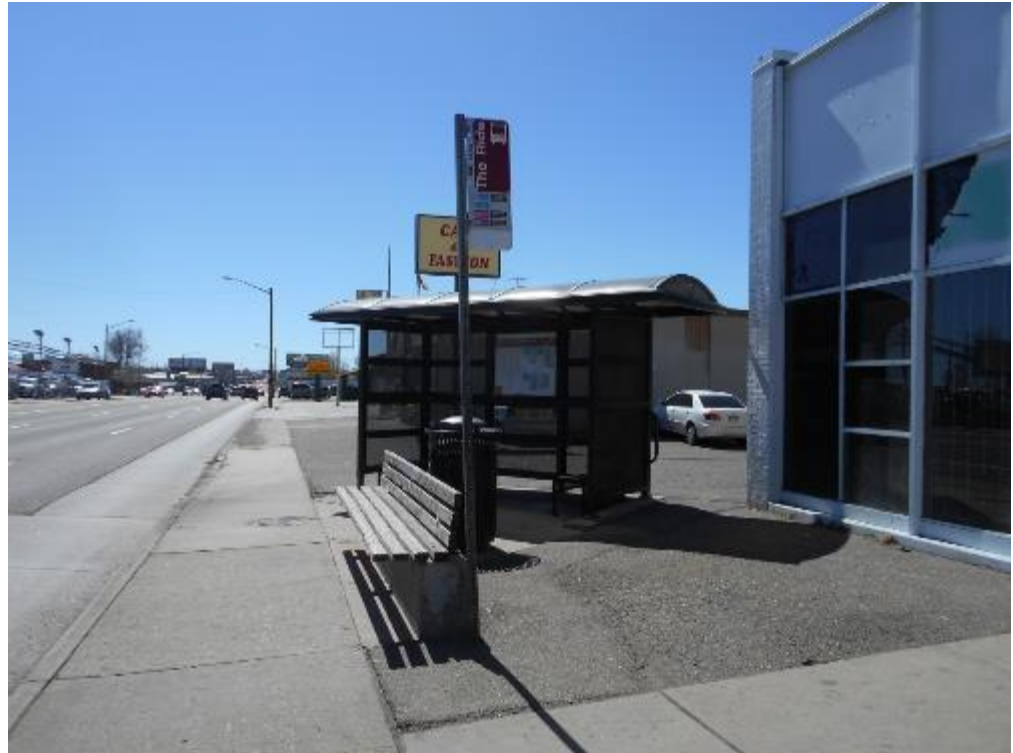
31. View of 969-979 Federal Boulevard (Casa de Fashion/The Treasure Thrift Store) facing south from the western side of Federal Boulevard. Typical green-painted, metal bus structure in foreground; paint sample PC-3 was collected at this location.

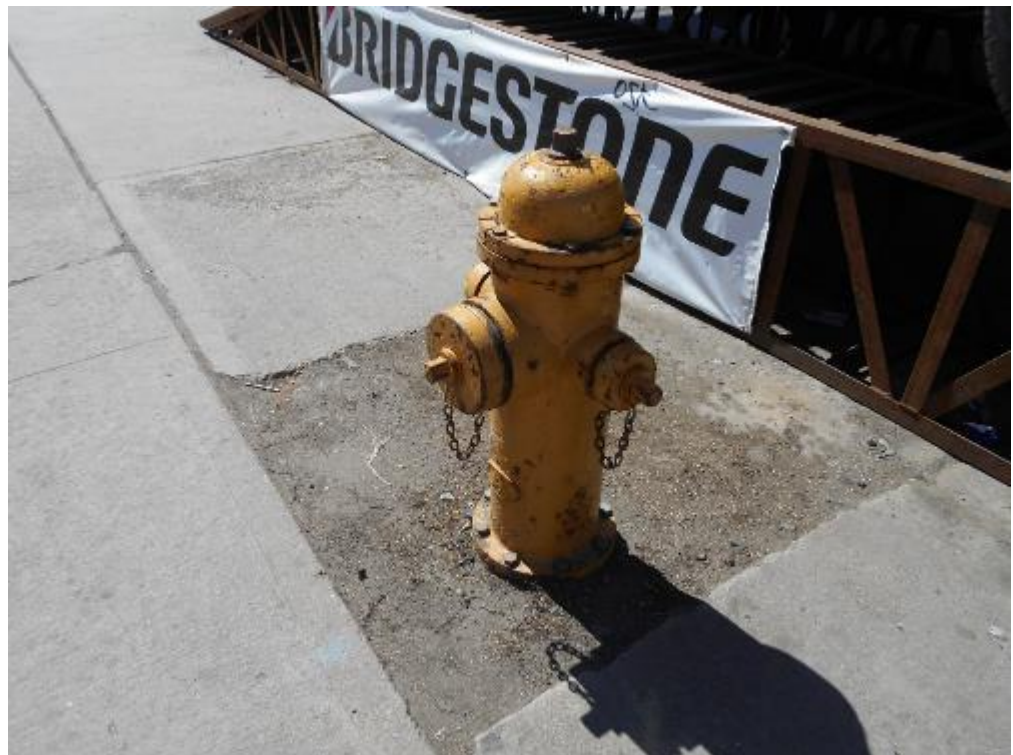
32. View of typical yellow-painted, metal fire hydrant. Paint sample PC-1 was collected at this location.

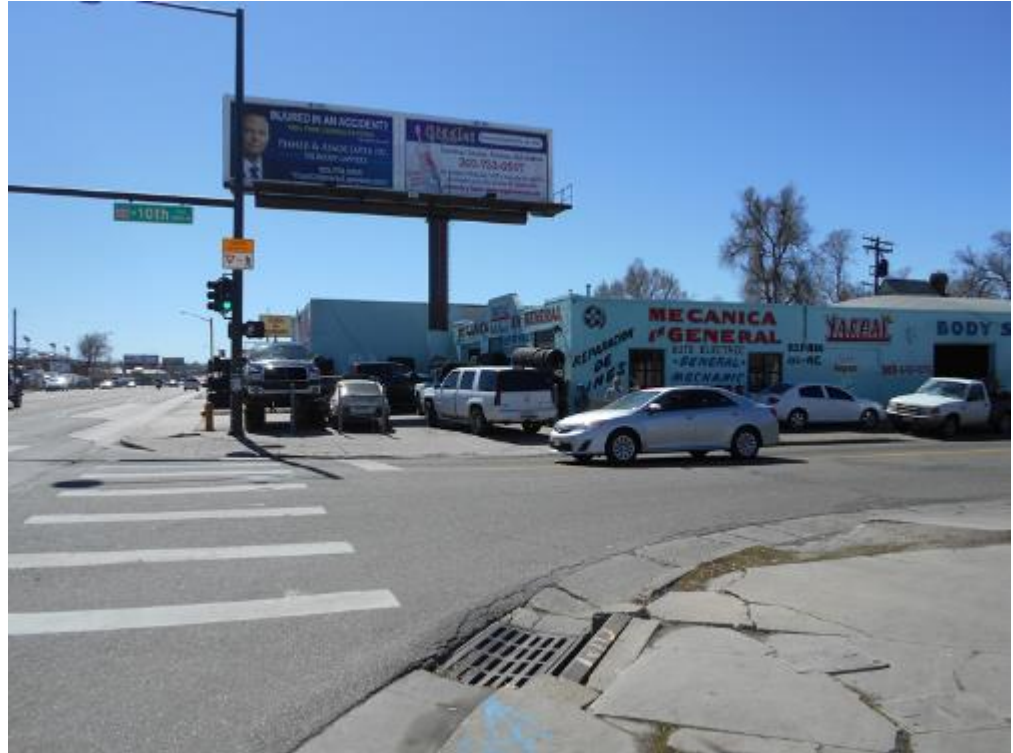
33. View of 995 Federal Boulevard (Mechanica en General). Typical green-painted metal signal pole visible in foreground; paint sample PC-2 was collected at this location.
