State Highway 9 Wildlife Crossings Monitoring – Annual Report Year 1

> Report No. CDOT-2017-04 Feb 2017

STATE HIGHWAY 9 WILDLIFE CROSSINGS MONITORING – PROGRESS REPORT

Phase 1 Pre-completion Monitoring December 2015 through March 2016

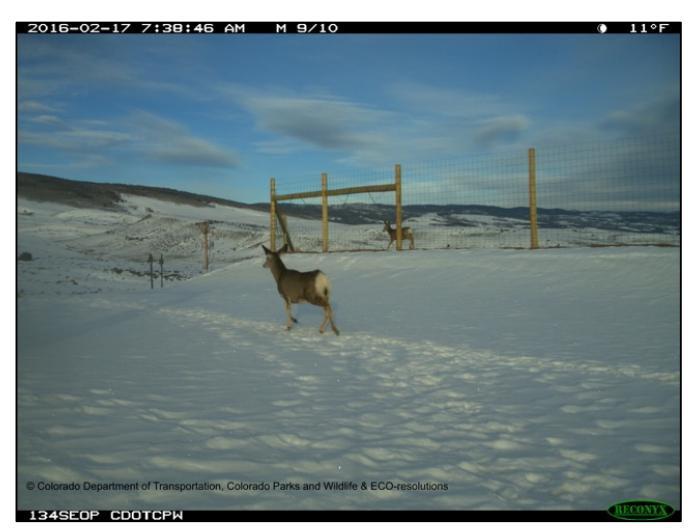
On several occasions mule deer were documented crossing over the North Overpass outside of the wildlife exclusion fence, along the structure edge. A gap in the wildlife fence between the fence and the edge of the structure was blocked with four-strand barbed wire fencing; however, camera monitoring documented that deer trapped in the right-ofway breached the barbed wire and crossed the overpass outside of the fence (Fig. 9).

Figure 9. Mule deer crossing over the North Overpass outside of the wildlife exclusion fence.

- Fence gap on North Overpass. To prevent mule deer from crossing the overpass outside of the wildlife fence, as documented by camera monitoring, the researchers recommended that the gap between the fence and the structure edge be closed with wildlife fencing. These fence gaps was closed during Phase 2 construction.
