# Rock Cut Blasting Aesthetics Best Management Practices Phase II

## Technical Report Documentation Page

1. Report No. CDOT-2021-02	2. Government Accession No.	3. Recipient's Catalog No.	
4. Title and Subtitle ROCK CUT BLASTING AESTHETICS BEST MANAGEMENT PRACTICES PHASE II		5. Report Date June 2021

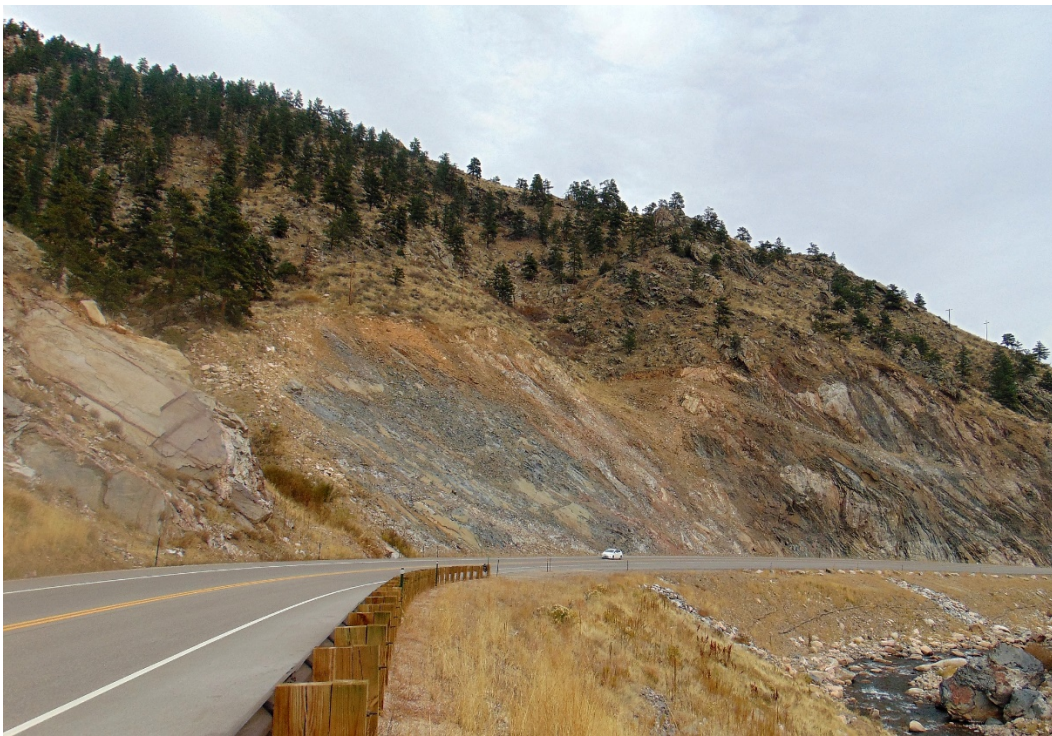
**Figure 11. US 34 MP 77.5**

plane that became the face of the cut. The foliation plane is visible in Figure 11. Additional rock excavation was needed to remove unstable materials following the rockslide and the result was on overrun in plan quantities. Use of advanced bedrock mapping techniques, seismic surveys and subsurface exploration at the top of the cut may have provided sufficient geologic information during the design phase to accurately predict the occurrence of the natural failure zone. The designers could have used this knowledge to plan the excavation and save costs. At other locations along the route, the joint patterns in the foliated rock were favorable to excavation and tended to obscure the half casts from presplit blasting.

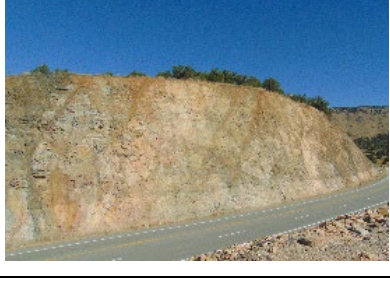
Granodiorite with foliated biotite gneiss xenoliths/inclusion, spheroidally weathered outcrops	Height: 35 to 40 ft Length: 650 ft 65-70 degree southeast facing slope	Westbound 44 seconds; Eastbound 20 seconds; static view from pullout SE side of road across from cut, SE end	Controlled blasting using pre-split blasting and cushion blasting techniques. Scaling, rock dowels and draped wire mesh rockfall mitigation.	Rock excavation to limits shown on the plans left a narrow ridge of highly fractured and jointed bedrock near the east end of the project, south side. This ridge was deemed unstable and additional blasting was required to remove the hazard.

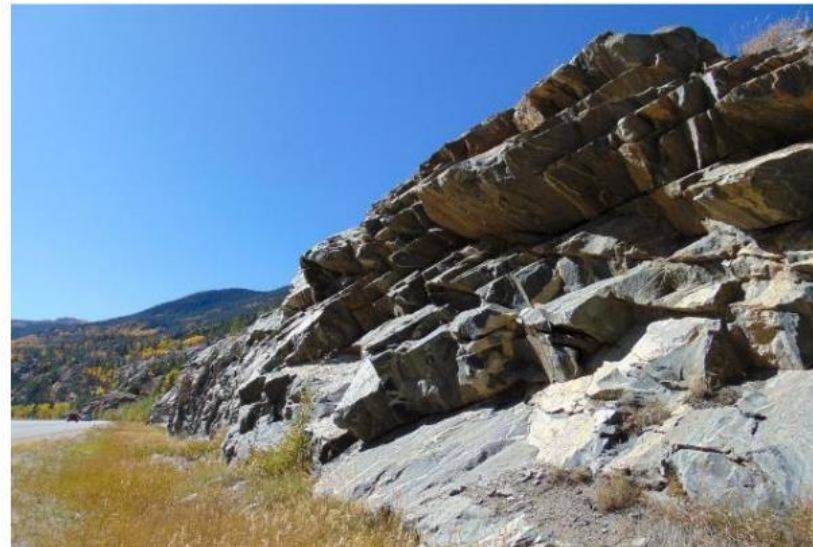
**Joint planar surface dip toward roadway**

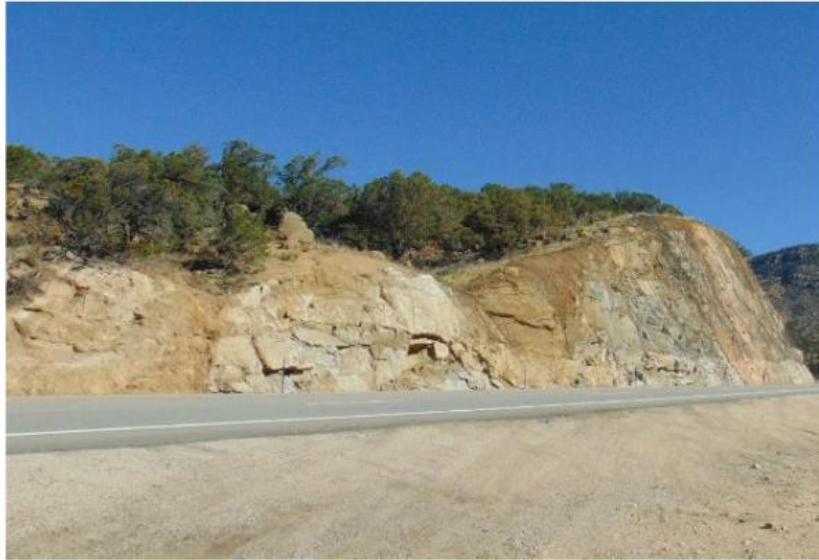
View to northeast, rock wedge missing

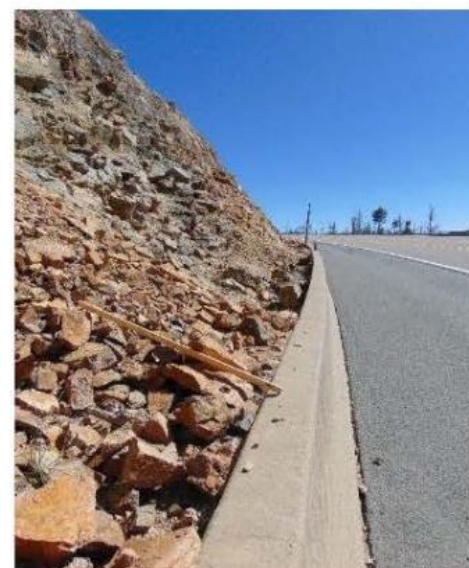
Rock filling behind barrier

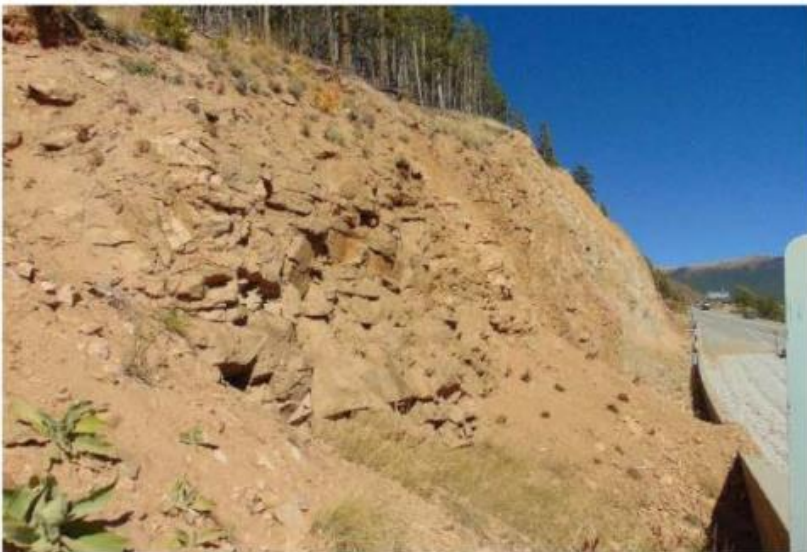
10/7/2019	Rocks behind and on barrier	563	Fractured rock on slope, loose rocks behind and on barrier
10/7/2019	Failed bolts	559	Failed bolts in weathered joint area

Fractured rock and loose rock on slope and behind barrier, view to east-northeast

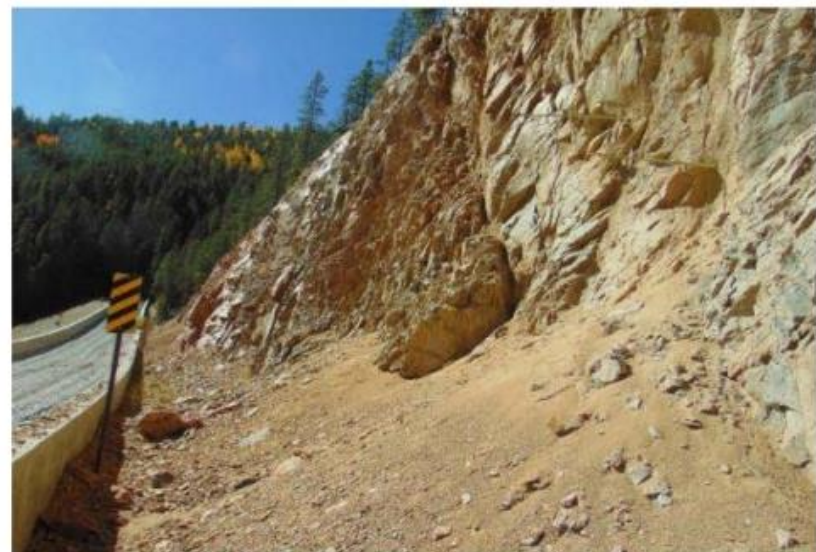
Failed rock bolts at right side photo, view to west-southwest

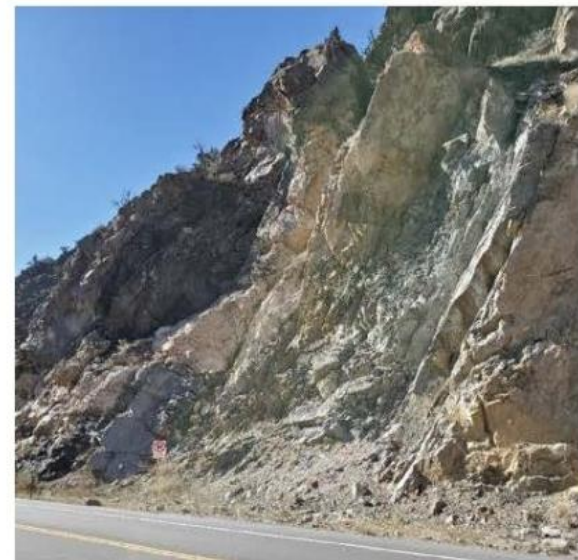
Looking south at loose rock on slope, boulder in ditch
