## INTERCHANGE SAFETY

### *C-470 and Ken Caryl Rd. Interchange*

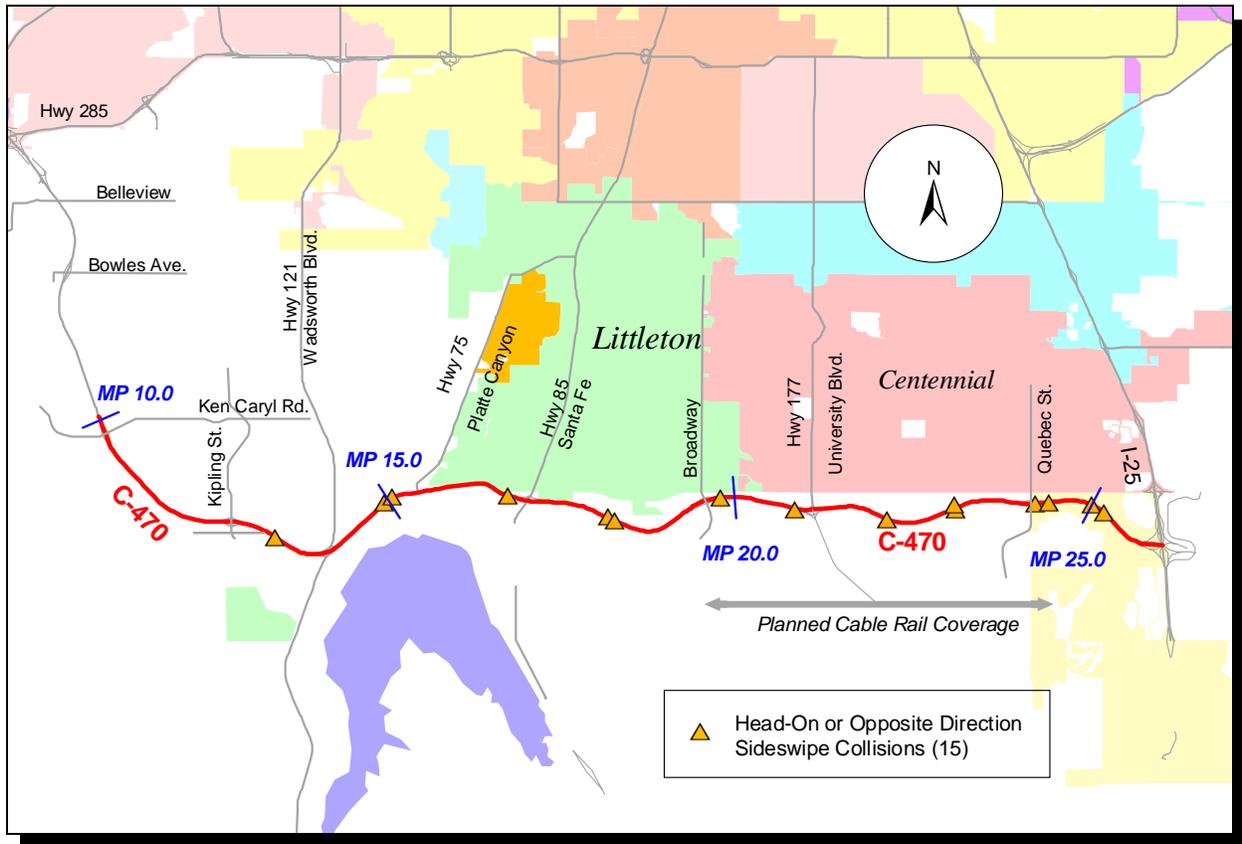
**Figure 16b**

Figure 16b identifies the locations where head-on and opposing direction sideswipe collisions occurred during the study period. The planned cable rail section will enclose an area where several of these severe accidents have historically taken place.

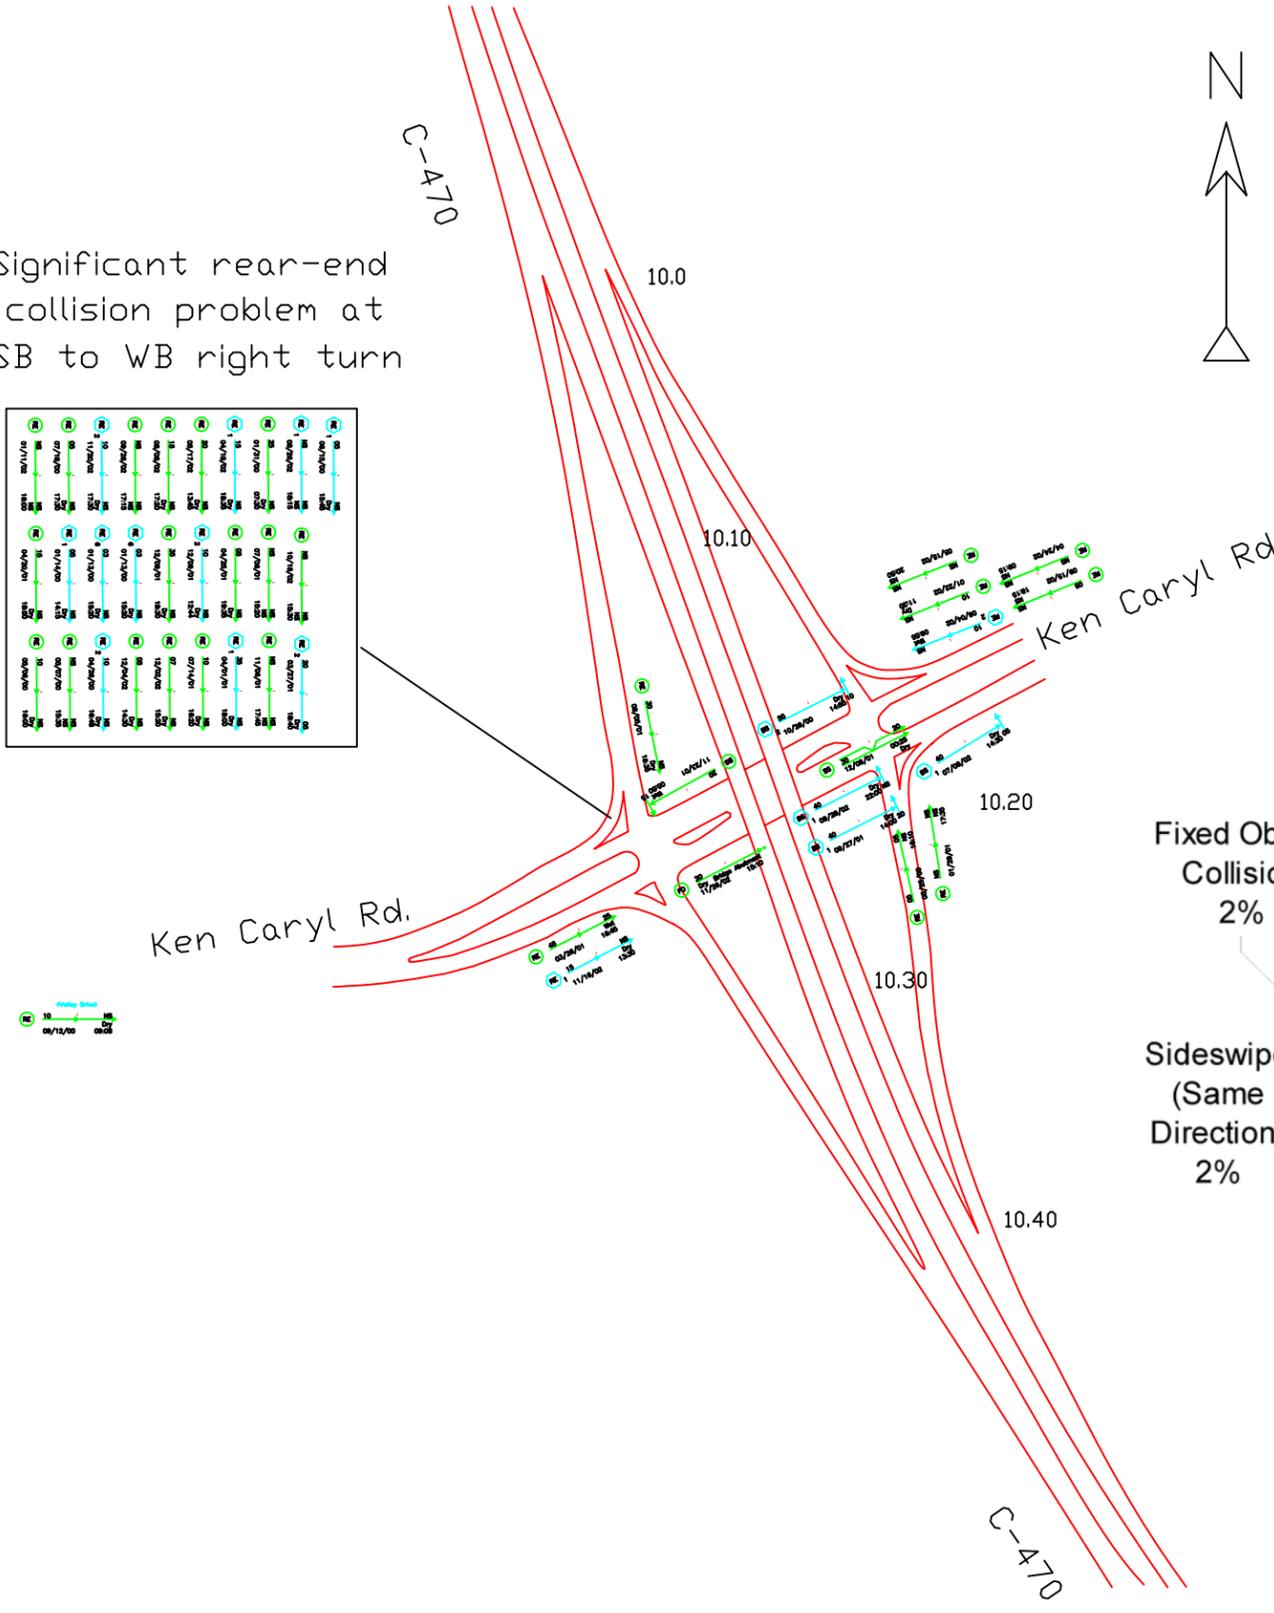
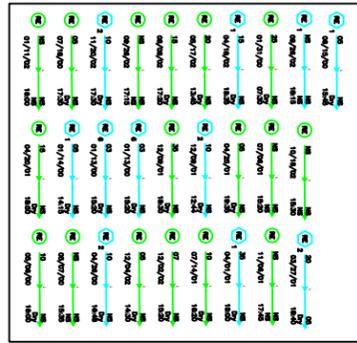
# C-470 & Ken Caryl Rd. Interchange

The accident type distribution profile shows that rear end collisions make up most of the accidents at the ramp terminals and on Ken Caryl Rd., accounting for 85% of the total. A significant number of these rear end accidents are occurring in the right turn movement from the southbound (EB C-470) off ramp to westbound Ken Caryl Rd. During the 3 year study period approximately 28 crashes were reported at this location. Improvements such as extended acceleration lanes on Ken Caryl Rd. can help moderate the incidence of these accidents. Ensuring optimum visibility from the intersection to the east can also help curtail the tendency for drivers to start and then unexpectedly stop to clear traffic.

Five broadside collisions are noted at the east side ramp terminal. At this location, east bound drivers are occasionally running through a red signal indication resulting in a crash with northbound drivers turning onto Ken Caryl from the westbound C-470 off ramp. Ensuring optimum visibility of the eastbound traffic signal for approaching vehicles can help reduce the incidence of these crashes.

Significant rear-end collision problem at SB to WB right turn
