APPENDIX D
GEOTECHNICAL MAPS

West Vail Pass Geohazard Maps

Project Name: West Vail Pass Task Order #2

Project Number: 217-520

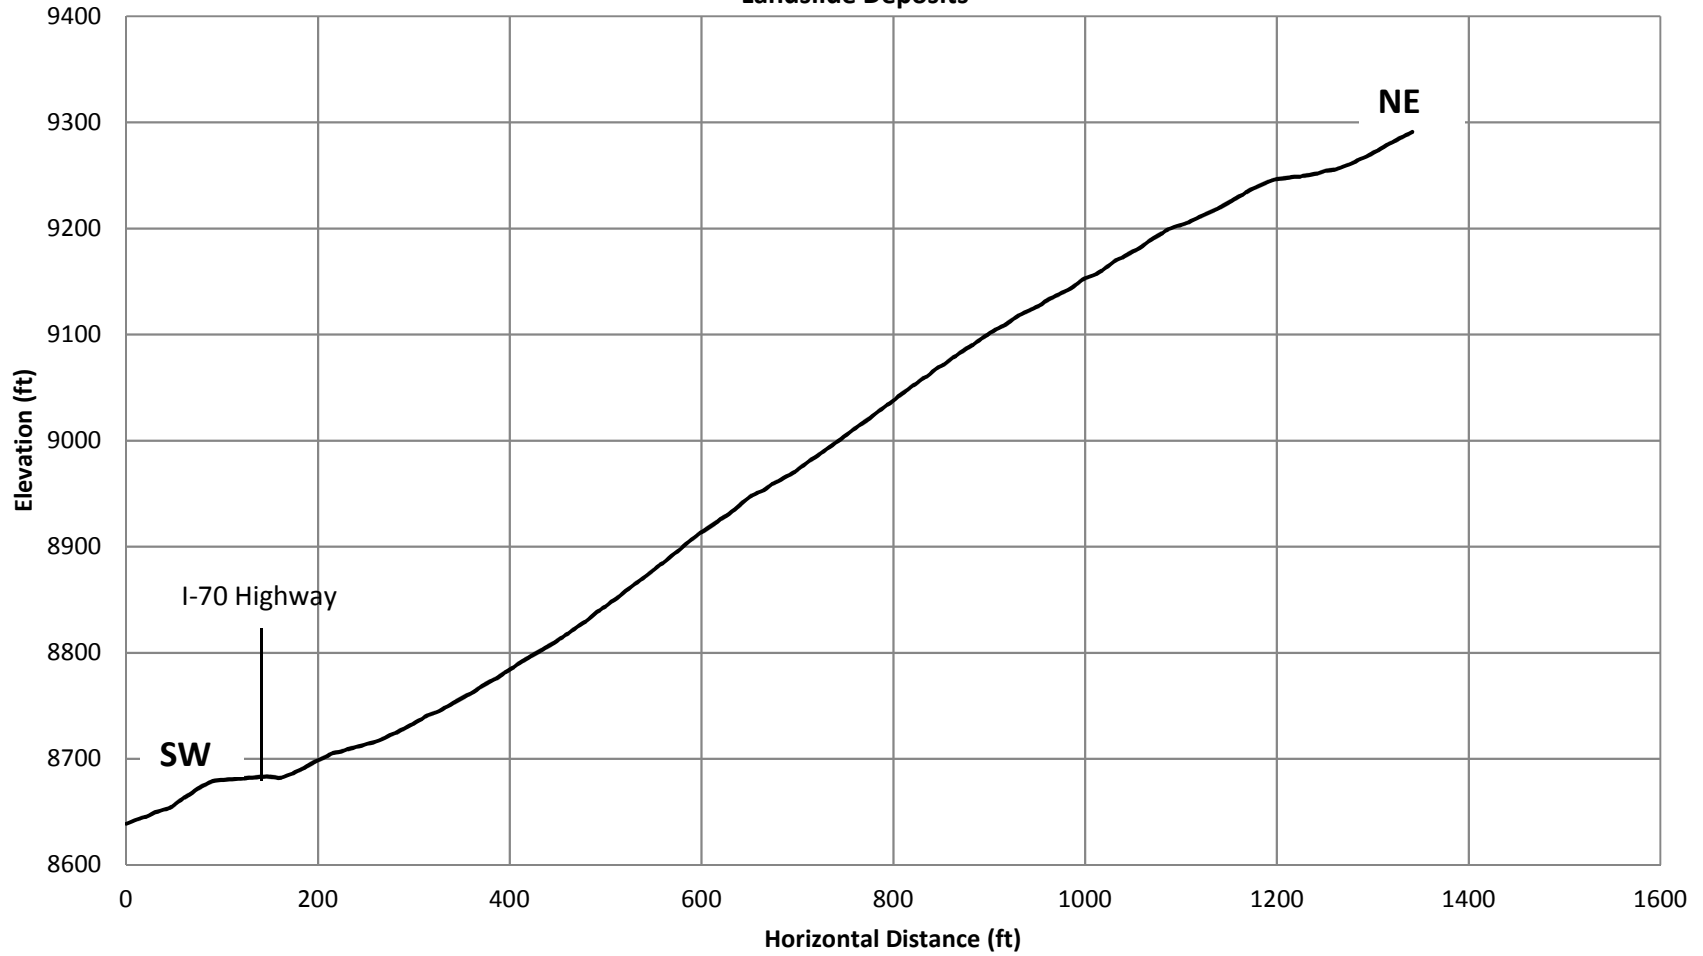
XS-1 Profile Approximately MP 181.6

Landslide Deposits

54% Slope

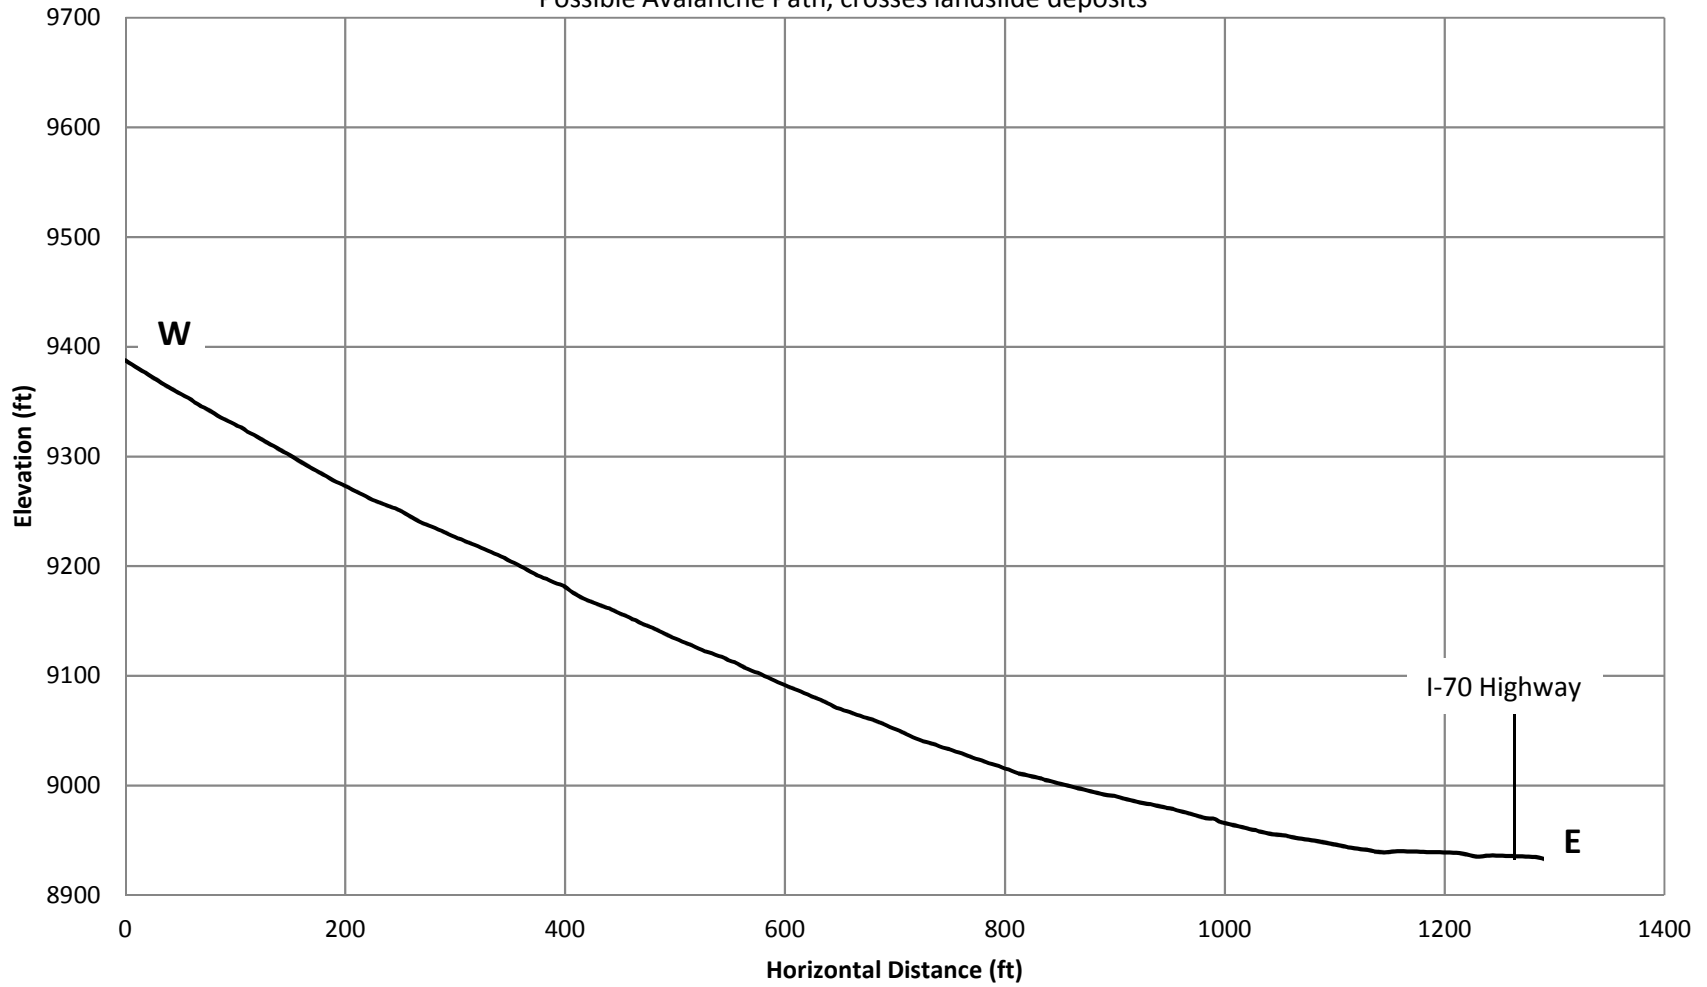
XS-2 Profile Approximately MP 182.7

36% Slope

Possible Avalanche Path, crosses landslide deposits

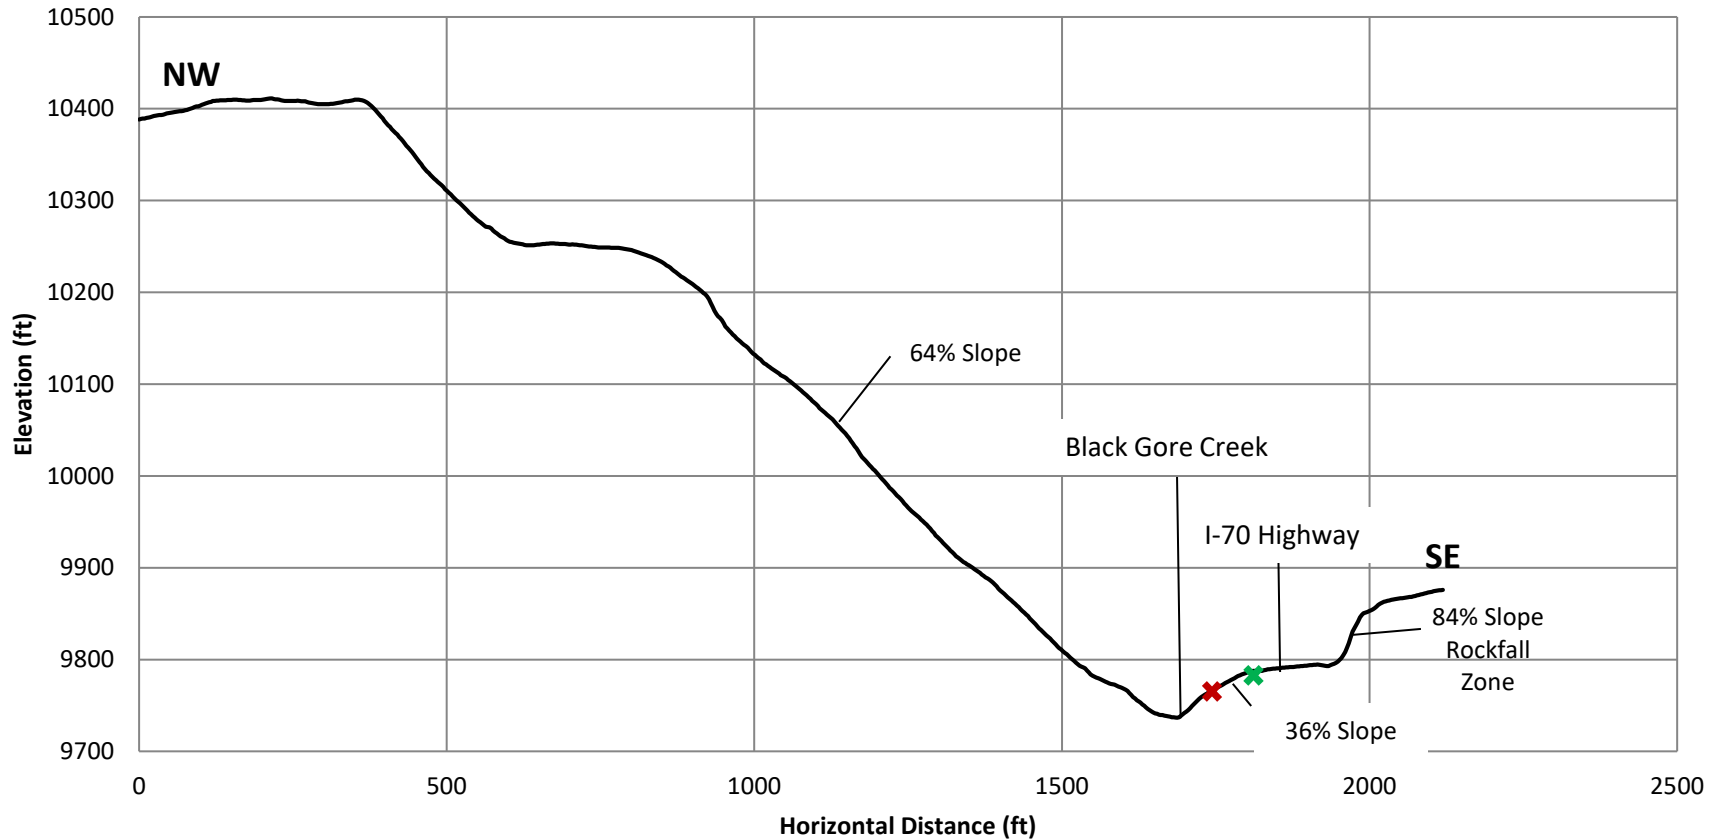
XS-5 Profile Approximately MP 185.8

Possible Avalanche Path

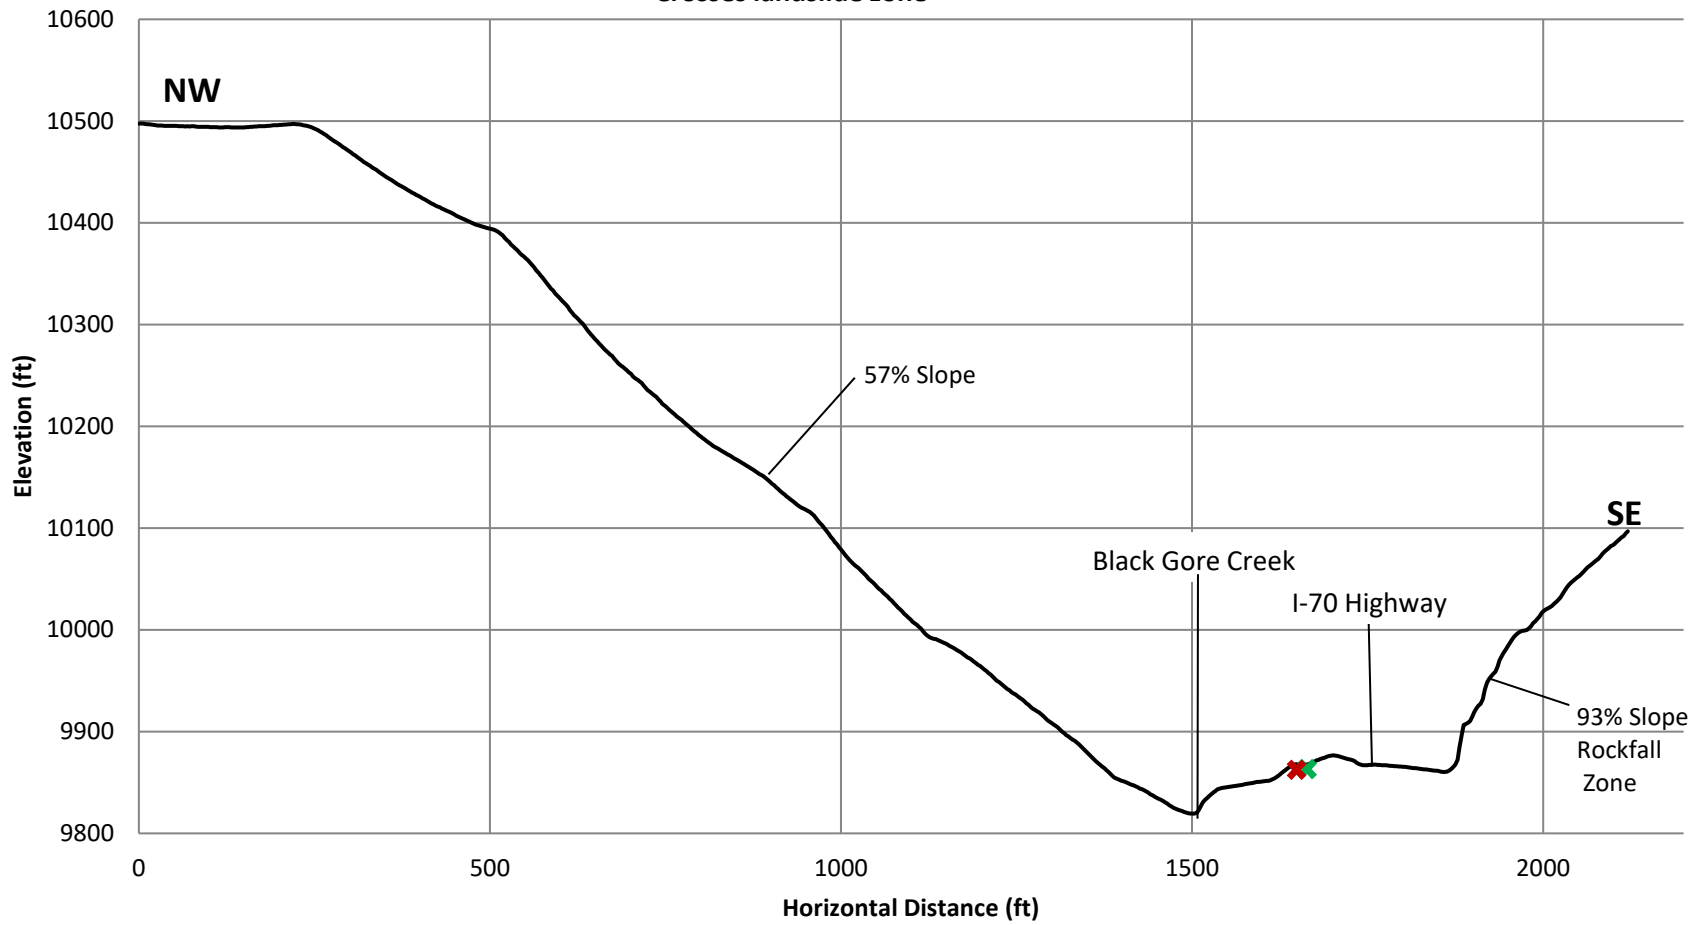
XS-7 Profile Approximately MP 186.1

Crosses landslide zone

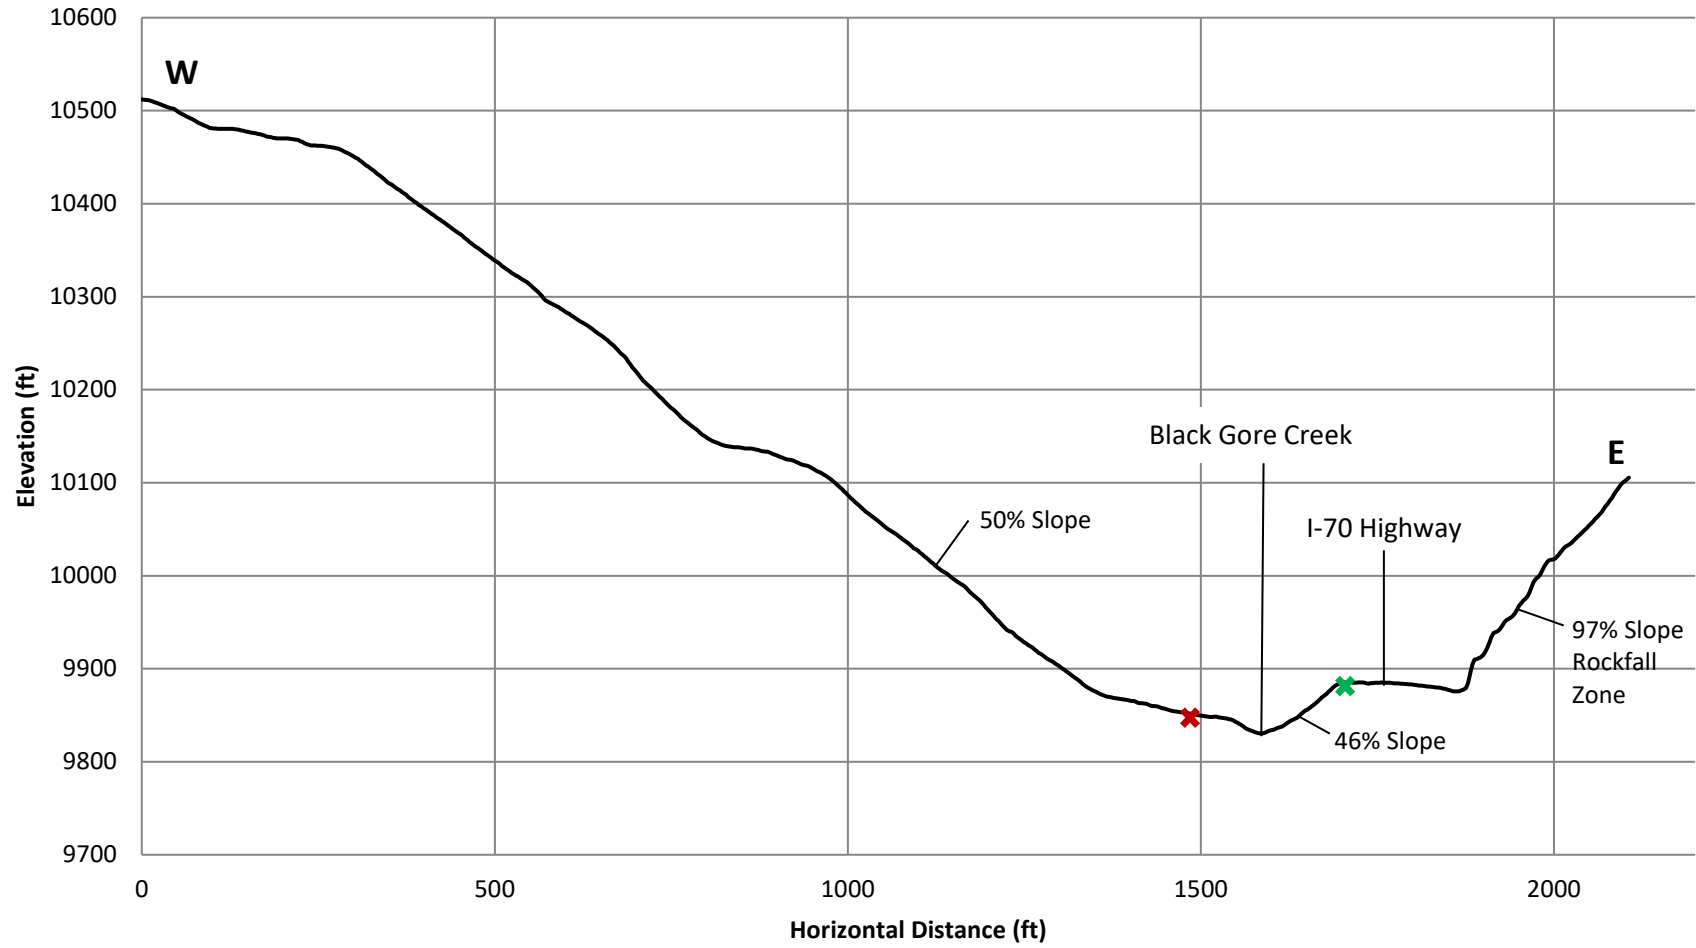
XS-8 Profile Approximately MP 186.2

Possible Avalanche Path

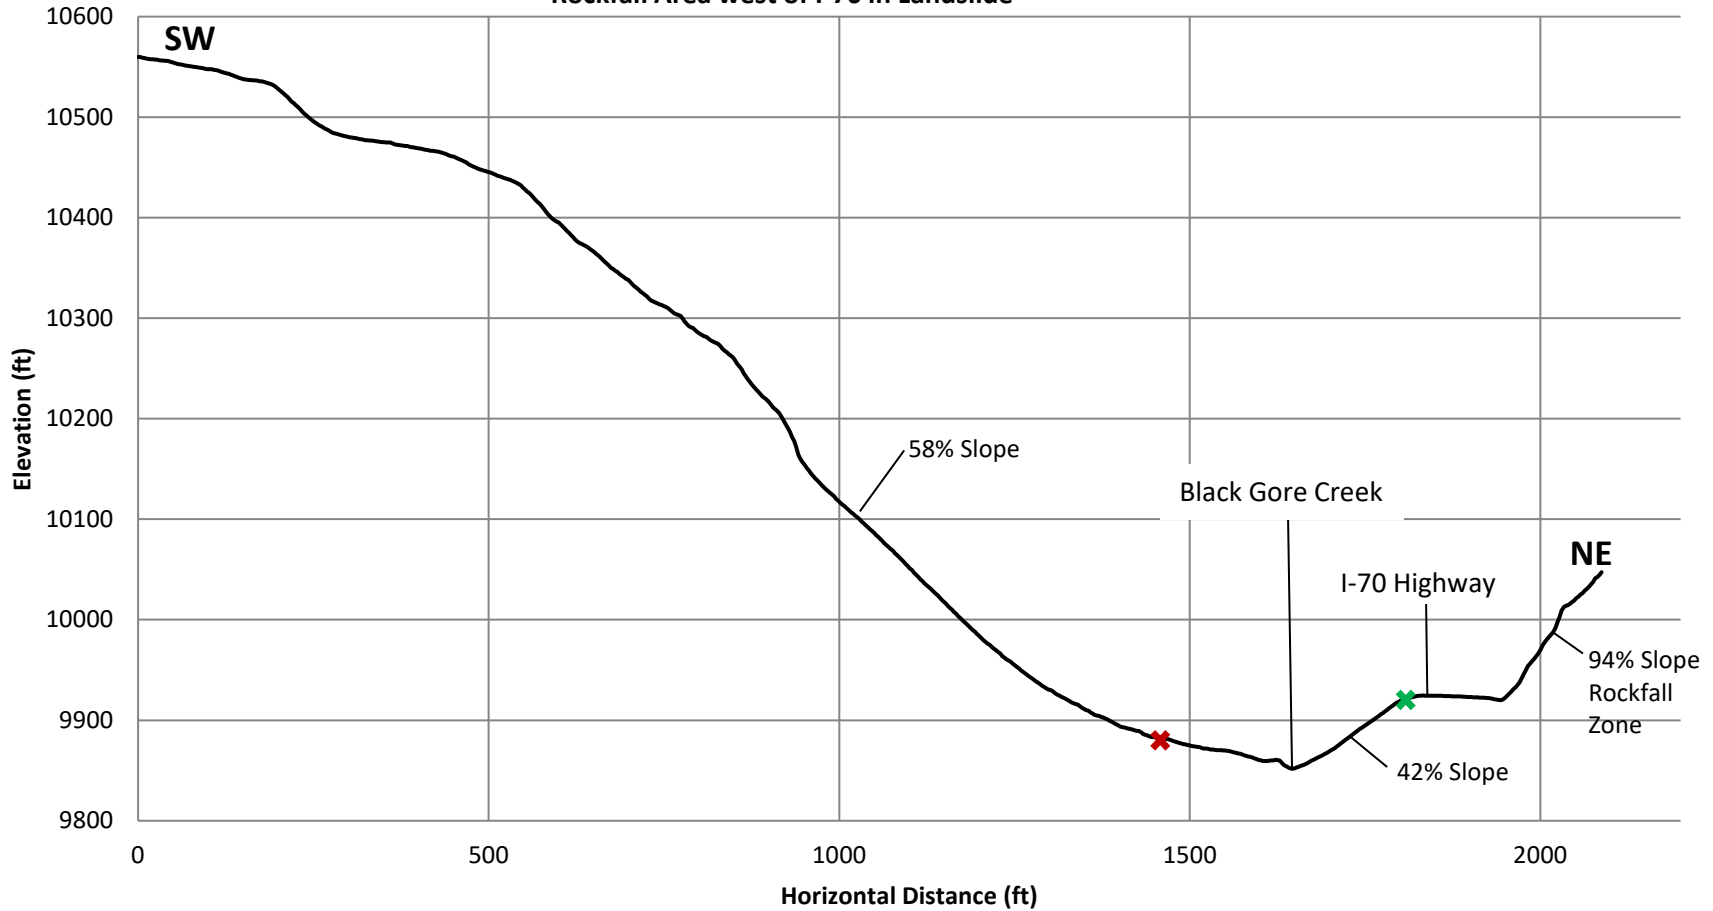
XS-9 Profile Approximately MP 186.3

Rockfall Area west of I-70 in Landslide
