**Report No. CDOT-DTD-R-2002-2
Final Report**

CONSTRUCTION AND MONITORING OF POST-TENSIONED MASONRY SOUND WALLS

**CDOT Project BR 287-3(061)
US 36 and Federal Blvd.
Westminster, Colorado**

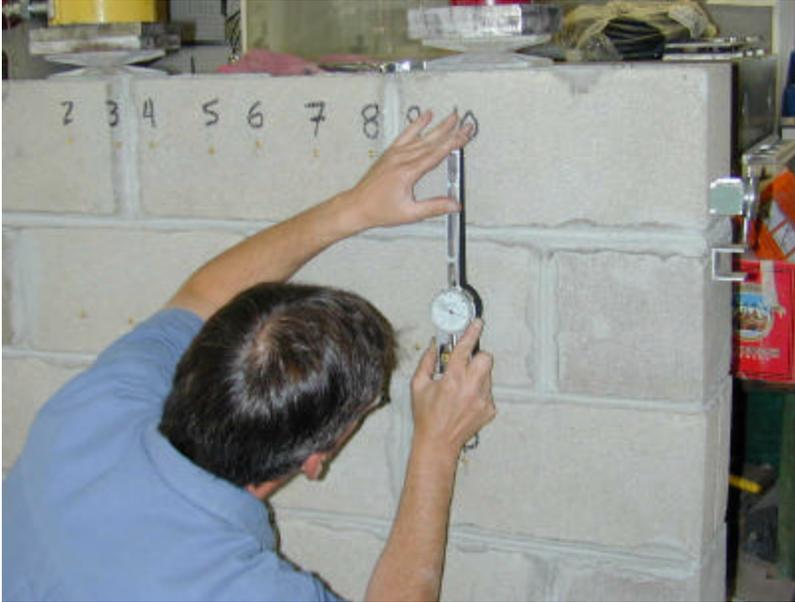
Figure 2. Laboratory tests of bond beam anchorage. The top course is a fully grouted, horizontally reinforced bond beam constructed with 8-inch concrete block. Strains were measured with a dial gage at 10 points between the two tendons (top of photograph).

Anchorage testing was conducted to evaluate the adequacy of the bond beam top anchorages. In order to test the anchorages, a small 4 foot by 4 foot wallette was built that contained a bond beam at the bottom and top course. Each bond beam was horizontally reinforced with two #4 bars to provide an anchorage for two 11/16-inch diameter tendons. The tendons were installed vertically at 24-inch centers using standard Dur-o-Wal anchorage plates. Load-indicating washers were installed at the top anchorage to indicate when the maximum rod tension had been reached. As the tendons were tensioned, deflection readings were taken on the face of the masonry immediately below the anchorage and at intervals between the two tendon anchorages (see Figure 2). Measurements were taken with a Demec gage with resolution of 0.0001 inch. The displacement readings were plotted along with calculated values for the displacement (Figure 3). The displacement calculations follow the classical solution by Timoshenko for a beam on an elastic foundation and agree well with the measured displacements assuming typical concrete masonry material properties.

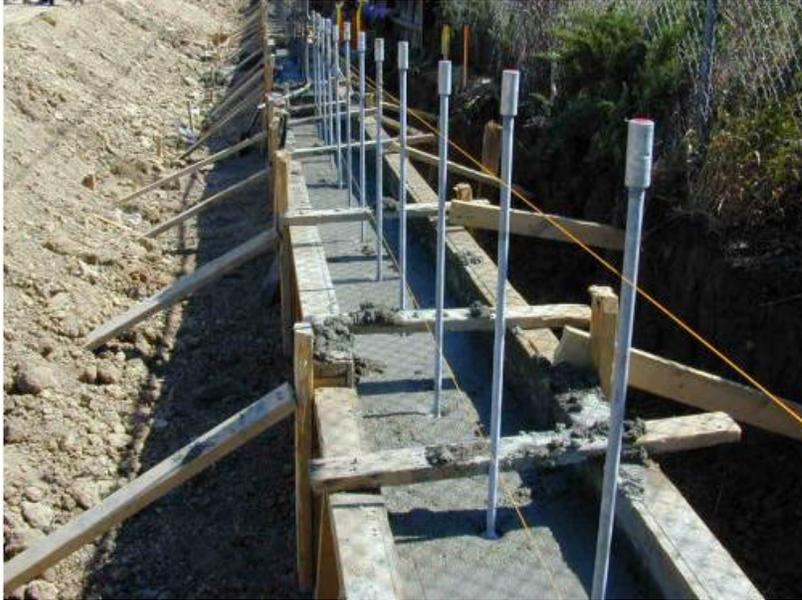
Figure 4. Photograph of grade beam with tendon anchorages installed.

The concrete grade beams at the base of the CMU wall were cast on August 11, 2000. Immediately after the pour, the anchorage assemblies (Dur-o-Wal D/A-790F Sure-Stress) were inserted in the fresh concrete and vibrated to ensure consolidation around the anchorage. The anchorage assembly, consisting of the anchorage and a 36-inch tendon, were aligned to a string line to ensure that the tendons would be located along the center line of the wall. Figure 4 shows the layout of the tendons in the grade beam prior to building the wall.

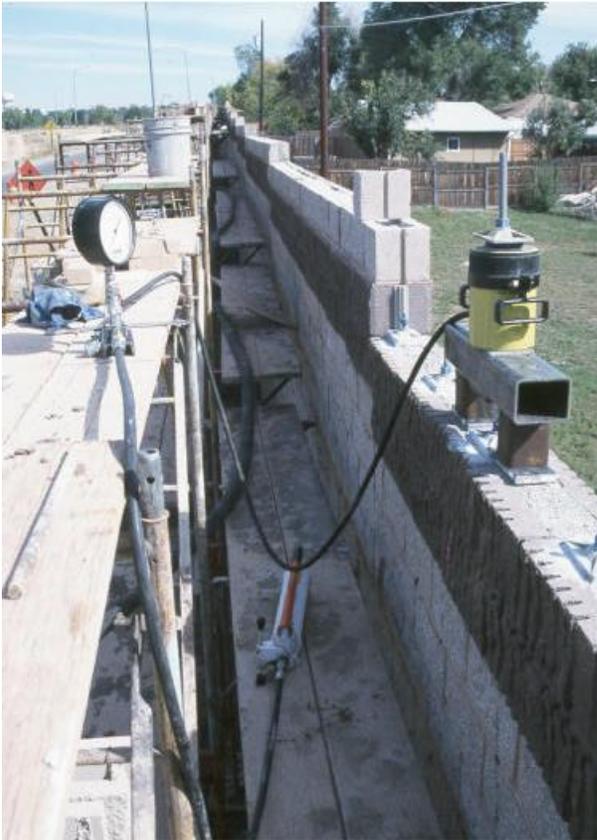
Figure 5. A hand hydraulic pump was used with a hydraulic ram to accurately tension the instrumented and intermediate tendons.

The tendons were tensioned October 2, 2000. The tensioning began at the north end of the test wall with gage #1 and proceeded to the south (gage #8). The instrumented tendons, installed at 4 ft. centers (every other tendon), were tensioned first and the intermediate (non-instrumented) tendons were tensioned in a secondary operation. Figure 5 shows the tensioning equipment consisting of steel shims, a tubular steel beam, an open cylinder hydraulic ram, and hydraulic pump. The tendon force is distributed into the bond beam upon final tensioning by 4 by 6 inch cast bearing plates (Dur-o-Wal D/A 790BP Sure-Stress).

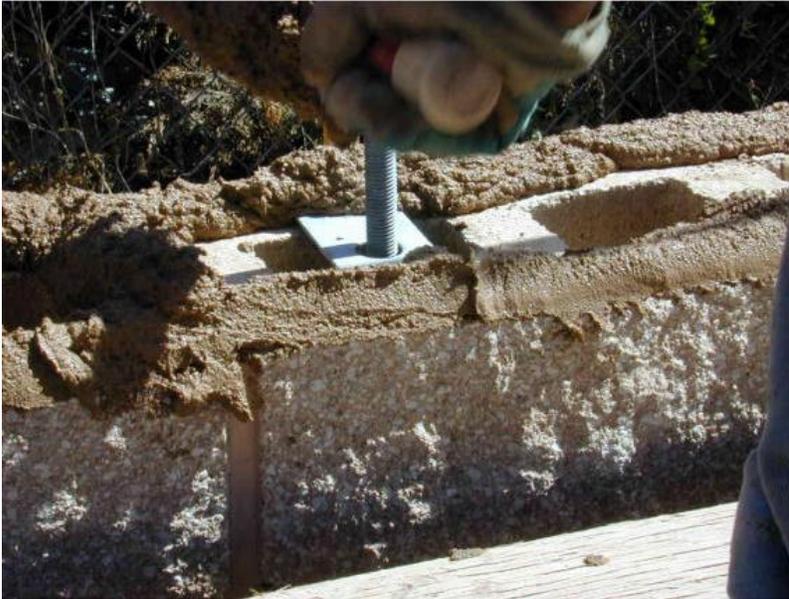
Figure 7. Photograph of the wall under construction. A tendon restraint plate can be seen in the center of the photograph.

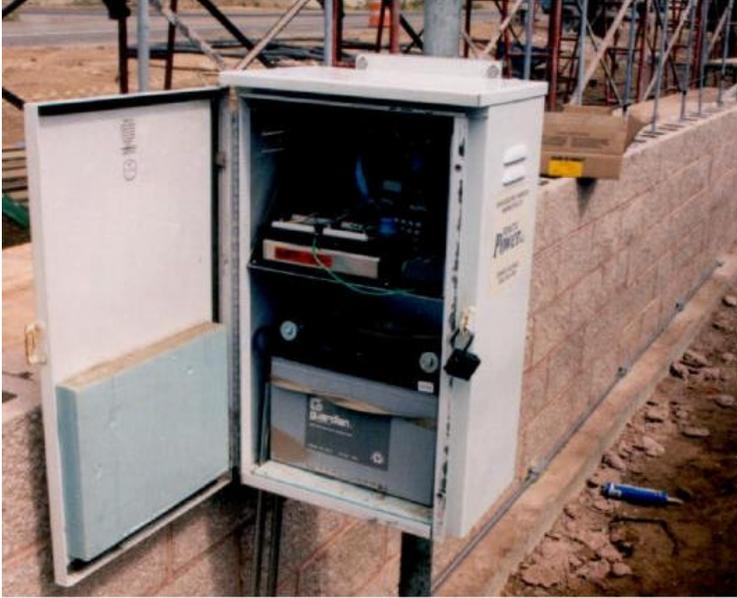
Figure 8. View of the instrument cabinet and the partially built post-tensioned wall in the background.

The lower portion of the wall was constructed the week of August 21, 2000 and the vibrating wire strain gages were installed late during the same week. The vibrating wire strain gages were preinstalled on 36-inch sections of tendons by Geokon, Inc. Eight tendons were instrumented and leads from the strain gages were routed down the cell to the bottom of the wall where the wire exited the wall. Electrical conduit was run from each instrumented cell to an instrument cabinet to protect the wiring. The electrical cabinet housed a Campbell Scientific CR-10 data recorder, 8-channel multiplexer, vibrating wire interface for the CR-10, and a 12 Volt deep-cycle battery to power the system. The data recorder was programmed to record both the strain and temperature of each tendon once per hour.

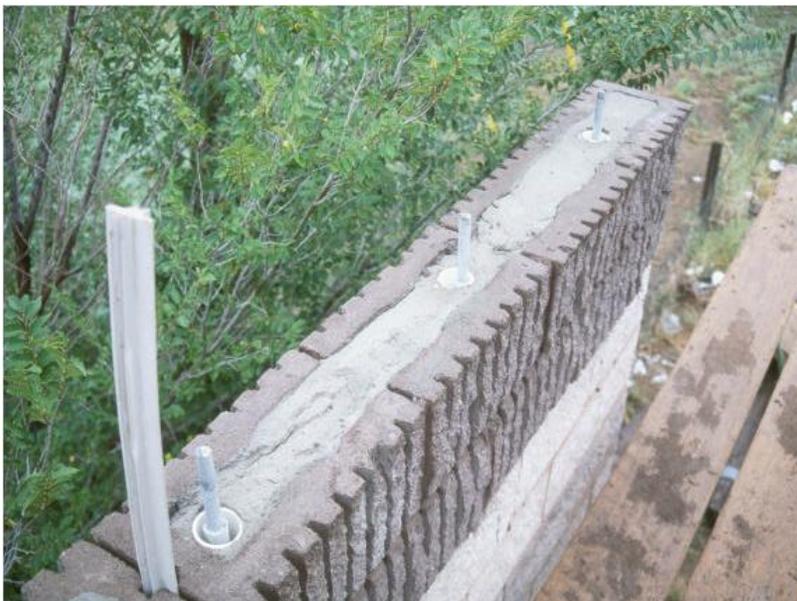
Figure 9. View of the top of the post-tensioned wall showing the sleeve inserted into the bond beam to prevent bonding of the tendon. Mortar beds were placed beneath the bearing plates to form the anchorage at this course. An additional ungrouted course was placed above the anchorage and the wall was topped with a precast concrete cap.
