**FIGURE 2**  
**TOPOGRAPHIC MAP**  
 OF  
**STRAIGHT CREEK PORTION**  
 SUMMIT COUNTY, COLO.  
 PROJECT 1-70-3 (13) 212  
 DILLON-EMPIRE JUNCTION  
 FOR  
 COLORADO DEPARTMENT OF HIGHWAYS  
 DENVER, COLORADO  
 BY  
 CONTINENTAL ENGINEERS INC.  
 DENVER, COLO.

**COLORADO DEPARTMENT OF HIGHWAYS**  
**GEOLOGIC SKETCH MAP-SLIDE A, STRAIGHT CREEK SLIDE AREA, SUMMIT COUNTY, COLORADO**

**GEOLOGIC MAP OF SLIDES 1 AND 2, STRAIGHT CREEK SLIDE AREA, SUMMIT COUNTY, CO**

STRAIGHT CREEK SLIDE AREA—SLIDE 1

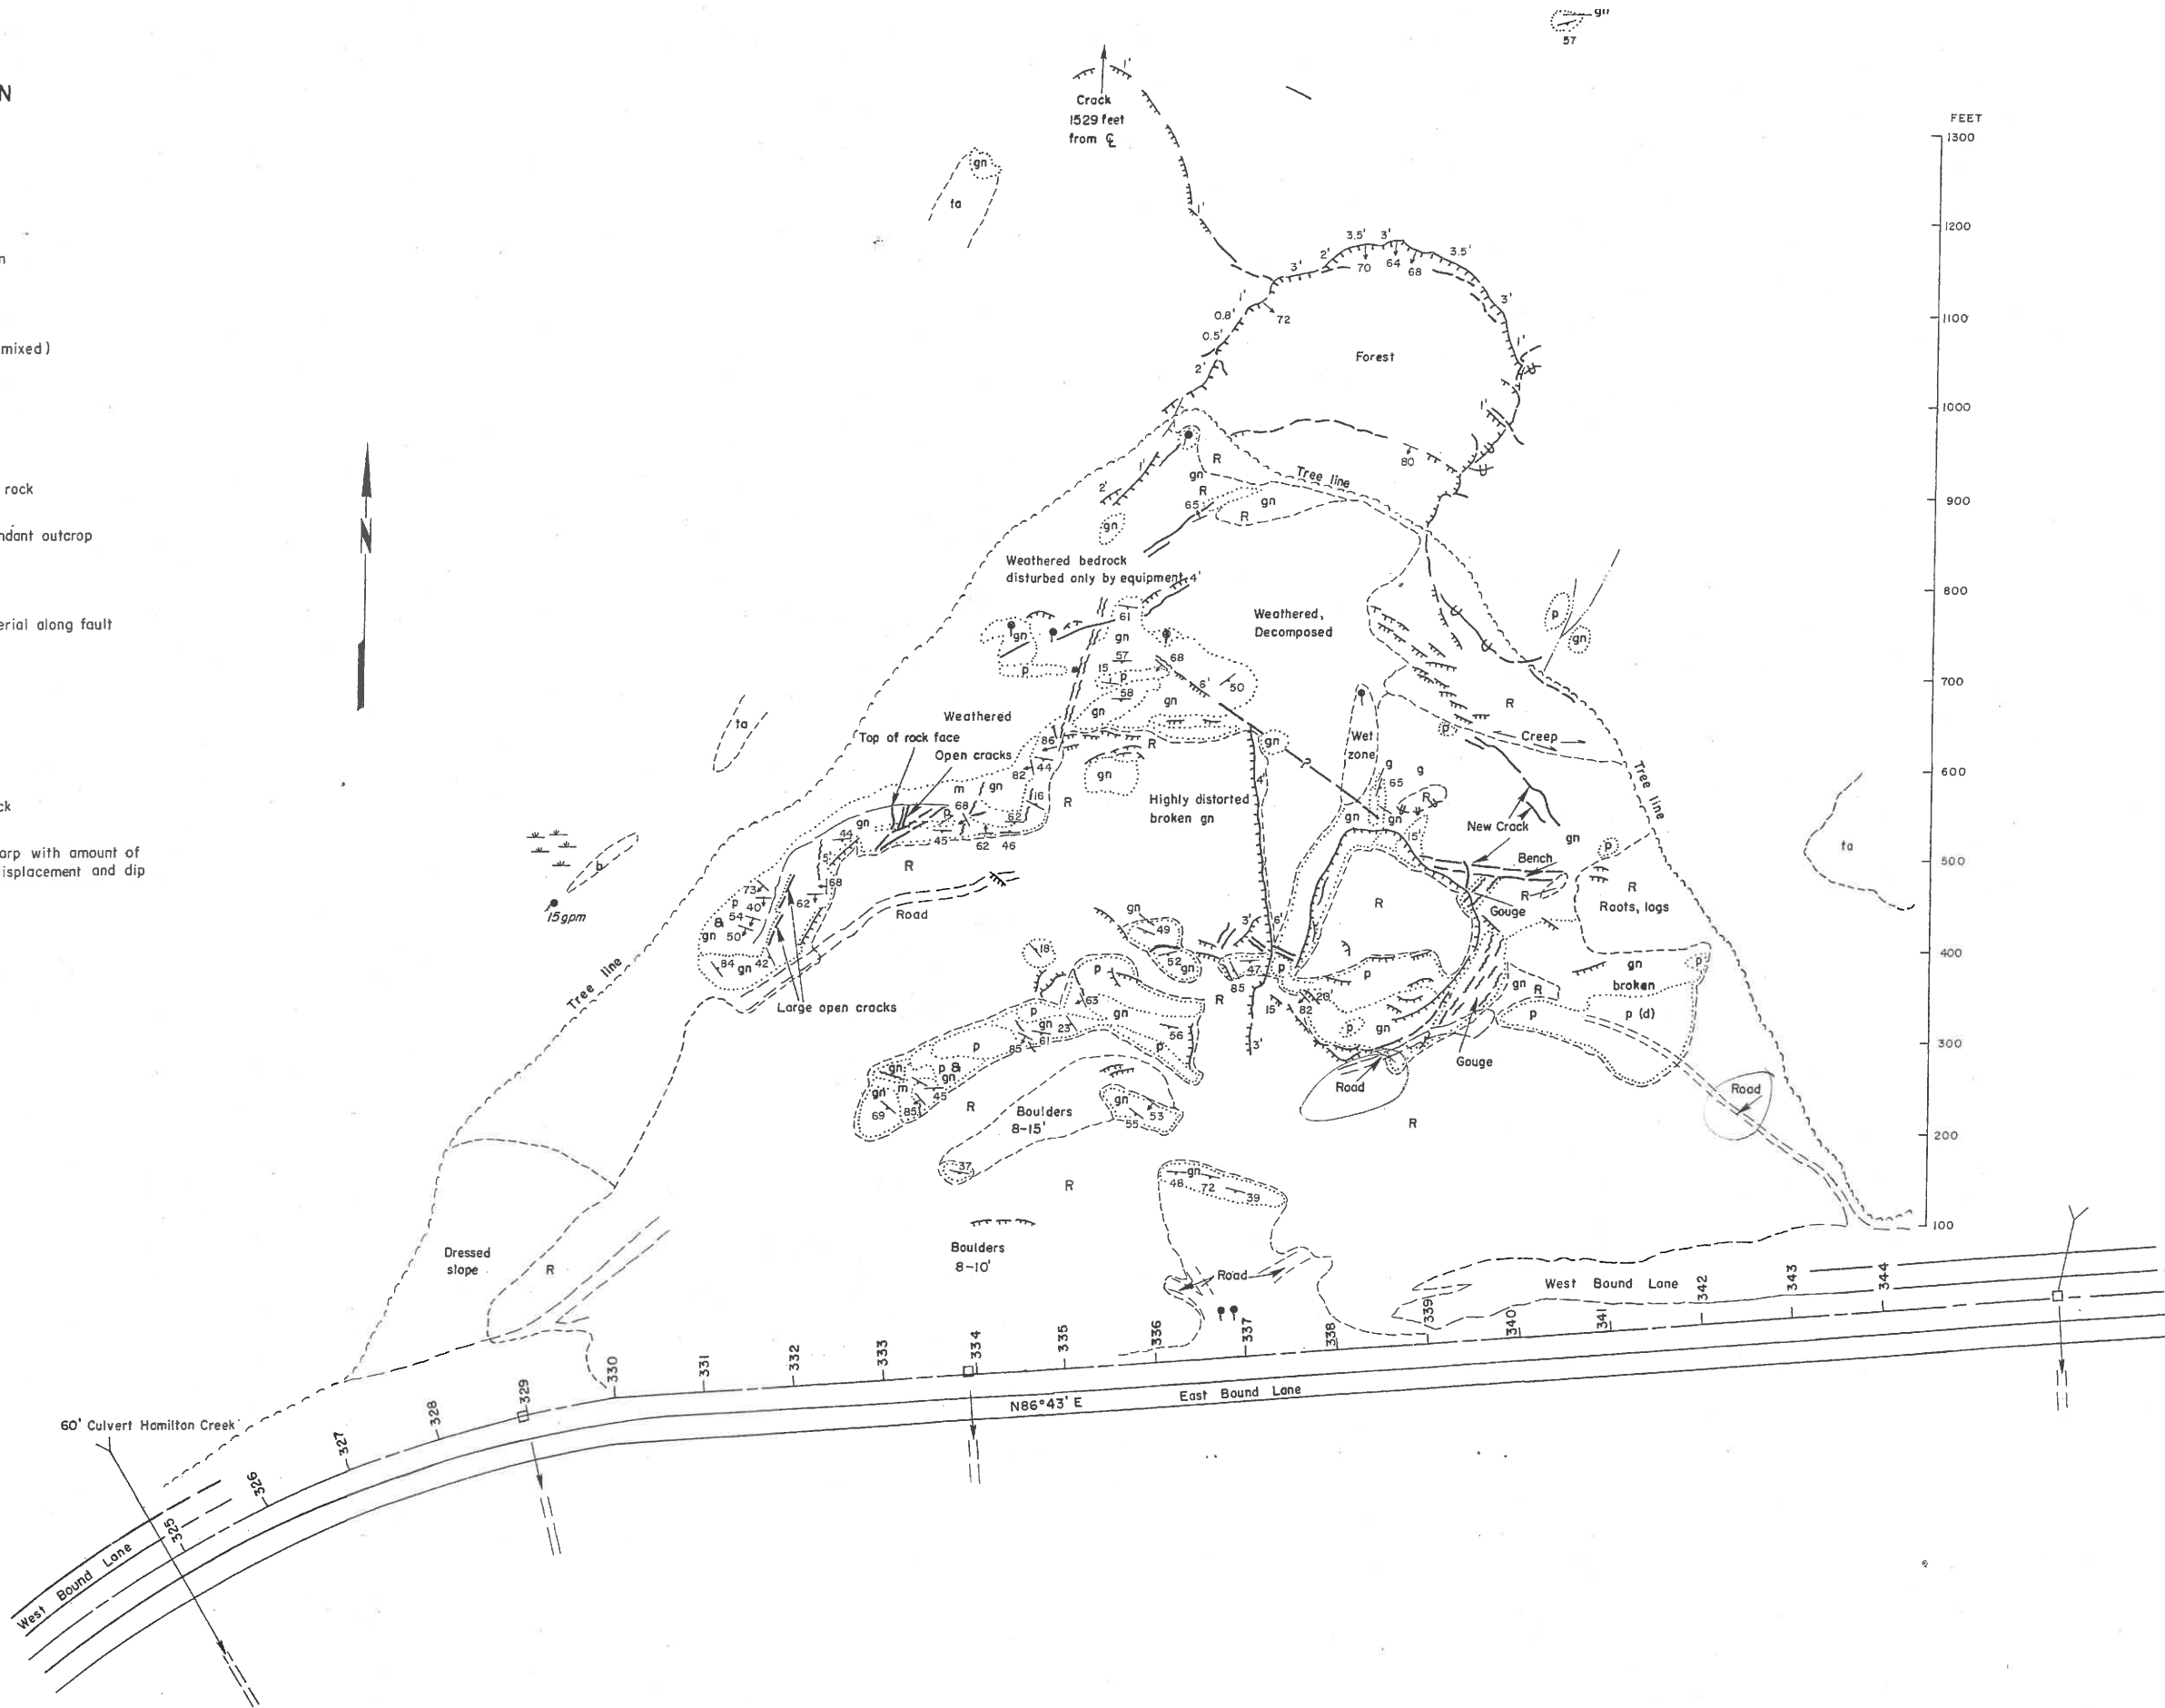
COLORADO DEPARTMENT OF HIGHWAYS  
 AND  
 ROBINSON & ASSOCIATES  
 GEOLOGY BY D.M. COCHRAN  
 AUGUST, 1971

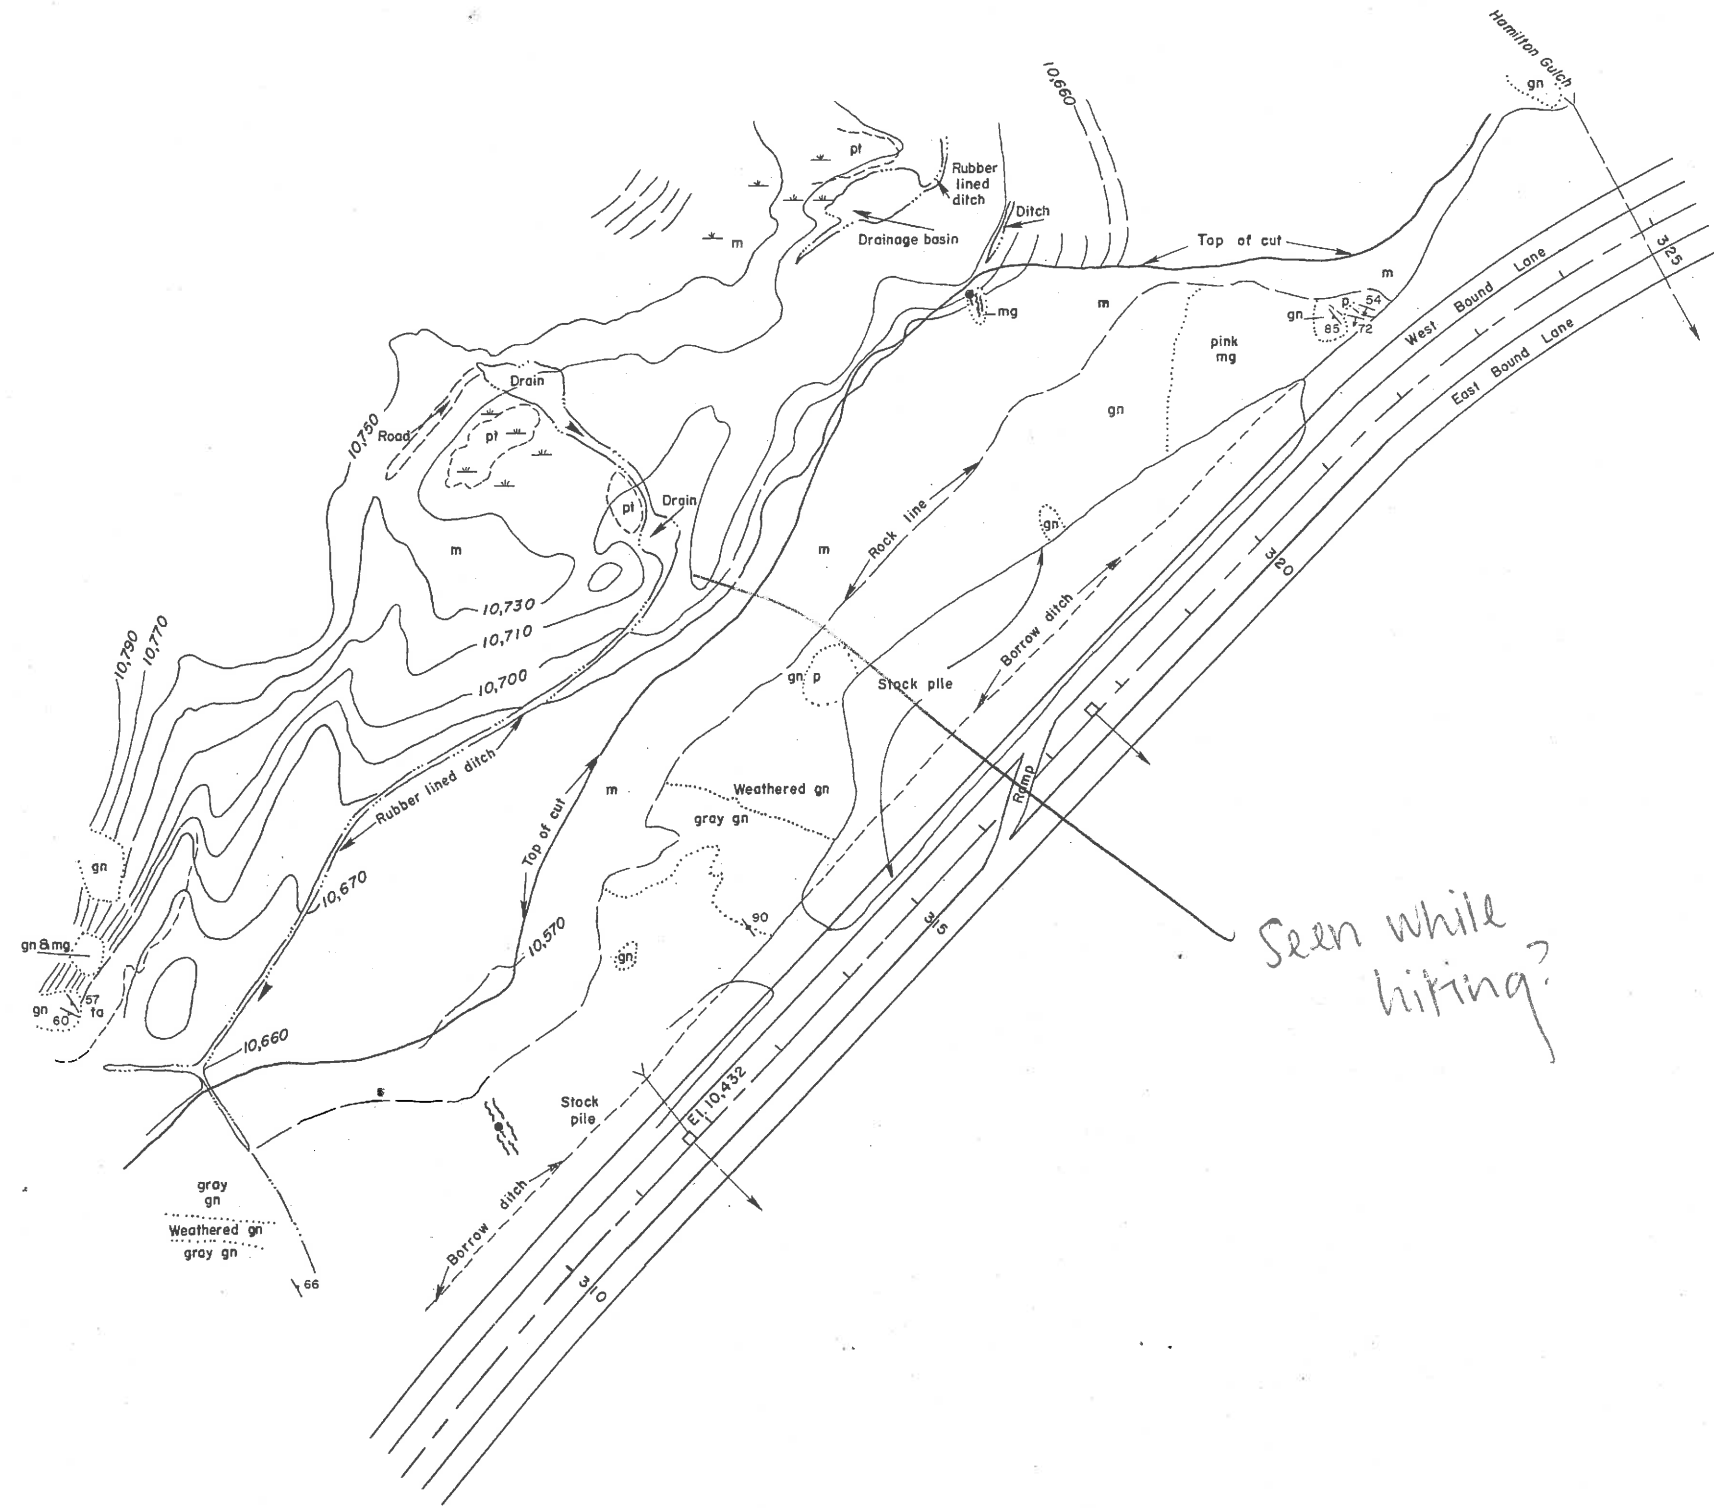
**COLORADO DEPARTMENT OF HIGHWAYS**  
 SKETCH MAP-SLIDE B, STRAIGHT CREEK SLIDE AREA, SUMMIT COUNTY, COLORADO

COLORADO DEPARTMENT OF HIGHWAYS  
 AND  
 ROBINSON & ASSOCIATES  
 MAPPED BY D.M. COCHRAN  
 AUGUST, 1971

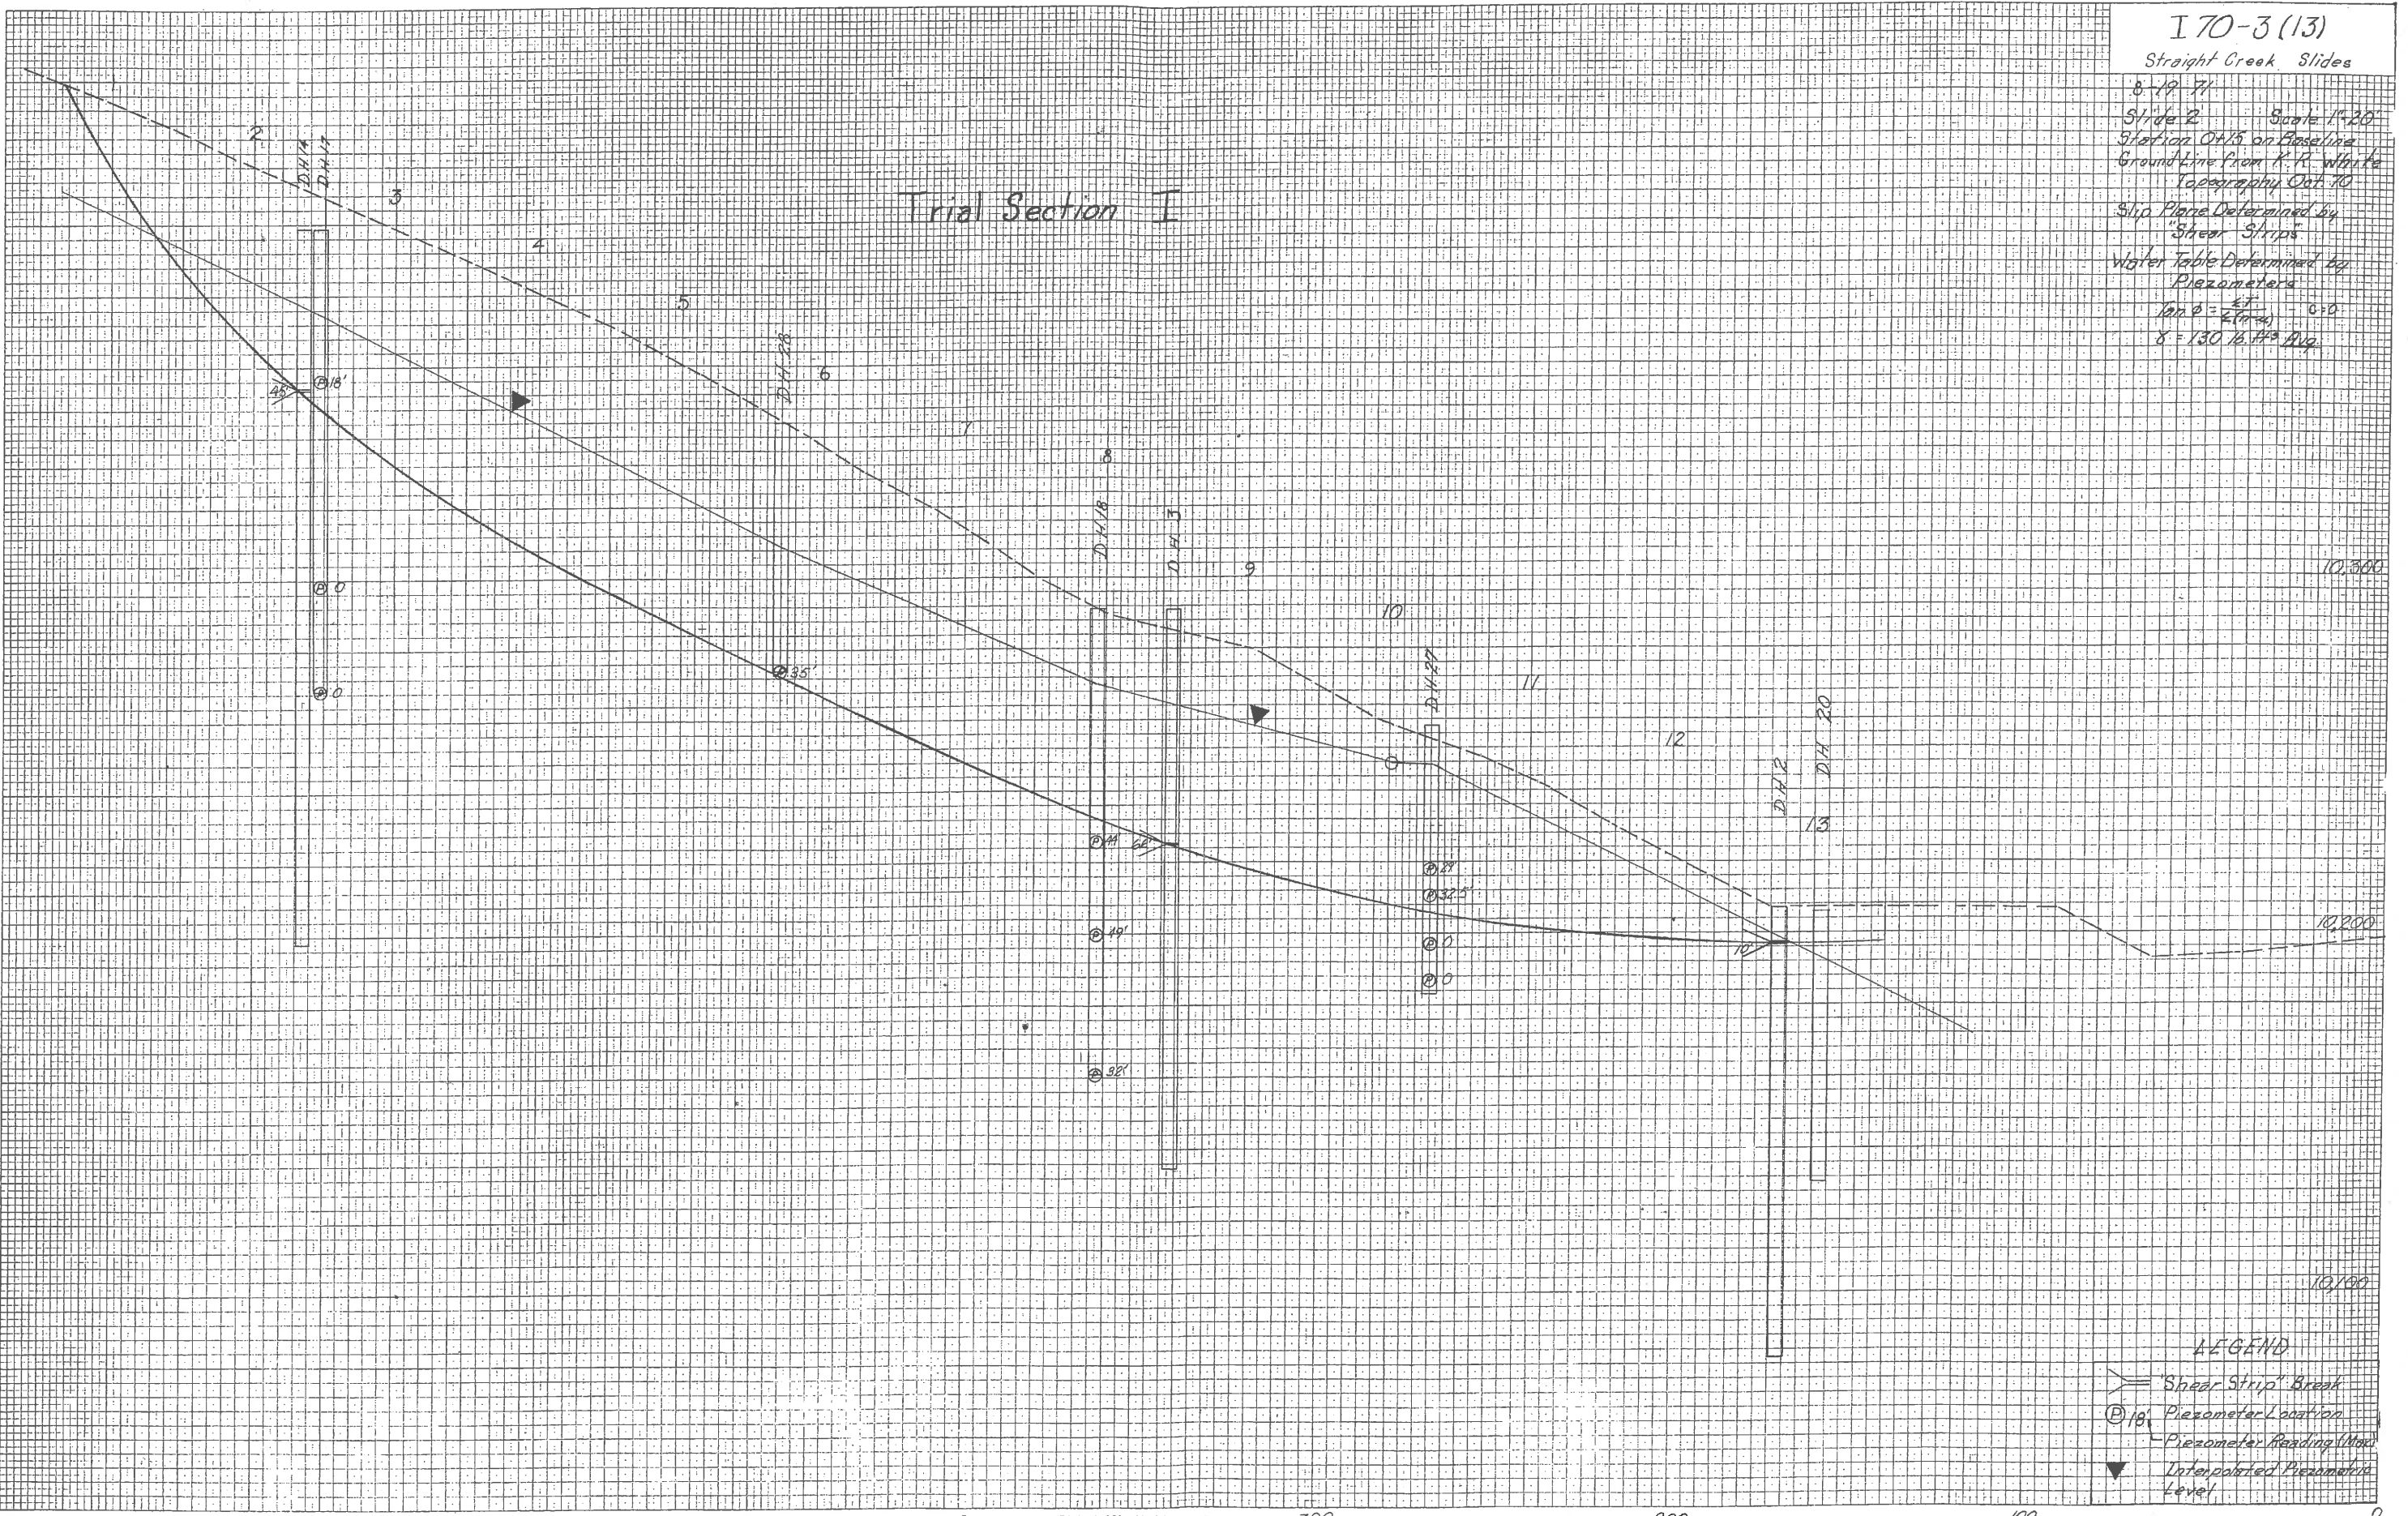
## Trial Section I

Slip Plane Determined by  
"Shear Strips"

Water Table Determined by  
Piezometers

$\tan \phi = \frac{c}{\sigma} = 0.0$   
 $\delta = 130 \text{ lb./ft.}^2 \text{ Avg.}$

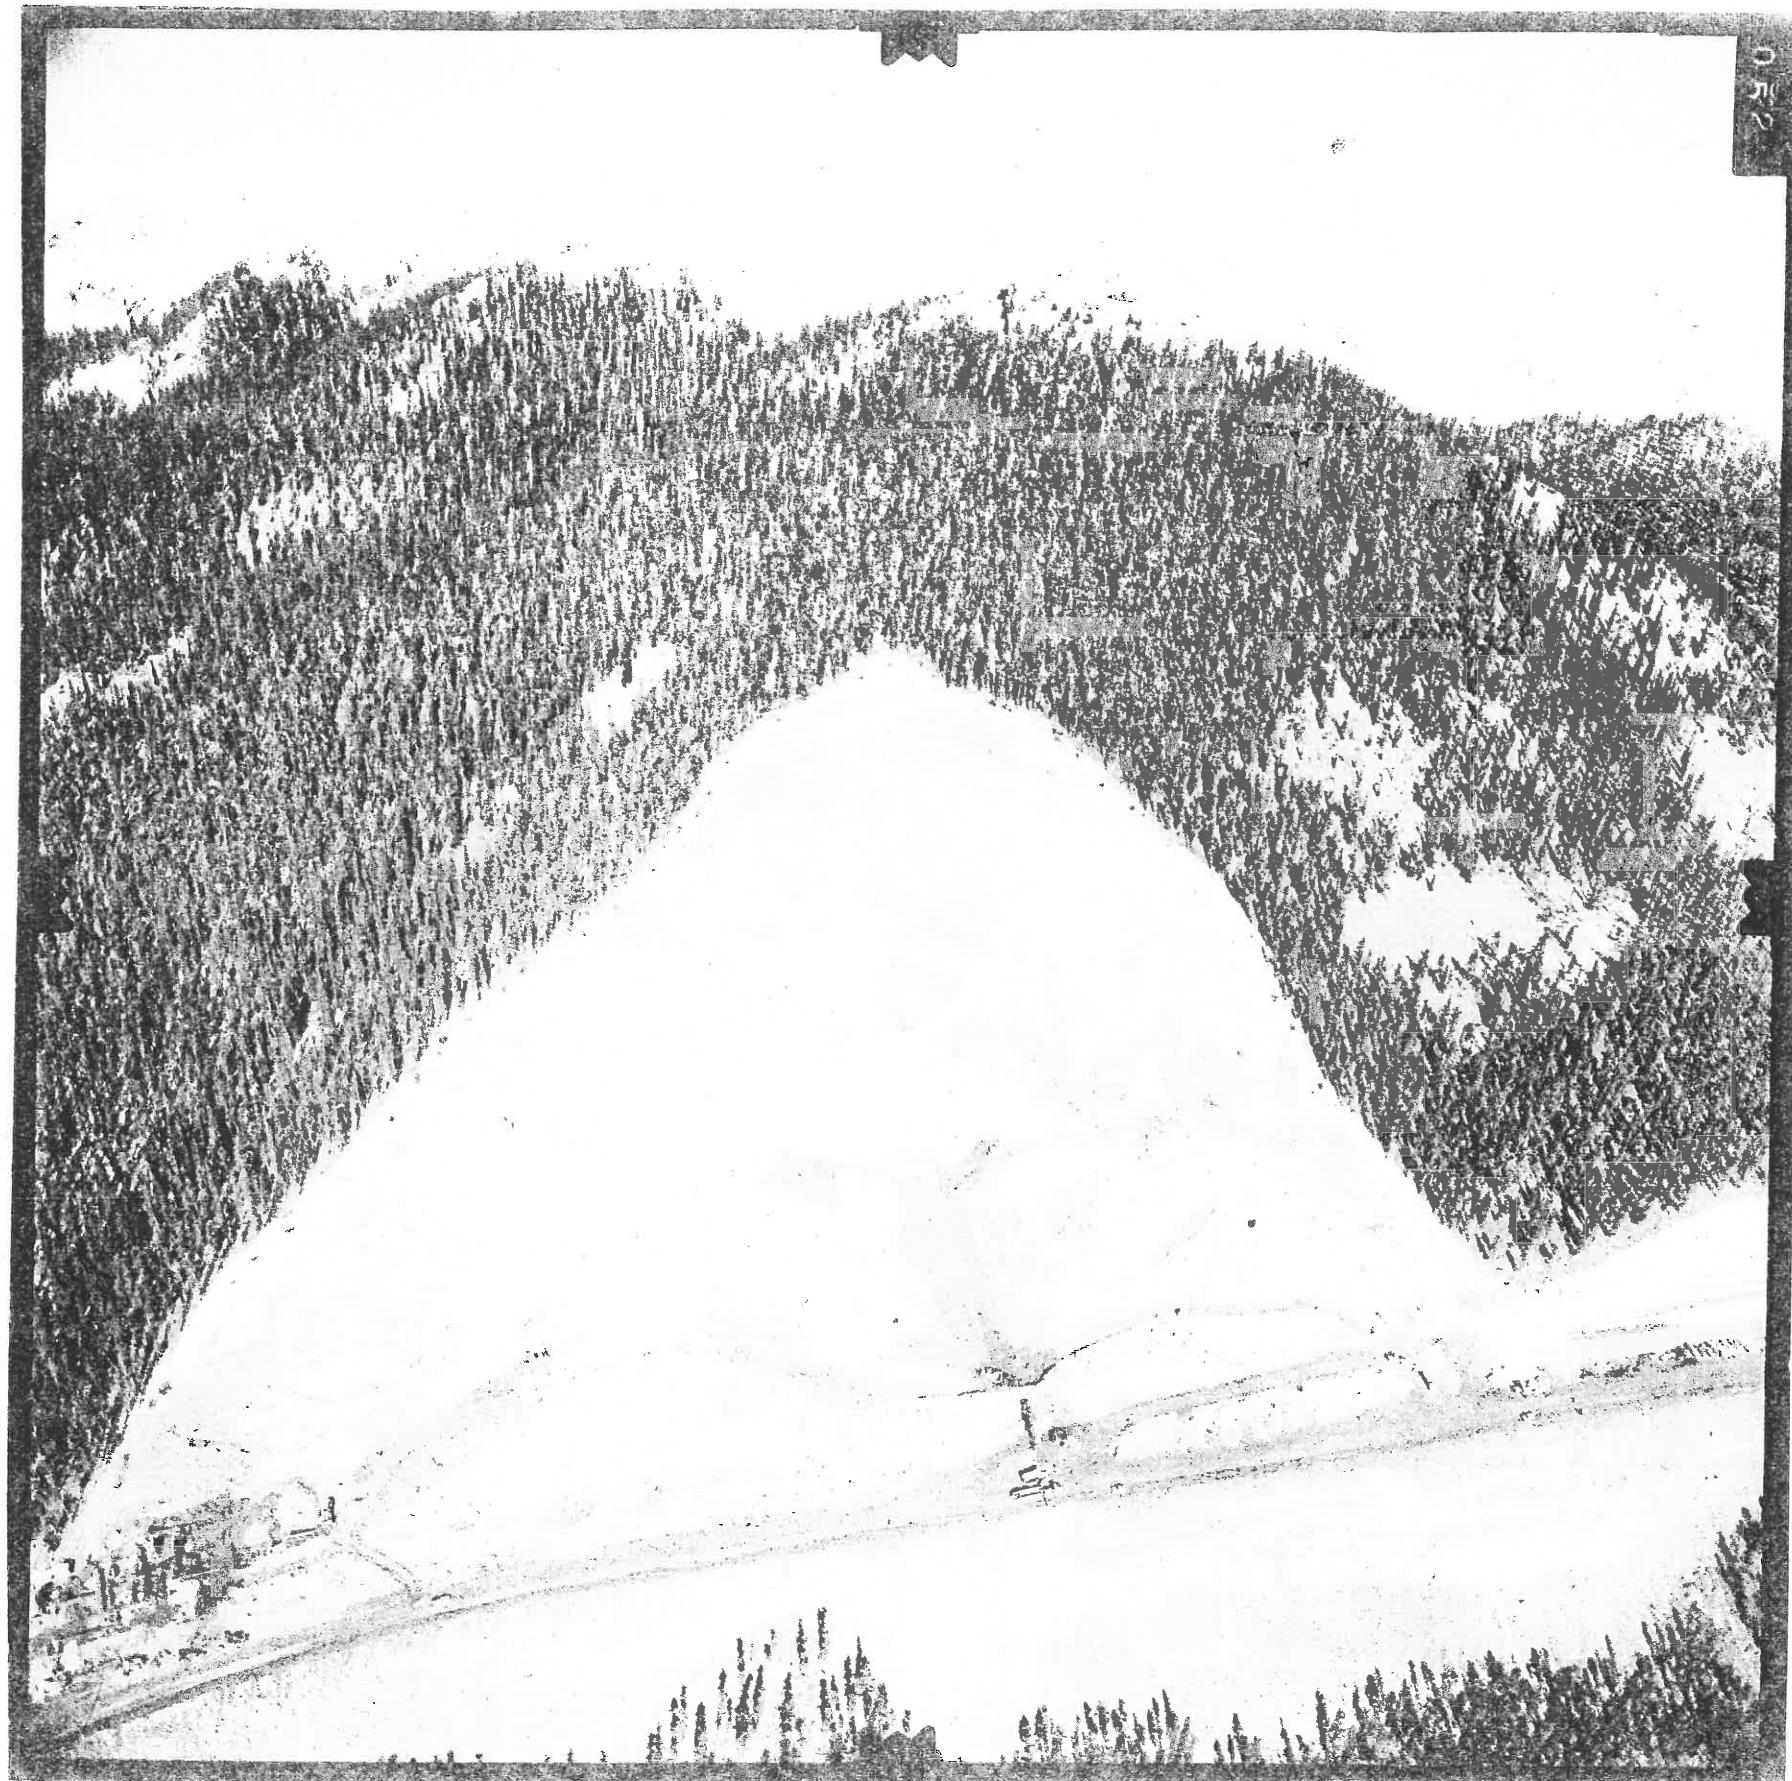
SLIDE A

This photo, taken in October, 1970, shows the areal extent of the cut at Slide A. Cracks were observed nearly 600 feet behind the top of the cut. The text describes the geology.

The crusher is visible in the lower left corner.

The equipment in the photo is constructing a 1 1/2:1 corrective cut slope and gathering material for crushing as recommended by the Ken R. White Co. in 1969.

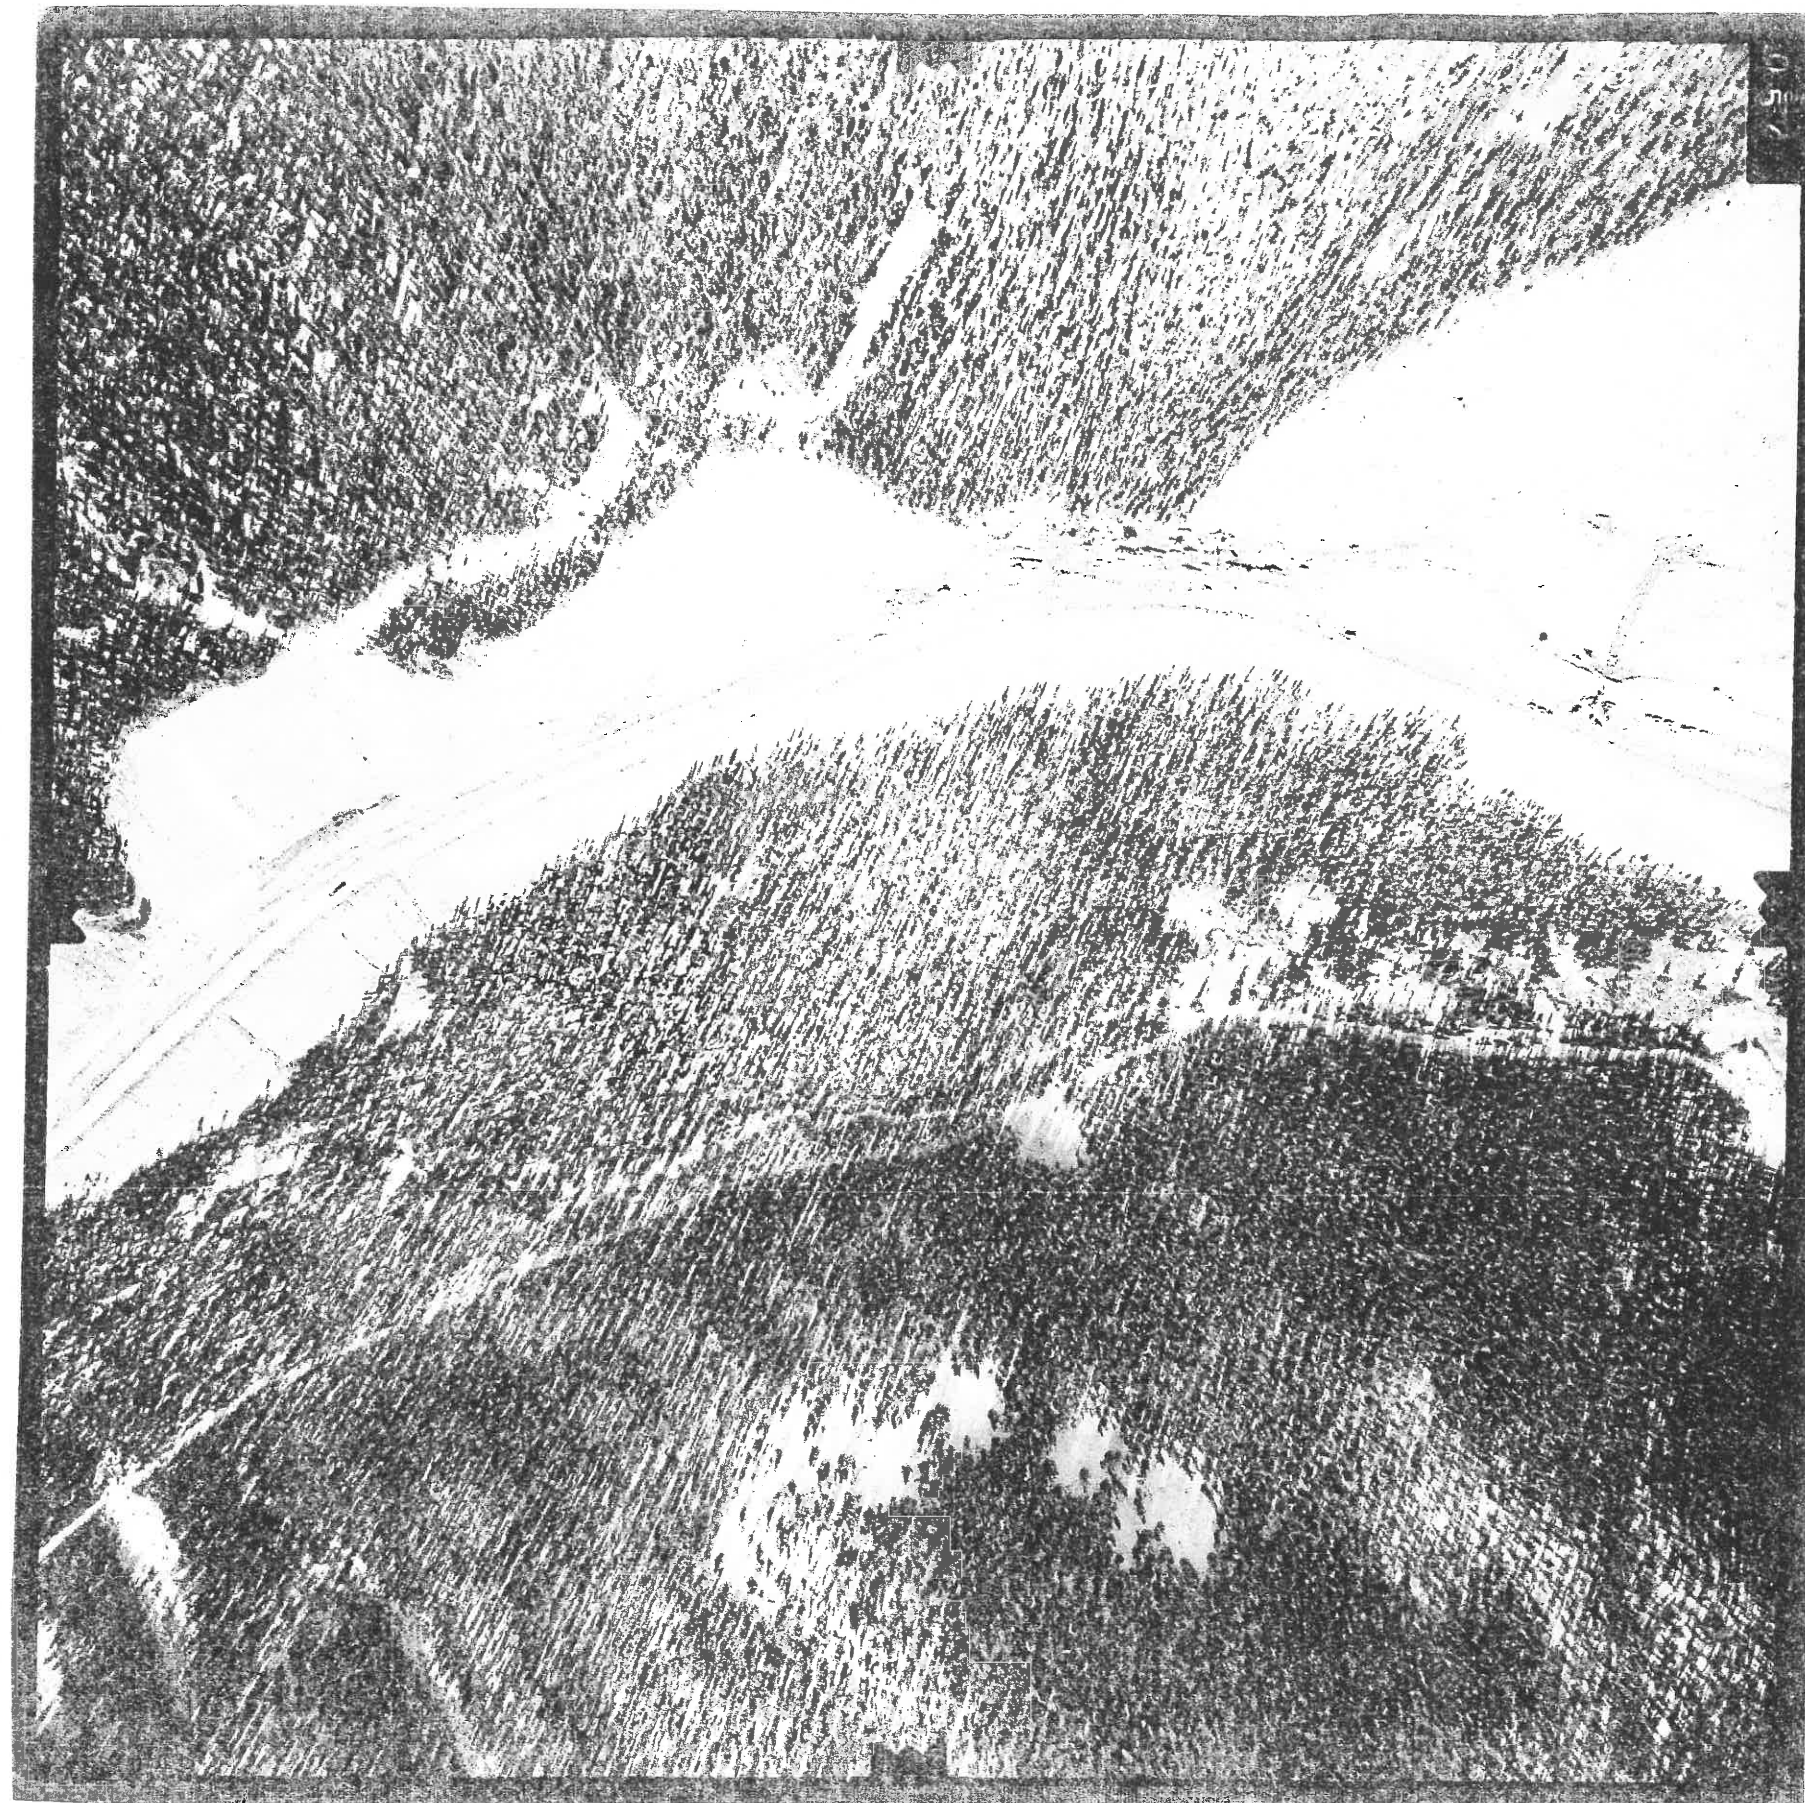
SLIDE B

The area known as Slide B is located at the aggregate stockpile in the upper center of the photo.

Hamilton Gulch is right of the slide area, and the crusher is visible immediately right of Hamilton Gulch.

The light colored area on the east (right) side of Slide B can be used as a rock source, if needed.

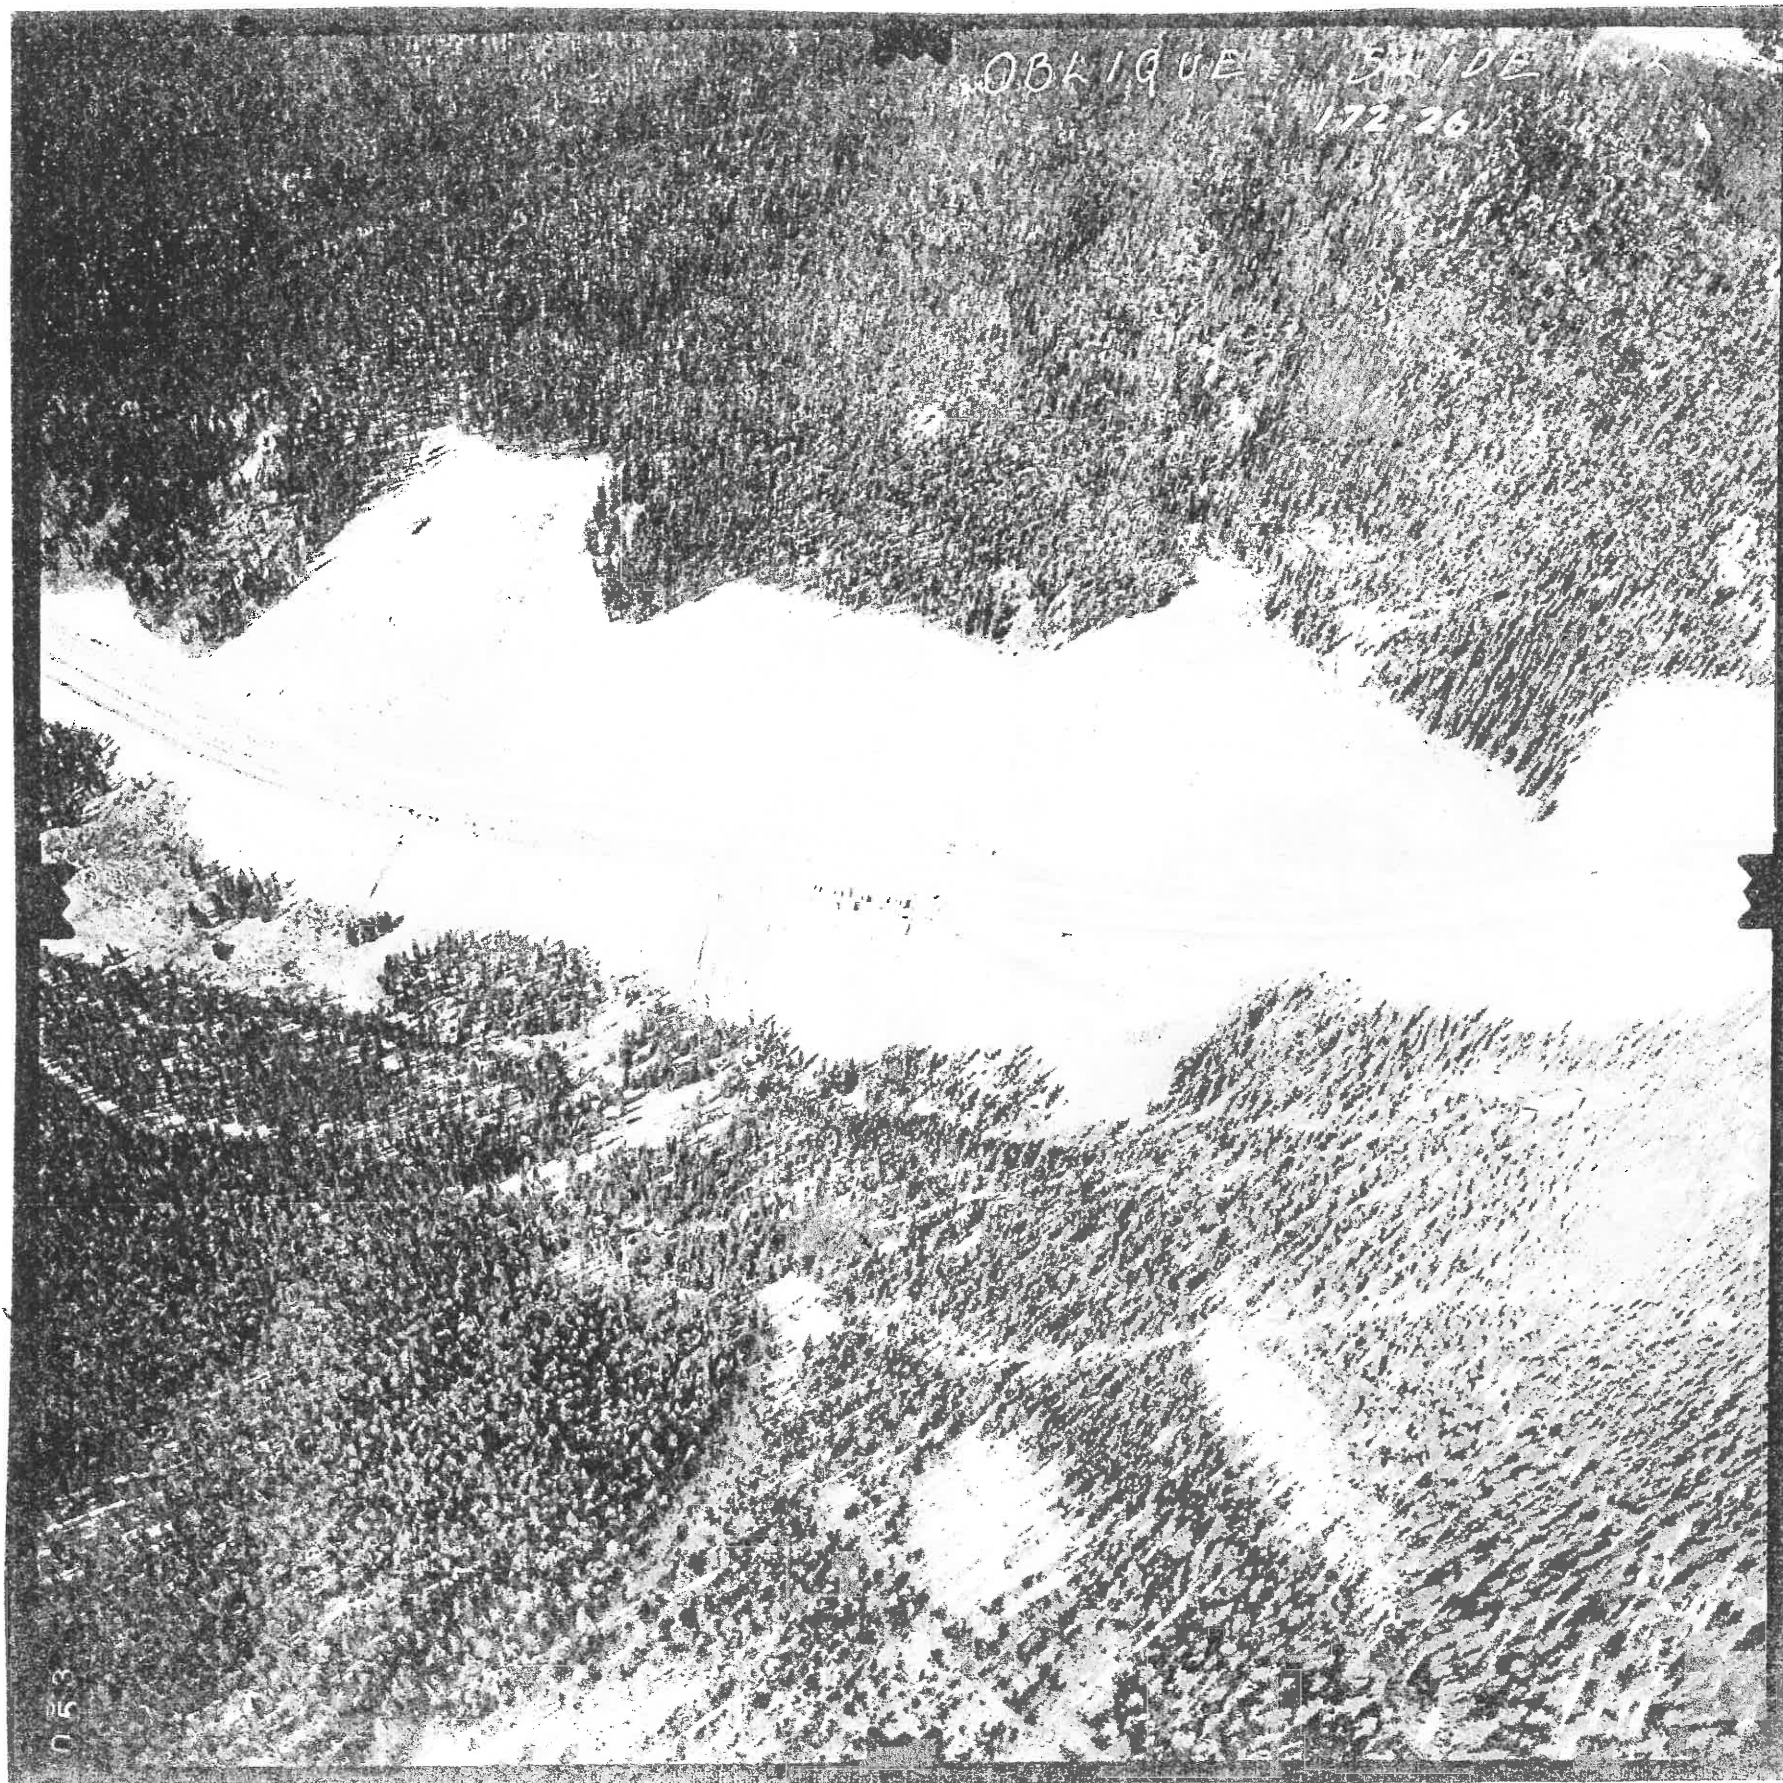
Slides 1 and 2

This photo covers approximately the same area as the topographic map of Slides 1 and 2, Figure 3. Slide 1 is located in the right center of the photo, and Slide 2 in the left center.

The area of toe distress at Slide 1 is located below the additional fill area on the right (near) side of the lanes at Slide 1.

The area of toe distress at Slide 2 is located in the fill and natural ground below the center of Slide 2.
