**FIGURE 2**  
**TOPOGRAPHIC MAP**  
 OF  
**STRAIGHT CREEK PORTION**  
 SUMMIT COUNTY, COLO.  
 PROJECT 1-70-3 (13) 212  
 DILLON-EMPIRE JUNCTION  
 FOR  
 COLORADO DEPARTMENT OF HIGHWAYS  
 DENVER, COLORADO  
 BY  
 CONTINENTAL ENGINEERS INC.  
 DENVER, COLO.

**COLORADO DEPARTMENT OF HIGHWAYS**  
**GEOLOGIC SKETCH MAP-SLIDE A, STRAIGHT CREEK SLIDE AREA, SUMMIT COUNTY, COLORADO**

**GEOLOGIC MAP OF SLIDES 1 AND 2, STRAIGHT CREEK SLIDE AREA, SUMMIT COUNTY, CO**

STRAIGHT CREEK SLIDE AREA—SLIDE 1

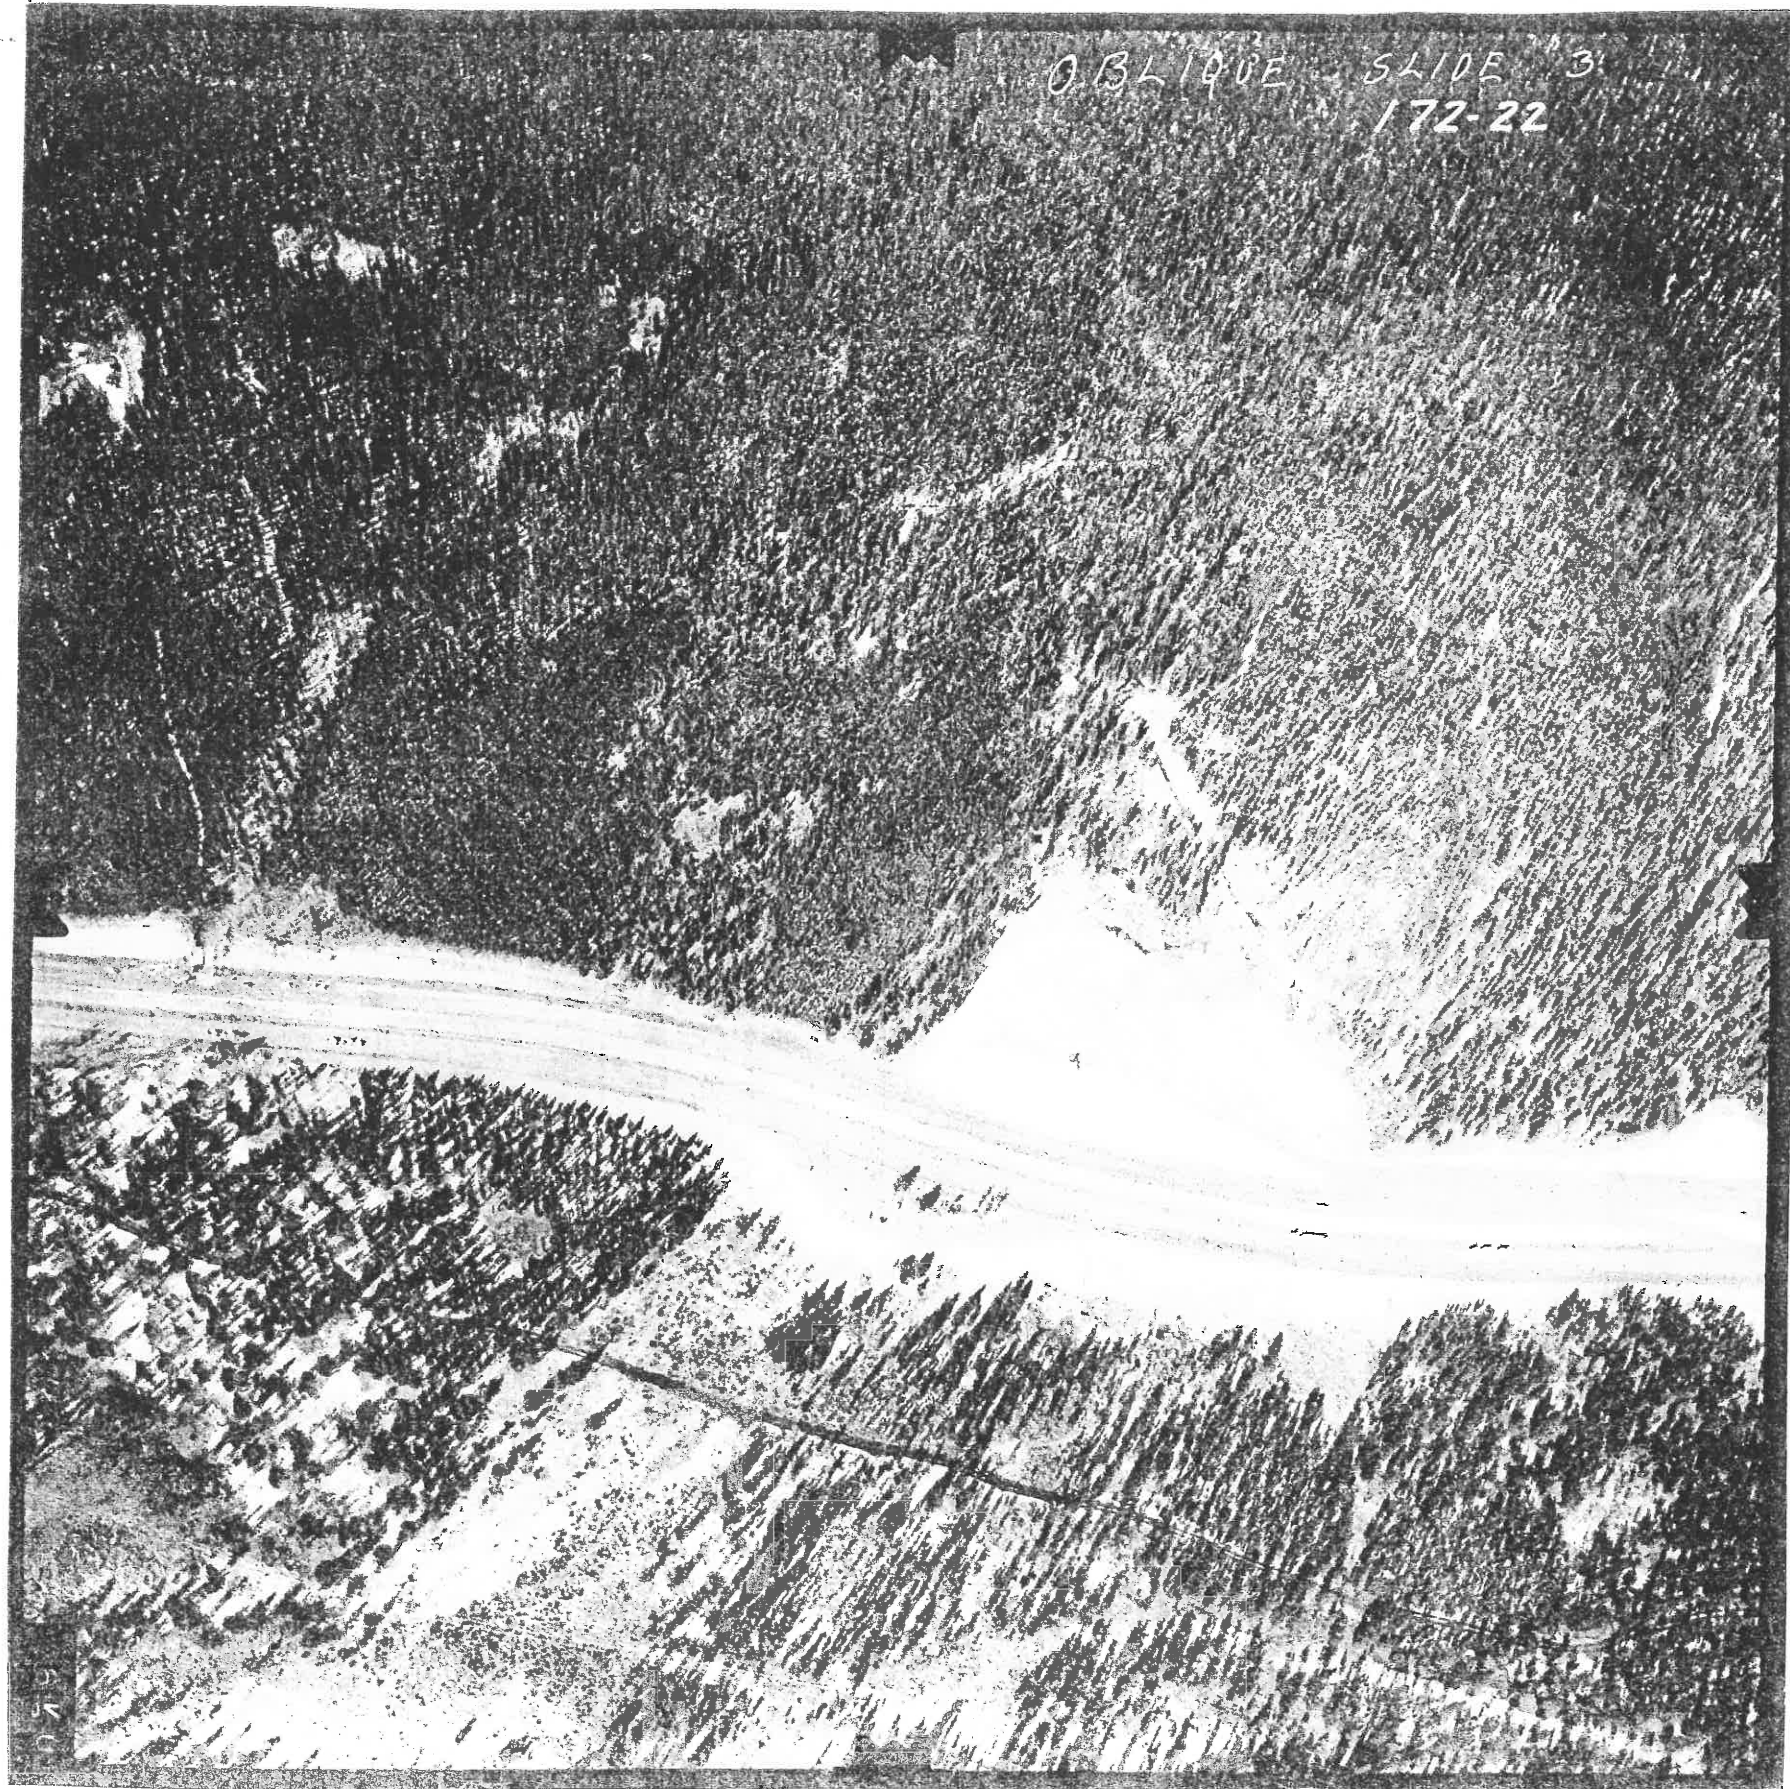
SLIDE 3

Visible in this October, 1970 photo is the buttness and drainage system installed at Slide 3. The area of recent cracking is higher and right of the existing cut area.

The area of toe distress is located in the fill and natural ground east (right) of the pullout area, and across from the east end of the buttness.
