# Aquatic Resources Delineation Report Bridge G-12-C

Stanley Consultants, Inc.  
8000 South Chester St, Ste 500  
Centennial, Colorado 80112

Colorado Department of Transportation, Region 2  
5615 Will Blvd.  
Pueblo, CO 81008

FINAL  
January 2021

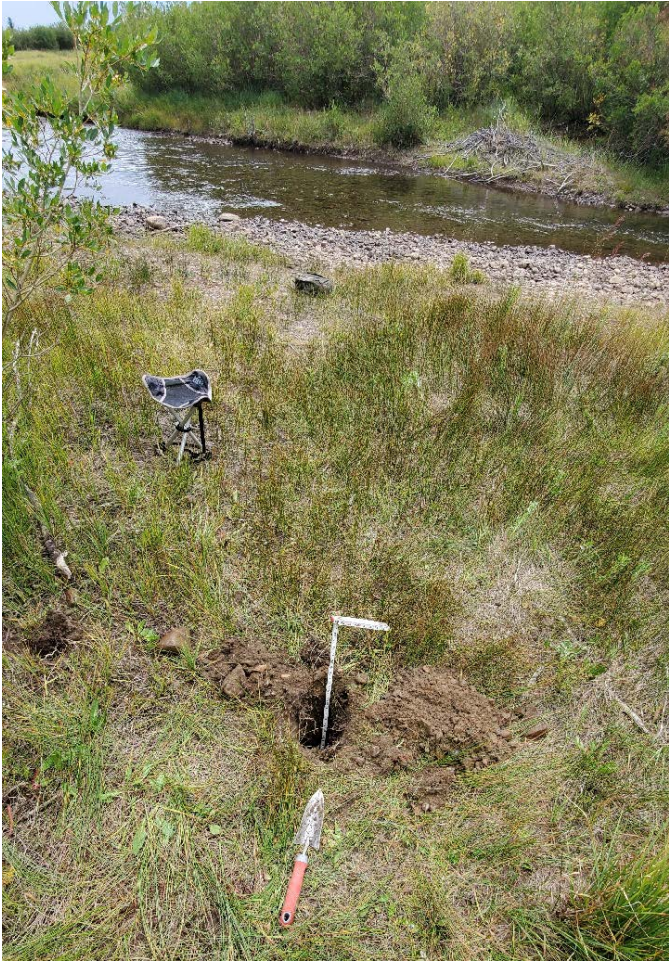
**Feature:** Wetland 1  
**Date:** 9/21/2020  
**FACWet Score:** 0.81  
**Photo Location:** Within wetland boundary  
**Description:** Wetland is a palustrine shrub-scrub wetland (0.02 ac) located on the northeastern side of the G-12-C bridge.

Wetland 1 is a palustrine shrub-scrub wetland (0.02 ac) located on the northeastern side of the G-12-C bridge. Part of the wetland starts below the OHWM with most extending into the riparian bank and terrace between the roadway fill toe of slope and the adjacent hillside toe of slope (See Wetland 1, Appendix E: Photo Inventory). Vegetation is characterized as shrub-scrub riparian dominated by three species of willow (OBL) and with an herbaceous stratum of Baltic rush (FACW) and leafy tussock sedge (OBL) dominants. The soils observed in the soil pit (SP1) consisted of dark gray and dark grayish-brown sandy soils with redox coated sand grains starting as shallow as 2 inches and continuing to beyond 18 inches. The main layer (2-10 inches) satisfied the Sandy Redox (S5) hydric soil indicator. Wetland hydrology was present at this dry time of the year primarily as saturation starting at 10 inches, though other secondary indicators, such as drainage patterns and geomorphic position, were also observed.

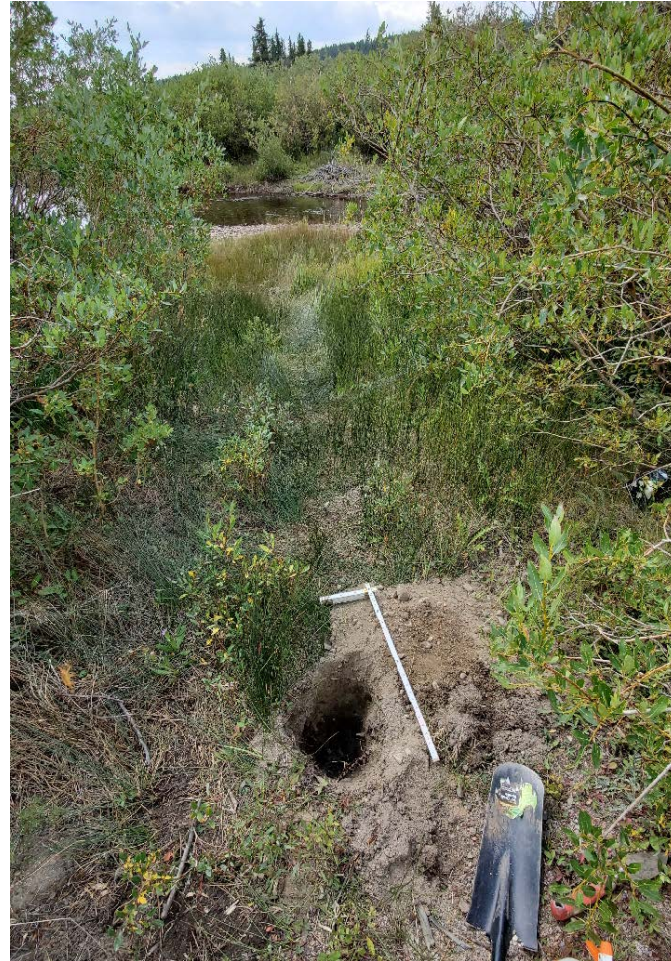
**Feature:** Wetland 1  
**Date:** 9/21/2020  
**FACWet Score:** 0.81  
**Photo Location:** Upland point, facing southwest  
**Description:** Wetland is a palustrine shrub-scrub wetland (0.02 ac) located on the northeastern side of the G-12-C bridge.

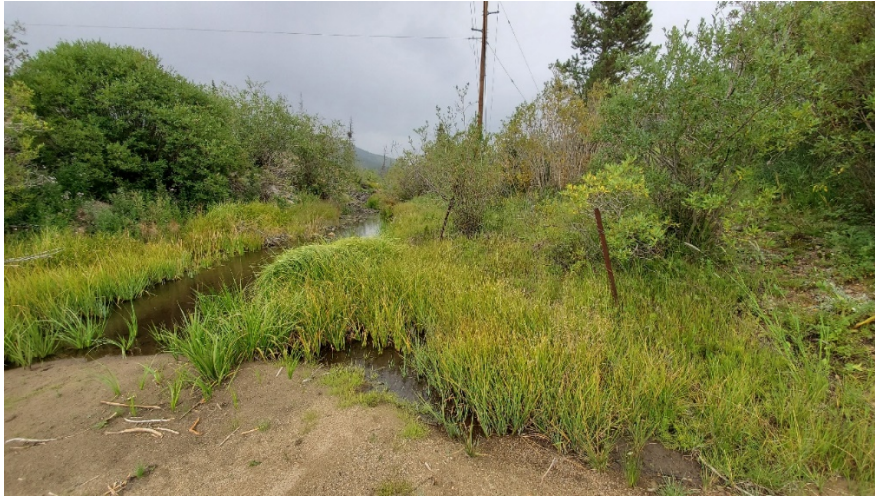
**Feature:** Wetland 2

**Photo Location:** Inside wetland, facing south

**Description:** Wetland is a palustrine shrub-scrub wetland (0.06 ac) located along the edge of the Middle Fork of the South Platte River, as a wetland fringe at or below the OHWM.

This wetland is supported by the water of the river and its large back channel area, which apparently used to be the main channel before the highway bridge was built and the river channel was moved to accommodate the structure. This wetland fringe can be observed along the edge of the open water portions of the historic channel or back channel area, and also the main channel, though the plant species may vary some depending on the location. On this portion of the wetland fringe, the upland areas are immediately adjacent and to the east and are a part of the highway road fill slope which also contains some of the same deep-rooted willows.

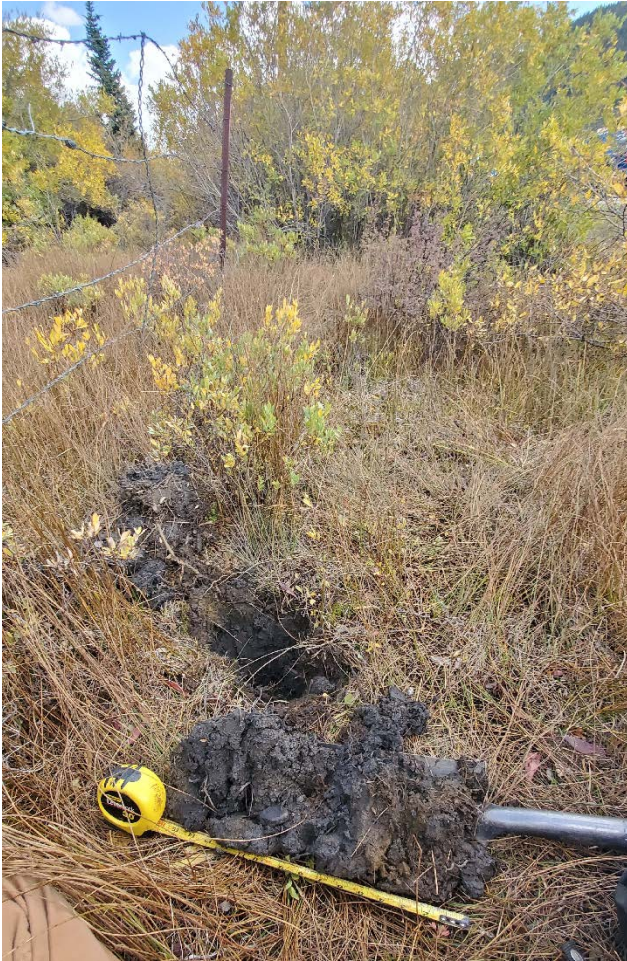
**Feature:** Wetland 3  
**Date:** 9/21/2020  
**FACWet Score:** 0.81  
**Photo Location:** Within wetland, facing north  
**Description:** Wetland is a palustrine shrub-scrub wetland (0.04 ac) located on the uphill and west side of Drainage 1.

Wetland 3 is a palustrine shrub-scrub wetland (0.04 ac) located on the uphill and west side of a small drainage (see Drainage 1) (See Wetland 3, Appendix E: Photo Inventory). Vegetation is characterized as shrub-scrub riparian dominated by yellow willow (OBL), resin birch (OBL), and shrubby cinquefoil (FAC), with an herbaceous stratum dominated by Baltic rush (FACW) and club spike-moss (FACW). The soils observed in the soil pit (SP5) consisted of dark grayish brown to black sandy clay loams and sandy loam with redox concentrations starting within an inch of the surface and continuing to at least 16 inches. Redox includes both iron and manganese masses in the matrix and pore linings. This soil satisfied the hydric soil characteristics of Redox Dark Surface (F6). Wetland hydrology was present at this dry time of the year primarily as saturation to the surface, with secondary indicators also observed.

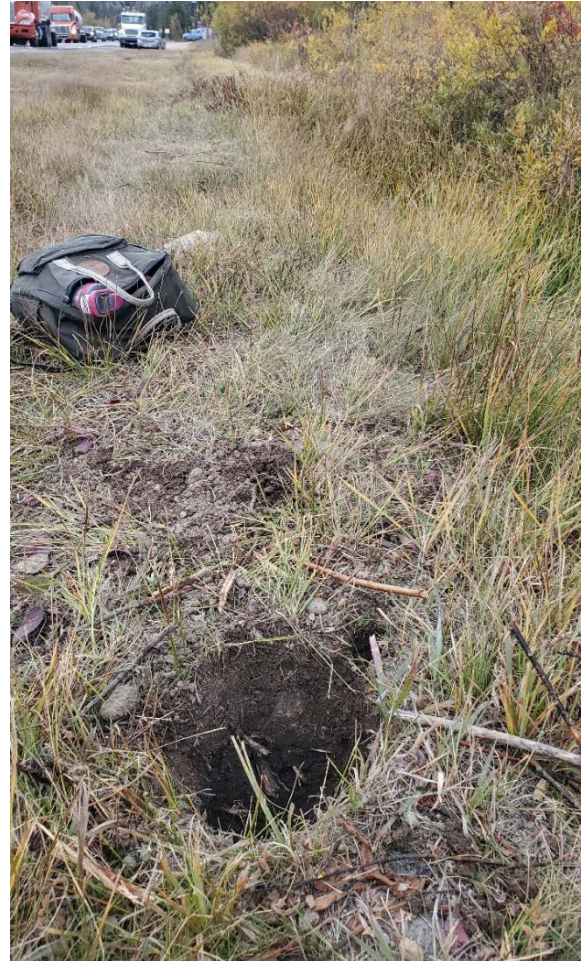
**Feature:** Wetland 3  
**Date:** 9/21/2020  
**FACWet Score:** 0.81  
**Photo Location:** Upland point, facing south  
**Description:** Wetland is a palustrine shrub-scrub wetland (0.04 ac) located on the uphill and west side of Drainage 1.

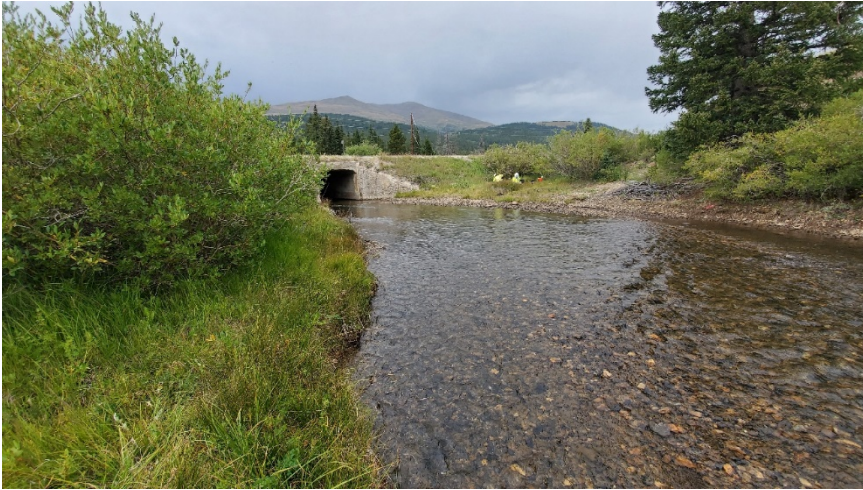
**Feature:** Middle Fork of the South Platte River

**Photo Location:** Southeast bank, facing upstream (west)

**Description:** Tributary is the primary, perennial riverine system in the area (243 linear feet, 0.14 acres).

wracking (See Middle Fork of the South Platte River, Appendix E: Photo Inventory). The scour was mostly in the most active part of the floodplain, the low water channel. The next higher level of the OHWM was where less frequent scour occurs mostly during yearly spring flood events, but enough to form a second, higher bank. This area is where the wrack was observed being deposited, likely during yearly spring or early summer snow melt runoff. The linear foot length includes the area of open water of the historic channel, which now behaves more like an oxbow or overflow channel.

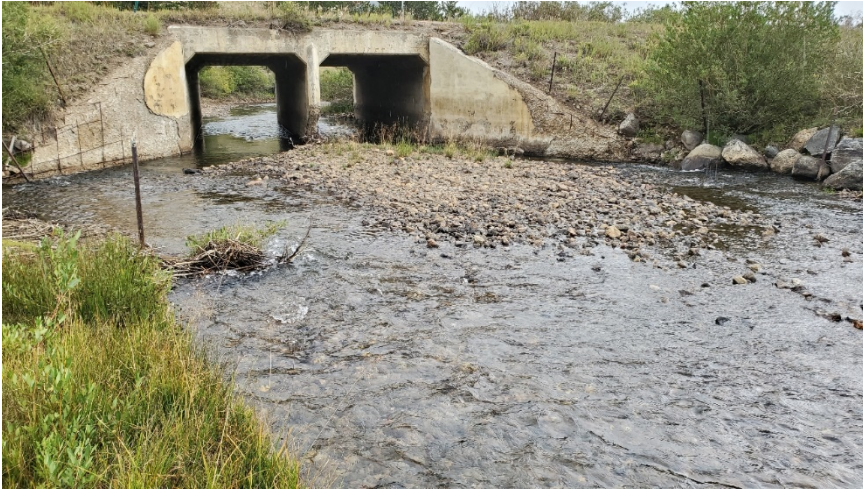
**Feature:** Middle Fork of the South Platte River

**Photo Location:** Northwest bank, facing downstream (east)

**Description:** Tributary is the primary, perennial riverine system in the area (243 linear feet, 0.14 acres).

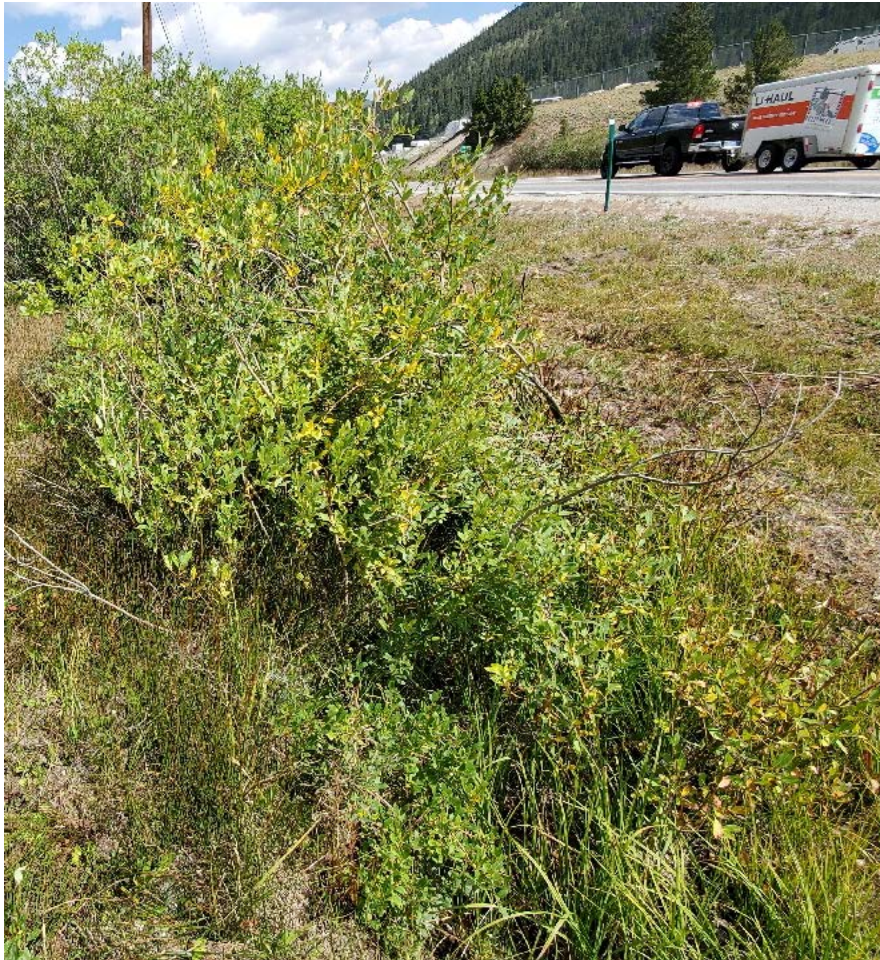
**Feature:** Drainage 1

**Photo Location:** Top of drainage facing downstream (north)

**Description:** Drainage is a small apparently perennial drainage (171 linear feet, 0.02 acres) that drains hillside seeps and roadside run-off into the Middle Fork of the South Platte River.
