# Aquatic Resources Delineation Report Bridge H-13-N Survey

Stanley Consultants, Inc.  
8000 South Chester St, Ste 500  
Centennial, Colorado 80112

Colorado Department of Transportation, Region 2  
5615 Wills Blvd.  
Pueblo, Colorado 81008

**January 2021**

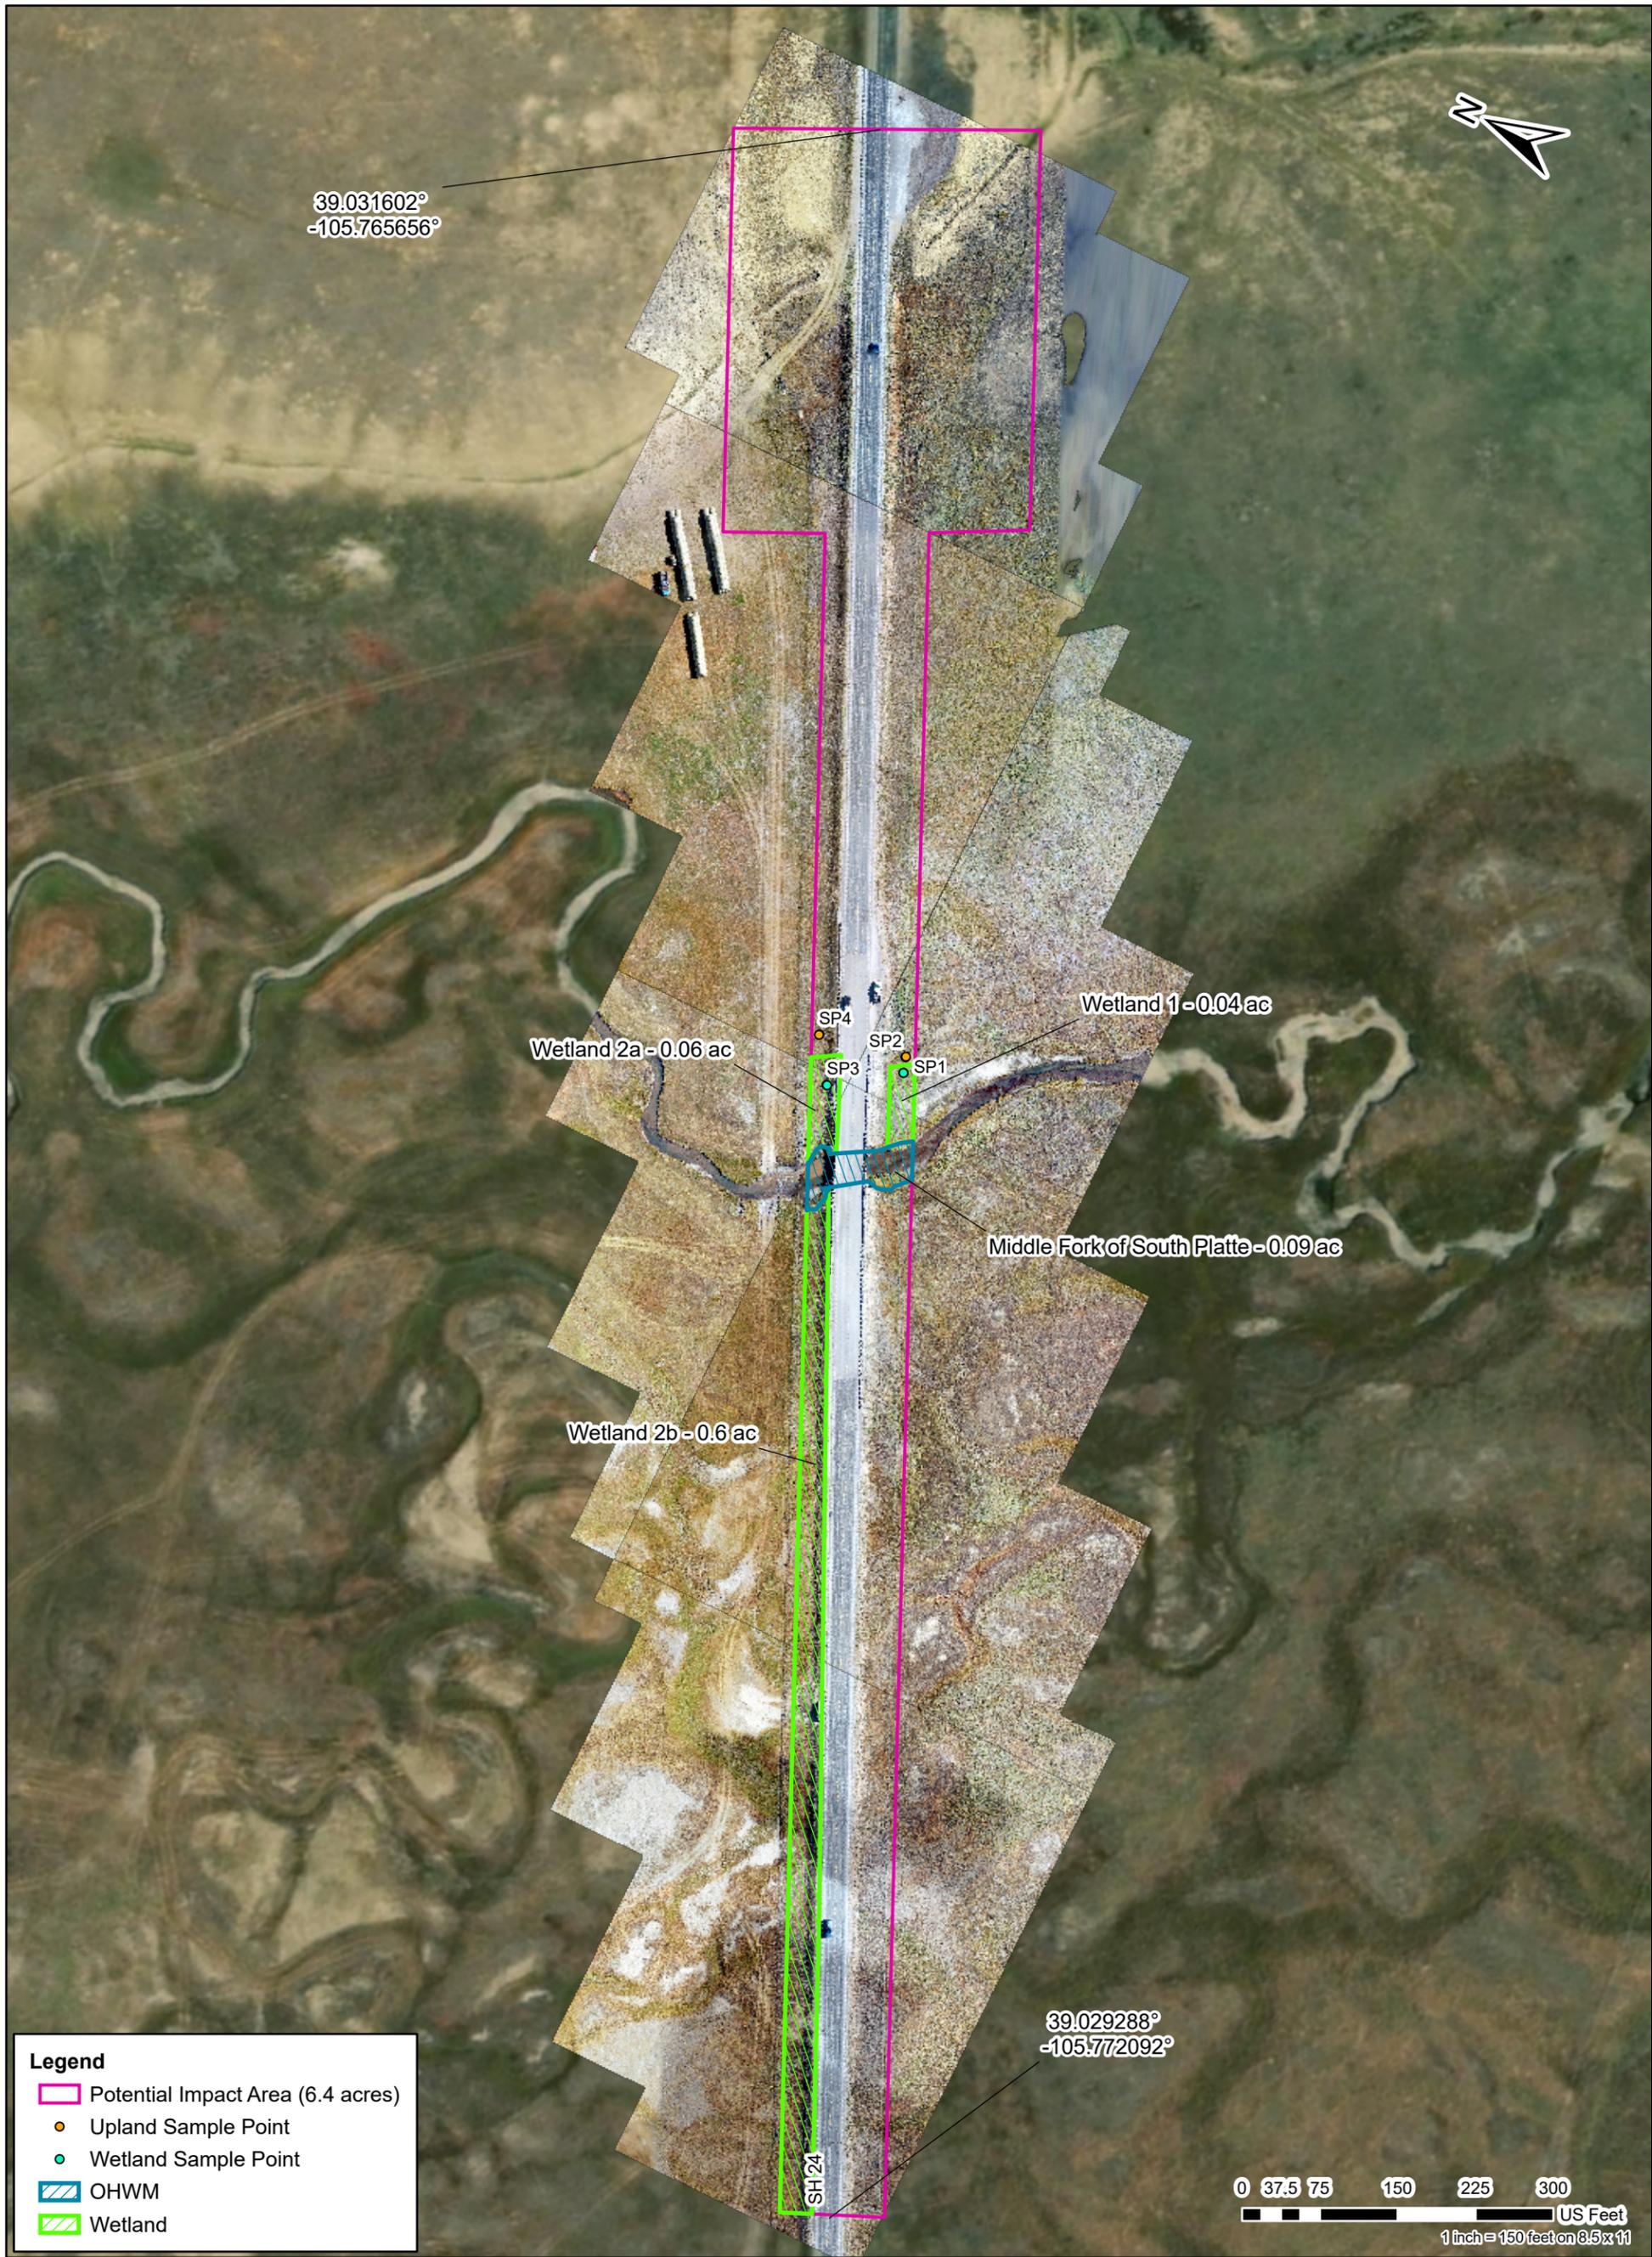
- Potential Impact Area (6.4 acres)
- Upland Sample Point
- Wetland Sample Point
- OHWM
- Wetland

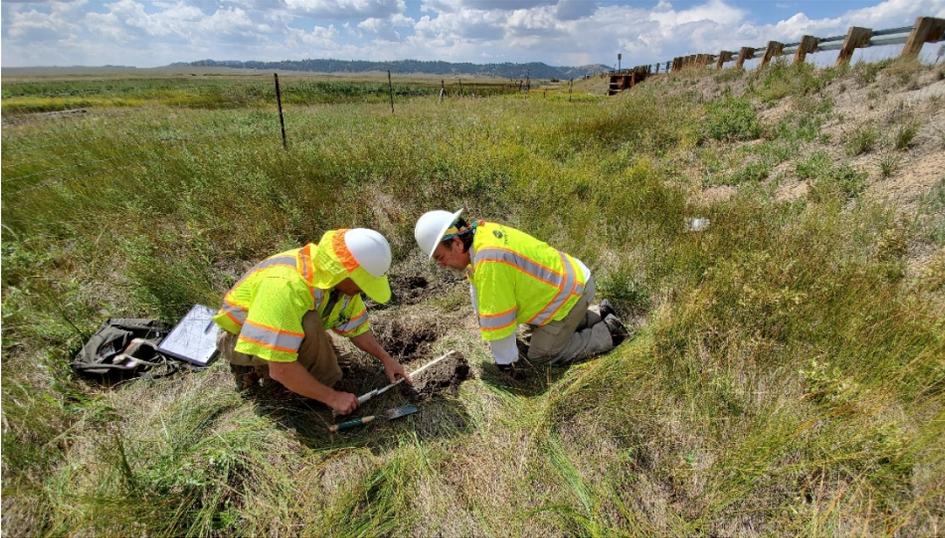
**Feature:** Wetland 1

**Photo Location:** Inside wetland, facing west

**Description:** Wetland is a palustrine emergent wetland (0.04 ac) located on the southeastern side of the H-13-N bridge.

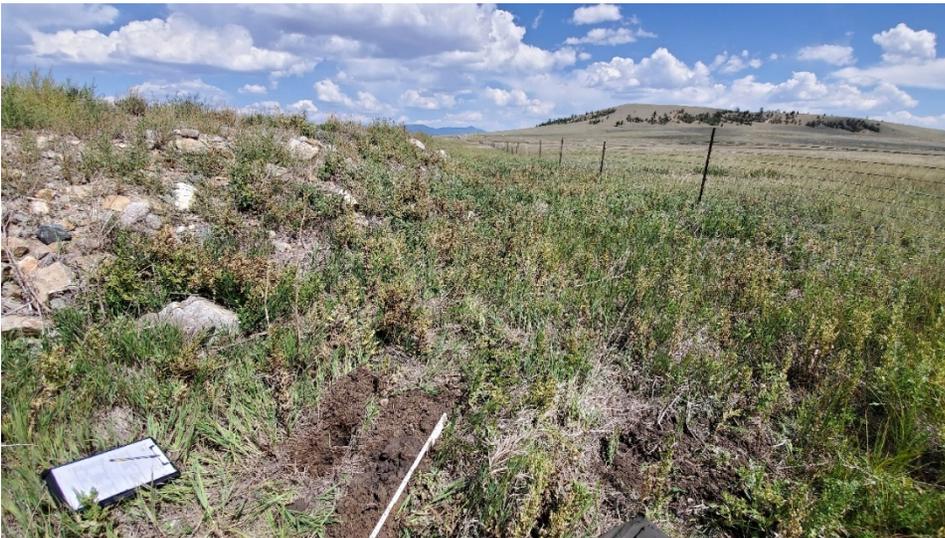
**Feature:** Wetland 1

**Photo Location:** Upland point, facing east

**Description:** Wetland is a palustrine emergent wetland (0.04 ac) located on the southeastern side of the H-13-N bridge.

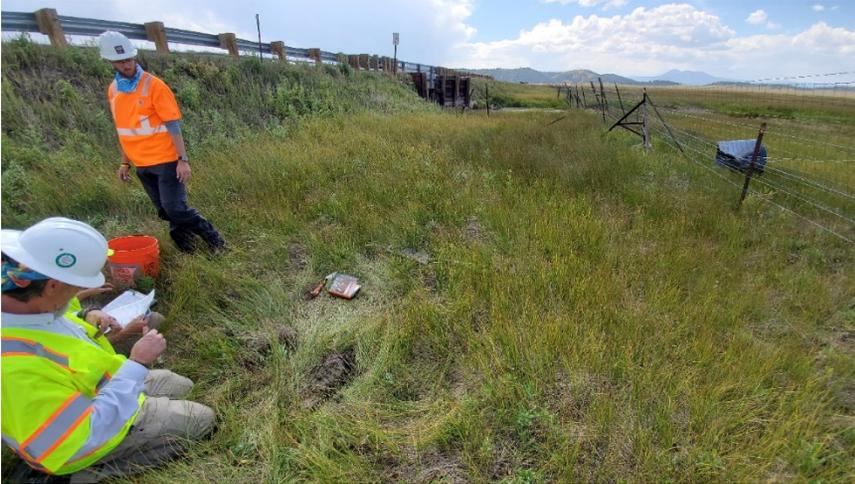
**Feature:** Wetland 2a

**Photo Location:** Inside wetland, facing west

**Description:** Wetland is a palustrine emergent wetland (0.06 ac) located along the edge of the Middle Fork of the South Platte River, on the northeast side of the H-13-N bridge.

Wetland 2a extends from the OHWM of the abutting channel onto the bank and terrace between the roadway fill toe of slope and the adjacent gently sloping drier land (See Wetland 2a, Appendix D: Photo Inventory). The soils observed in the soil pit (SP3) consisted of dark grayish-brown loam, loamy sand, and sandy loam on top of dark brown sand. The dark grayish-brown later extended from 5 to 12 inches below the surface and contained redox concentrations and coated sand grains within the matrix. This layer satisfied the Loamy Gleyed Matrix (F2) hydric indicator. Wetland hydrology was present at this dry time of the year as saturation starting at 8 inches and the water table starting at 12 inches, though other secondary indicators, such as drainage patterns and geomorphic position, were also observed.

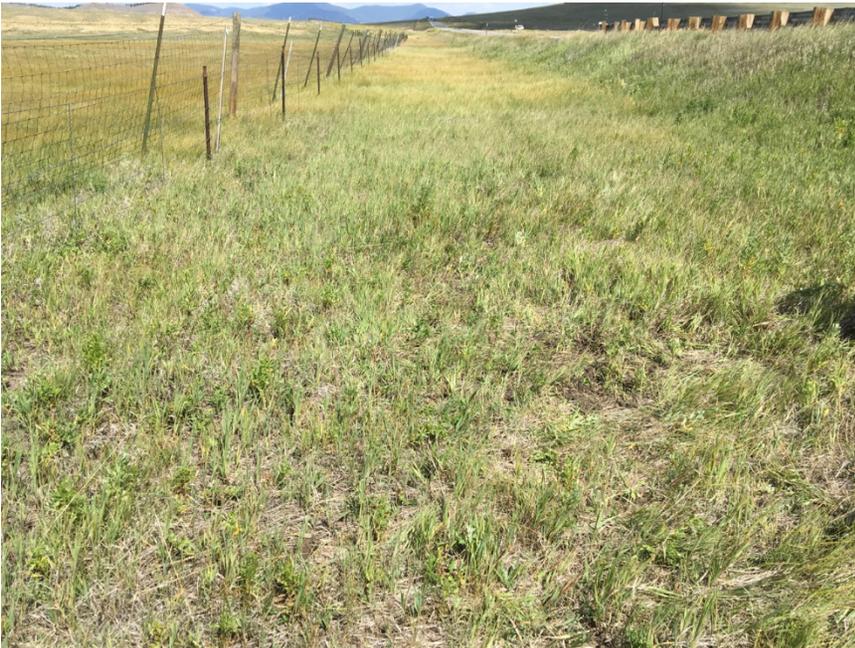
**Feature:** Wetland 2a

**Photo Location:** Upland point, facing east

**Description:** Wetland is a palustrine emergent wetland (0.06 ac) located along the edge of the Middle Fork of the South Platte River, on the northeast side of the H-13-N bridge.

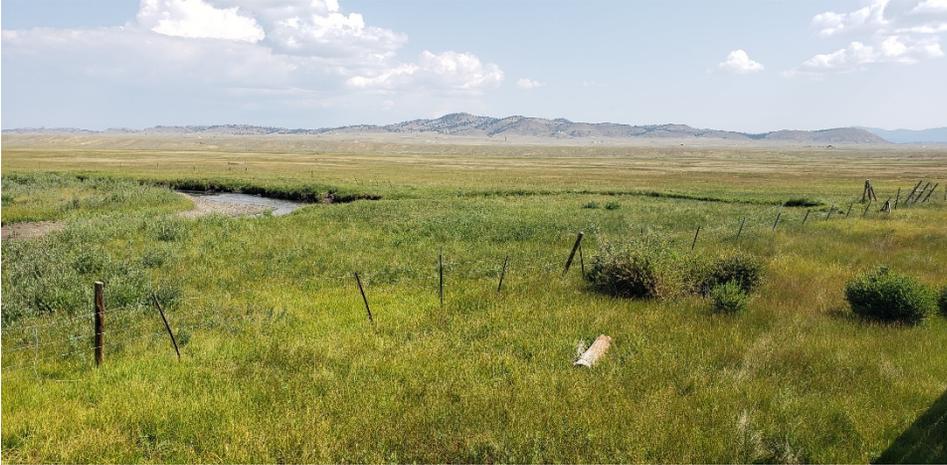
**Feature:** Wetland 2b

**Photo Location:** Within wetland, facing northeast

**Description:** Wetland is a palustrine emergent wetland (0.6 ac) located along the edge of the Middle Fork of the South Platte River, on the northwest side of the H-13-N bridge.

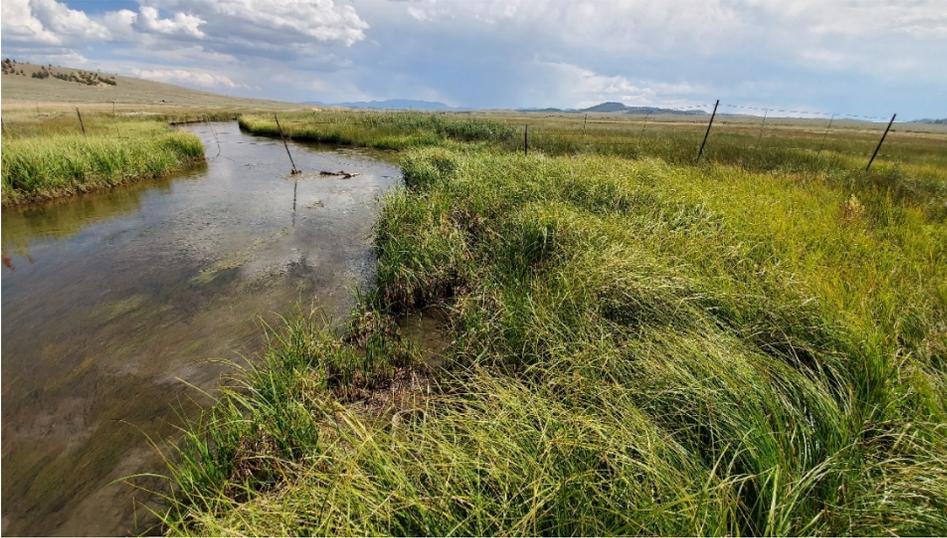
**Feature:** Middle Fork of the South Platte River

**Photo Location:** Southwest bank, facing downstream (south)

**Description:** Tributary is a perennial channel within a large, braided system riverine system (102 linear feet, 0.09 acres).
