Aquatic Resources Delineation Report Bridge I-13-G

January 2021

Bridge I-13-G is located on US 24 at milepost 227.095, approximately 12 miles southwest of Hartsel, Colorado. The bridge is a treated timber stringer (30-ft wide by 71-ft long) structure that crosses over an intermittent stream and currently allows for cattle to pass under the bridge. The Project will replace this bridge with a similarly sized concrete and steel bridge, or a concrete box culvert. The new structure will provide a similar opening with a minimum of 7 ft of clearance to allow for cattle underpass.

Colorado Department of Transportation
R2 Bridges Project - I-13-G

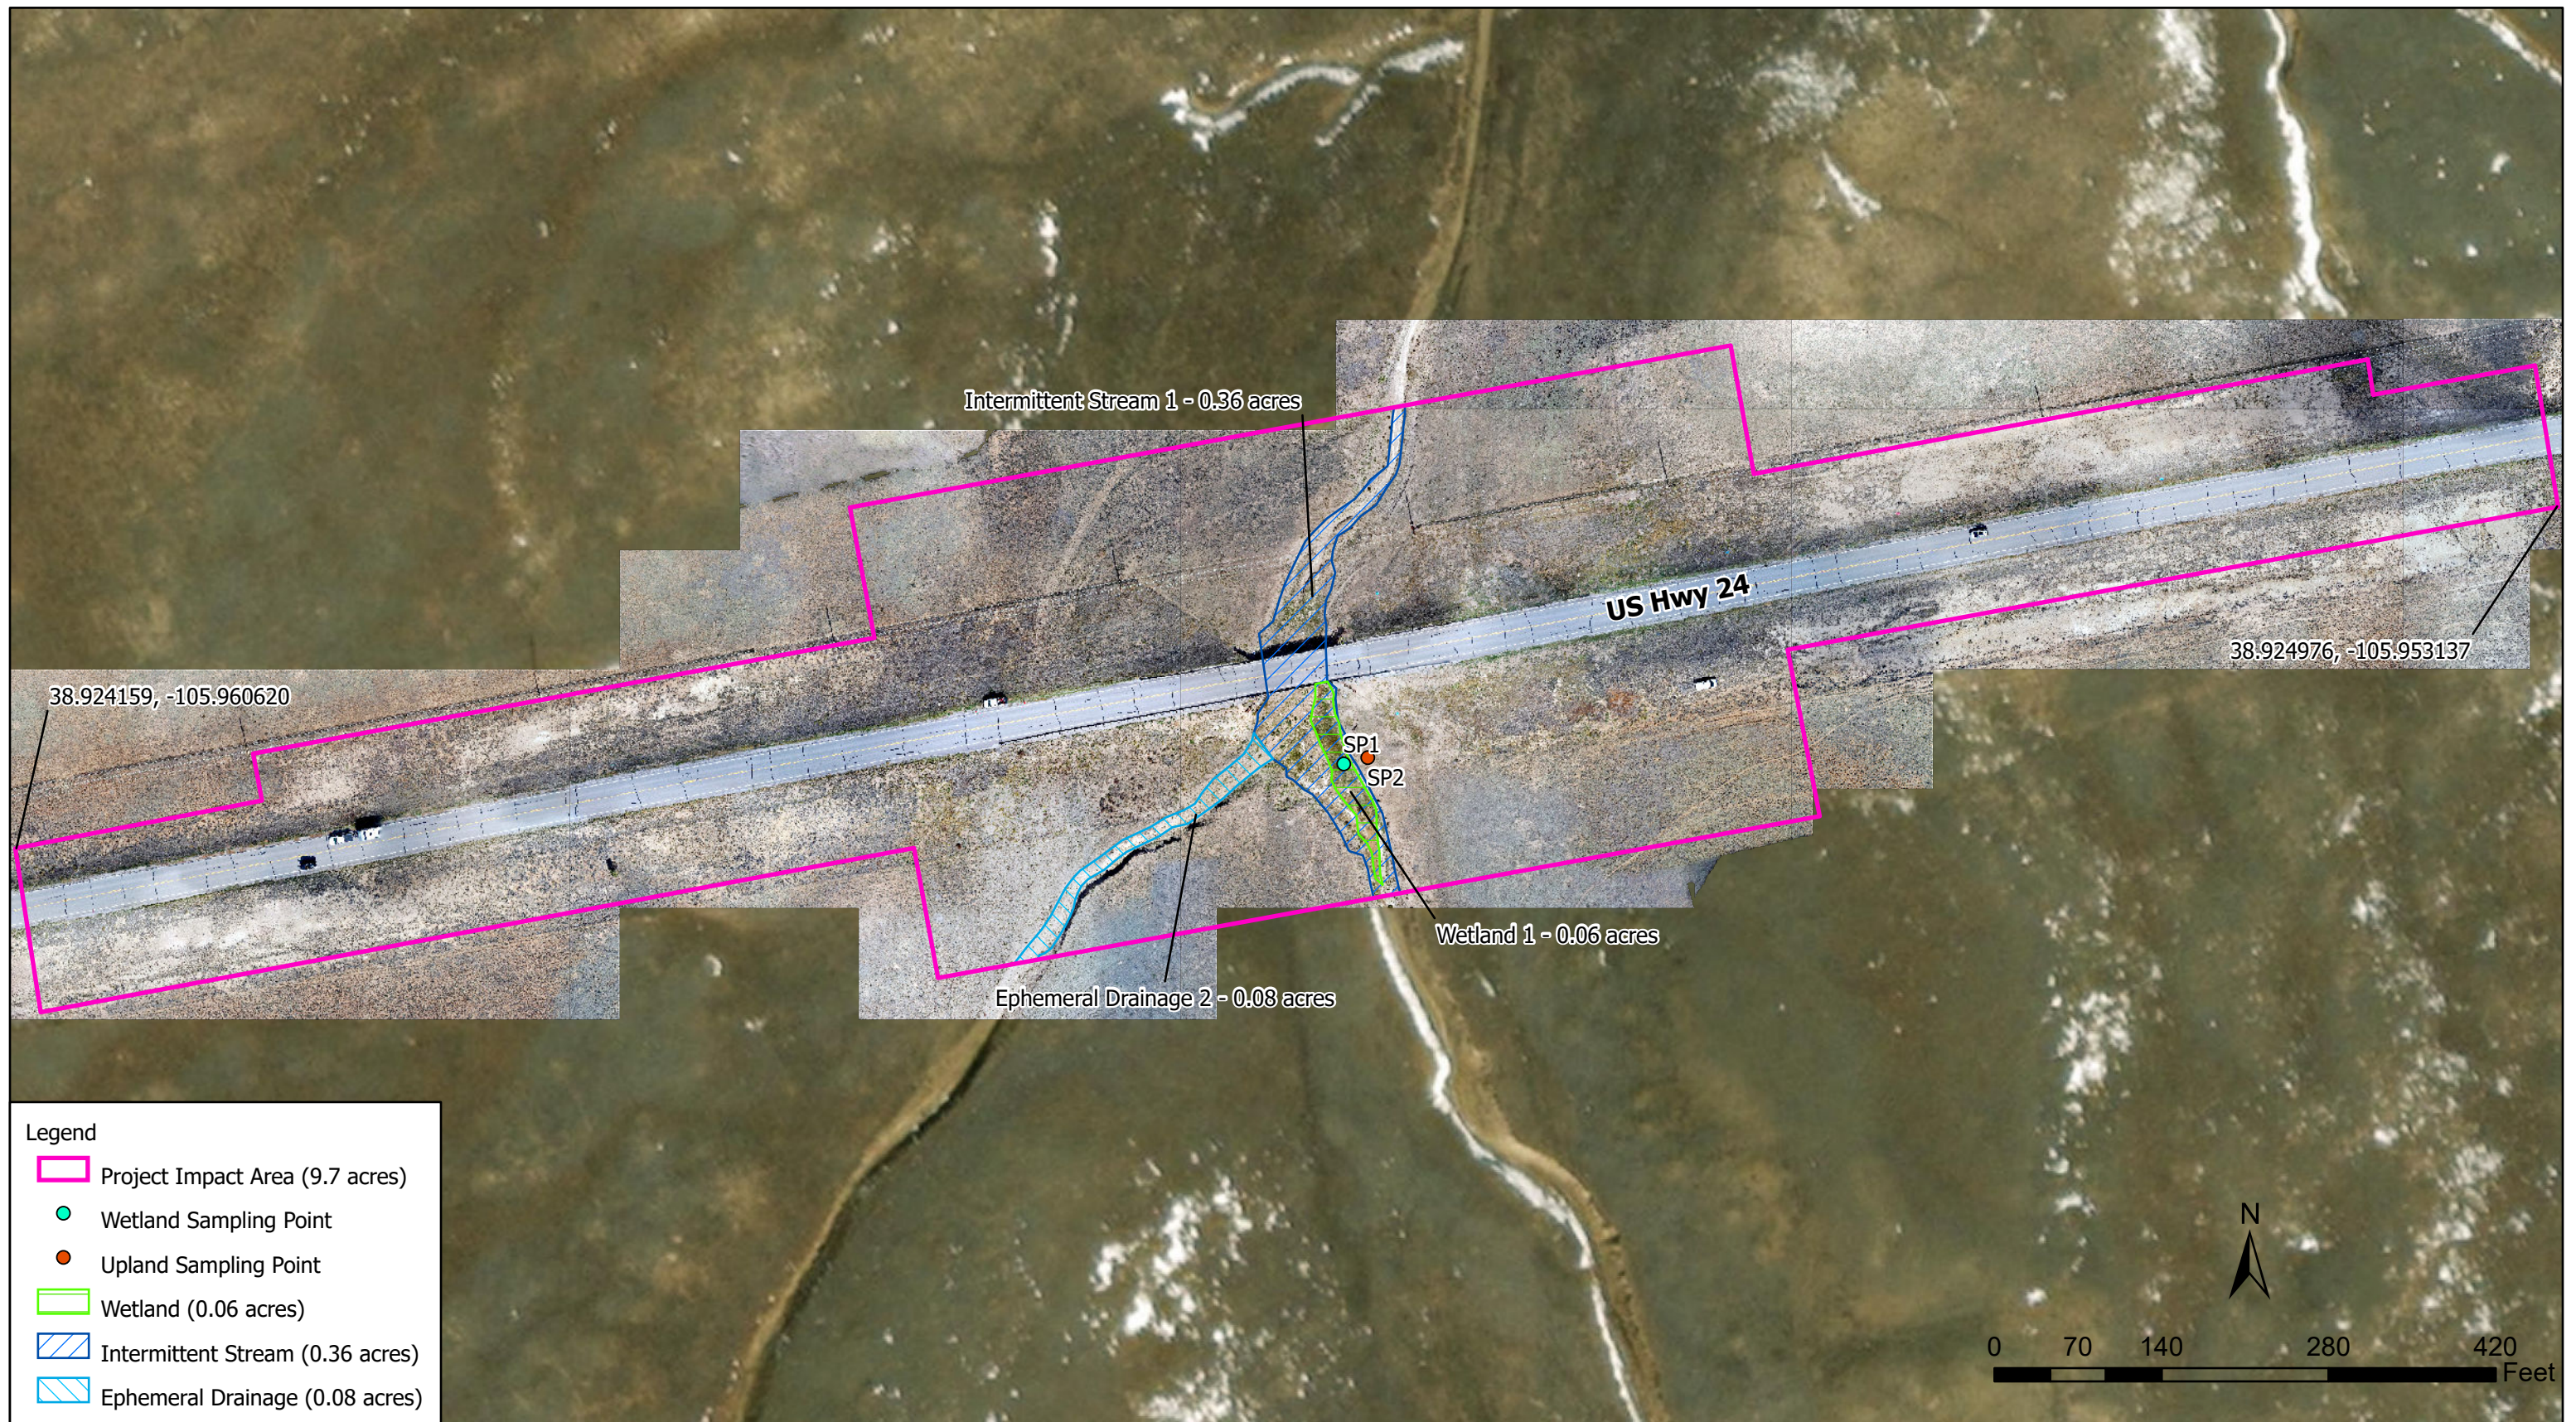
Figure 2: Aquatic Delineation Map

- Project Impact Area (9.7 acres)
- Wetland Sampling Point
- Upland Sampling Point
- Wetland (0.06 acres)
- Intermittent Stream (0.36 acres)
- Ephemeral Drainage (0.08 acres)

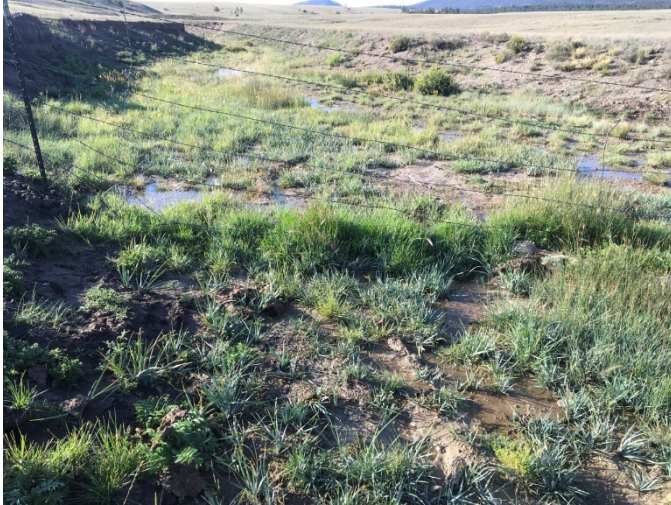
Photo 1.
Wetland 1, looking south and upstream from SP1. Wet alkaline meadow, lightly grazed, surface water present with a slight flow after recent rains.

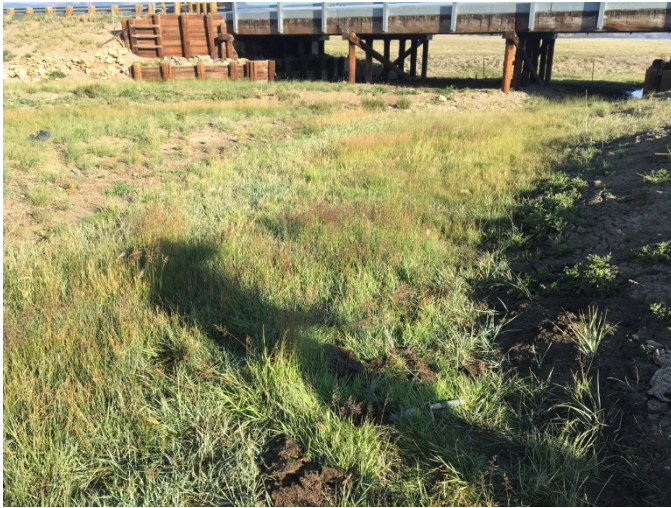
Photo 2.
Wetland 1, looking north towards US 24 and I-13-G from SP1. Wetland continues to the right side of bridge and ends in small scour pool. Upland slope on right edge of photo, with the main channel to the left of the wetland area.

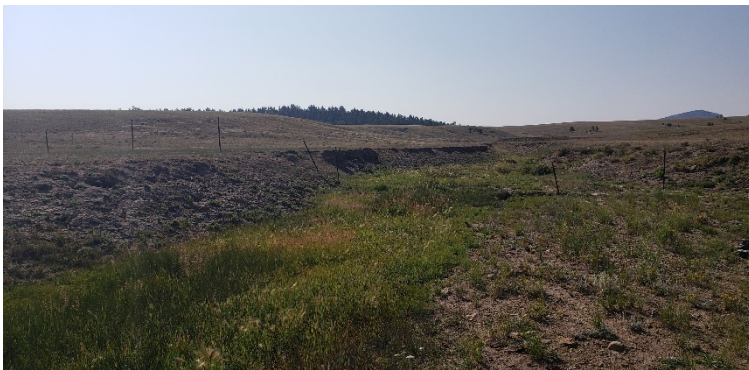
Photo 3.
Wetland 1 and Intermittent Drainage 1, looking north from I-13-G, with upland bench on left (location of SP2).

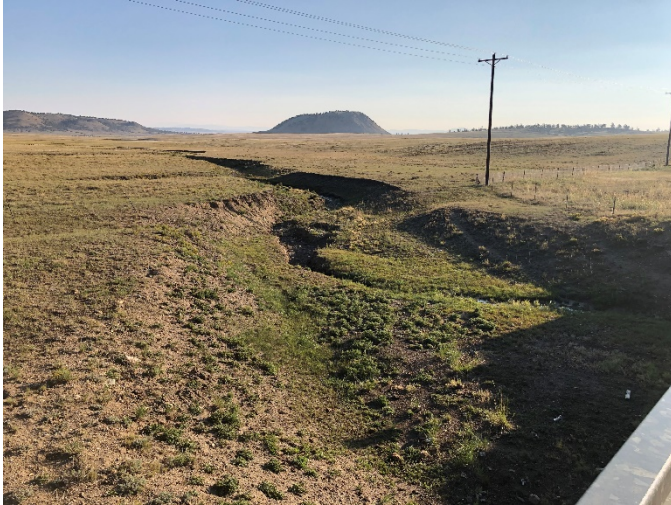
Photo 4.
Intermittent Drainage 1, looking north from I-13-G at downstream section of drainage. After structure, the channel quickly narrows down to a more typical channel width.

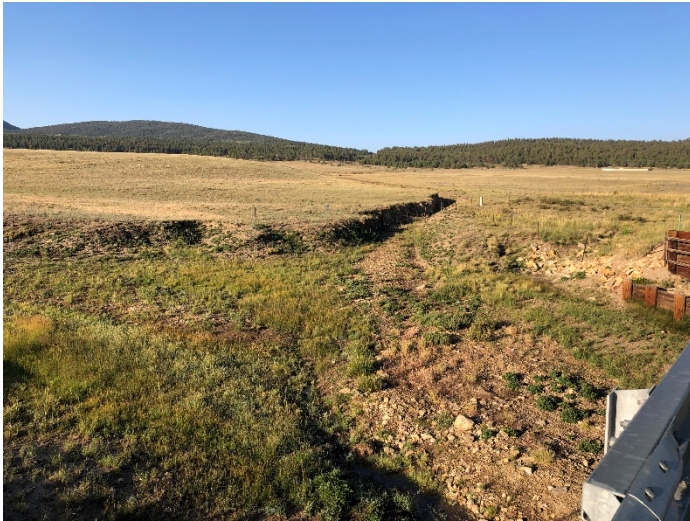
Photo 5.
Ephemeral Drainage 2, looking southwest from I-13-G towards confluence of drainages. E-Drainage 2 is in the background.

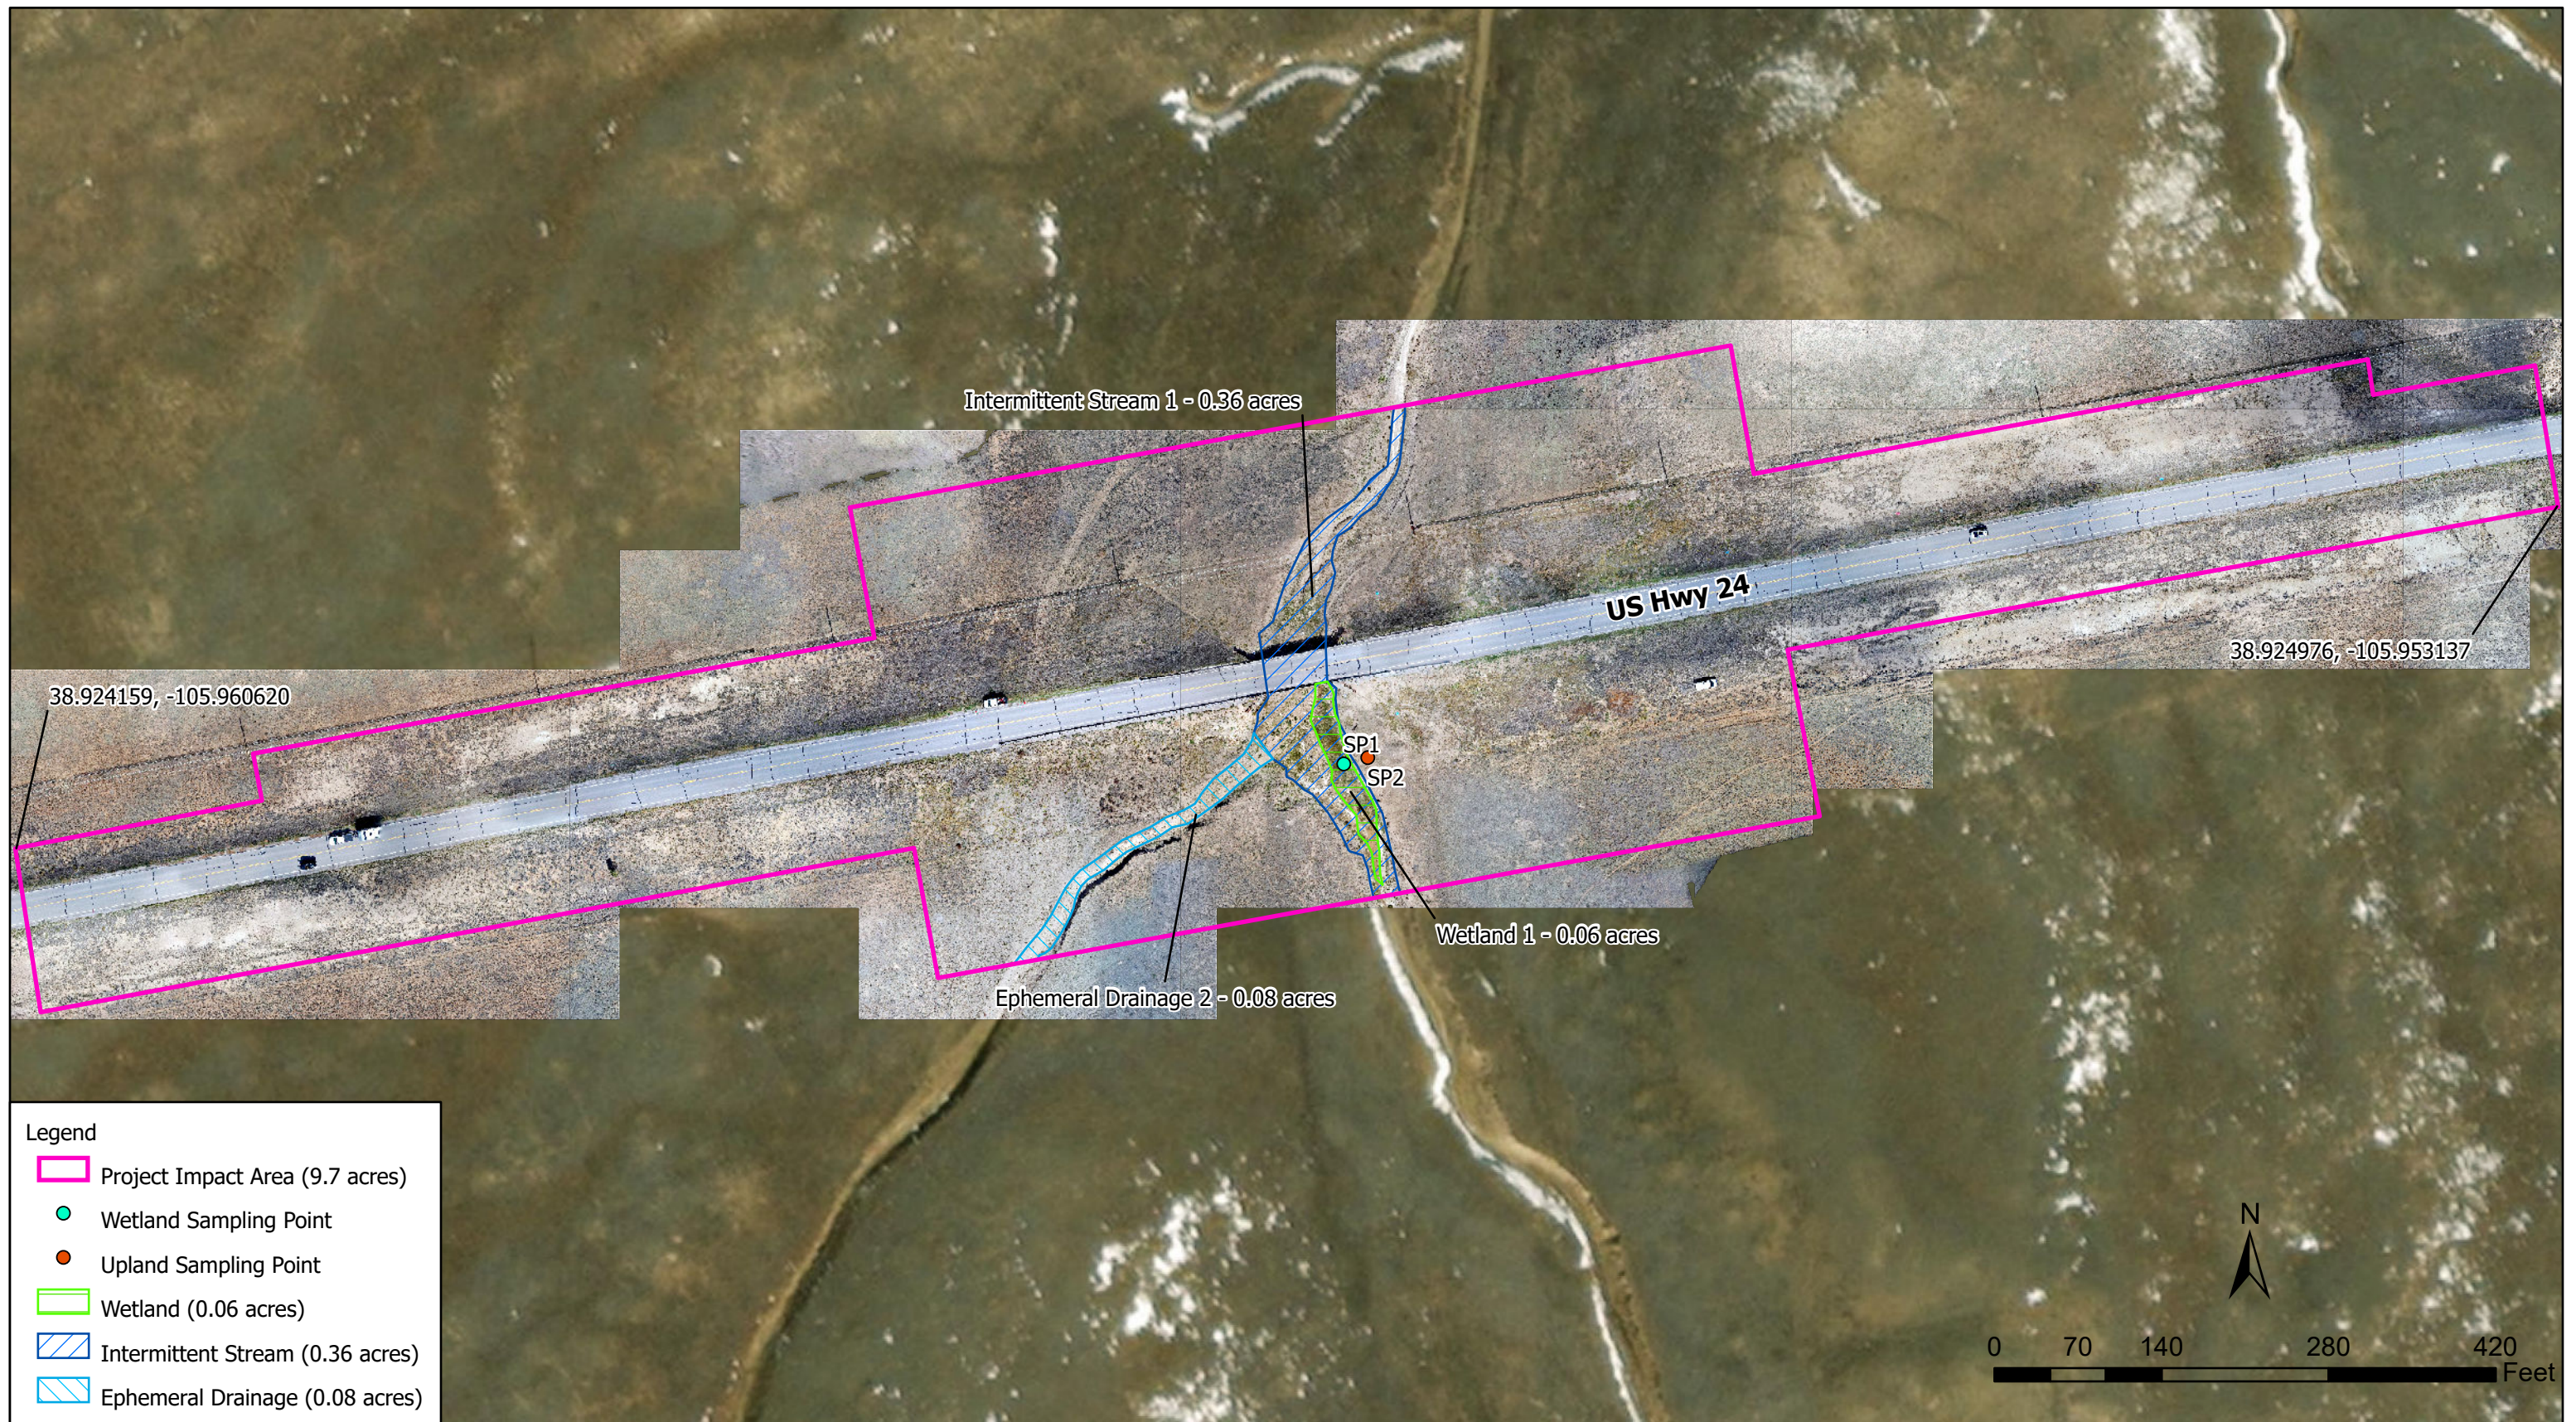
Figure 2: Aquatic Delineation Map

- Project Impact Area (9.7 acres)
- Wetland Sampling Point
- Upland Sampling Point
- Wetland (0.06 acres)
- Intermittent Stream (0.36 acres)
- Ephemeral Drainage (0.08 acres)
