# Aquatic Resources Delineation Report Bridge I-13-H

Stanley Consultants, Inc.  
8000 South Chester St, Ste 500  
Centennial, Colorado 80112

Colorado Department of Transportation, Region 2  
5615 Wills Blvd.  
Pueblo, Colorado 81008

**January 2021**

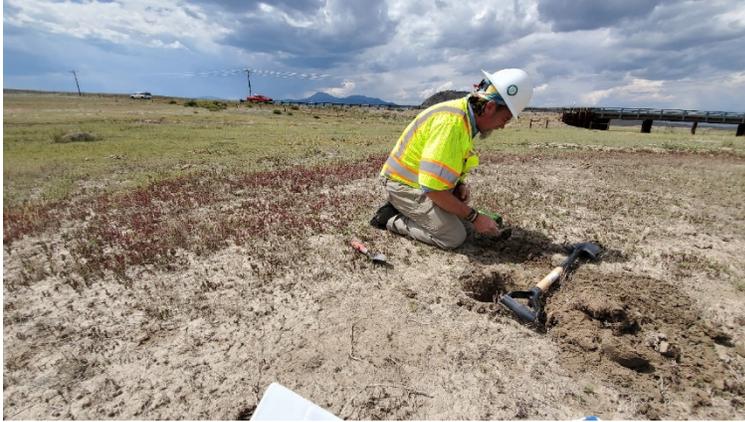
**Photo 1.**  
**Wetland 1,** looking northwest at SP1 (wetland point) towards US 24. Wet alkaline meadow, heavily grazed, dry at the time of investigation as the wetland is likely seasonal.

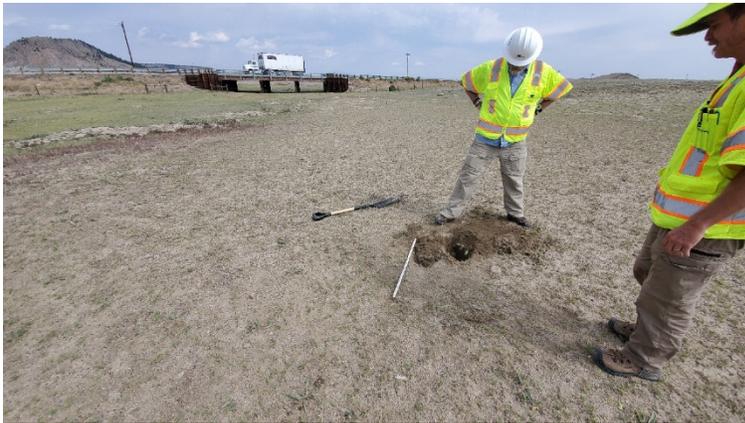
**Photo 2.**  
**Wetland 1,** looking northwest at SP2 (upland point) towards US 24. Upland area close to wetland boundary (photo left), soils and hydrology failed but vegetation was still considered hydrophytic. Site heavily grazed and disturbed by livestock.

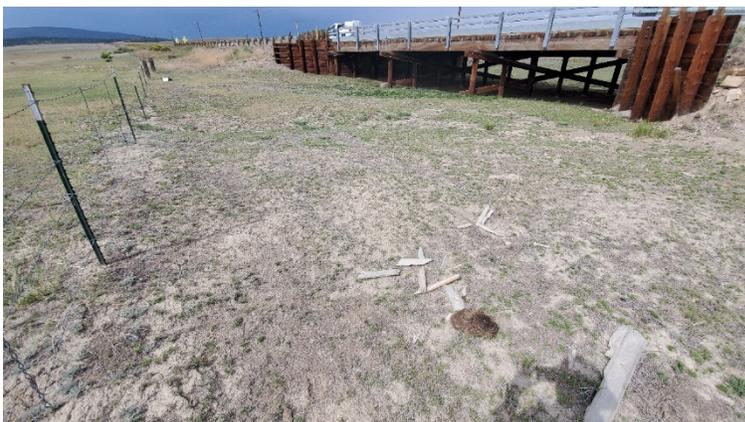
**Photo 3.**  
**Wetland 1,** looking southwest towards I-13-H and US 24 at part of Wetland 1 as it narrows under the bridge. Foreground is in the wetland, but area by other side of bridge failed to display wetland conditions.

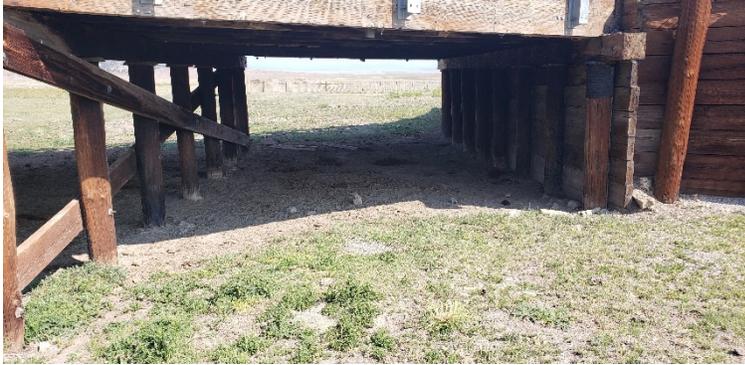
**Photo 4.**  
**Wetland 1**, looking northwest under Bridge I-13-H where Wetland 1 narrows and stops under bridge and become a small scour pool in front of the abutment.

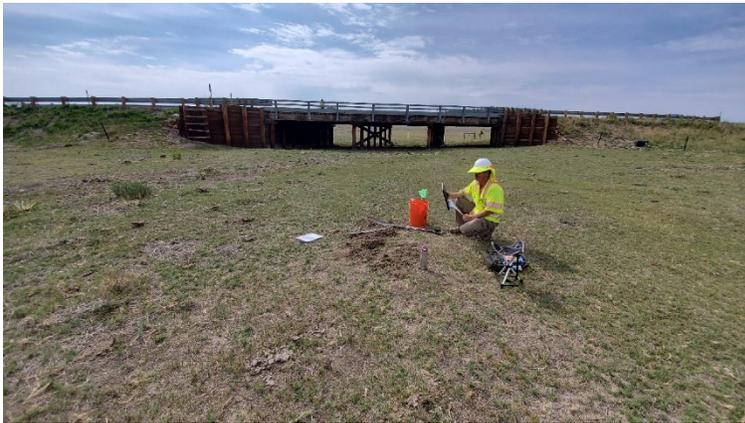
**Photo 5.**  
**SP3**, looking southeast from SP3 (upland point) on other side of I-13-H from Wetland 1. Area failed to indicate wetland conditions.
