# Aquatic Resources Delineation Report Bridge I-15-AO

FINAL

**January 2021**

COLORADO DEPARTMENT OF TRANSPORTATION  
 Region 2 Bridge Rebuild Project - Bridge I-15-AO  
 Aquatic Resources Delineation Report

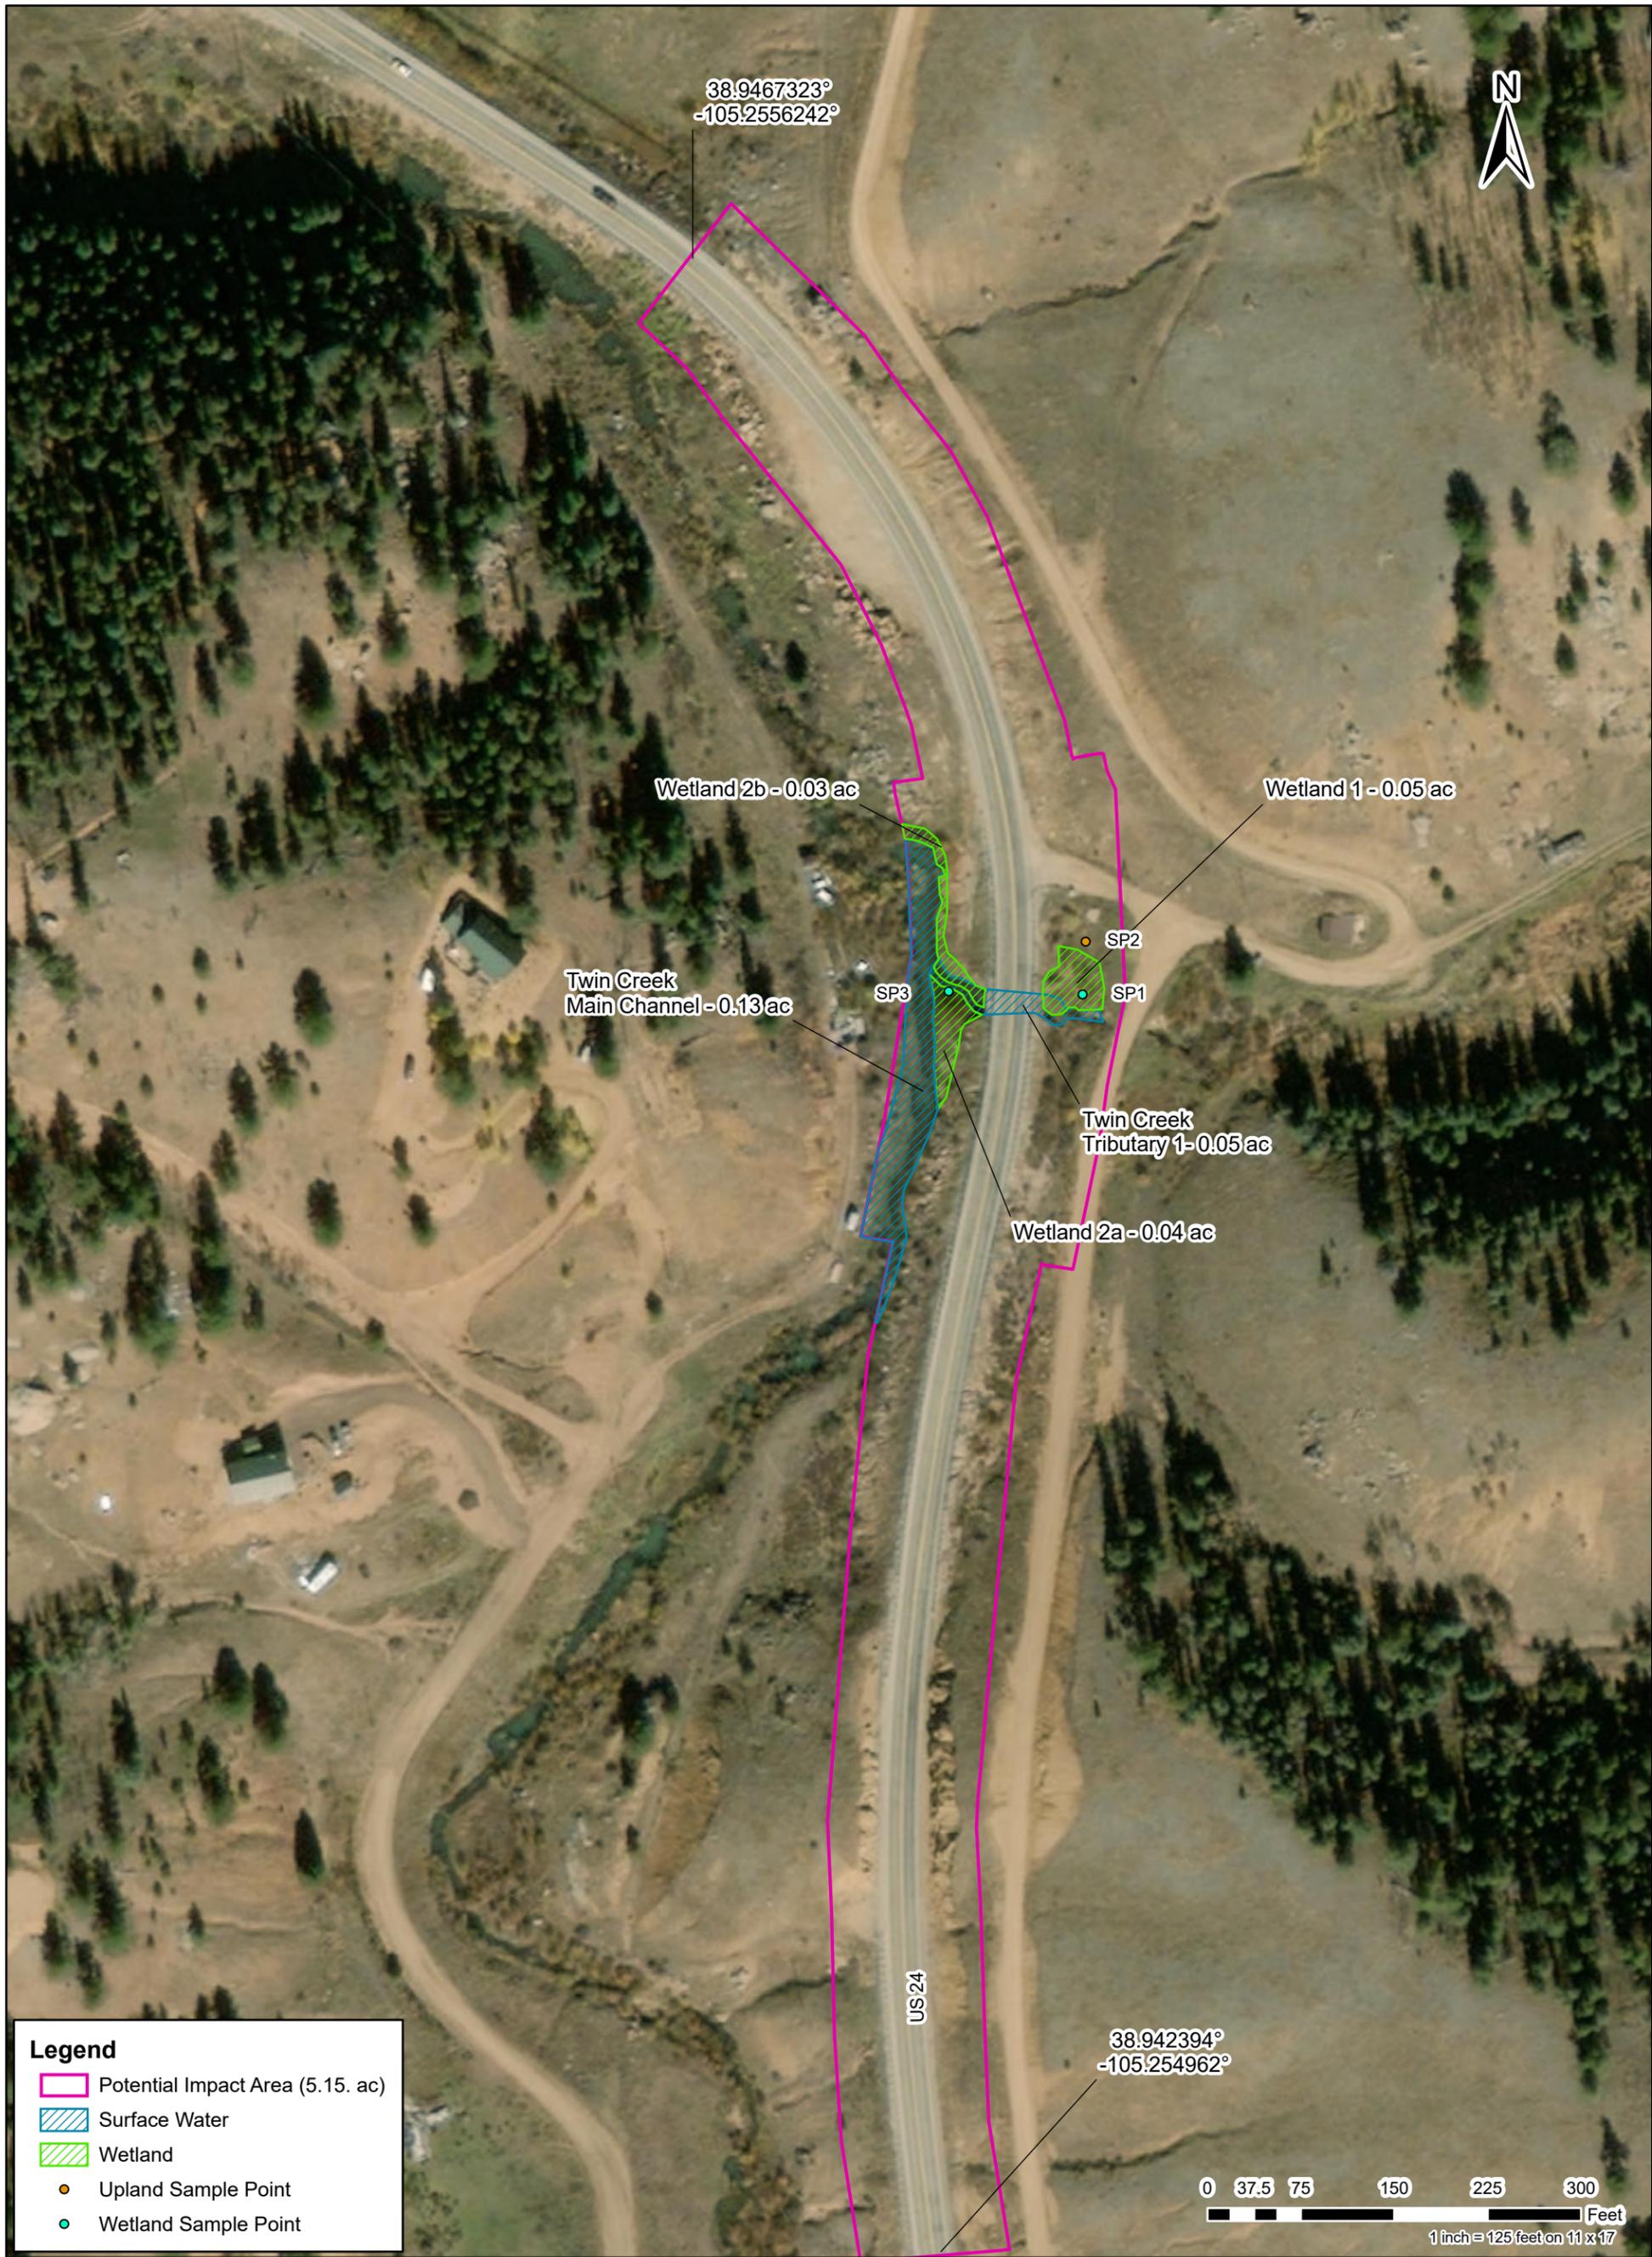
**Figure 2**  
**Aquatic Resources Delineation Map**

- Potential Impact Area (5.15. ac)
- Surface Water
- Wetland
- Upland Sample Point
- Wetland Sample Point

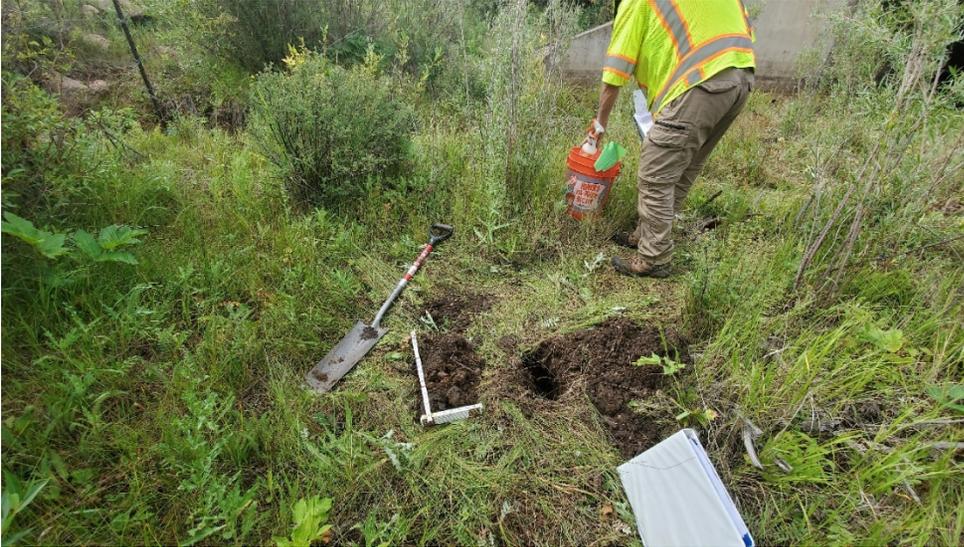
**Feature:** Wetland 1

**Photo Location:** Inside wetland, facing south

**Description:** Wetland is a palustrine scrub-shrub wetland(0.05 ac) located on the northeastern side of the I-15-AO bridge.

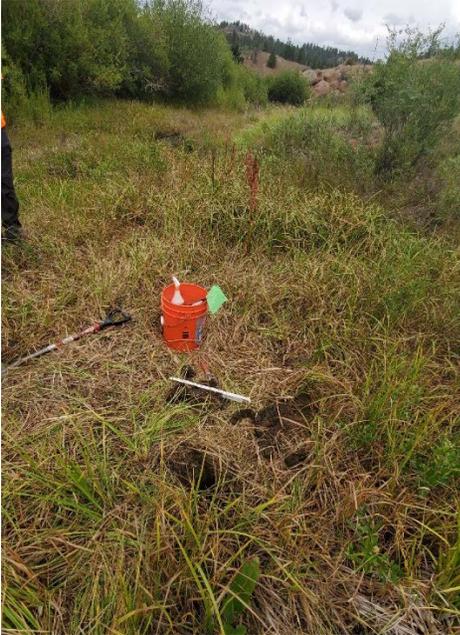
**Feature:** Wetland 2a

**Photo Location:** Inside wetland, facing north

**Description:** Wetland is a palustrine emergent wetland (0.04 ac) located along the edge of Twin Creek, on the southwest side of the I-15-AO bridge.

Wetland 2a wetland extends from the OHWM of the abutting channel onto the bank and terrace between the roadway fill toe of slope and the adjacent gently sloping drier land (see Wetland 2a, Appendix D: Photo Inventory). The soils observed in the soil pit (SP3)

consisted of dark grayish-brown clay loam on top of a dark gravel bar. The dark grayish-brown later extended from the surface to below 18 inches and contained redox concentrations within the pore linings in the top 8 inches. This layer satisfied the Redox Dark Surface (F6) hydric indicator. Wetland hydrology was present as saturation starting at the soil surface and the water table starting at 8 inches, as well as sediment deposits and water-stained leaves.

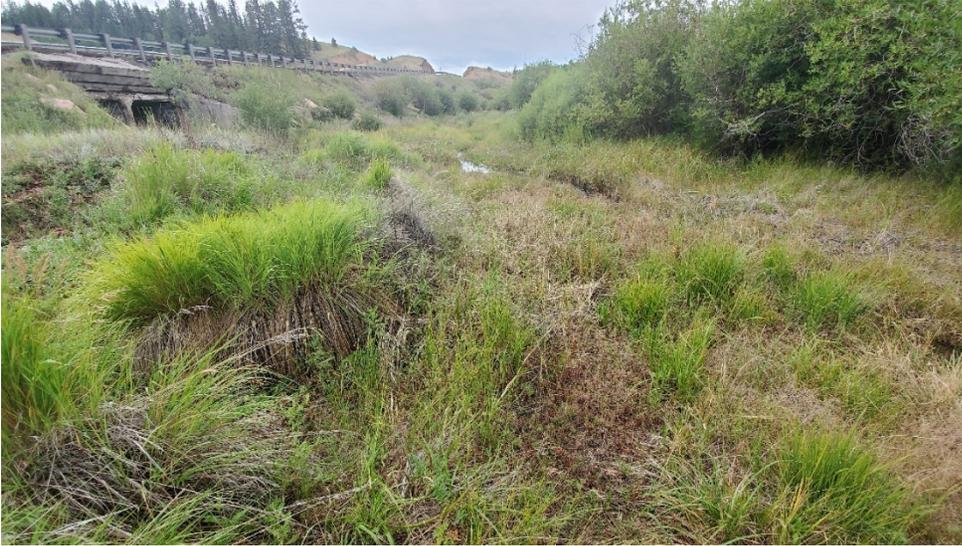
**Feature:** Wetland 2b

**Photo Location:** Within wetland, facing south

**Description:** Wetland is a palustrine emergent wetland (0.06 ac) located along the edge of Twin Creek, on the northwest side of the I-15-AO bridge. The wetland is located on a terrace above Twin Creek.

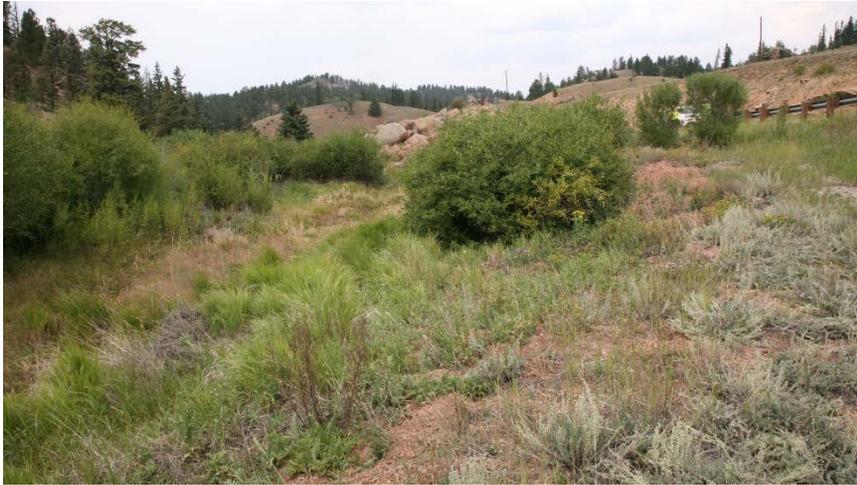
**Feature:** Wetland 2b

**Photo Location:** Facing north into uplands

**Description:** Wetland is a palustrine emergent wetland (0.06 ac) located along the edge of Twin Creek, on the northwest side of the I-15-AO bridge. The wetland boundary stop where vegetation species transition into upland dominated species and the terrain slopes up to meet the road fill toe of slope..

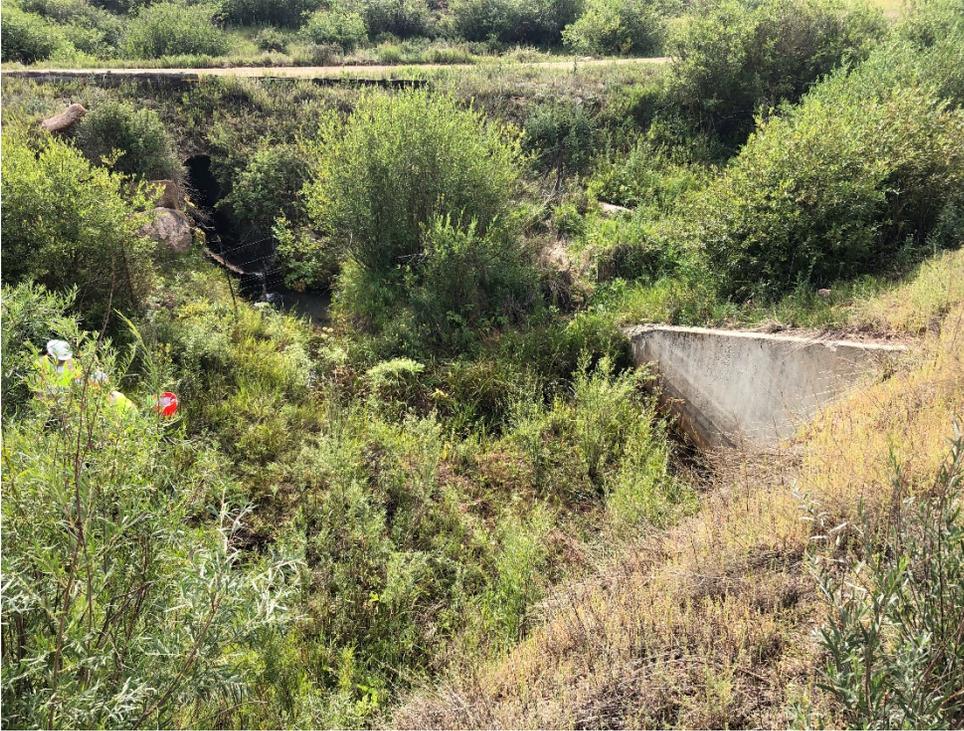
Photopage 4

**Description:** The terrain around the southeast side of the bridge rises sharply from the drainage banks, which extends from the culvert in the top left corner of the photo to the wing wall in the center right of the photo. Note the two surveyors on the center left of the photo, collecting a sample point from SP1 (see Appendix A, Figure 2), in Wetland 1 – they are located much lower than the terrain on the southeast corner of the bridge.

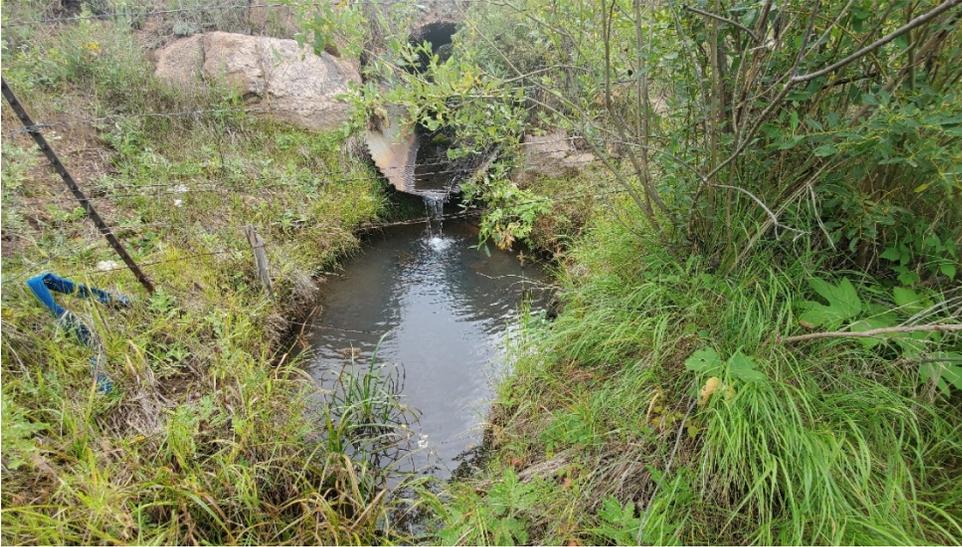
**Feature:** Twin Creek – Tributary 1

**Photo Location:** East side of I-15-AO bridge, facing upstream (east)

**Description:** Tributary is an intermittent to perennial branch of Twin Creek that discharges into the main channel of Twin Creek immediately downstream of the bridge. The portion of the channel within the PIA is 175 linear feet and 0.05 acres. Vegetation on the east side of the bridge is characterized as freshwater wetland scrub-shrub.

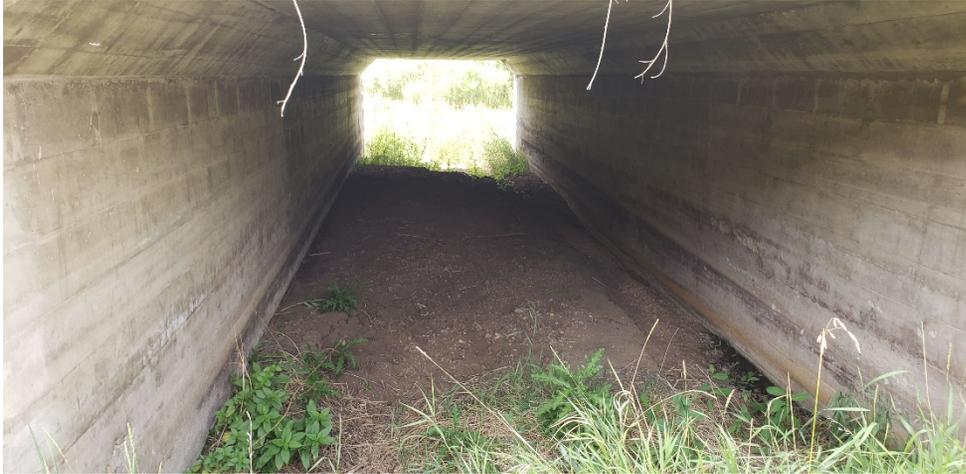
**Feature:** Twin Creek – Tributary 1

**Photo Location:** Under the I-15-AO bridge, facing downstream (west)

**Description:** Tributary is an intermittent to perennial branch of Twin Creek that discharges into the main channel of Twin Creek immediately downstream of the bridge. The portion of the channel within the PIA is 175 linear feet and 0.05 acres.
