Aquatic Resources Delineation Report

Bridge J-14-C Survey

January 2021

**COLORADO DEPARTMENT OF TRANSPORTATION
Region 2 Bridge Rebuild Project - Bridge J-14-C
Aquatic Resources Delineation Report**

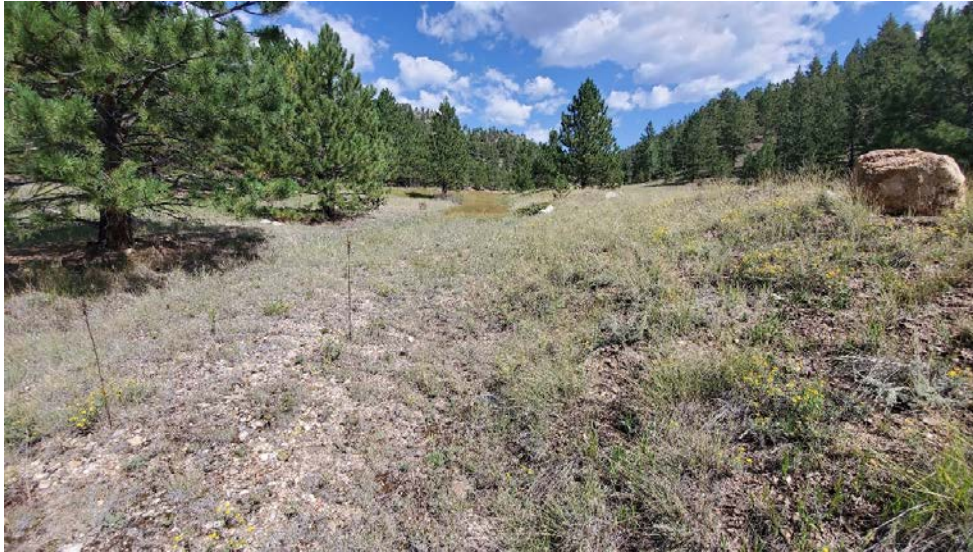
Photo 1

Feature: Louis Gulch

Photo Location: Upstream (north) side of bridge, facing upstream (north)

Description: This photo is taken at the upstream extent of the channel's OHWM. The drainage is a swale with no visible OHWM upstream of the PIA, although a more distinct OHWM may be present further upstream from the surveyed area, as is suggested by the band of Baltic rush (*Juncus balticus*) rush visible at the top of the drainage in this photo.

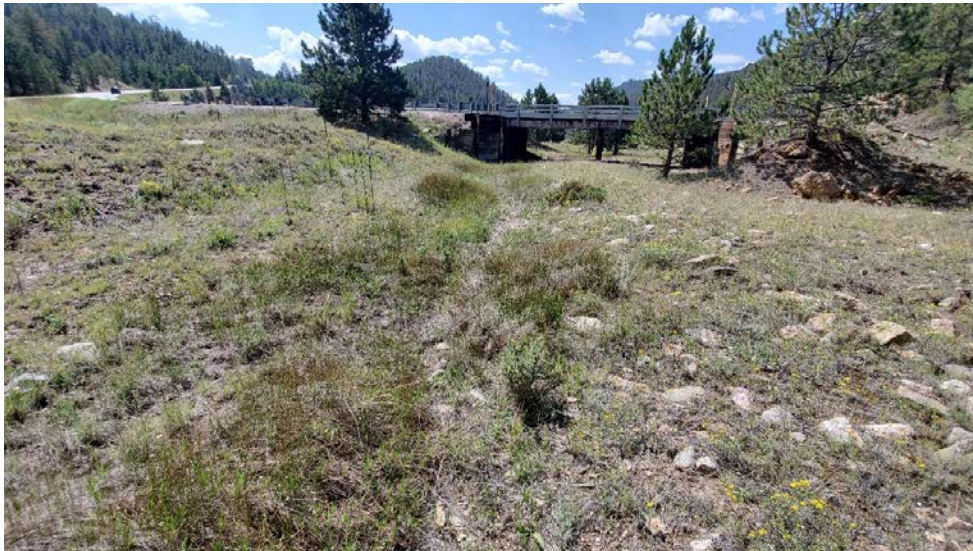
Photo 2

Feature: Louis Gulch

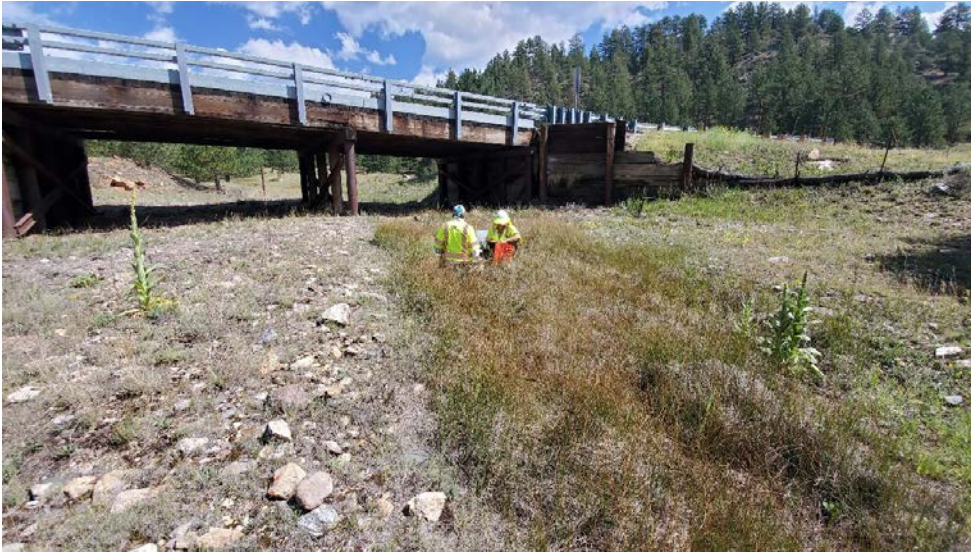
Photo 3

Feature: Louis Gulch

Photo Location: Downstream (south) side of bridge, facing upstream (north)

Description: Baltic rush becomes denser and more concentrated downstream of the bridge. Large cobble deposits were observed within the OHWM throughout the PIA.

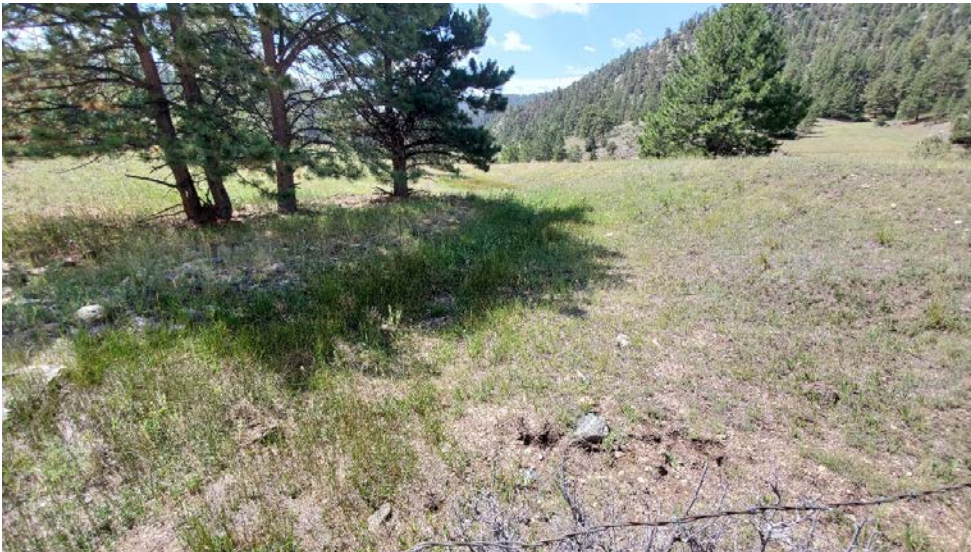
Photo 4

Feature: Louis Gulch

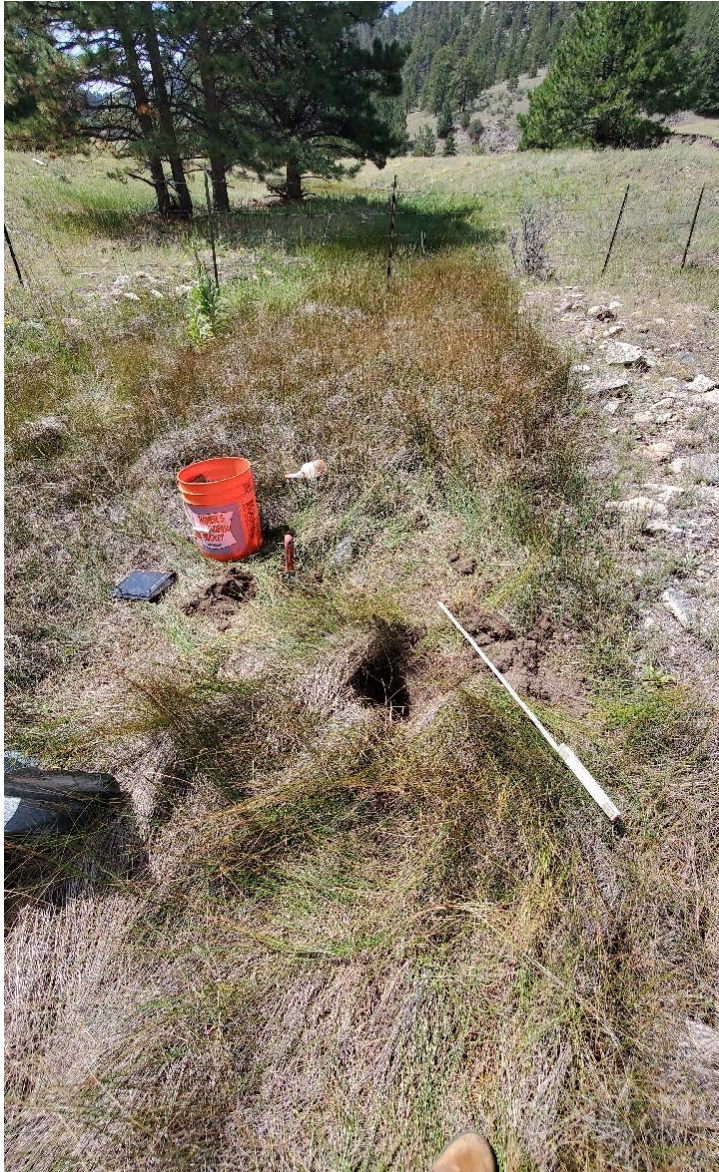
Photo 5

Feature: Louis Gulch

Description: This soil pit, located at a low point with the most moisture and highest concentration of Baltic rush, contained dry, sandy soil that, while dark, did not contain redox features that would qualify the soil as hydric.
