Aquatic Resources Delineation Report

Bridge M-21-C

FINAL

January 2021

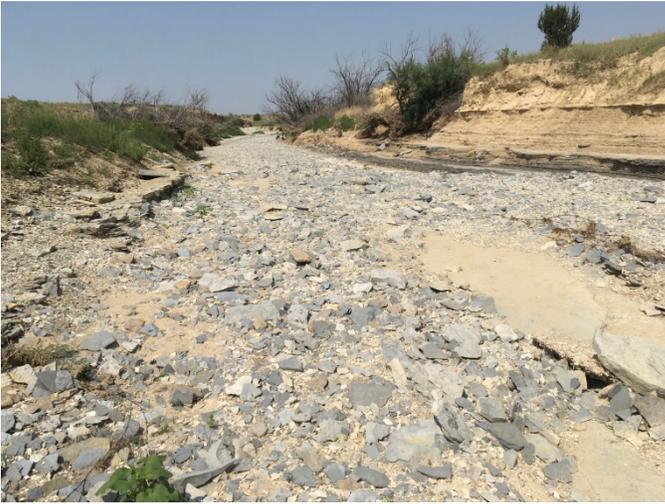
Photo 1.
Hoe Ranch Arroyo, looking north and downstream from bridge, at cross section A. OHWM can be seen starting below bankside woody vegetation.

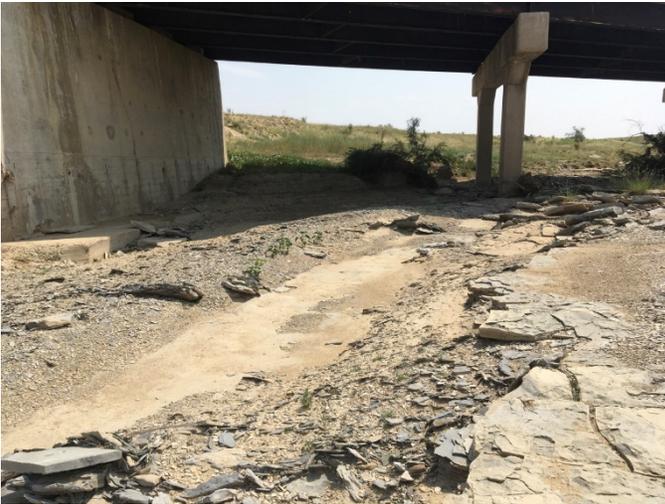
Photo 2.
Hoe Ranch Arroyo, looking south and upstream towards bridge, from cross section A. OHWM is from the bridge abutment (on left) to just outside of the photo on the right.

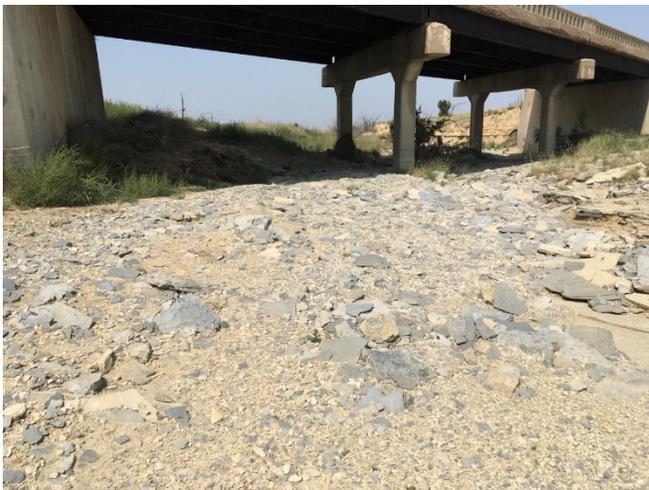
Photo 3.
Hoe Ranch Arroyo, looking north and under bridge structure. OHWM widens out some due to bridge structure, OHWM touches bridge abutment on the left then bend to contact the abutment on the other side (photo right, in background).

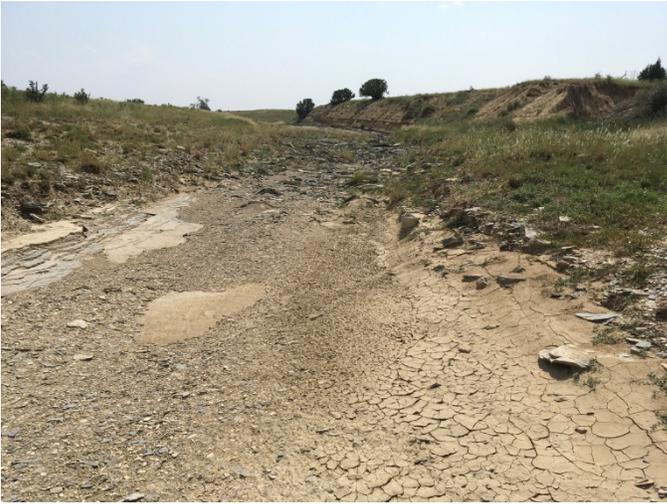
Photo 4.
Hoe Ranch Arroyo, looking south and upstream of bridge. Wide, eroded channel with soil cracking and sediment sorting can be seen.

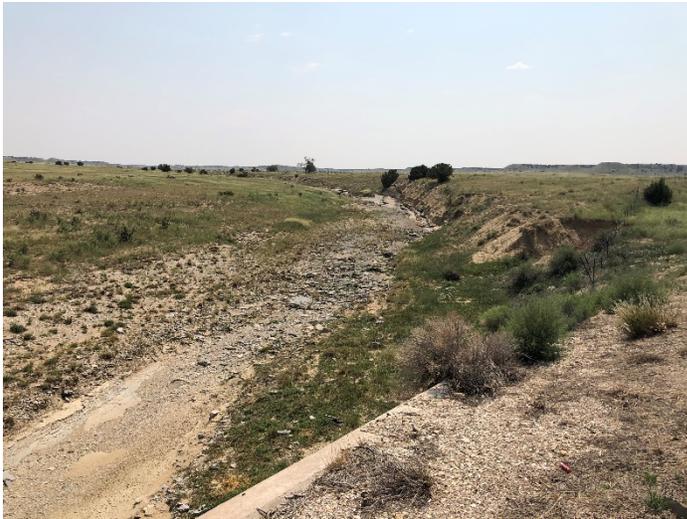
Photo 5.
Luning Arroyo, looking south and upstream of bridge. Banks widening out some here, then cuts into hillside in background.
