Aquatic Resources Delineation Report

Bridge M-21-I

FINAL

January 2021

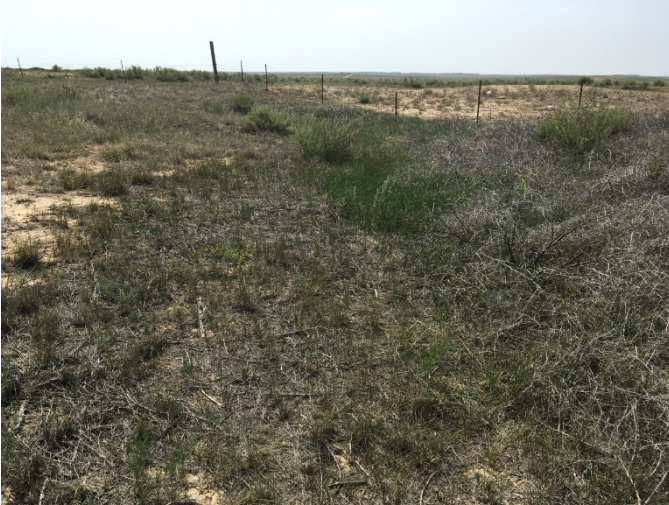
Photo 1.
Ephemeral swale, looking southwest and upgradient from bridge, at the condition of the swale. No continuous, well defined channel, only vague, rarely used swale coming from left side of the low dam (see Photo 3).

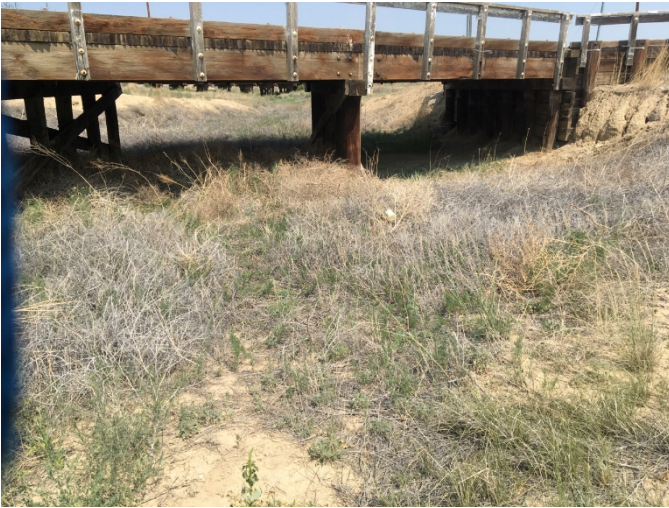
Photo 2.
Ephemeral swale, looking north and downgradient from near the CDOT ROW fence. The swale appears to just be a vegetated, ephemeral swale, with no defined channel. Possible small scour pool on right side of the underside of the bridge. However, its also heavily used by resting cattle, may rarely contain water.

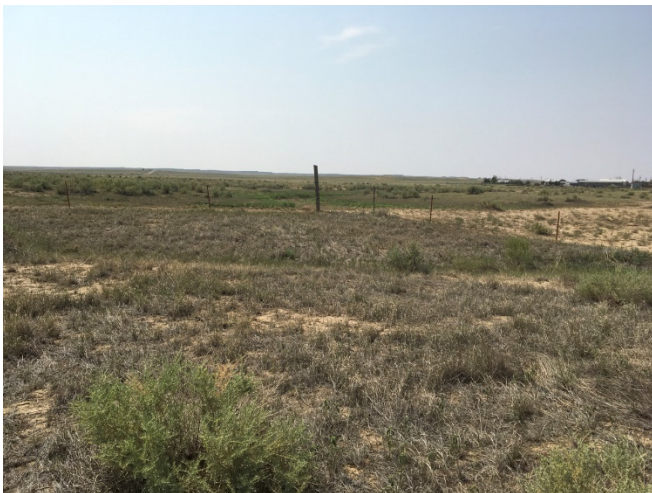
Photo 3.
Ephemeral swale, looking south at low dam which prevents nearly all flows that come from the south, from flowing in its original channel. There was evidence that rare events may breach the dam on the left side.
