Aquatic Resources Delineation Report

Bridge M-21-J

FINAL

January 2021

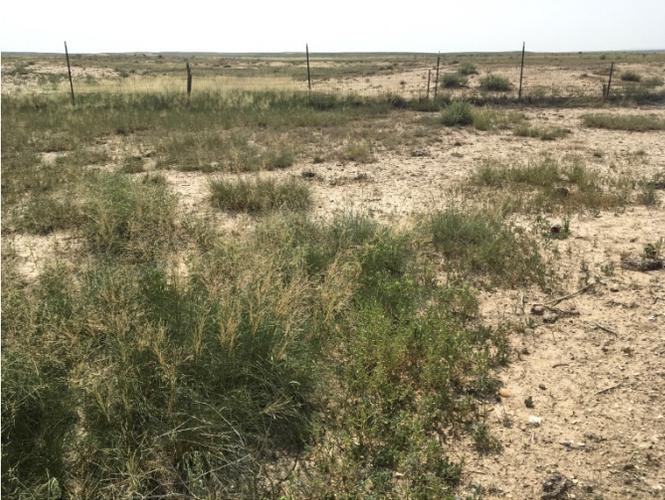
Photo 1.
Ephemeral swale, looking southeast and upgradient from bridge, at the condition of the swale. No floodplain of any type exists in this area, only a vague area of concentrated sheet flow.

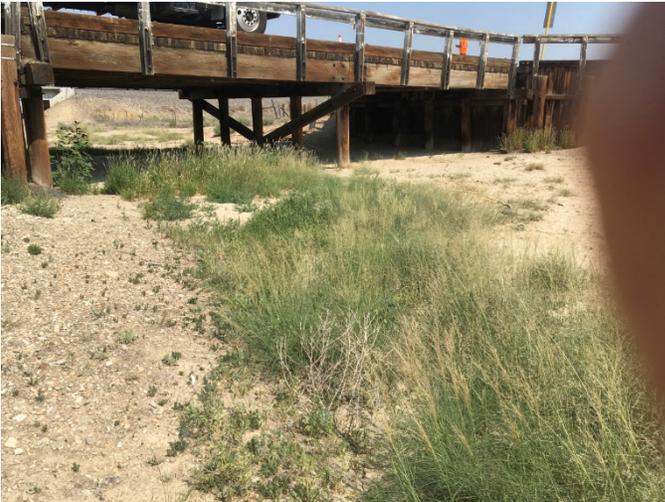
Photo 2.
Ephemeral swale, looking north and downgradient from near the CDOT ROW fence. The swale appears to just be a vegetated, ephemeral swale, with no defined channel of any sort. No distinct scour pool was observed under the bridge. Only the abutments appear to focus the normal sheet flow under the bridge.

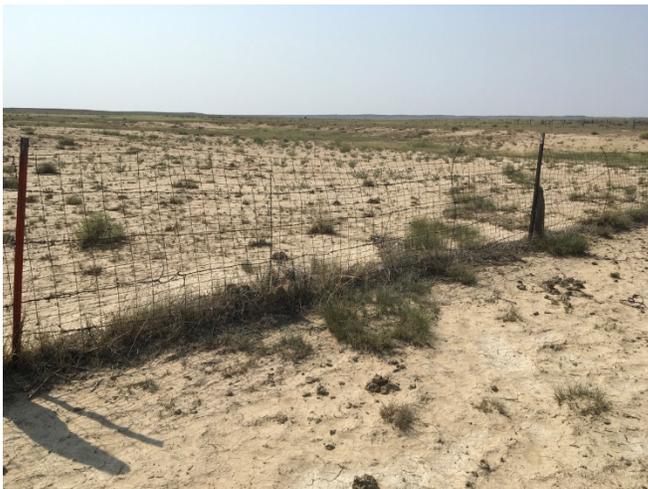
Photo 3.
Ephemeral swale, looking southeast beyond the CDOT ROW fence. No distinct floodplain, only a vague indication of any focused sheet flow in the distance.

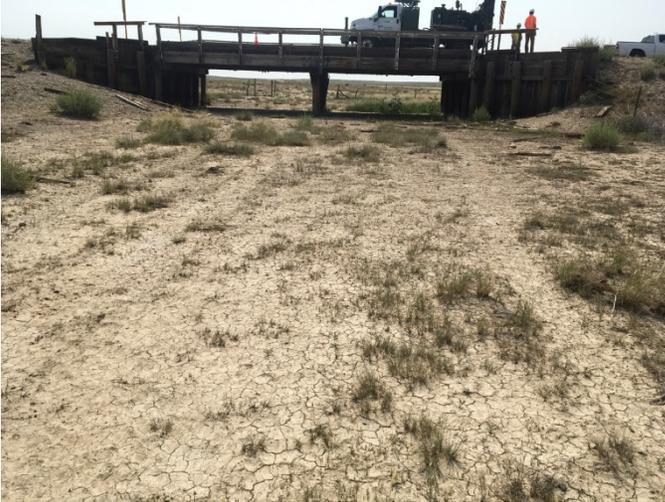
- There was no strong indication of any scour pool under the bridge. Slight soil cracks were evident downgradient of the bridge; this type of soil cracking is common in silty soils such as this, where precipitation may puddle for short periods of time immediately after storm events.

Photo 4.
Ephemeral swale, looking southeast and upgradient towards the bridge. No channel of any kind, only a vague area of concentrated sheet flow. Soil cracks are shallow and likely only indicate occasional and brief pooling after storm events. Due to the shallow slope in this area, it is not surprising what little water this area receives, it tends to move slowly, allowing soil cracks to form in this silty soil.

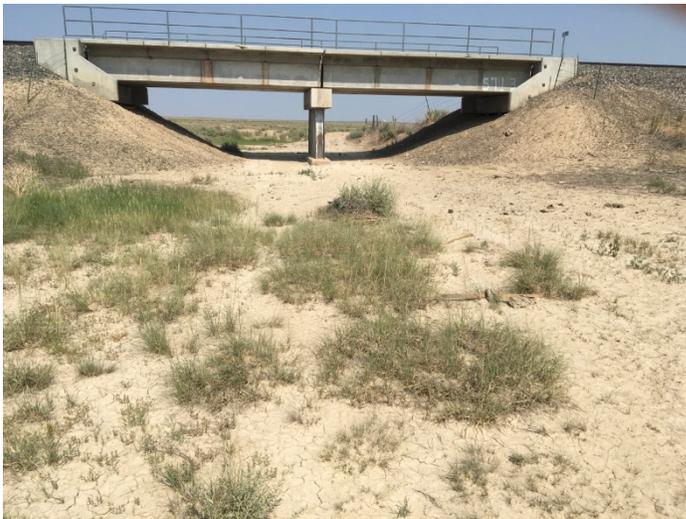
- Downgradient of the bridge, the slight swale feature continues towards the north, under the railroad bridge, and beyond. However, due to the very low gradient slope through this area, any storm event likely flows as sheet flow and moves very slowly along this northward path, leading to occasional pooling and minor soil cracking accompanied by a lack of any visible OHWM-defined channel or even a well-defined swale.

Photo 5.
Ephemeral swale, looking northwest and downgradient of bridge. No distinct channels of any sort, only a vague swale. Vegetation of grasses and forbs cover parts of the exposed silty soils. Railroad bridge in the distance.
